KAMEHAMEHA I SCULPTURE CONSERVATION TREATMENT REPORT

CONSERVATION TREATMENT REPORT

TITLE: Kamehameha I

DATE OF REPORT: 20 September 2001

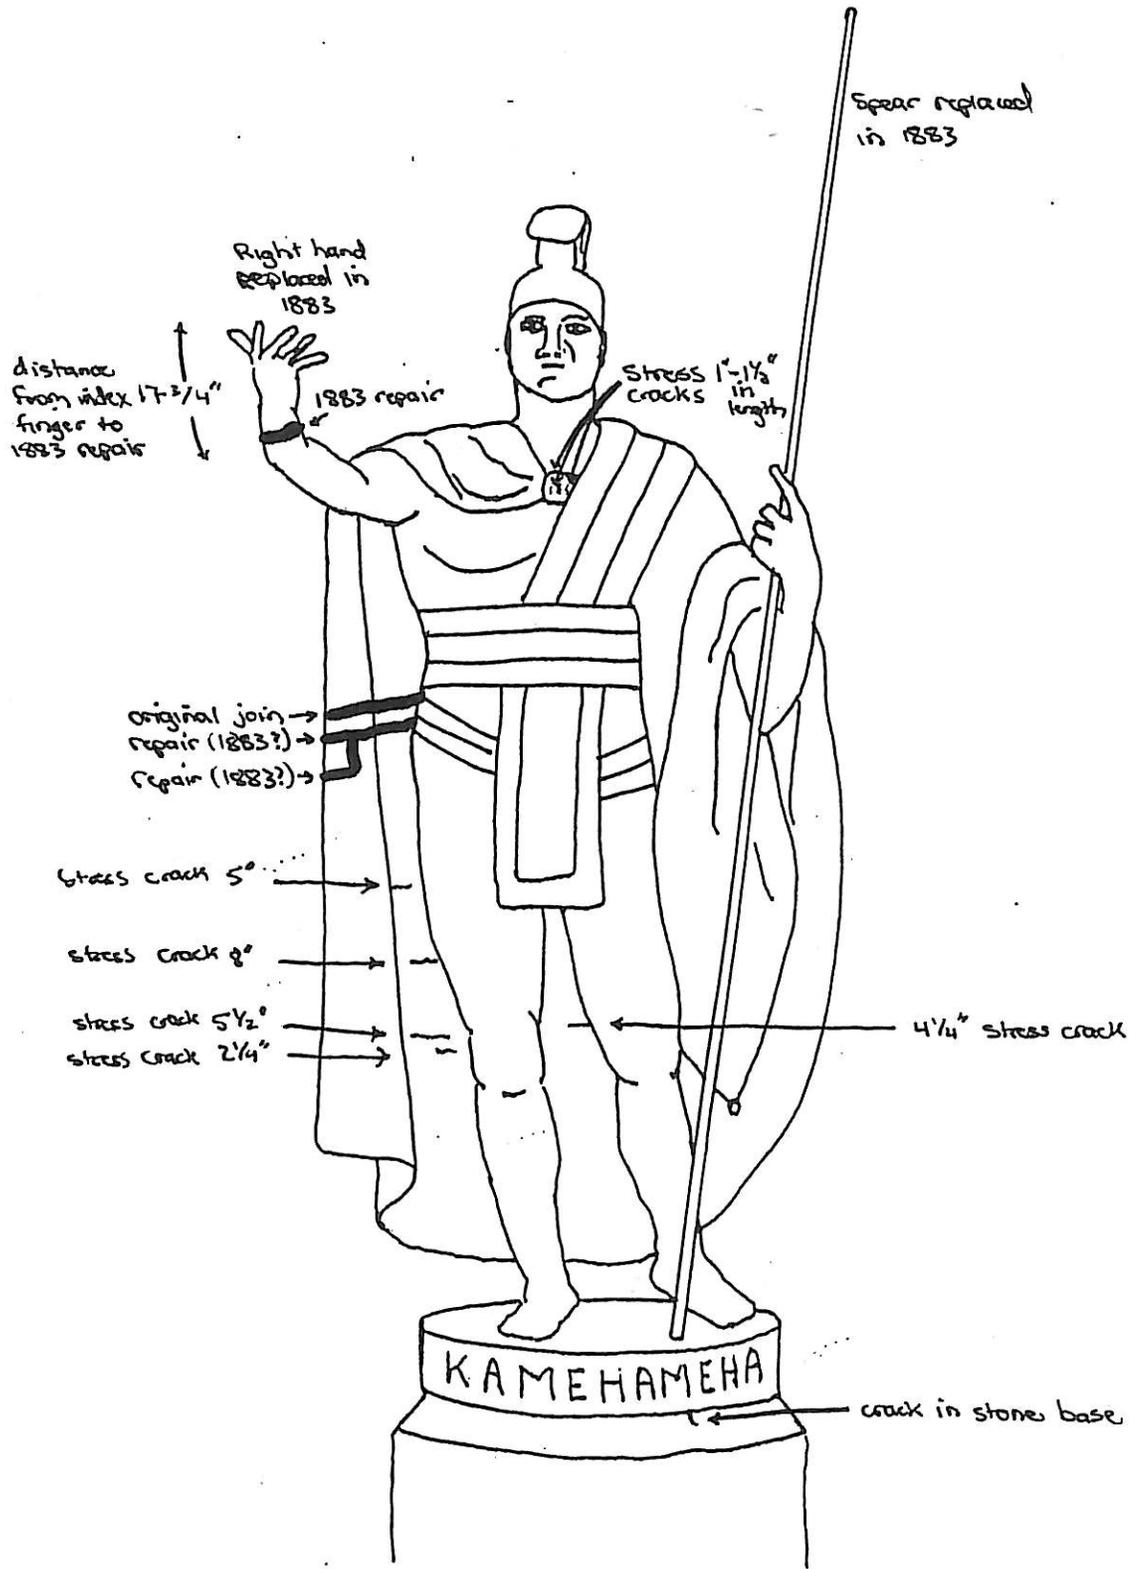
Condition Notes from March 2001 Conservation Project: FRONT

The sculpture is structurally in sound condition. The previous repairs and original welds are secure, although there are gaps along some of the weld lines. There are four areas of stress cracking, as noted on the attached diagram. The circular base is dented and cracked on the top and proper right side (see diagram). The crack is open in some areas. It is not known when this damage occurred, although it is not recent. Corrosion has developed within the cracks, and there are no signs of recent advances.

There are two areas of damage on the back proper right side of the cloak (see attached diagram). One of these was reported in newspaper articles from 1883, when it was noted that the cloak was damaged either during the shipwreck or from knocking against the boat as it was raised from the sea. One of these areas consists of a rectangular cast panel

that has been lead soldered in place. A small sample of solder was analyzed by x-ray fluorescence, and indicates an alloy of 89.5% Sn, 10.44% Pb, a few parts per million of copper and antimony, and no iron. (David Scott, The Getty Conservation Institute). The other is a complex open crack. This complex crack could be a casting flaw, since the metal is very thin along its edges. There are many round plugs in the cast that were inserted by the foundry to cover casting flaws. Some are carefully chased to match the adjacent surface, and some are not. There are approximately 25 small holes in the brass from air pockets in the original cast.

6. After paint removal, the condition of the monument was further assessed. Old repairs and original welded joins were found to be structurally secure. Four areas of stress cracking, gaps between the separately cast sections, small casting flaws, the tear on the proper right back side of the cape and the crack through the circular base were noted on the attached diagram for future monitoring

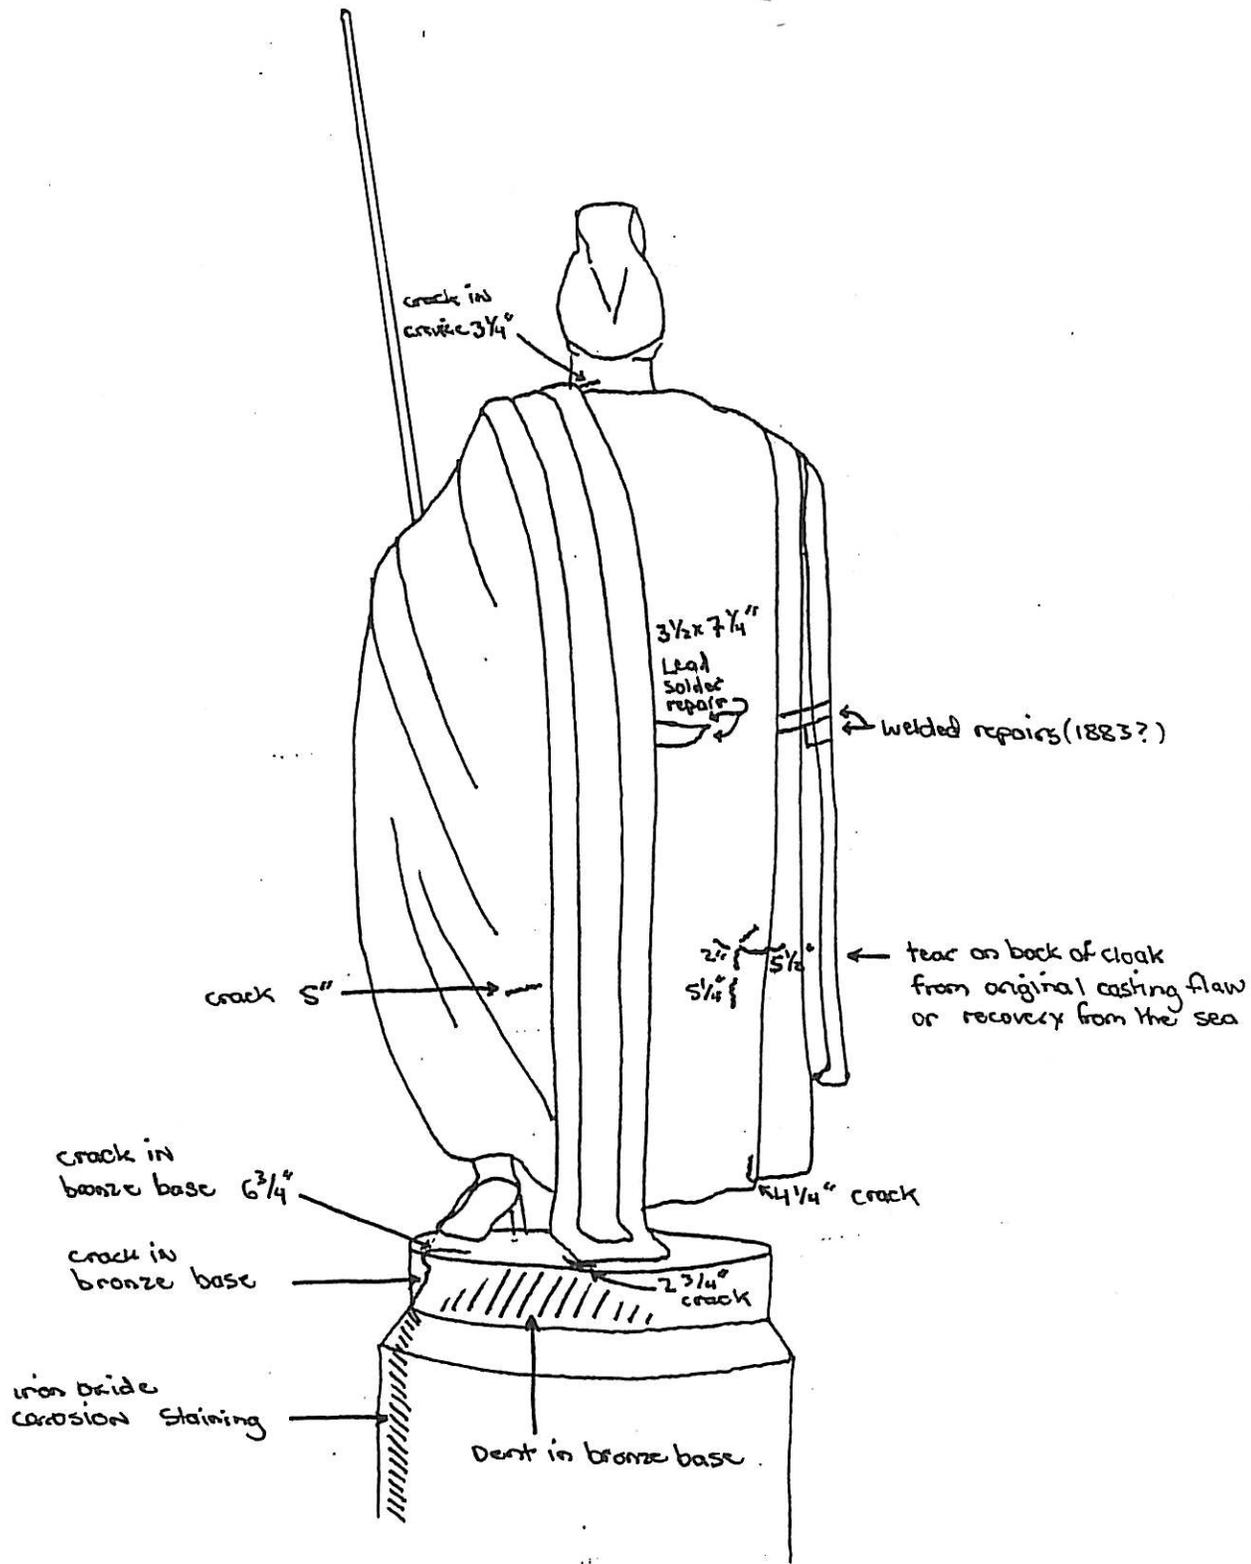
Condition Notes from March 2001 Conservation Project: BACK

The interior iron armature was not examined by radiography, fiber optics or other analytic devices. The only visible evidence of iron corrosion is iron oxide stains running down the side of the circular base onto the stone base adjacent to the dented and cracked area. No iron oxides were seen on the surface of the paint. Although most of the iron wires from gates and vents of the original cast were removed in the foundry, some were not, as noted by small areas of local iron corrosion on the brass surface.

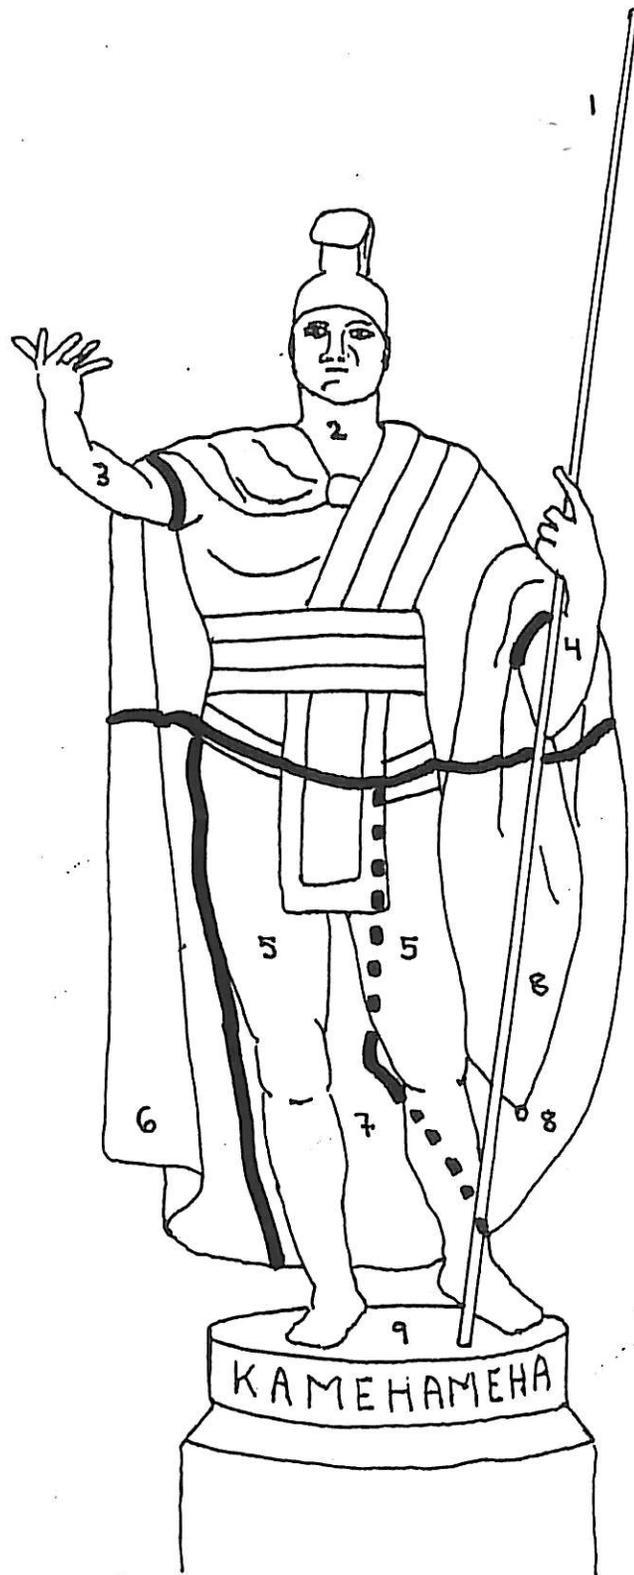
Original Fabrication in Nine Separately Cast Elements: FRONT

The monumental figure of King Kamehameha I is hollow cast in brass over an iron armature. The cast was made in nine separate sections, then welded together (see attached diagram). The figure of the King wears a *kīhei* (cloak), *mahiōle* (helmet), *kā'ei* (sash), and Western classical style sandals. His left hand holds a copper alloy *pololū* spear (unlike the original), which was fabricated during the restoration, and loosely inserted into the hand and welded to the circular base. His right arm is outstretched with an open palm, in a Western gesture of welcome.
