WOMEN'S OLD GYMNASIUM
HISTORIC STRUCTURE REPORT

Northwestern State University
Natchitoches, Louisiana

Regina T. Binder
With Joan Berkowitz and David Bitterman

1993

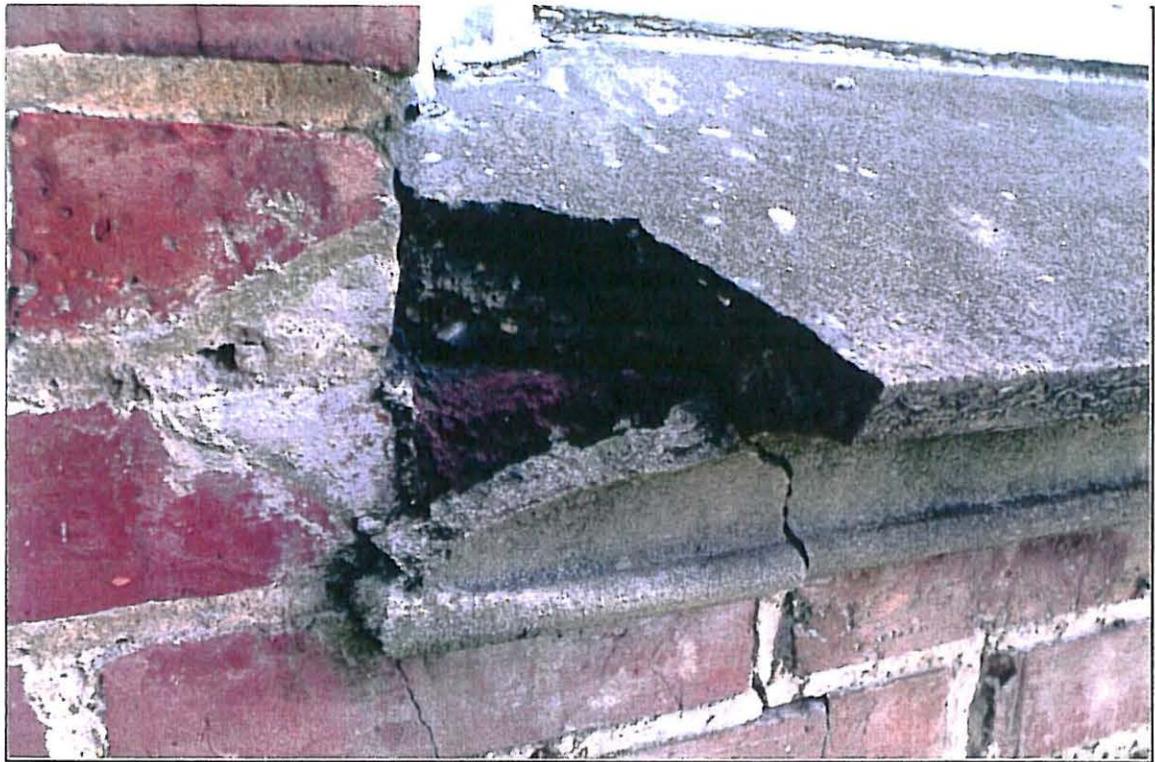
Figure 43. Typical deterioration and loss of an applied cast stone window sill.

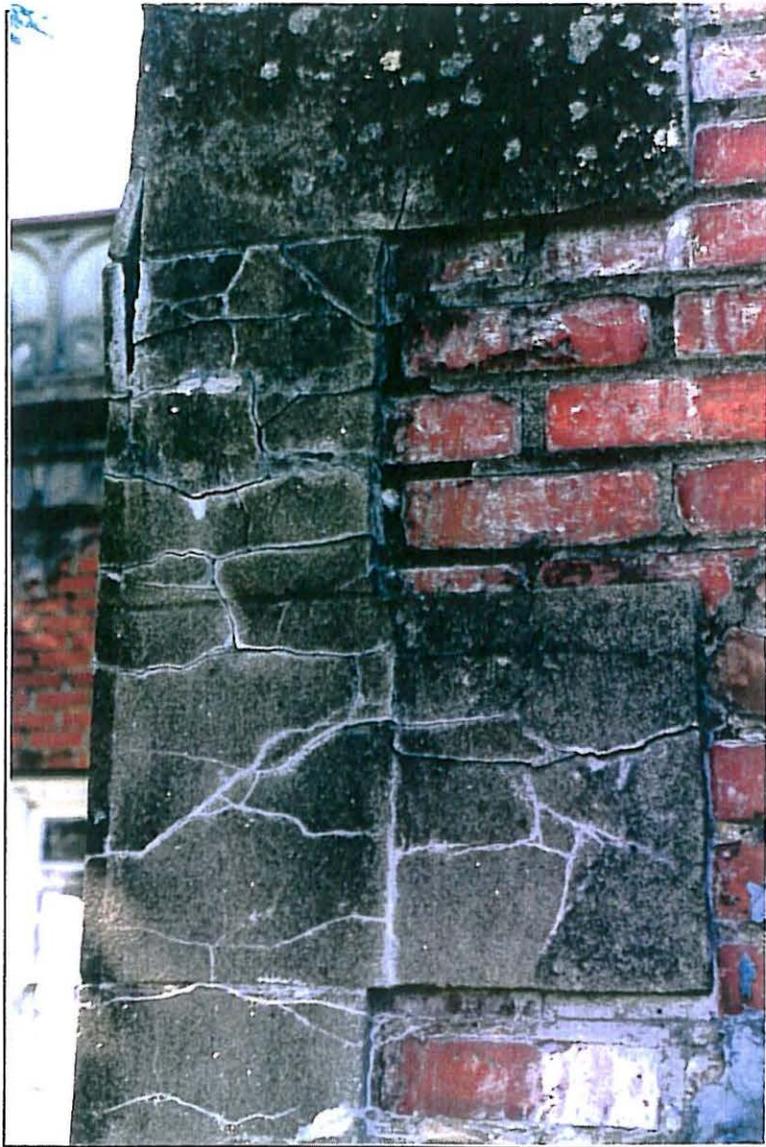
Figure 44. Typical cast stone quoin deterioration. Note extensive cracking, surface accretion of leaching component materials and detachment.

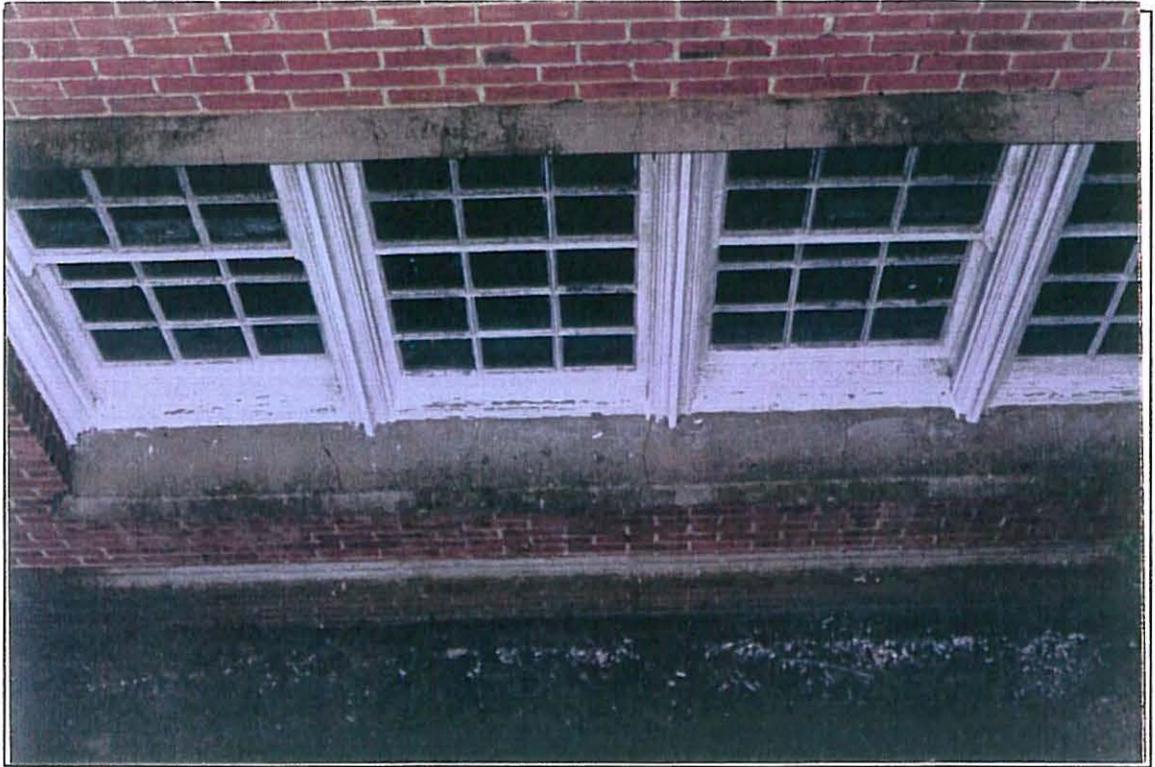
Figure 46. Typical view of cracking seen on cast stone window sills and hoods. At least fifteen fractures are observed in this location.

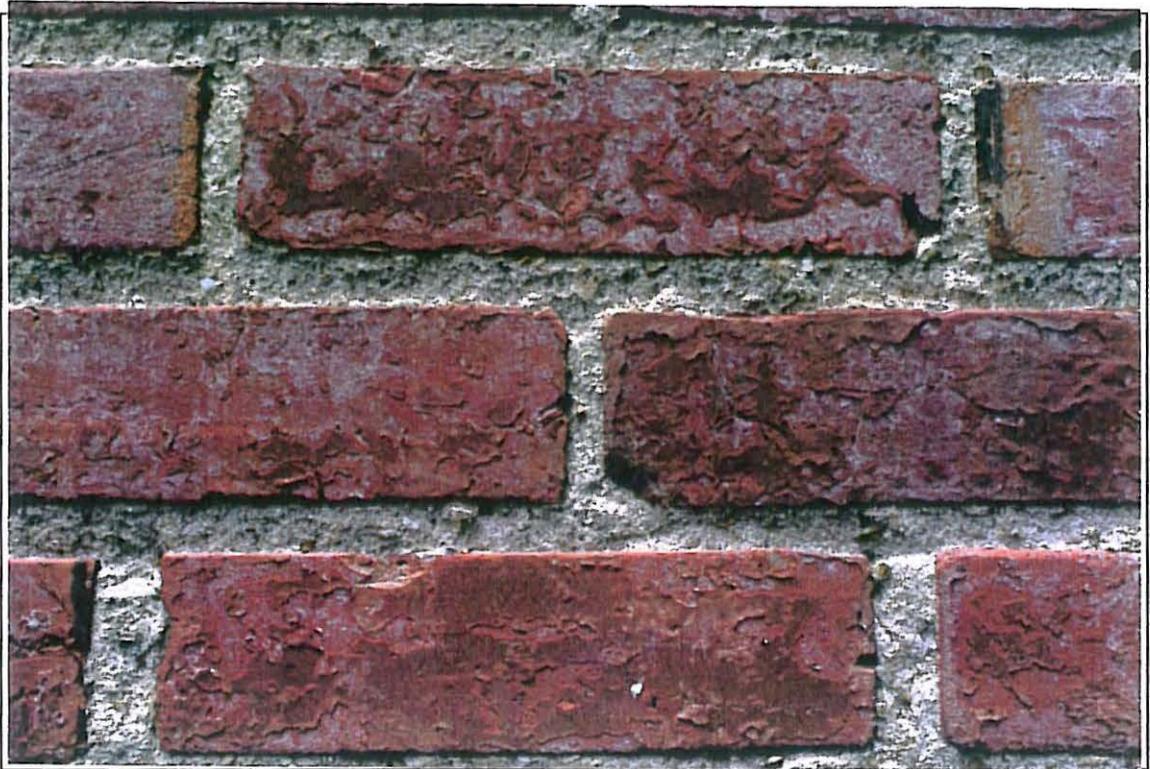
Figure 51. Typical view of flaking brick with efflorescence. Note deteriorating mortar.
