HISTORIC AMERICAN TIMBER-FRAMED STEEPLES

II. Restoration Strategies

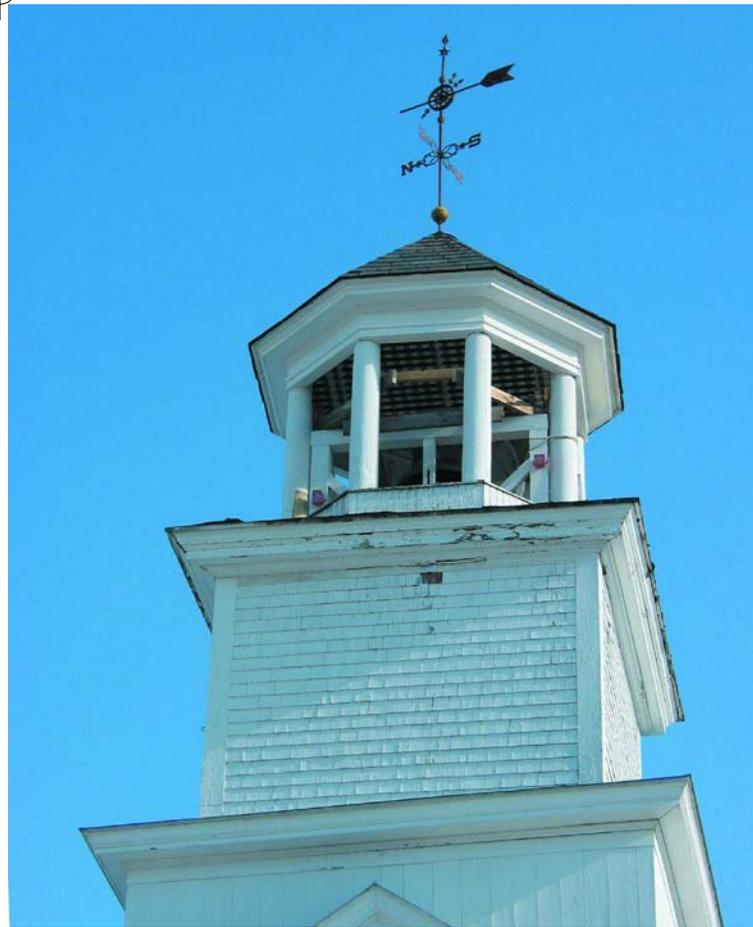
Fig. 3. Steeple of South Woodstock church before repairs. Compound tilt, somewhat unusual, includes typical backward lean from overloading of the first interior truss combined with sideward lean from rotting posts and sleepers along the south side of the tower.

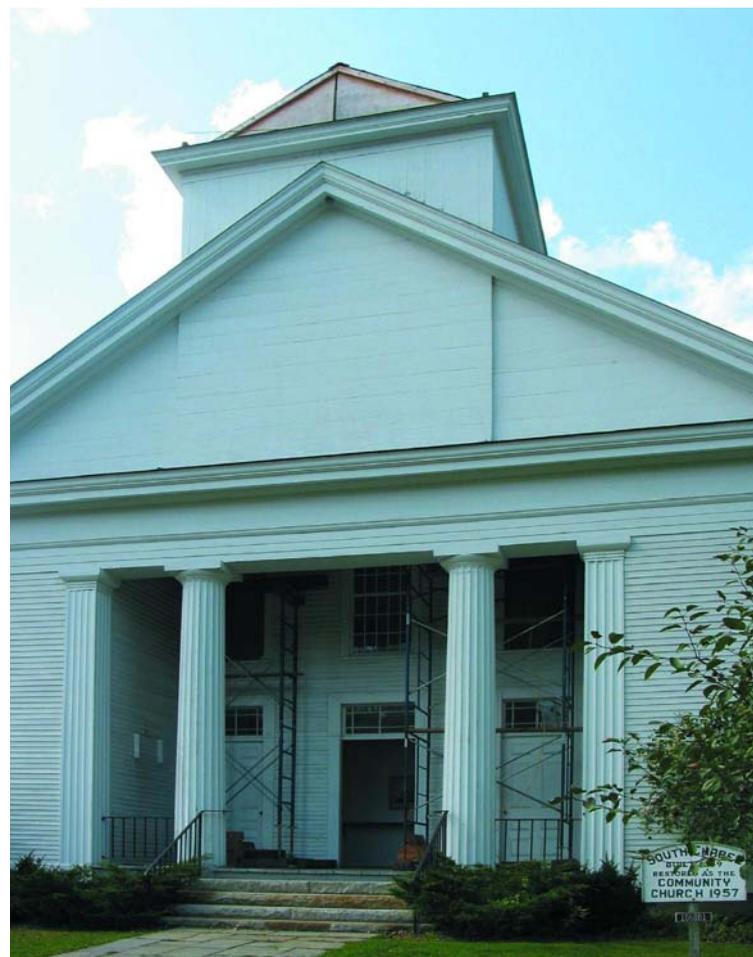
Fig. 4. Greek Revival façade of South Woodstock Community Church after removal of steeple upper stages and capping of tower with light temporary roof. Church was built in 1839 as South Woodstock Congregational Chapel and took its present name in 1957.

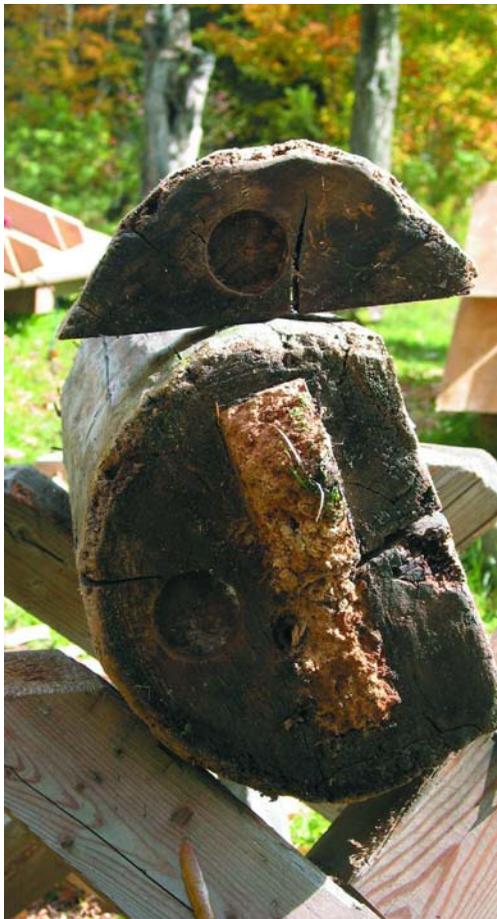
Fig. 5. Original column butt with turning center and regularly offset tenon. Crescent section perched on top is from another column.

With the columns on the ground, we discovered the original turning centers, 2-in.-dia. holes 2 in. deep, giving us reference points for correctly locating tenons on the bottom of restored or replacement columns. An octagonal layout had been superimposed upon the diagonal sleepers, and mortises cut at eight regularly spaced points. We were able to cut (or insert) tenons on the bottoms of the columns at a regular offset from the turning centers to engage the sleeper mortises correctly to hold the columns plumb (Figs. 5–7, 10).

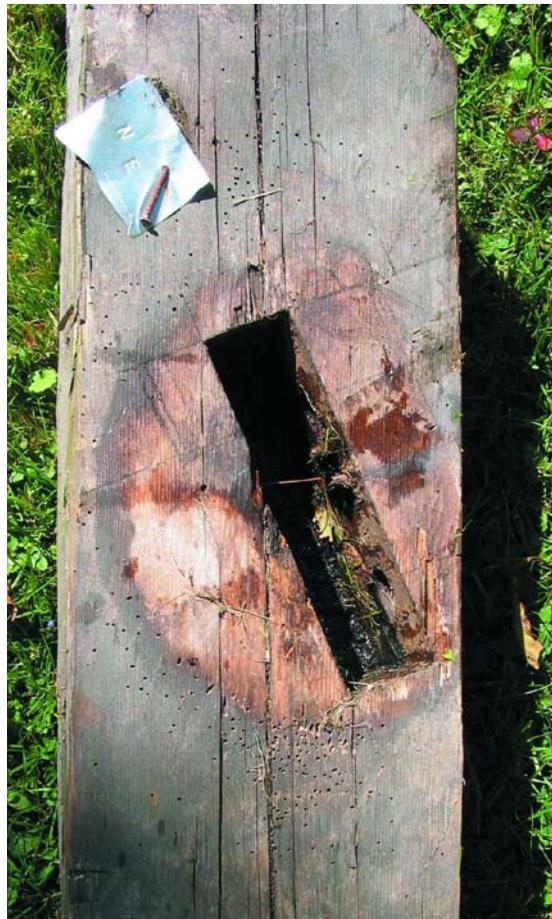
Fig. 6. Original mortise in sleeper, skewed as necessary to follow regular octagonal pattern. Ghost reflects hewn clearance reduction of column in Fig. 5.

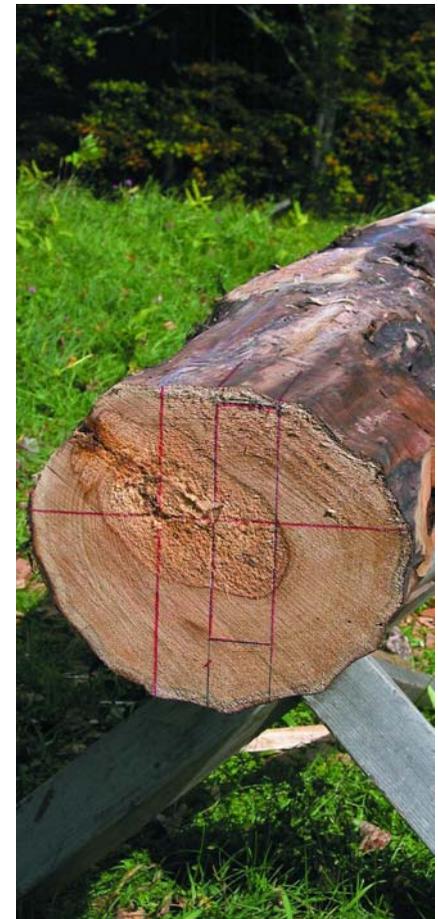
Fig. 7. Layout for tenon on repaired column. Pierced hole at upper left crossing of lines represents reference center.

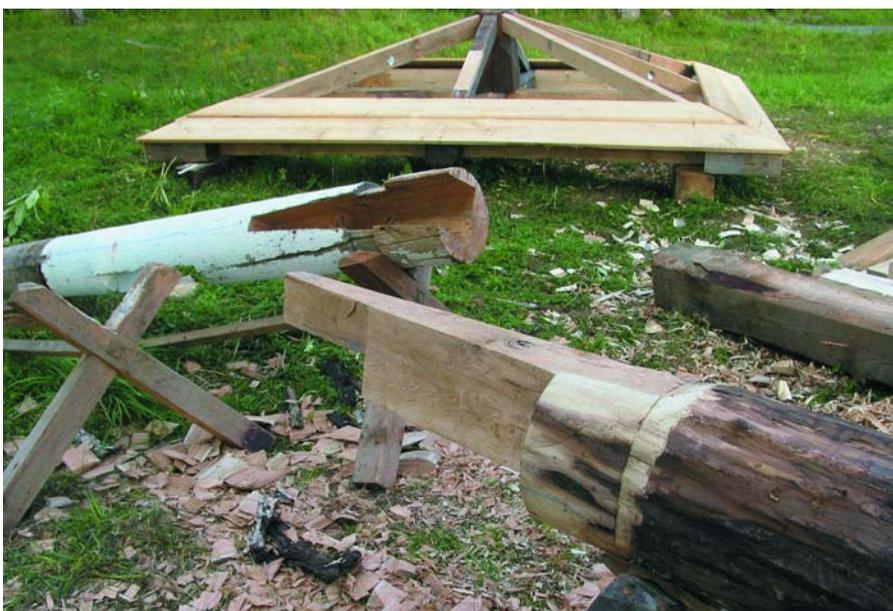
Fig. 8. Distinctive scarf joint in progress between new column bottom and old column top. Mostly rebuilt bell deck in the background.

Restoration required copying the dimensions, species and joinery of the various members and reassembling them. The in-place tower called for extensive free and slotted tenoning since it couldn't be fully pulled apart. We were free to rebuild the second stage, however, as it was originally built. The butternut columns were elaborately repaired and two replaced, although finding reasonably straight and sound 13-in.-dia., 18-ft. butternut logs was difficult because of the present diseased state of the species (Figs. 8–11).

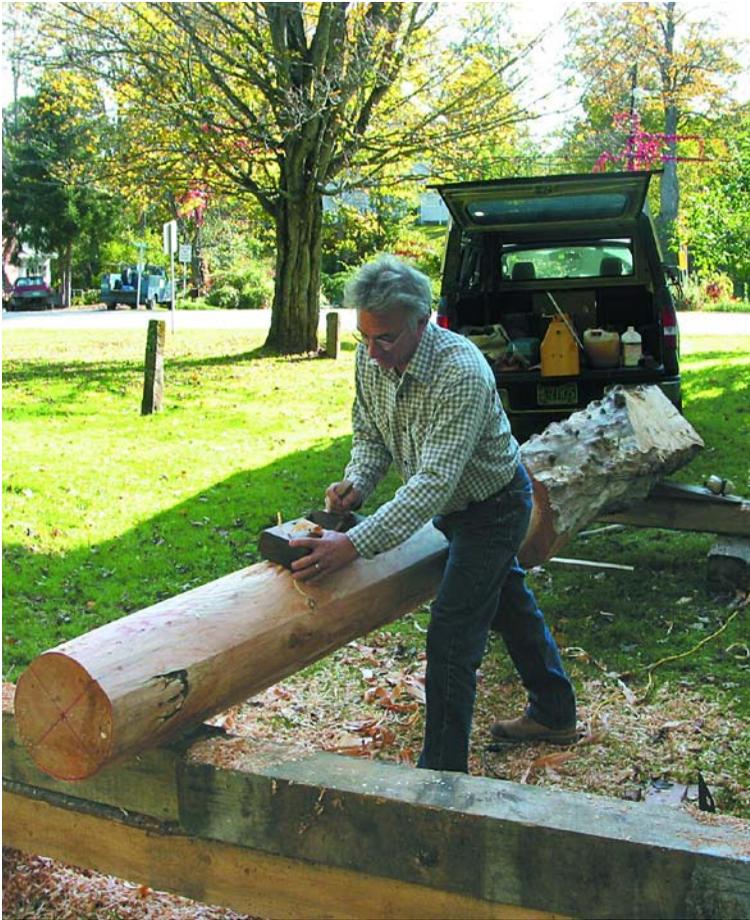
Fig. 9. Author smooths one of two new replacement columns, laid out, sawn, shaved and planed rather than turned as were originals. Bulky surface where left rough suggests difficulty of finding good butternut today.

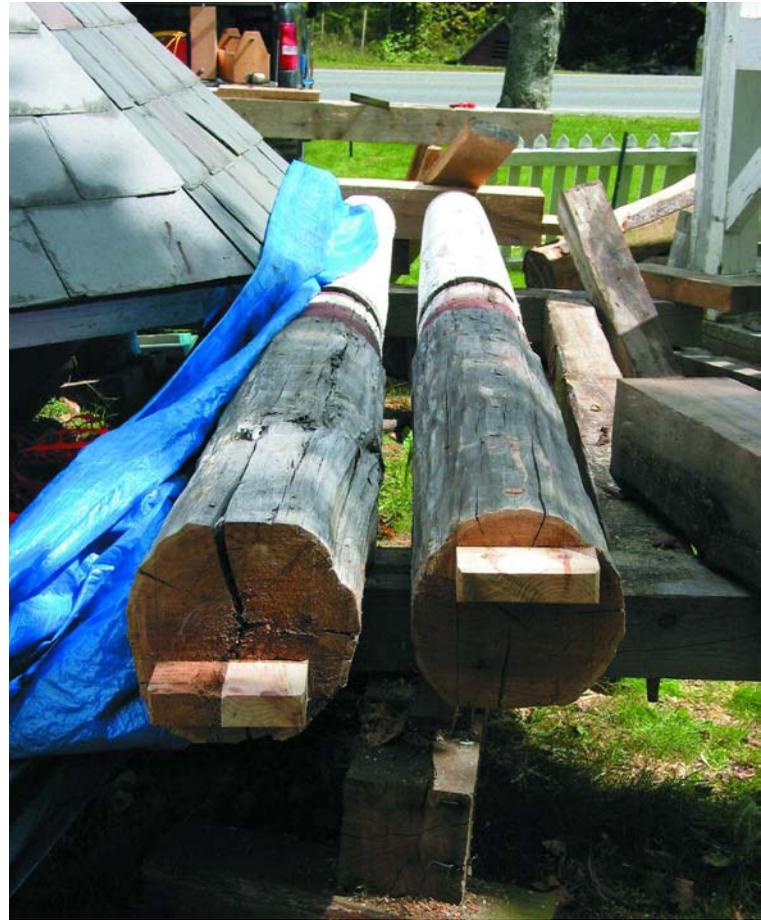
Fig. 10. Repaired columns using original lower ends, shortened to remove decay, in one case leaving enough sound wood for an integral half-tenon. Pale wood indicates free tenons.

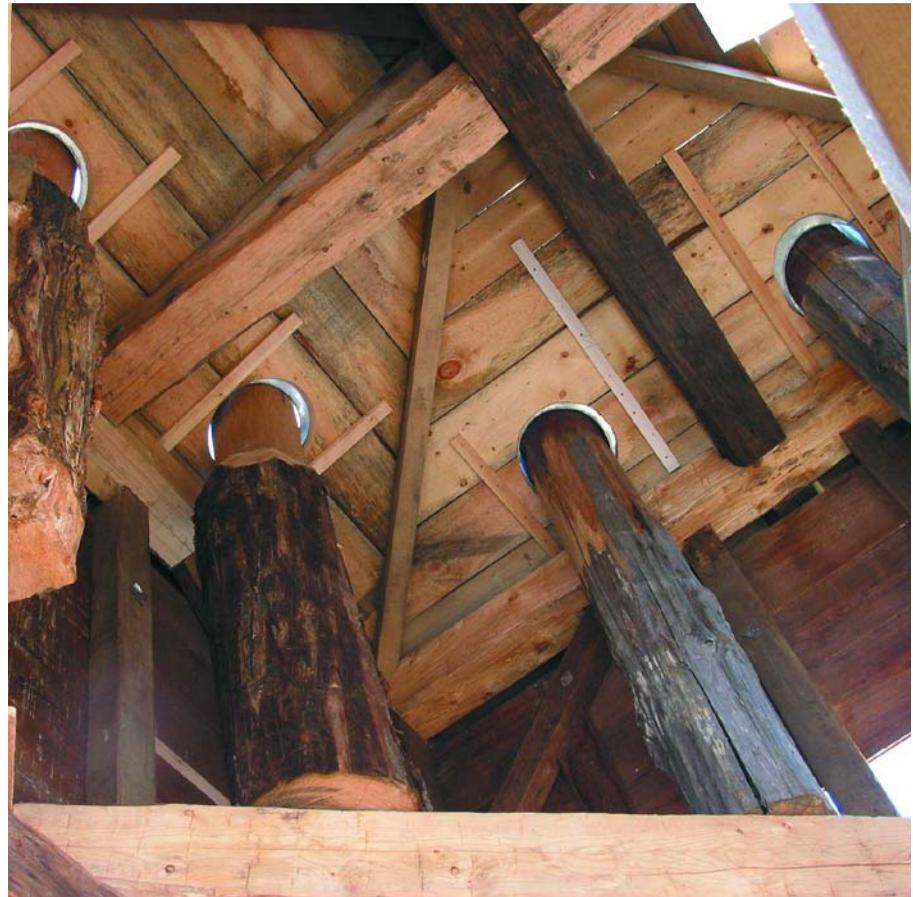
Fig. 11. Reconstructed bell deck admits scarfed and new columns (two at left) through the boarding to appear in the belfry as tapered cylinders.

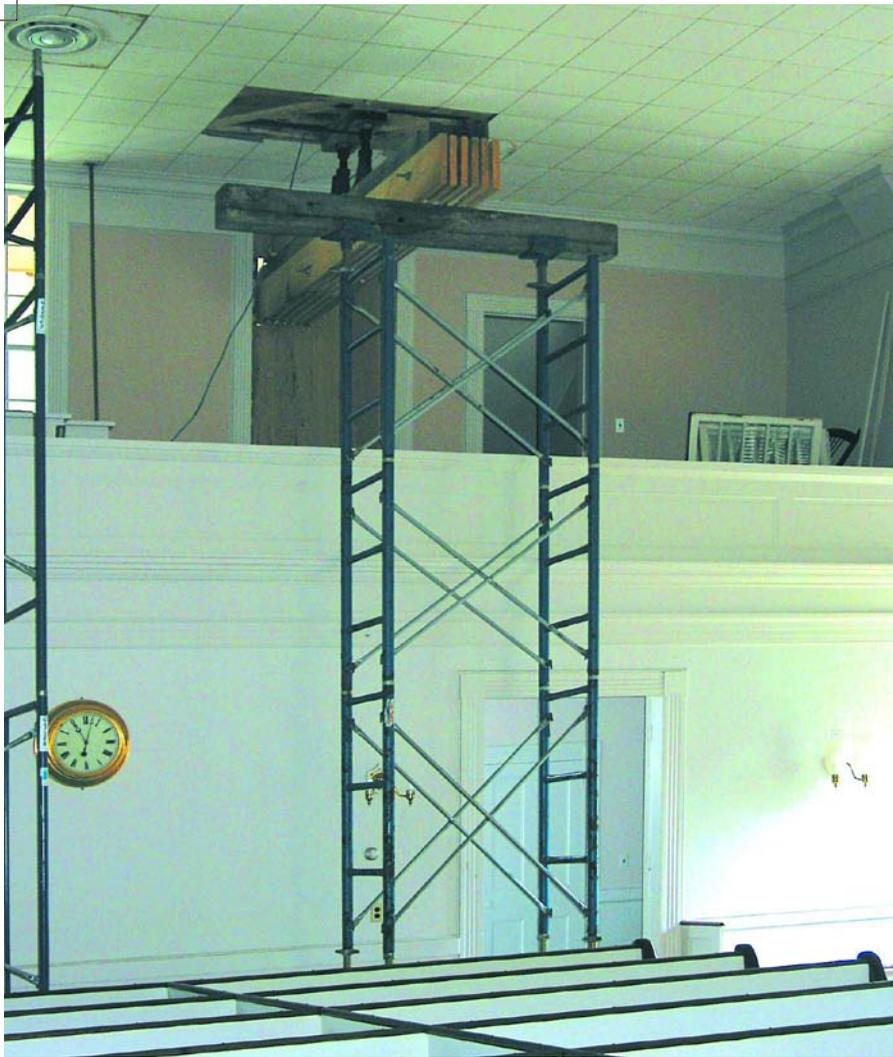
Fig. 12. Structural stage inside church paired with another on the porch outside (see Fig. 4) provided base for lifting elements within tower.

We strengthened the truss incorporating the rear posts of the lower tower by adding another set of queenpost main braces and another straining beam, parallel to the originals, as shown on the facing page. We installed these when the entire truss was lifted to level on structural scaffolding and the original truss connections, now relaxed, could be wedged tight as well. The structural scaffolding rose from the main floor of the church and from the inset front porch floor, with cribbing below the floor in the crawl space to bring the load to ground (Figs. 4 and 12).

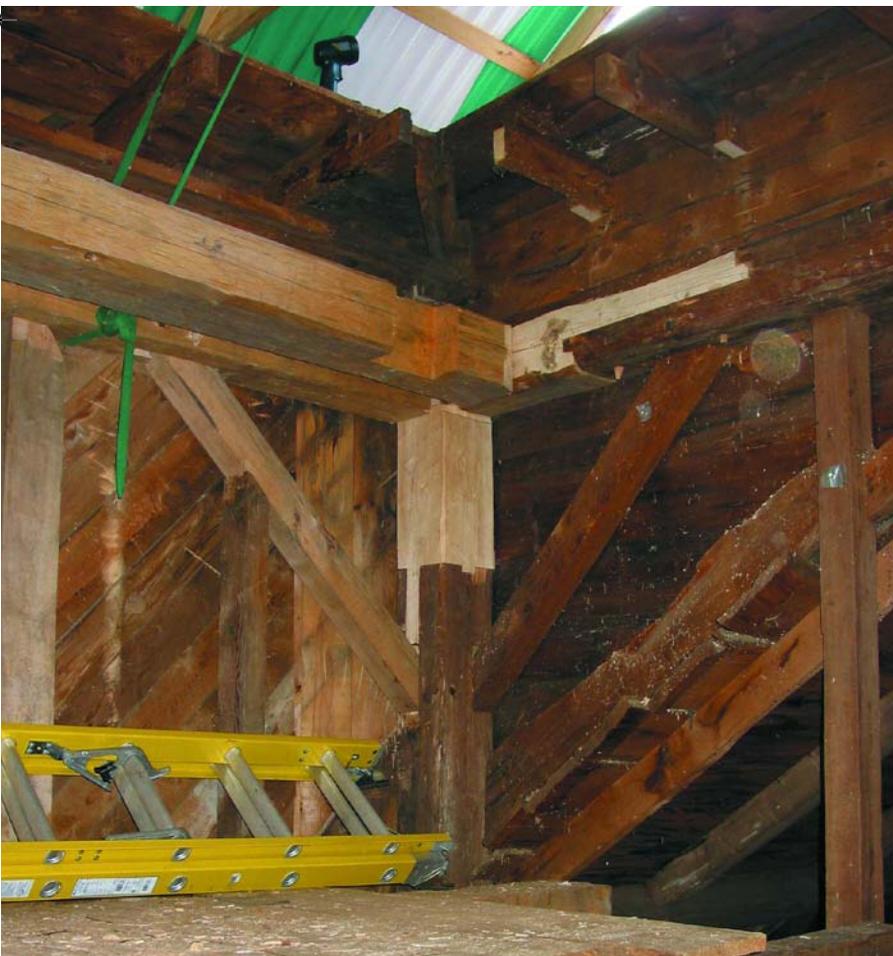
Fig. 13. Tower required numerous scarfed repairs and whole-member replacements, using structural staging as jacking base for insertions.

Each pair of scaffolding towers carried large built-up beams passing through the second floor windows of the front gable of the church. Screwjacks atop these lifted the sagged truss chord to slightly above level so that the additional queenpost elements could be installed and then loaded. We also increased the sleepers for the octagon columns from 7x9 to 10x11 inches in response to sagging observed in the originals. After completing repairs to the tower (Fig. 13), we lifted the ensemble, stage by stage, back into position.

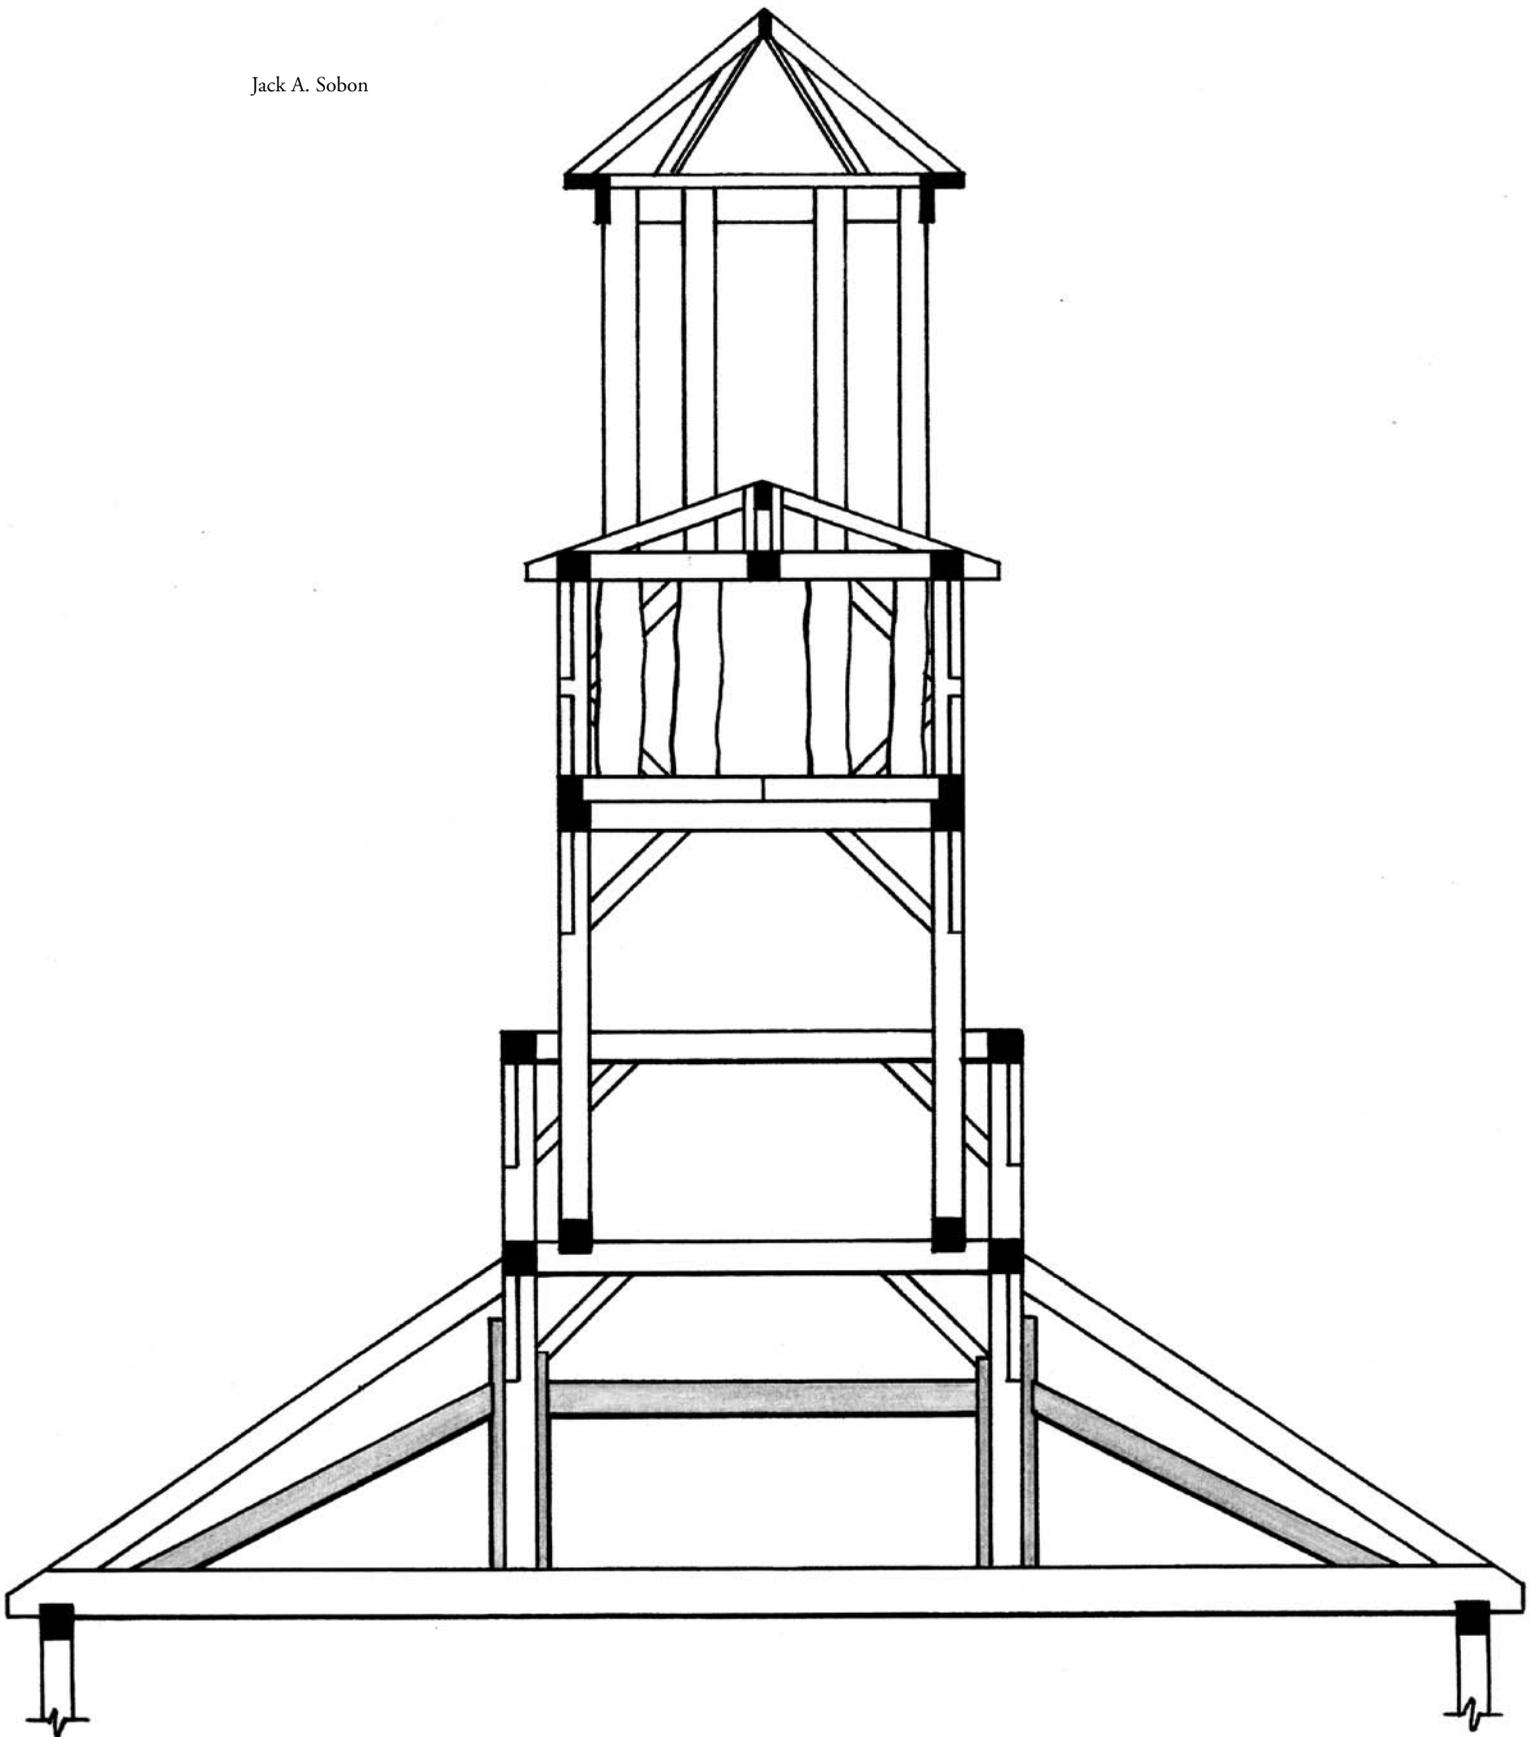
We made structural improvements only where excessive stress was observed. The truss supporting the back of the steeple was not stiff enough to help carry the weight of all the stages above in addition to its own significant roof load, and had sagged noticeably when we began work, a problem endemic to steeple supports of the period. (The resulting backward tilt of many 19th-century steeples is a common sight today in New England.) At South Woodstock, this problem was amplified by extensive water infiltration into the two tower sections and resultant rot.

Fig. 14. South Woodstock steeple frame section seen from inside looking toward back of church, showing queenpost truss formed by rear tower posts and truncated principal roof rafters. Shading indicates stiffening elements added during repairs. Posts rising to hipped bell deck are continuous.

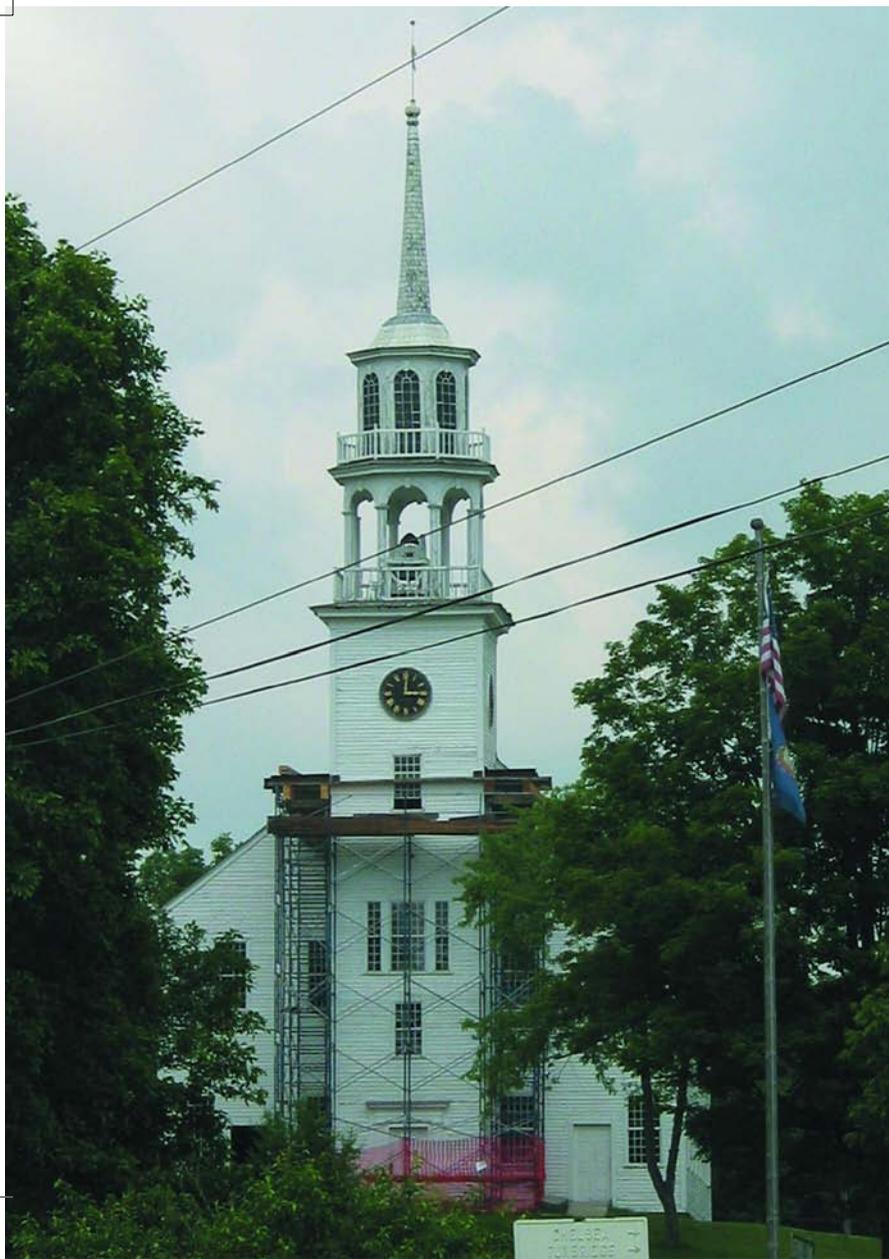
Fig. 15. Strafford Town House, Strafford, Vermont, 1799. Author used structural staging to lift and internally hold 68 ft. of steeple while repairs were made in place to supporting tower girts threatening failure.

IN carrying the belfry sleepers and posts, the tower girts also carry the lantern, spire, vane and all 68 ft. of framing and finish above. The main problem to be remedied at Strafford was the failure of tenons on three of the vital tower girts. The cause of this failure was twofold.

First, water infiltration at the front of the bell deck had run across the tower plate and down the posts. All being chestnut, they suffered little harm. The same water entering the mortises for the tower girts of spruce, pine and beech, however, caused their tenons to be weakened by decay, though not totally destroyed.

structure above was delivered by the sleepers to the inner edges of these timbers (because load always goes to the first point of stiffness). Meanwhile, the tenons of these supporting girts, 2 in. thick, 11 in. tall and set 2 in. from the outside face of the frame, unassisted by any bearing housings for the girts, took the entire eccentric load.

With few exceptions, American scribe and square rule framers from the 17th through the 20th centuries located tenons a framing square's tongue (1½ in.) or blade's width (2 in.) from an exterior reference face, almost ritualistically and regardless of the tenon's relationship to the forces it was expected to resist. At Strafford, with the weakened condition of the tower girt tenons, the eccentric loading and the absence of resistant bearing housings where the girts met the posts, rotation of the girts began to bend and break the tenons, threatening to drop the upper levels of the steeple.

Since the belfry, lantern and spire were to be left in position at Strafford, the rigging problem was how to lift these upper stages off the tower girts that were failing under load. The solution was to erect 42 vertical ft. of tied-together structural scaffolding around all three sides of the tower, footed on good gravel. On top of the scaffolding at two opposing sides of the tower we established framed cribs, each composed of two levels of stacked 8x9x17 hemlock timbers spread 5 ft. apart by tenoned 6x6s (Figs. 15 and 18).

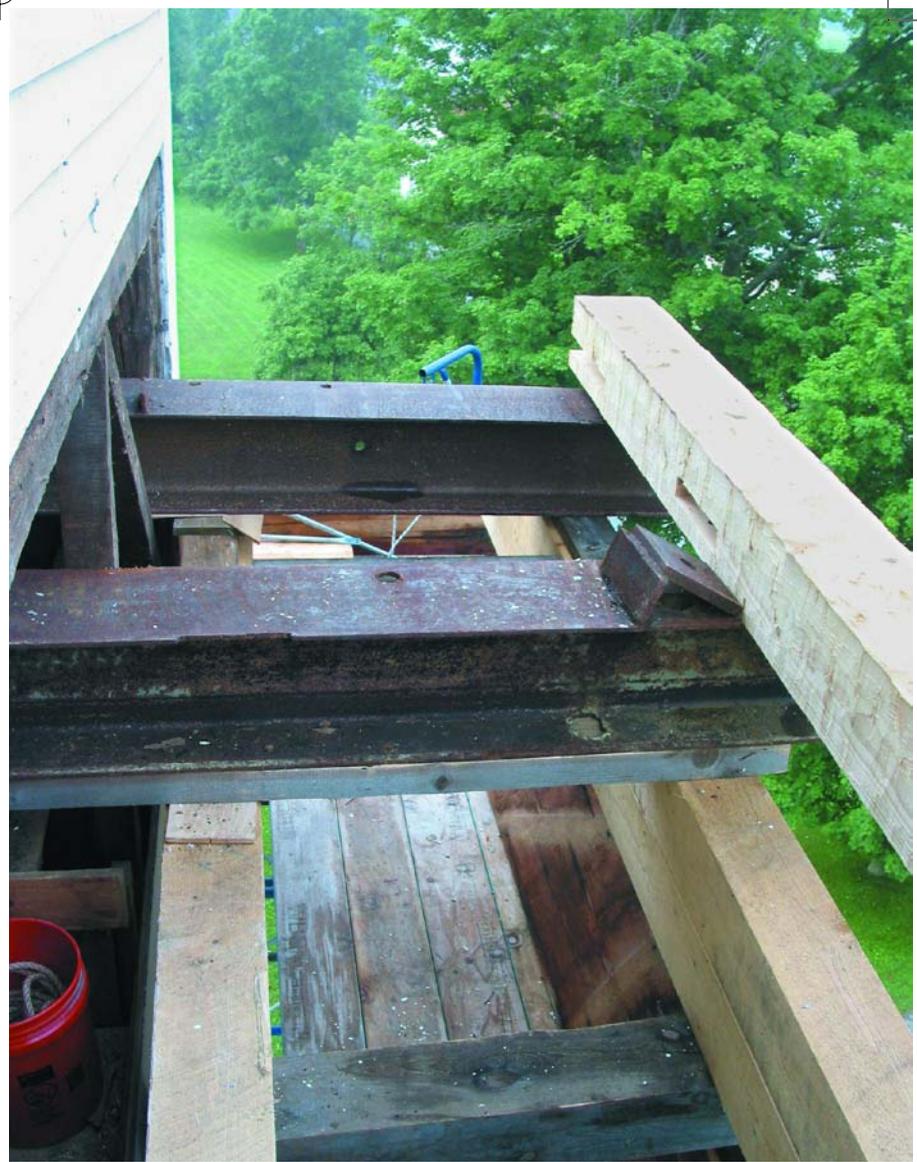
Fig. 18. Structural staging supports cribbing to carry steel I-beams that lifted upper stages of Strafford steeple off supporting tower girts.

tion them over the panel points of the scaffolding. From this high platform we carefully removed the original clapboards and wide sheathing boards, saving them and their wrought nails, to expose the girts we would replace and to provide a space for the steel to be slipped through. The 12x12 I-beams, 25 ft. long and weighing about 2000 lbs. each, were lifted by crane and beam tongs and guided into the tower to rest on wooden rollers over 3-in. planks (Fig. 18).

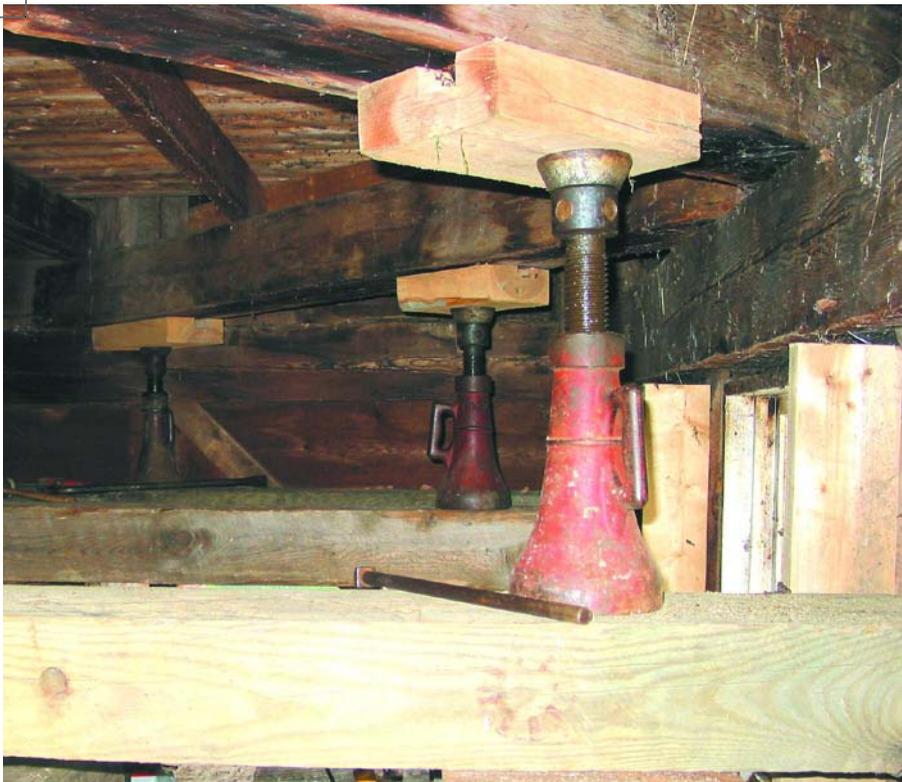
Fig. 19. Eight 20-ton screwjacks (three visible here) push up under belfry post positions to lift Strafford's upper steeple stages.

We placed heavy cribbing spanning the I-beams and 20-ton screwjacks atop these, pressing on 4x10 hardwood blocks under the belfry post positions on the belfry sleepers (Fig. 19).

Turning these eight jacks at first deflected the I-beams a couple of inches and then readily lifted the approximately 20,000 lbs. of upper steeple off the girts. At this point we were free to cut out the damaged girts and replace them with new timbers (spruce of very high quality), free-tenoning one end to engage the fixed frame, and then repair or reposition the diagonal braces that rose to the girts.

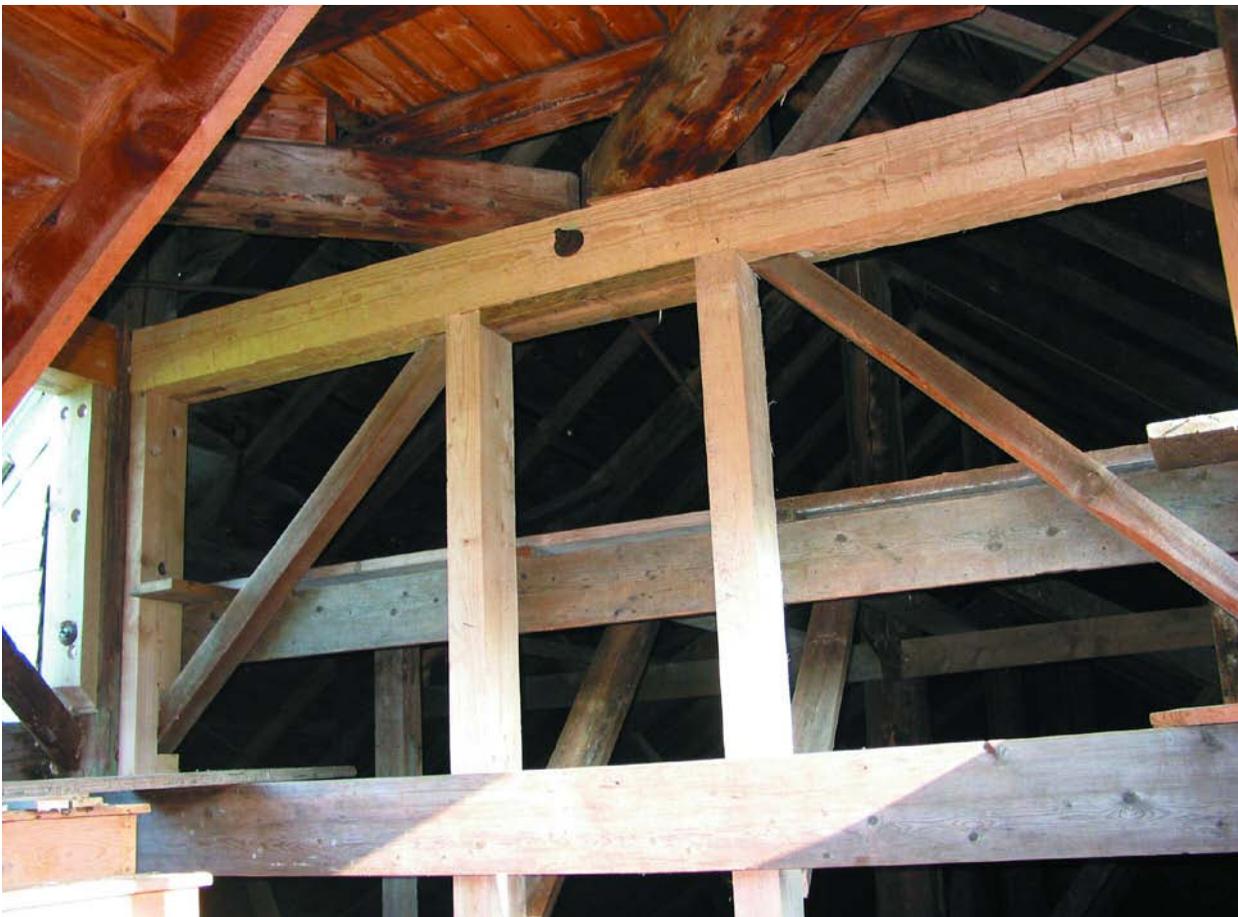
Fig. 20. New spruce tower girt supports diagonal sleepers carrying upper stages. Bolted 4x9 sisters at each end relieve 2-in. splined tenons of shear forces; long braces and median posts stiffen middle of girt against bending. At girt center, nutted iron rod (old but not original) runs back to tie beam of second interior roof truss.

Resistance to the fatal inward roll of the girts, as well as support for the free-tenon ends, were provided by bolting 4x9 hardwood studs to the corner posts right under a girt joint to the post and at two additional locations under a girt where belfry sleepers bear (Fig. 20).

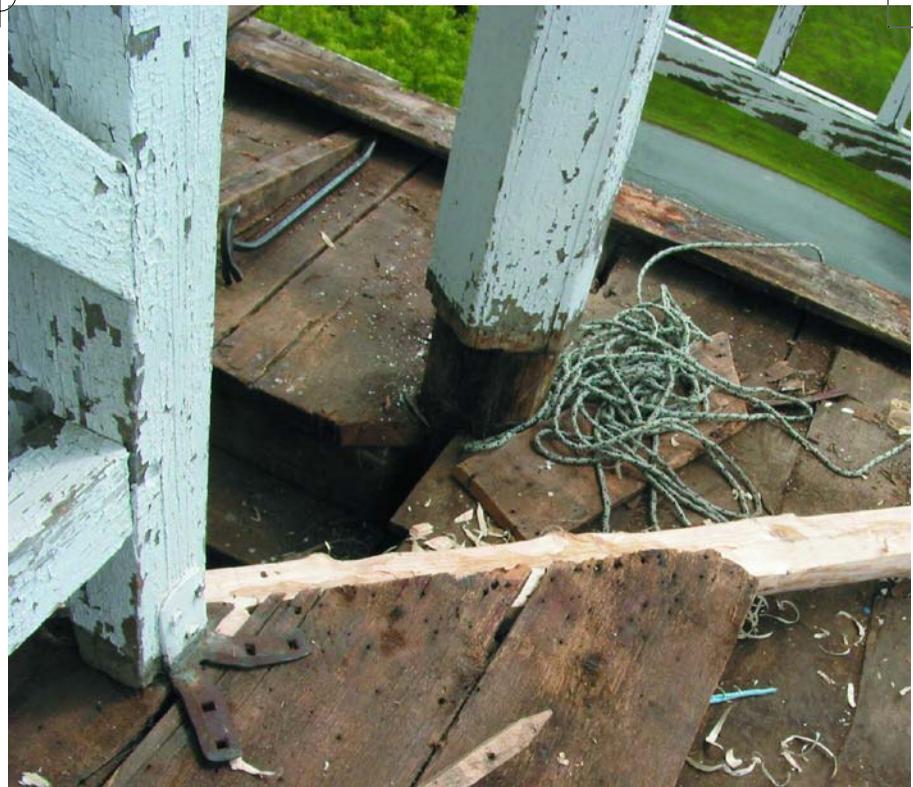
The bell deck was of great interest, with two versions still in place. The first, resting upon heavy bell girts crossing each other from the tower plates, comprised wide pine boards 1½ in. thick used in a sort of giant shingling (Fig. 21). The butt joints of these planks and the eight openings around the belfry posts had been caulked with oakum (rope fibers) mixed with tar, like the deck of a ship. However, unlike a ship's deck, no large crew would check the condition of its oakum caulking every day, so this deck failed to keep water out. Another had been built on top of it using 4x5 hardwood rafters, pine and spruce boards and painted pine shingles. Sometime in the 20th century this second deck was covered with galvanized metal. Throughout these changes, the columns were kept well flashed where they passed through the deck, a common locus of deterioration, and no problems occurred there.

Fig. 21. Old bell deck covering of thick planks caulked with oakum and tar revealed by removal of younger deck of rafters, boards and shingles.

Repairing the deck was straightforward. The metal and the wood shingles were removed, two hip rafters replaced in kind and the rotten boards renewed. The town had decided to try a membrane covering and a contractor laid it on ½-in. plywood so as not to attach it irreversibly to the historic bell deck. We left the original plank and oakum deck in place as a rare survivor.

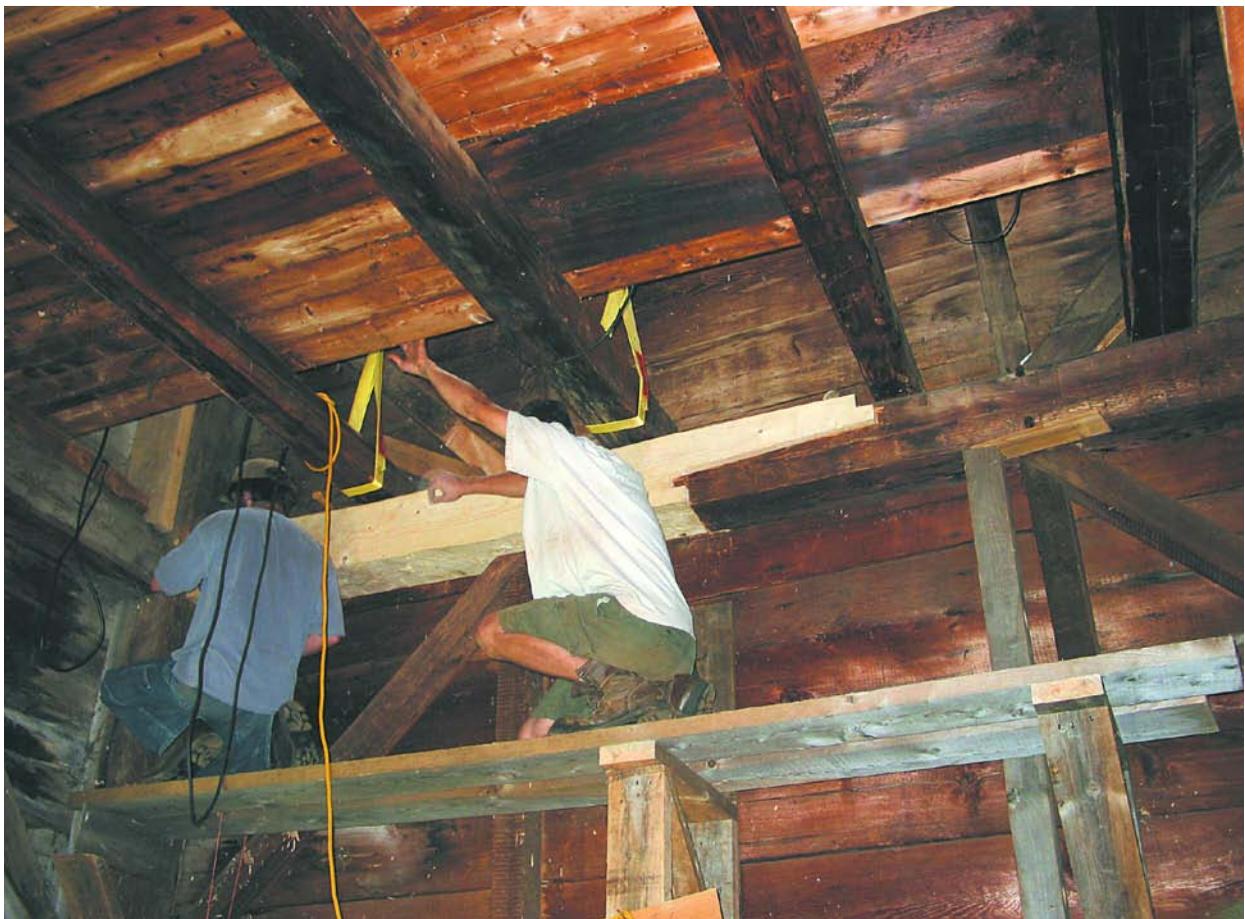
Other problems at Strafford included a horizontal tower girt (not directly bearing upper steeple loads) rotted for half its length and needing a scarfed timber repair (Fig. 22 overleaf). The bell deck was leaking and in need of a new covering as well as replacement of some of its structural members, including two hip rafters.

Fig. 22. Seth Kelley (at left) and Michael Cuba install stop-splayed and tongued scarfed repair to rotted wall girt in Strafford tower. Girt carries relatively light clock-room floor, does not support upper steeple stages. Free tenon (hidden by Kelley) allows insertion of new piece from side.
