Research into Protective Coating Systems for Outdoor Bronze Sculpture and Ornamentation

Phase III | 2000-08

National Gallery of Art

FINAL REPORT

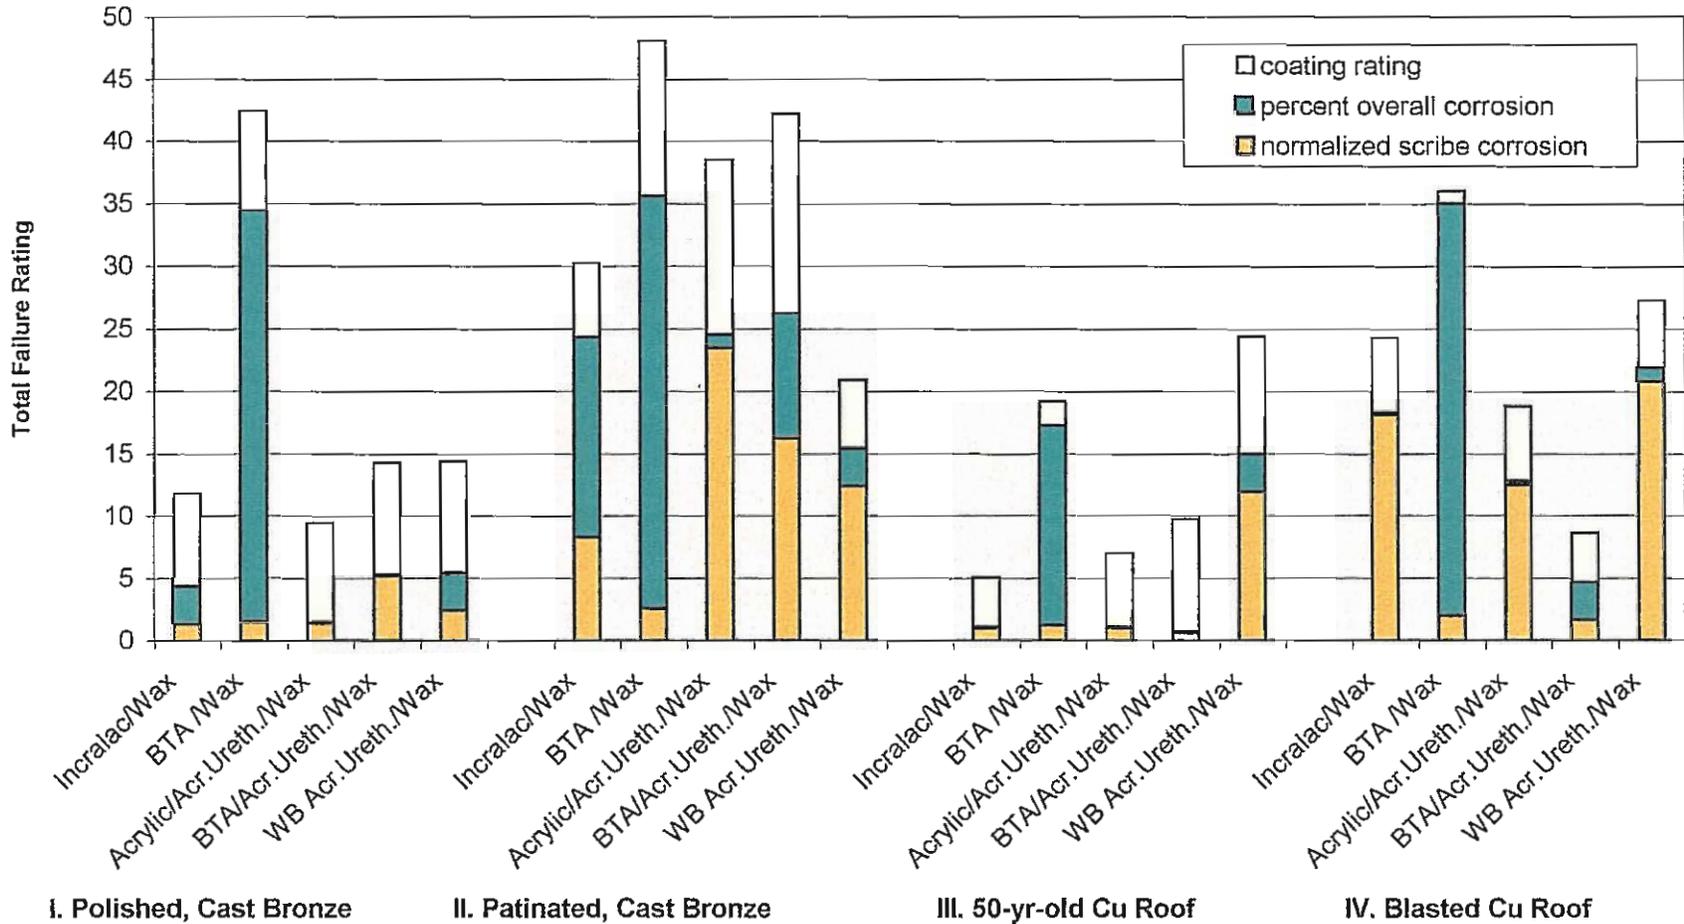
Figure 1

Subsequent to accelerated weathering, preliminary overall failure ratings of Phase II, set B samples were compiled for the 1997 NCPTT Final Report.⁷ This report also includes failure ratings for Phase I, set C samples, i.e., after 1.5 years natural outdoor weathering. These ratings were determined by combining individual corrosion and coating ratings according to set criteria from appropriate ASTM standards. The component ratings were weighted to best correspond to empirical rankings. Adhesion ratings before and after accelerated weathering, and dry film thickness, were also reported in the 1997 report. In this report we present revised failure ratings for all Phase II samples. These failure ratings are similar, but now based on the results of digital image analysis combined with visual evaluation. The revised ratings are also compared to electrochemical impedance tests for the samples on polished bronze. Revised overall failure ratings for Phase II samples after 120 days accelerated weathering (set B) are shown in Figure 1, and after about one year natural, outdoor weathering (set C) in Figure 2. Note that three samples placed on the roof from the polished bronze series disappeared during the course of the experiment and are therefore not represented. Since natural weathering was not much progressed after one year in most cases, description of these samples is included in Table I. Photographs of the naturally weathered samples are also attached.

**Total Failure Ratings for Coatings on Bronze or Copper Substrates
After 120 Days Accelerated Weathering**

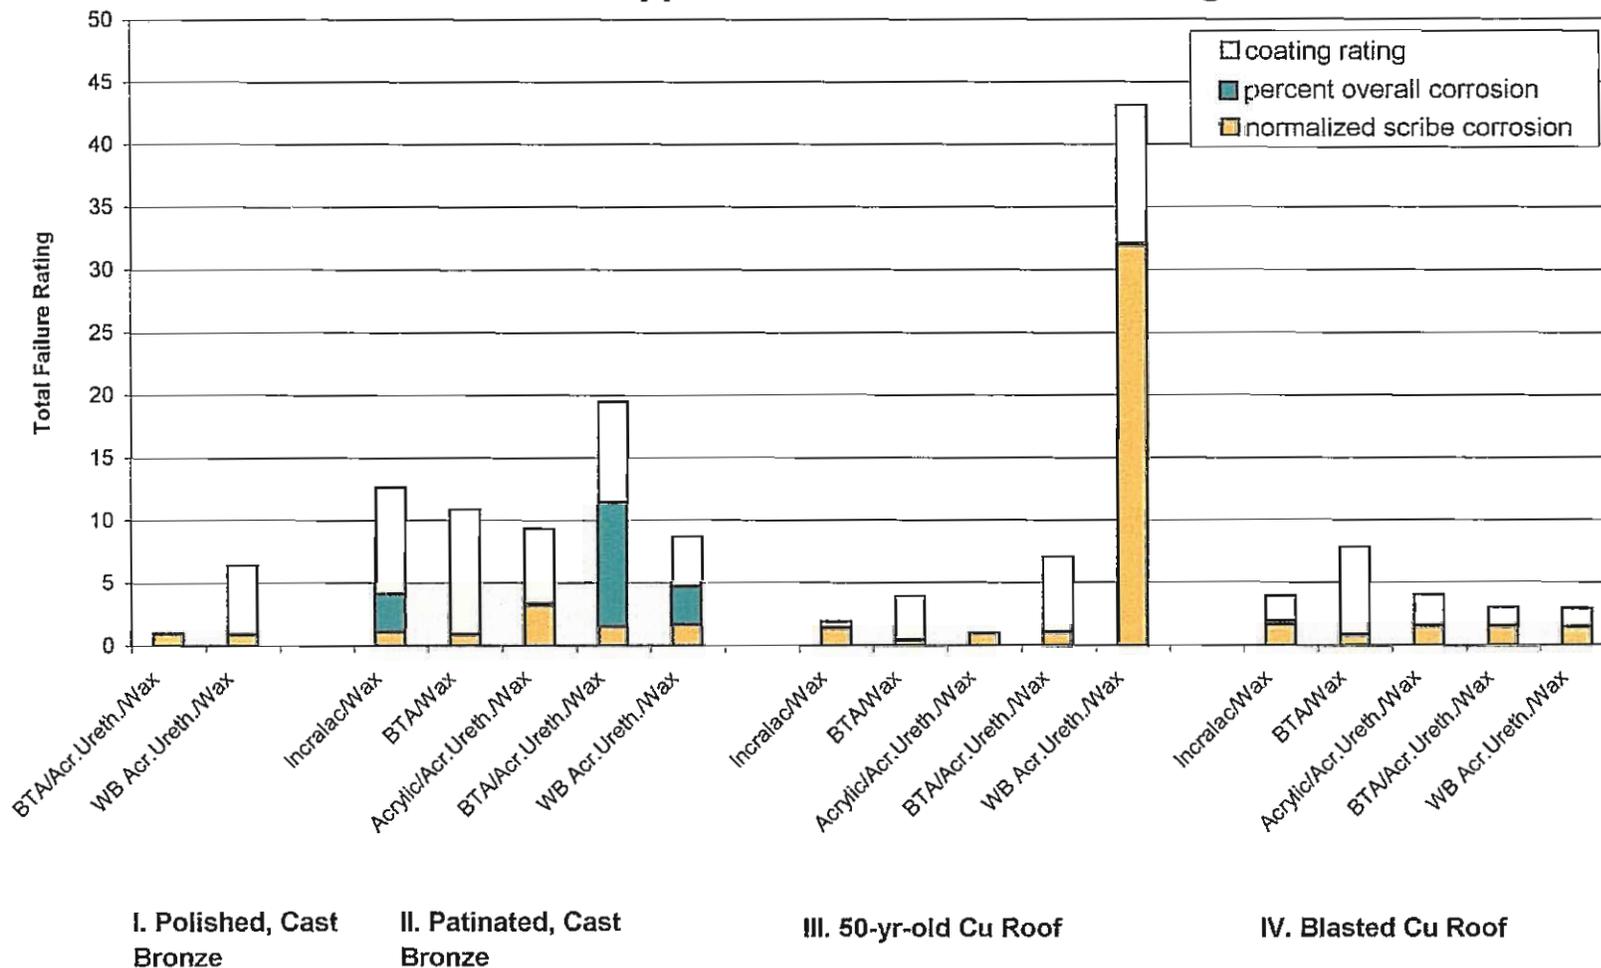
Figure 2

The waterborne acrylic urethane coating, although boosted in thickness in this study, did not perform well in general and failed dramatically on the 50-year-old brochantite patina after one year of natural weathering, i.e., at an even faster rate than predicted by accelerated tests. The latter case appears largely attributable to the extremely poor adhesion measured on this substrate vs. the others. However, this coating was a mediocre performer in all cases, regardless of substrate. This points to an inherent weakness in the coating itself, such as too great an affinity for moisture/electrolytes arising from residual water in the coating, as well as generally poor coating quality, which could not be avoided despite following manufacturer's recommendations during application.¹³ ATR spectra of this coating on polished bronze before and after weathering (not shown) show small relative increase in the free -OH stretch region, near 3535 wavenumbers, apparently confirming the uptake of moisture in the coating near the metal surface.

**Total Failure Ratings for Coatings on Bronze or Copper Substrates
After Approx. 1 Year Natural Weathering**

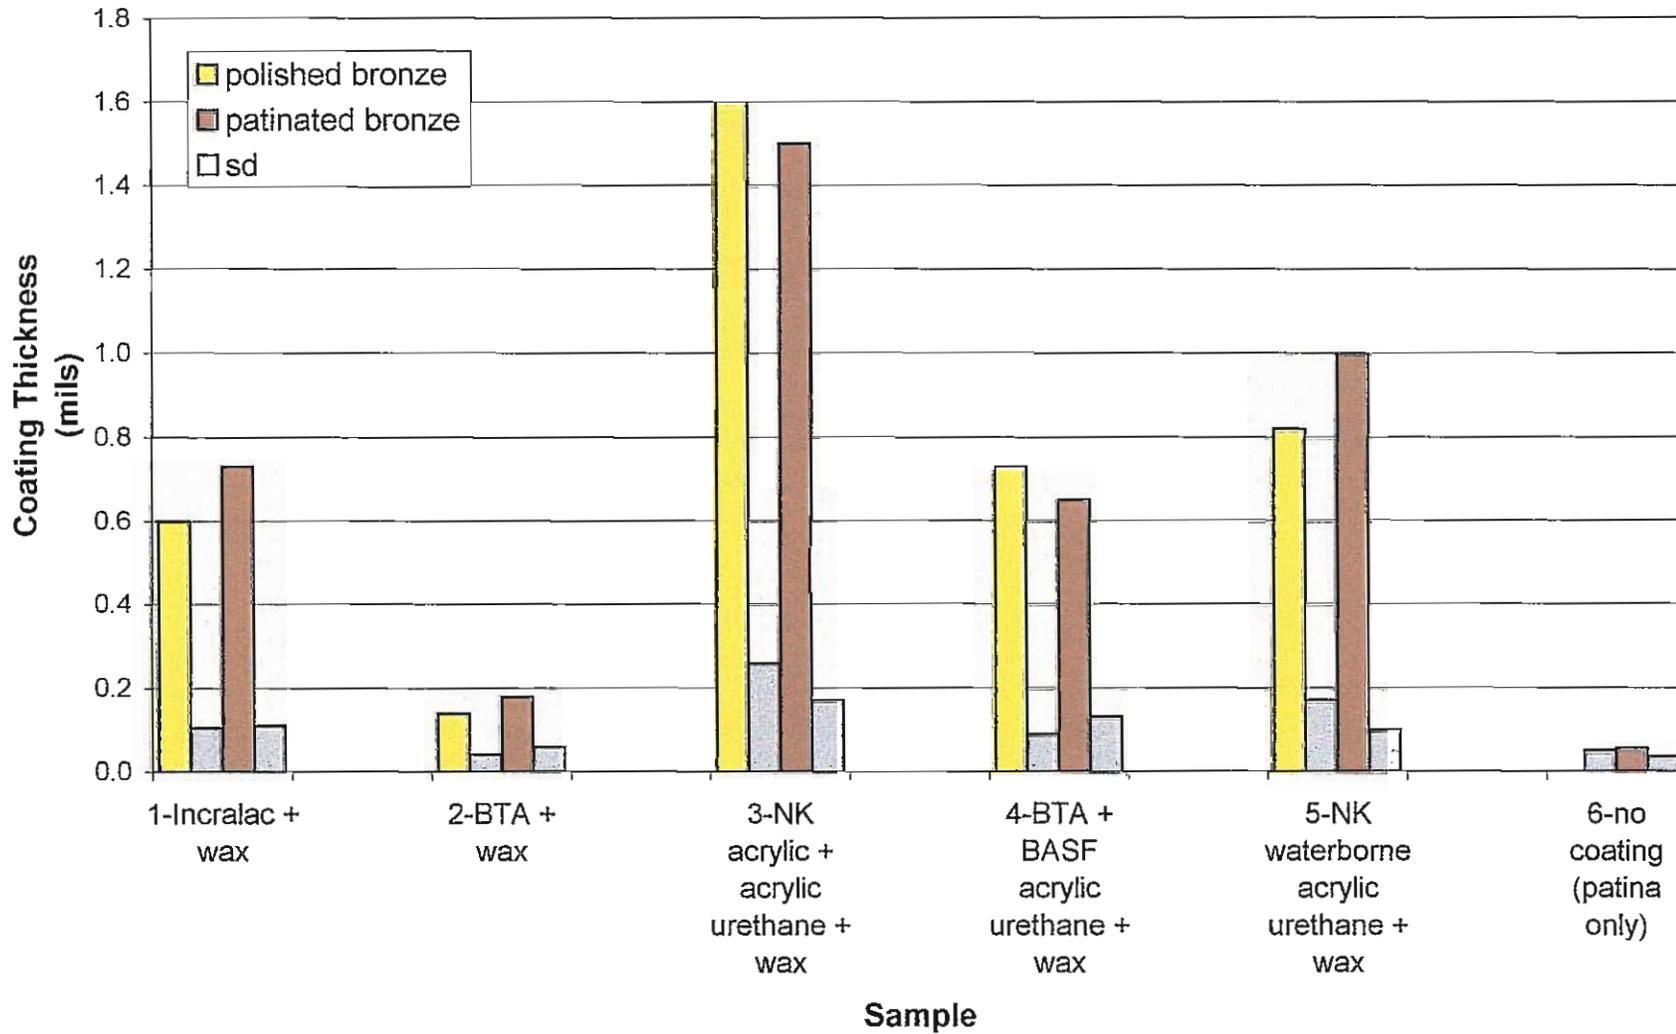
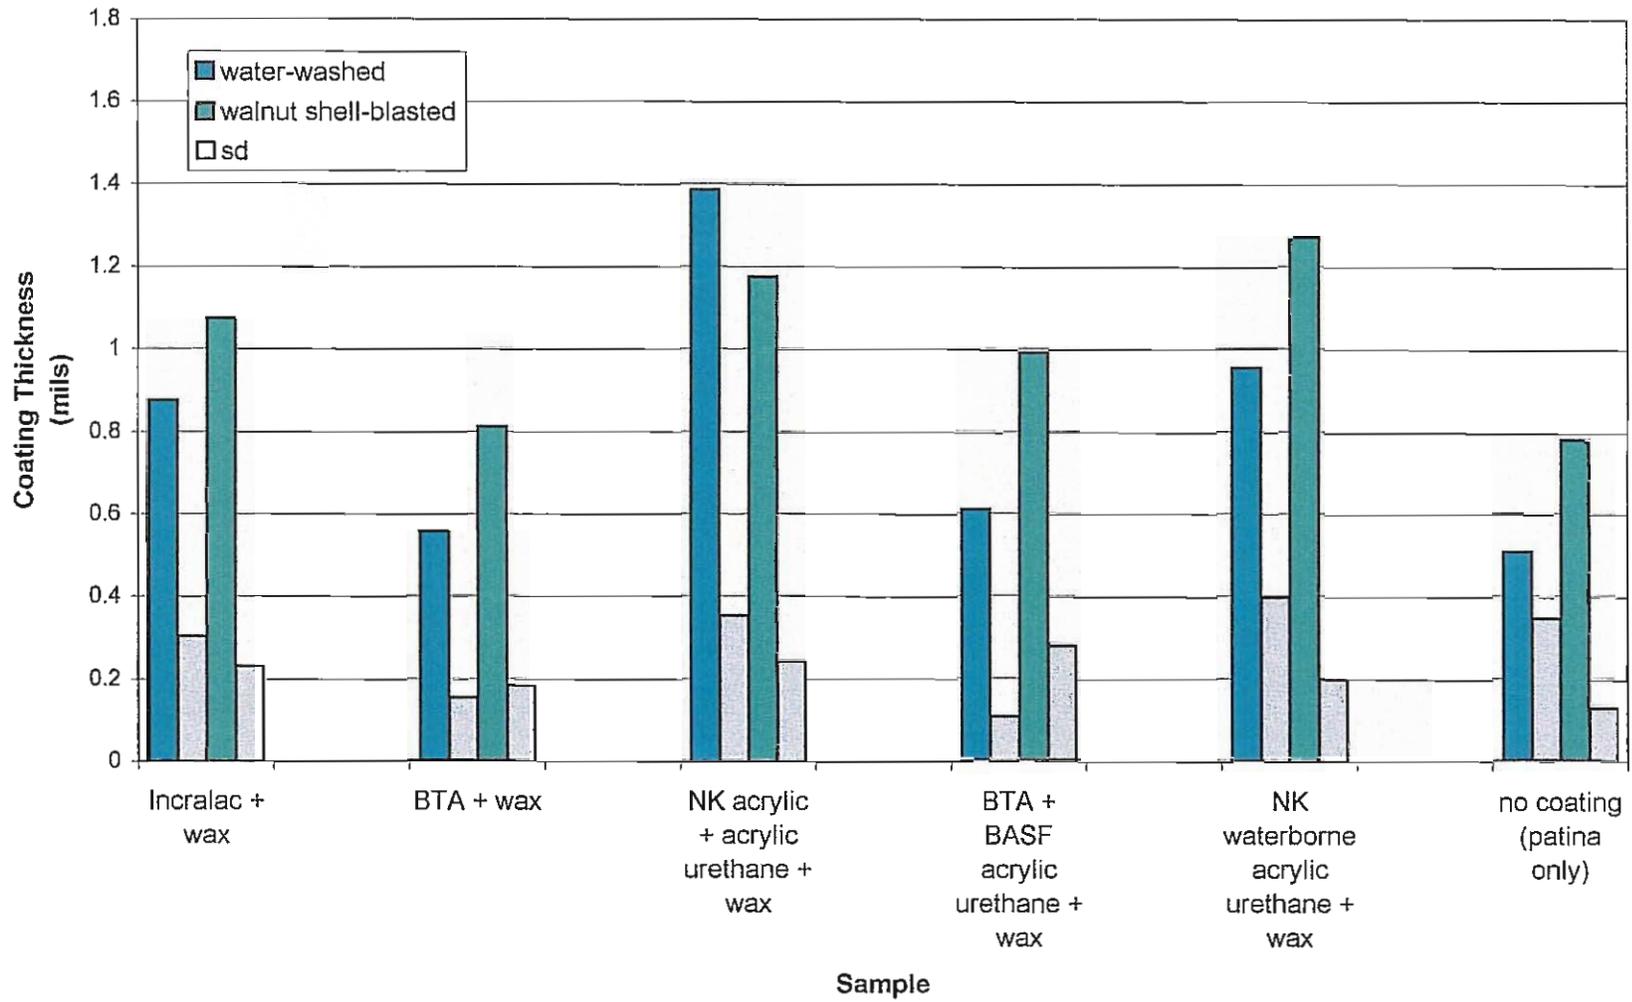
Comparison of the overall failure ratings and results of film thickness measurements (Figure 3-4),¹⁴ shows a correlation to poor performance of the BTA/wax coating, which is a much thinner coating than the others: 0.2 mils or less. This thickness is typical of normal wax application in conservation practice, and may be said handicap its performance potential. Although the Nikolas acrylic/acrylic urethane/wax coating was applied somewhat more thickly than the others, and thus could have received a slight boost, this effect is not readily apparent. The remaining three coatings were in a similar thickness range, from 0.6 to 1.0 mil, which represents a typical sprayed coating thickness in conservation practice. Coating thickness was therefore determined to not be a major factor in the performance of our samples outside of the BTA/wax coating. As previously mentioned, however, application of thicker wax coatings such as studied in Phase I did not improve performance markedly.

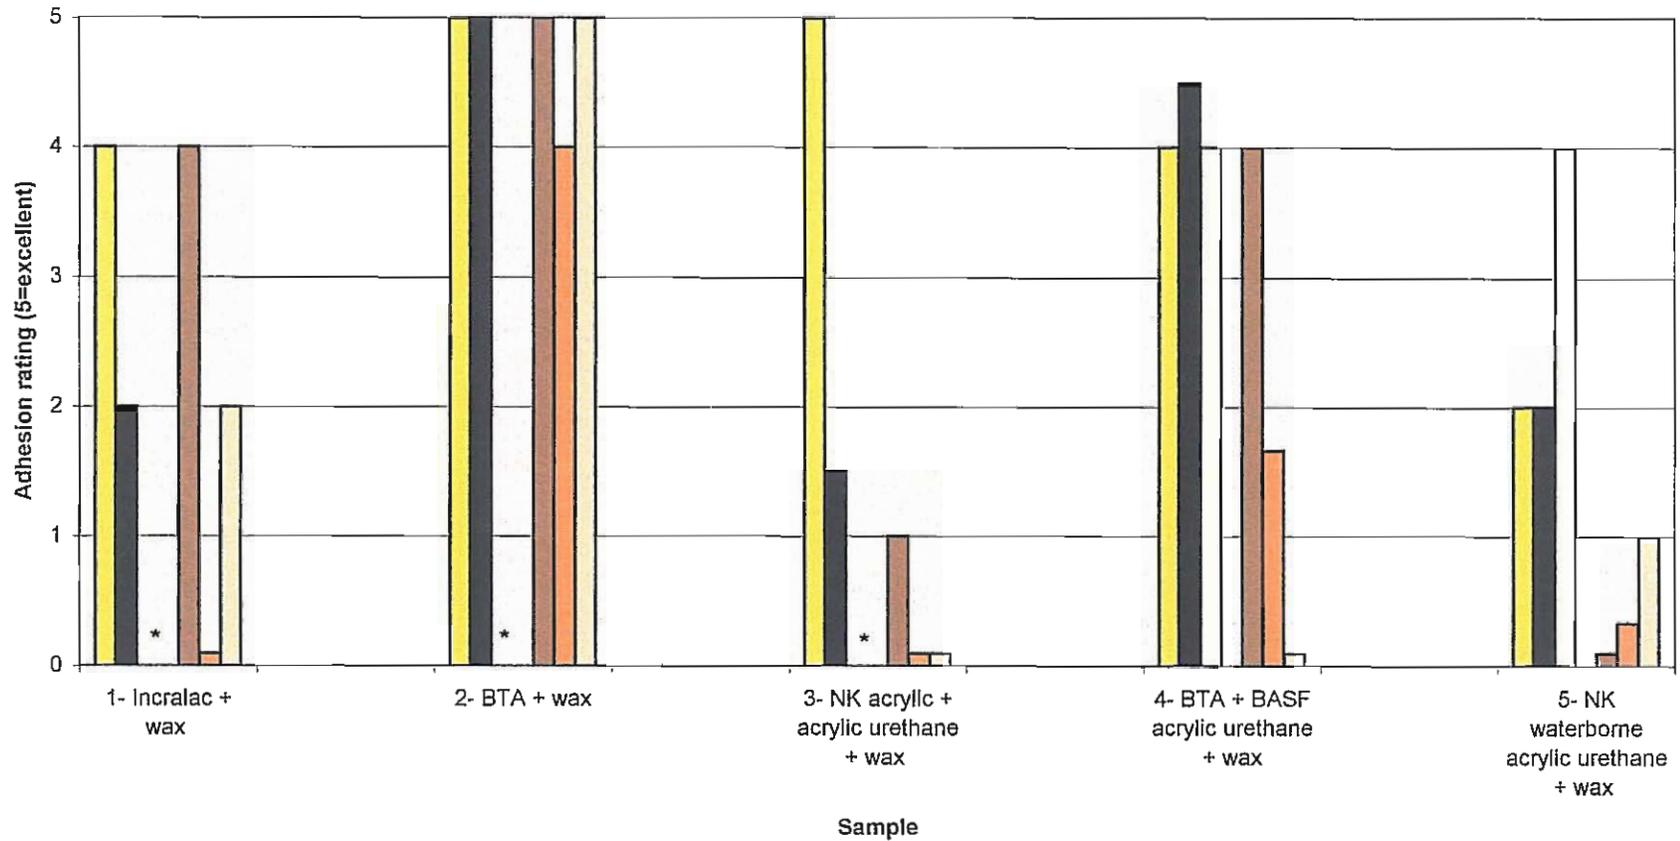
Figure 5

Comparison of the overall failure ratings to adhesion tests of coatings before and after weathering (Figures 5-6) shows that the excellent measured adhesion of the BTA/wax coating had relatively little effect on its performance. The adhesion test results for wax appear to be an artifact, however, because the wax has very poor cohesive strength, but is so thin that any de-adhesion within the wax layer itself is difficult to observe by this method. Thus, measurements are artificially inflated. While the wax is excellent at forming mechanical adhesion on rough surfaces, this type of adhesion is not sufficient to offset the porosity of the wax coating, which allows access of an electrolyte such as acid rain or Harrison's solution to the metal surface.

The adhesion bar graphs also show that significant losses in adhesion occurred on patinated bronze during weathering of the acrylic and solvent-borne acrylic urethane coatings. This clearly accounts for a good deal of failure not seen on the other substrates, although it is unclear whether this dynamic loss of adhesion contributed to poor coating performance as a cause or effect. As previously mentioned, the artificial patina was only loosely adhered to the bronze, also contributing to the generally poor adhesion of the coatings before and/or after weathering and causing cohesive failure within the patina layer. This was apparent in areas that delaminated from the bronze and were seen to have the patina stuck to the delaminated side of the coating.

Cross-Cut Adhesion Rating of Coatings on Cast Bronze, Phase II, Before and After Accelerated and Natural Weathering

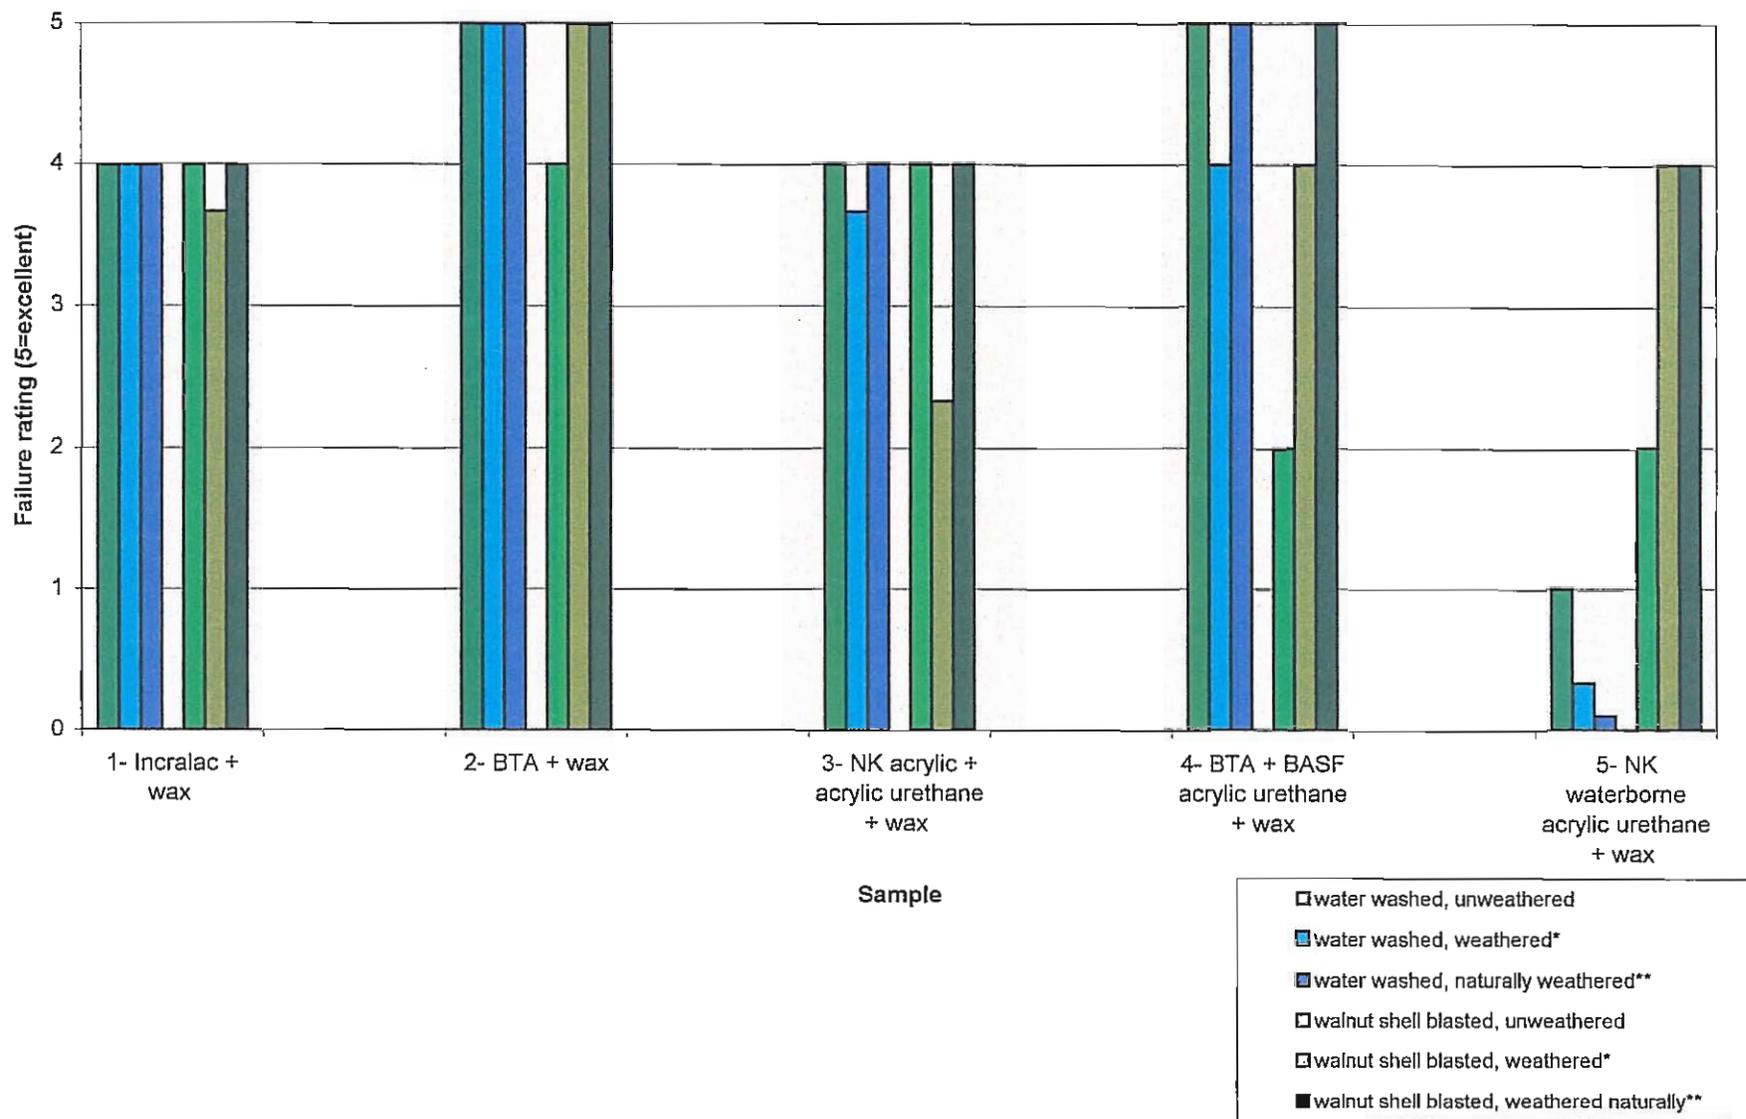
Figure 6

The almost non-existent adhesion of the waterborne coating on the copper roof samples may be due to poorer wetting of the coating on this substrate, which would result in little or no penetration into the patina.¹⁵ The poor adhesion in large part predicts the dramatic failure observed on the copper roof sample during natural weathering. On the other hand, it is quite interesting that the waterborne acrylic urethane on both the bronze substrates and the blasted copper roof actually gained some adhesion during weathering. This appears to explain the somewhat better performance of the waterborne acrylic urethane relative to the others at least on the patinated bronze. An explanation for the increased adhesion in these cases could be an interaction between the coating and metallic ions, causing increased curing or other strengthening properties. This should be investigated in future work.

X-Cut Adhesion Ratings of Coatings on 50-Year Old Copper Roof, Phase II, Before and After Accelerated Weathering

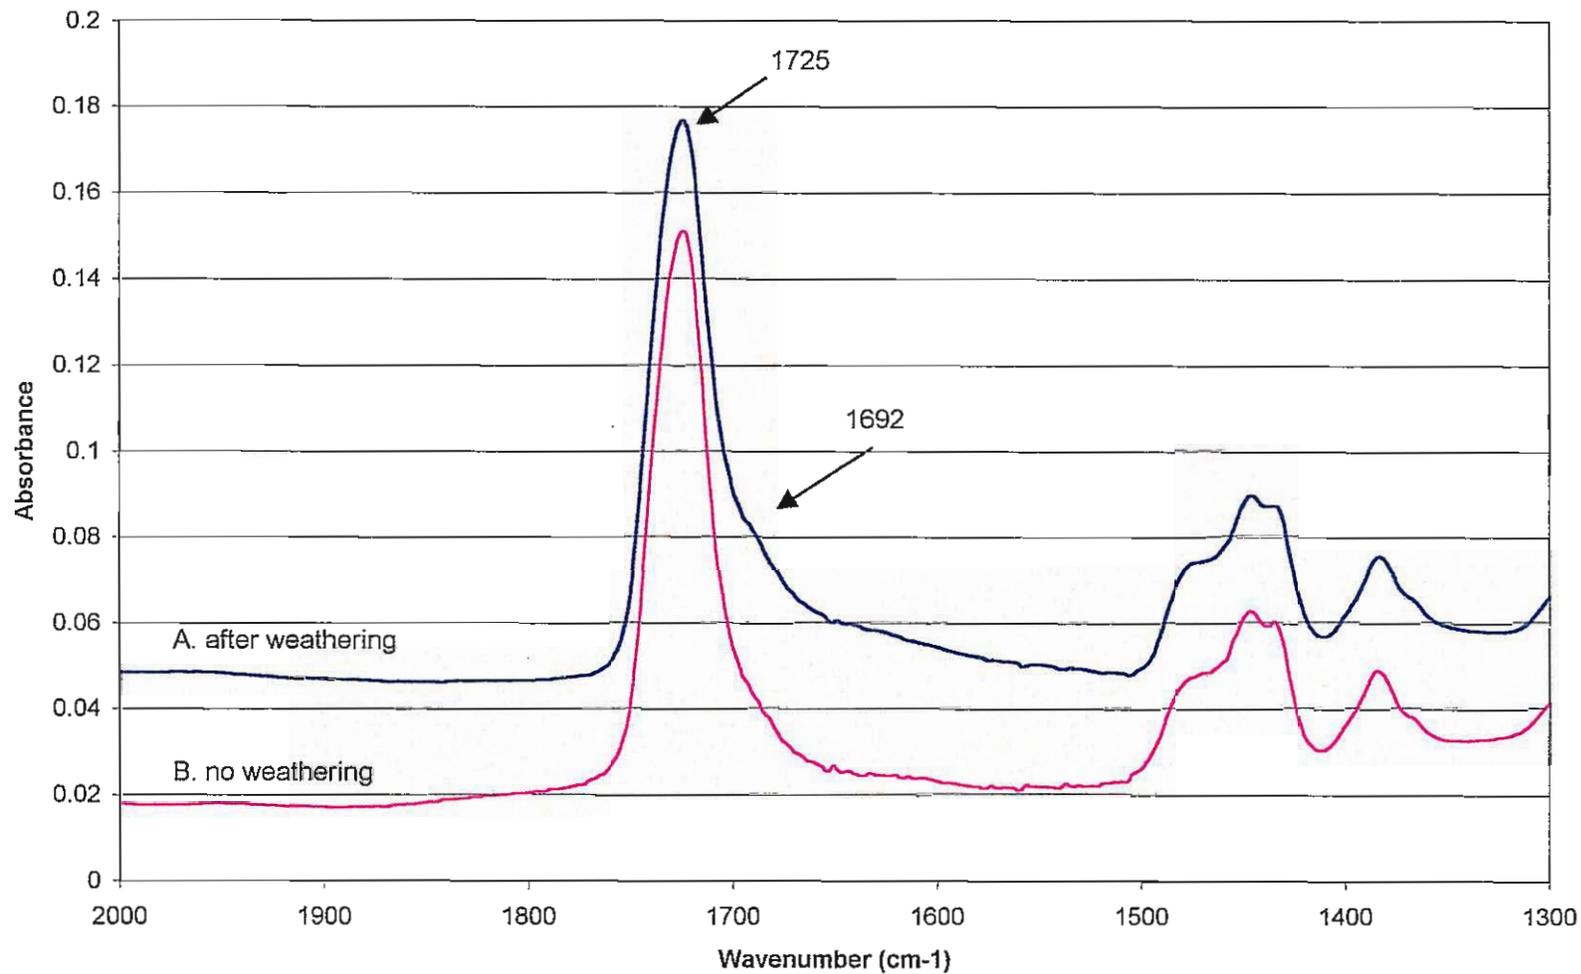
Figure 7

confirm that chemical changes may occur at the metal/coating interface during weathering. As shown in Figure 7, a broad shoulder centered near 1690 wavenumbers is developing during weathering. This indicates the formation of carboxylic acids and carboxylate salts near the metal surface, which most likely account for corrosion-induced de-adhesion and forecast future problems.

**ATR spectrum of Carbonyl Absorbance in Inctalac Films on Polished Bronze,
A) With and B) Without Accelerated Weathering**

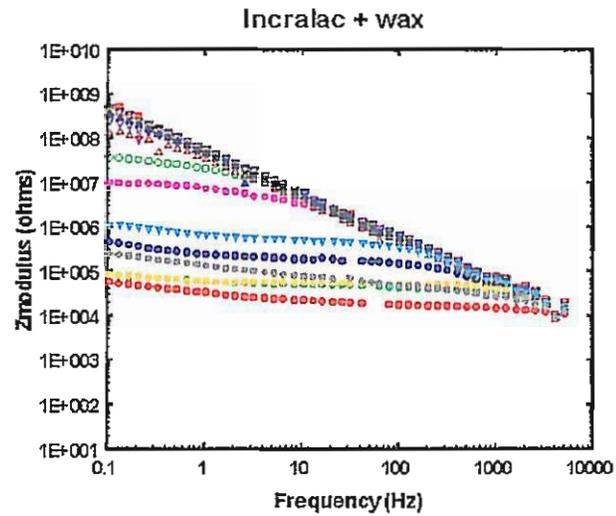
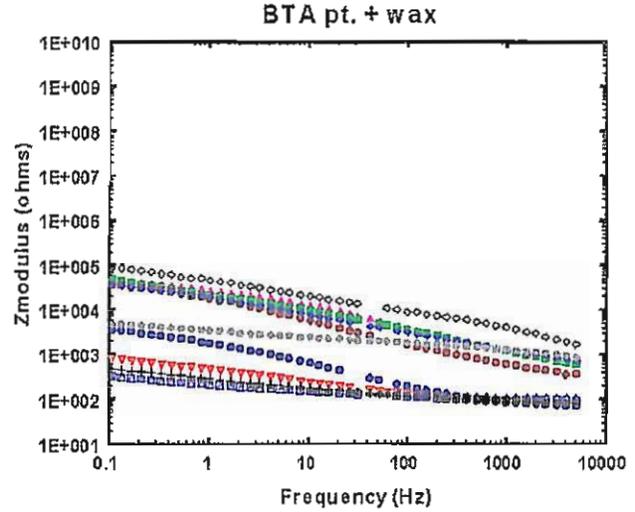
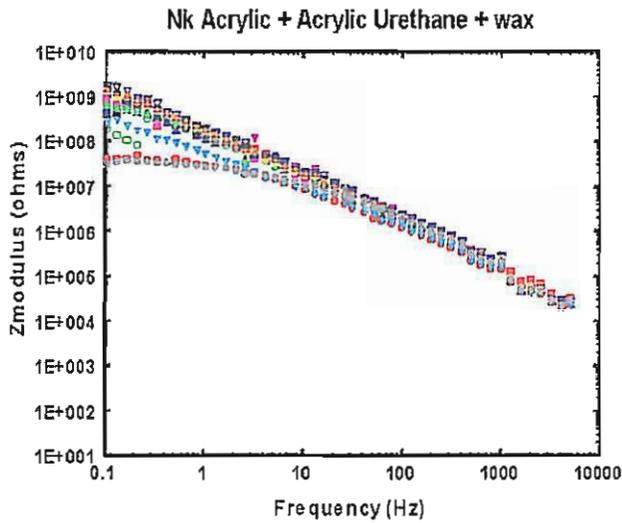
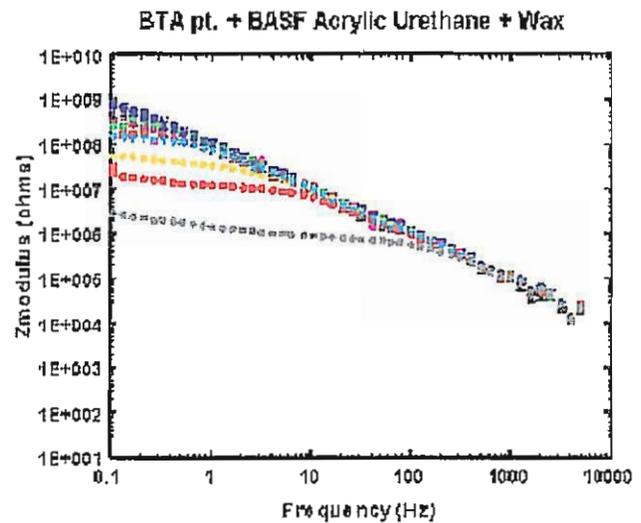
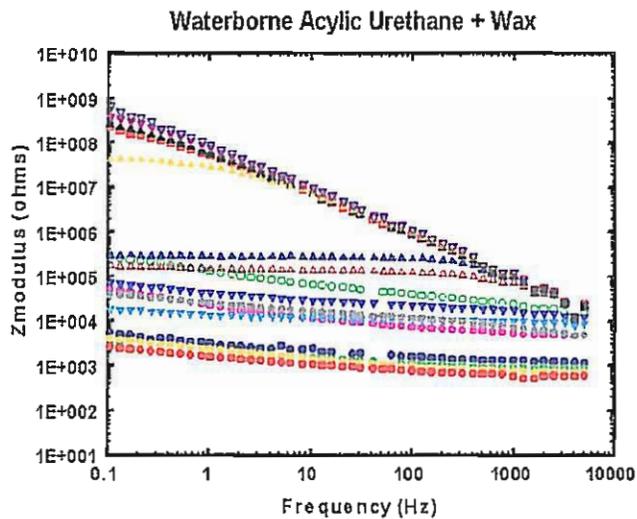
Figure 8

Phase II, sample set A are presently in their fourteenth week of cycling between UV and salt fog exposure in the North Dakota laboratory, and will continue until they reach complete failure. The respective Bode plots (Figure 8) reveal the following ranking, in order of worst to best: BTA + wax (#2) < waterborne acrylic urethane + wax (#5) < Incralac + wax (#1) < BTA + BASF acrylic urethane + wax (#4) ≤ Nikolas acrylic/acrylic urethane/wax (#3). This ranking is identical to the overall failure rating ranking for the blasted copper roof substrates, but differs from the ratings on the other substrates, including that for polished bronze. However, it should be added that failure ratings of coatings #1, 3, 4, and 5 were tightly grouped on the polished bronze after 120 days accelerated weathering at the National Gallery of Art. It is possible not only that the weathering protocol caused a difference in ranking, but also that a spread in the performance grouping is better predicted by EIS. This is particularly true of the waterborne acrylic urethane, for which the $|Z|_{0.1 \text{ Hz}}$ value drops precipitously between 35 and 42 days. Thus the EIS results appear to predict the dramatic failure of the waterborne coating on the naturally weathered polished bronze and 50-year-old copper roof. Furthermore, the $|Z|_{0.1 \text{ Hz}}$ value for Incralac + wax begins to waver under 10^6 ohms after 42 days. Again, this may better predict eventual loss in adhesion and failure on polished bronze than seen in the accelerated weathering protocol at the National Gallery. Loss of adhesion in Incralac coating systems after weathering was also found on sample set B, as well as Phase I samples (see Figure 2 and 1996 and 1997 Final Reports to NCPTT).

impedance modulus slope over time, suggesting the beginning of formation of microcracking in the coating. This behavior is borne out in the graph in Figure 10, where the Nikolas system $|Z|_{0.1 \text{ Hz}}$ remains fairly flat up to 77 days, and the BASF system starts some moisture cycling around 49 days.

Bode Plots of Polished Bronze Plates
During Prohesion[®] and QUV[®] Cycling

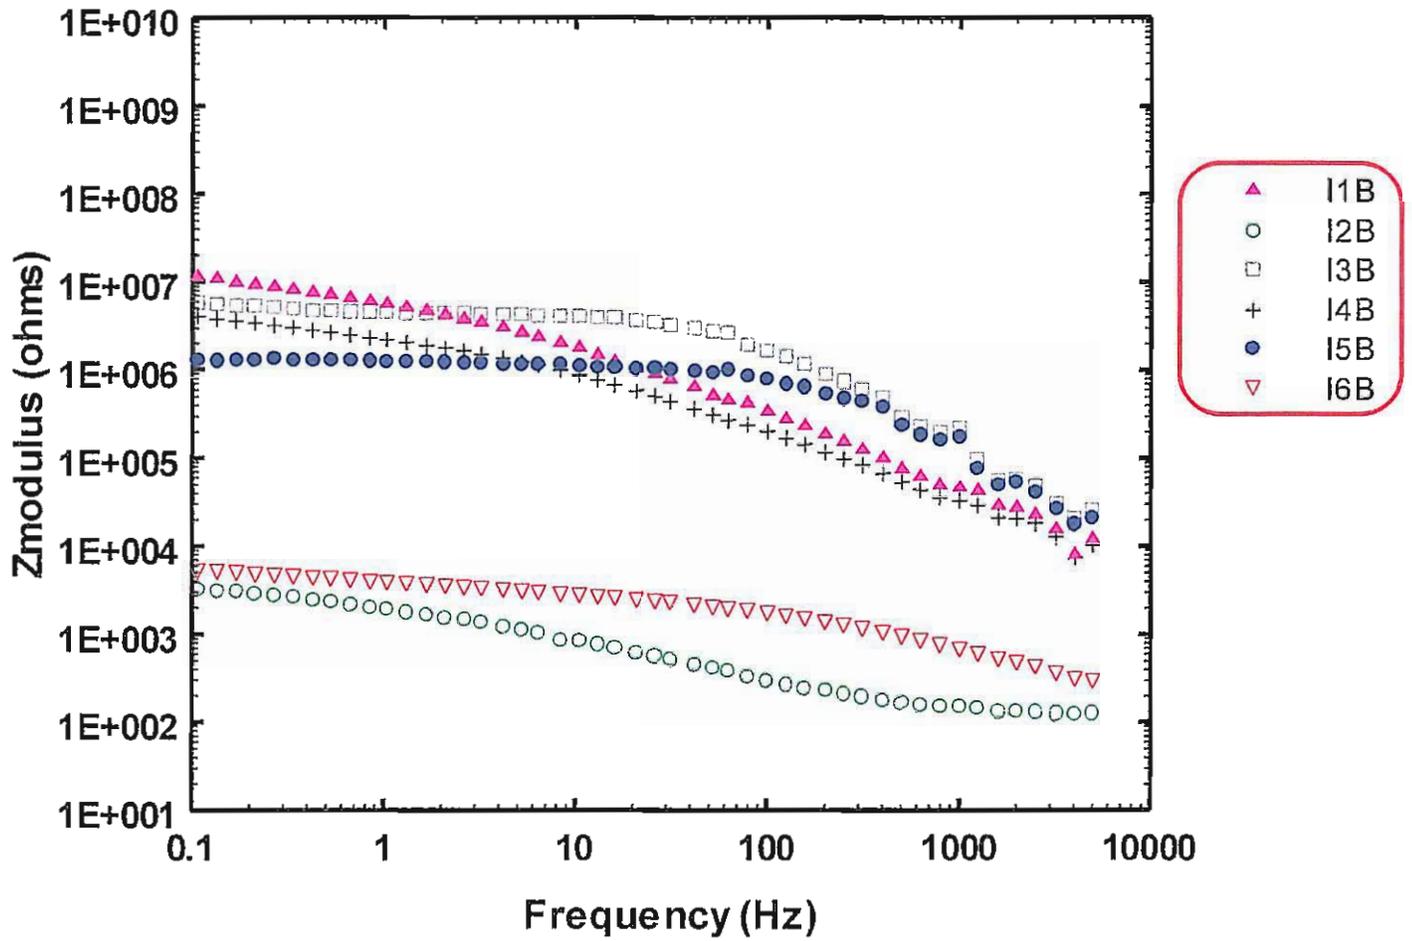
Figure 9

The Bode plot for samples previously weathered at the National Gallery of Art is shown in Figure 9. EIS rankings to date are, from worst to best, as follows: BTA pretreatment + wax (#2) < uncoated bronze << Nikolas waterborne acrylic urethane + wax (#5) < BTA pretreatment + BASF acrylic urethane + wax (#4) \leq Nikolas acrylic + Nikolas acrylic urethane + wax (#3) \leq Incralac + wax (#1). These results correspond quite well with the overall failure ratings shown in Figure 1, especially with regard to the close ranking of the acrylics and acrylic urethane coatings. EIS also confirms that, except for wax, the other four coatings were performing marginally well after 120 days of accelerated weathering at the National Gallery of Art. A disturbing result shown here is that the waxed samples actually fell behind the uncoated sample, which is now covered by a coherent layer of corrosion.

National Gallery of Art Accelerated
Weathered Samples

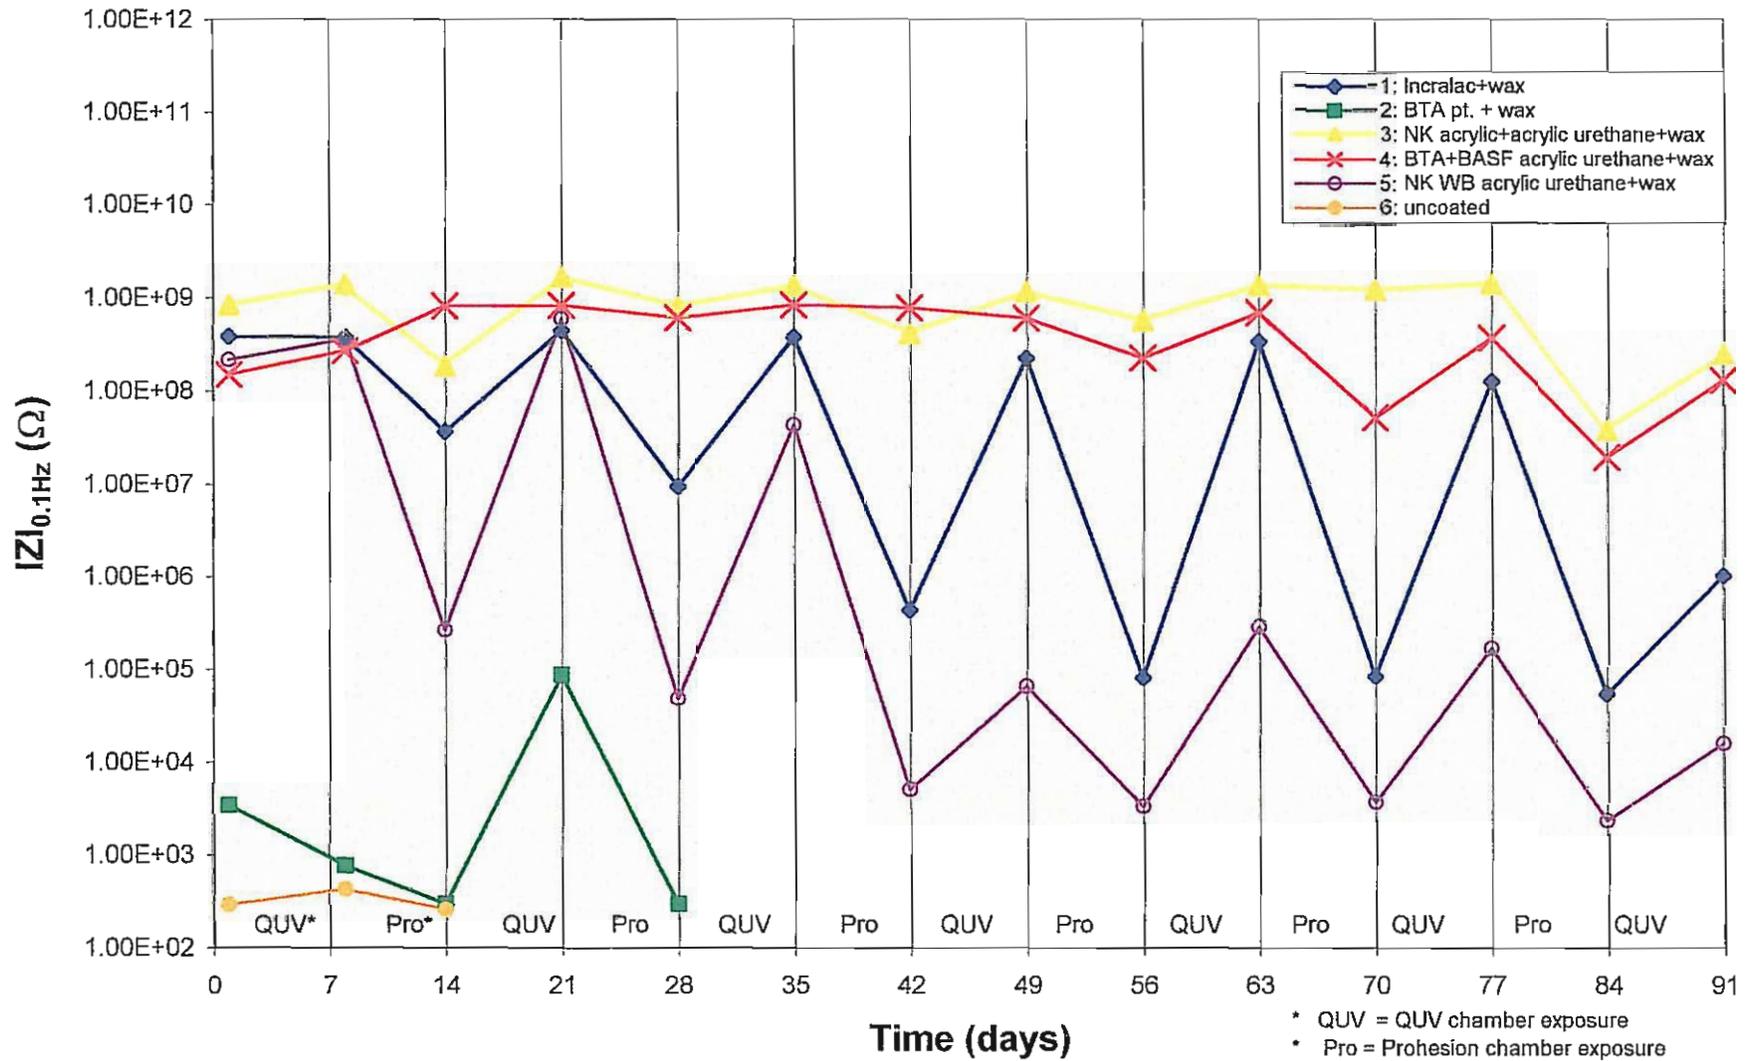
The impedance modulus $|Z|$ at 0.1 Hz is plotted against time/cycle of weathering for sample set A in Figure 10. The uncoated sample has $|Z|_{0.1 \text{ Hz}}$ between 10^2 and 10^3 ohms. This marks the effective point of failure, when the coating no longer exceeds the impedance of the uncoated metal. Coatings that have impedance $|Z|_{0.1 \text{ Hz}}$ above 10^7 ohms are considered to be performing well under this weathering protocol. As seen in Figure 10, after 91 days of weathering only the Nikolas acrylic/acrylic urethane/wax and the BTA/BASF acrylic urethane/wax coatings remain in this category.

Figure 10 also illustrates that the impedance of the coatings does not fall sequentially with time, but rather oscillates up and down. This phenomenon arises from moisture cycling in the weathering regime. After one week in the Prohesion[®] chamber, if the coating has imbibed quite a lot of moisture, the metal at the bottom of the pores is wetted and conductivity increases. This causes the impedance to drop. When the sample is again exposed to QUV[®], the moisture evaporates and the impedance rises. Two of the coatings exhibit large oscillations in impedance with weathering cycles: Incralac and the waterborne acrylic urethane. This indicates that these coatings, especially the latter, are vulnerable to moisture/electrolyte ingress. Although not readily shown on this graph, this was also true of the wax coating.

In one instance, impedance did not rise after QUV[®] exposure: the wax coating at 7 days. This suggests that moisture was actually trapped beneath the coating, in part explaining the rapid formation of corrosion that has been observed on the wax-coated samples. In fact, EIS readings for the BTA + wax-coated sample were discontinued after only 26 days because of its rapid failure. It should be noted that the initial impedance reading of the wax coating was less than 10^4 ohms, which is already very poor. Thus the wax coating does little to effectively block moisture/electrolyte ingress. Another noteworthy feature of the graph in Figure 10 is the temporary increase in impedance that is observed for the wax coating after 14 days. This may be interpreted as the formation of a new passivating layer at the metal/coating interface, most likely formed by the reaction of copper ions with chlorides and/or oxygen. When this layer subsequently breaks down after 26 days, impedance drops again. In addition, the Bode plot of the wax coating in Figure 8 shows a decrease not only in low frequency impedance with time of weathering, but a decrease also at high frequency. This indicates significant increase in porosity in the film. The Bode plot shows that after only eleven days of exposure to the weathering cycle, the BTA/wax coating failed. Results thus underscore the fact that this wax coating is in a different performance category altogether than the other coatings tested in this study. Thus, the BTA/wax coating cannot be considered to be truly protective.

**$|Z|_{0.1\text{Hz}}$ vs. Time of QUV/Prohesion Exposure
for Coatings on Polished Bronze Samples**

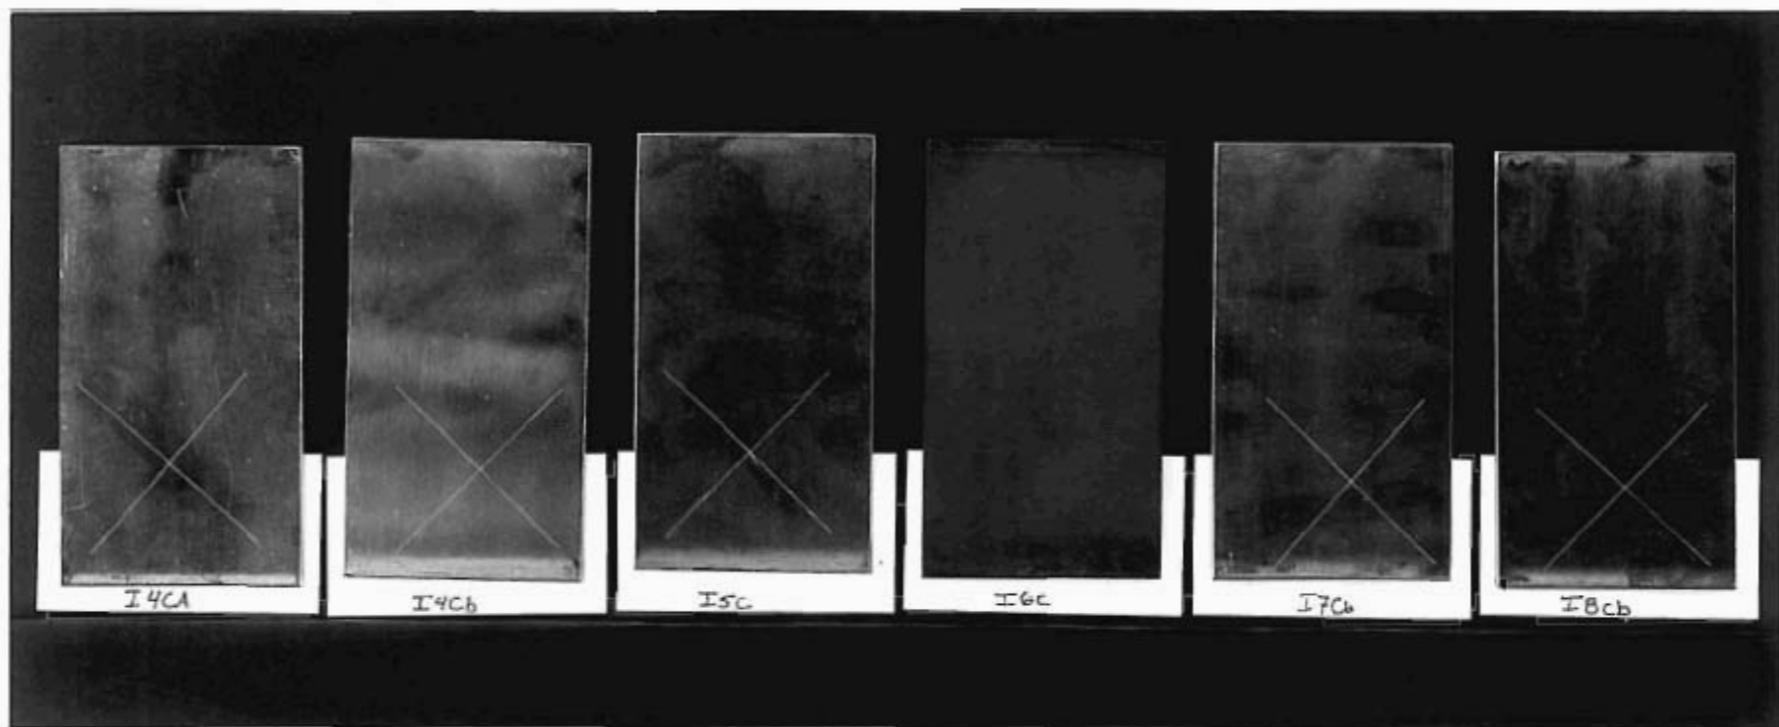
NATURALLY WEATHERED Polished
bronze samples.
After 1 year outside.
* Note samples 1-3 missing.
