Research into Protective Coating Systems for Outdoor Bronze Sculpture and Ornamentation

Phase III | 2000-08

National Gallery of Art

FINAL REPORT

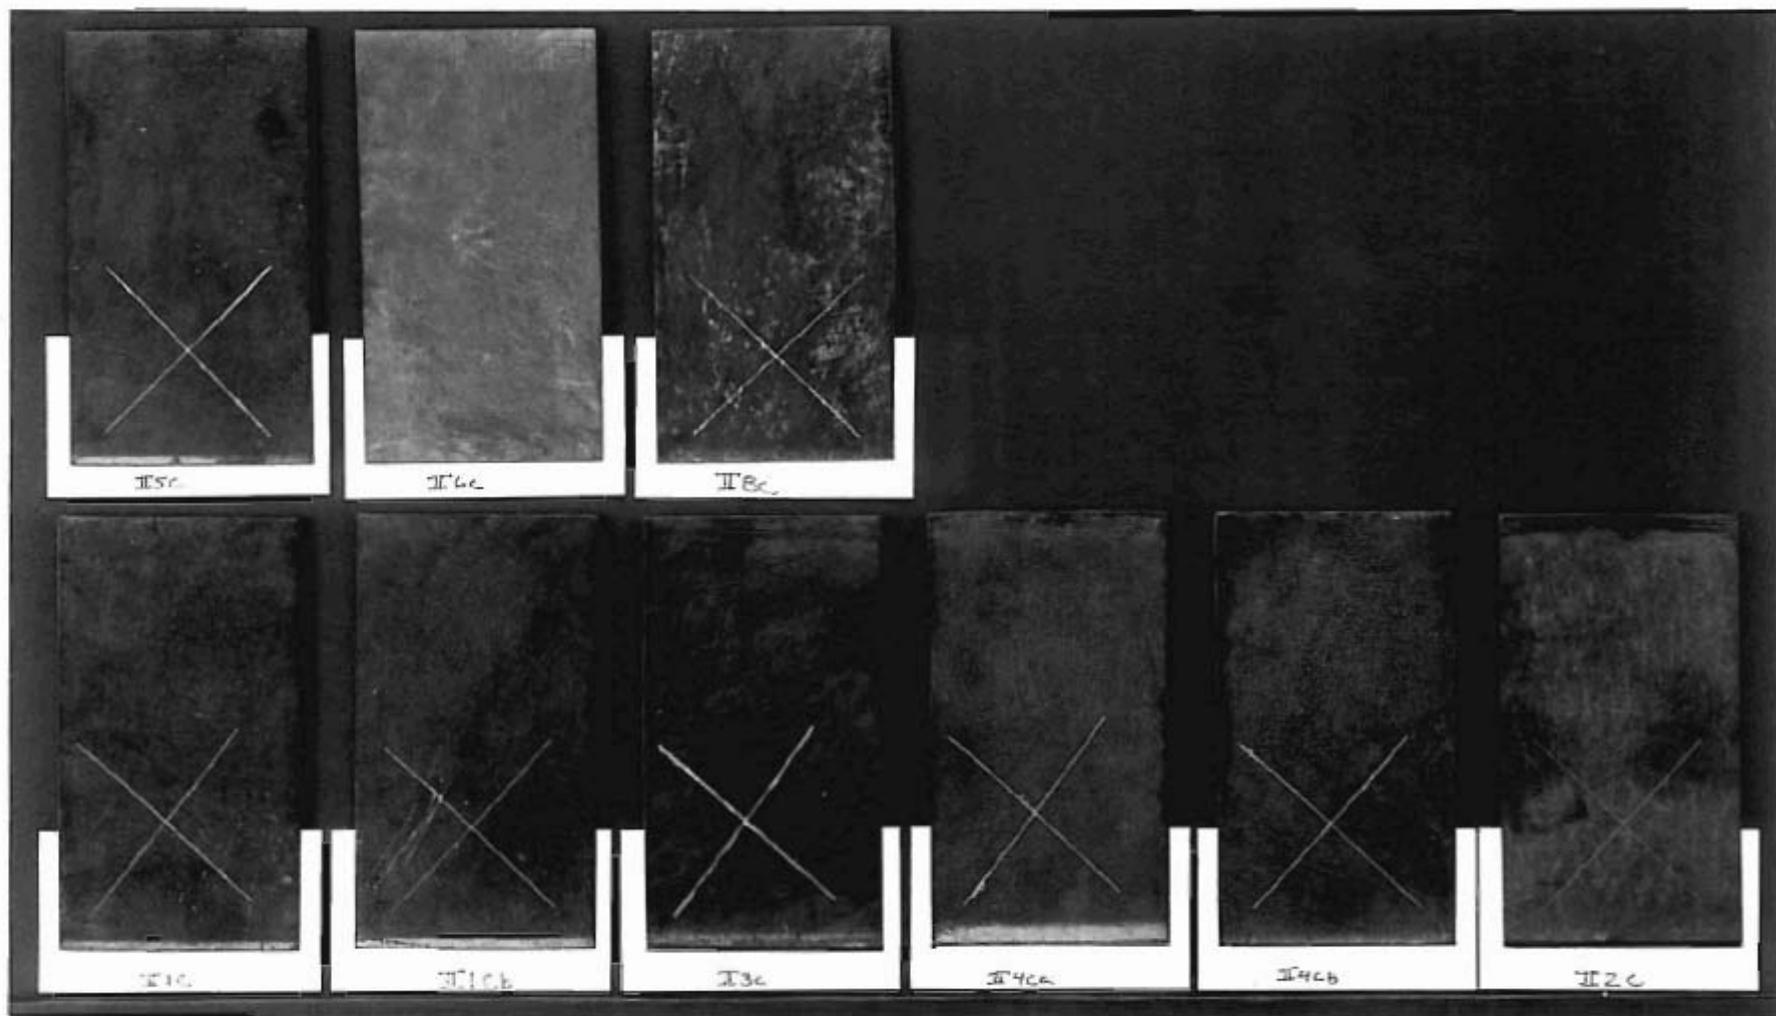
NATURALLY WEATHERED Artificially
patinated bronze samples.
After 1 year outside.

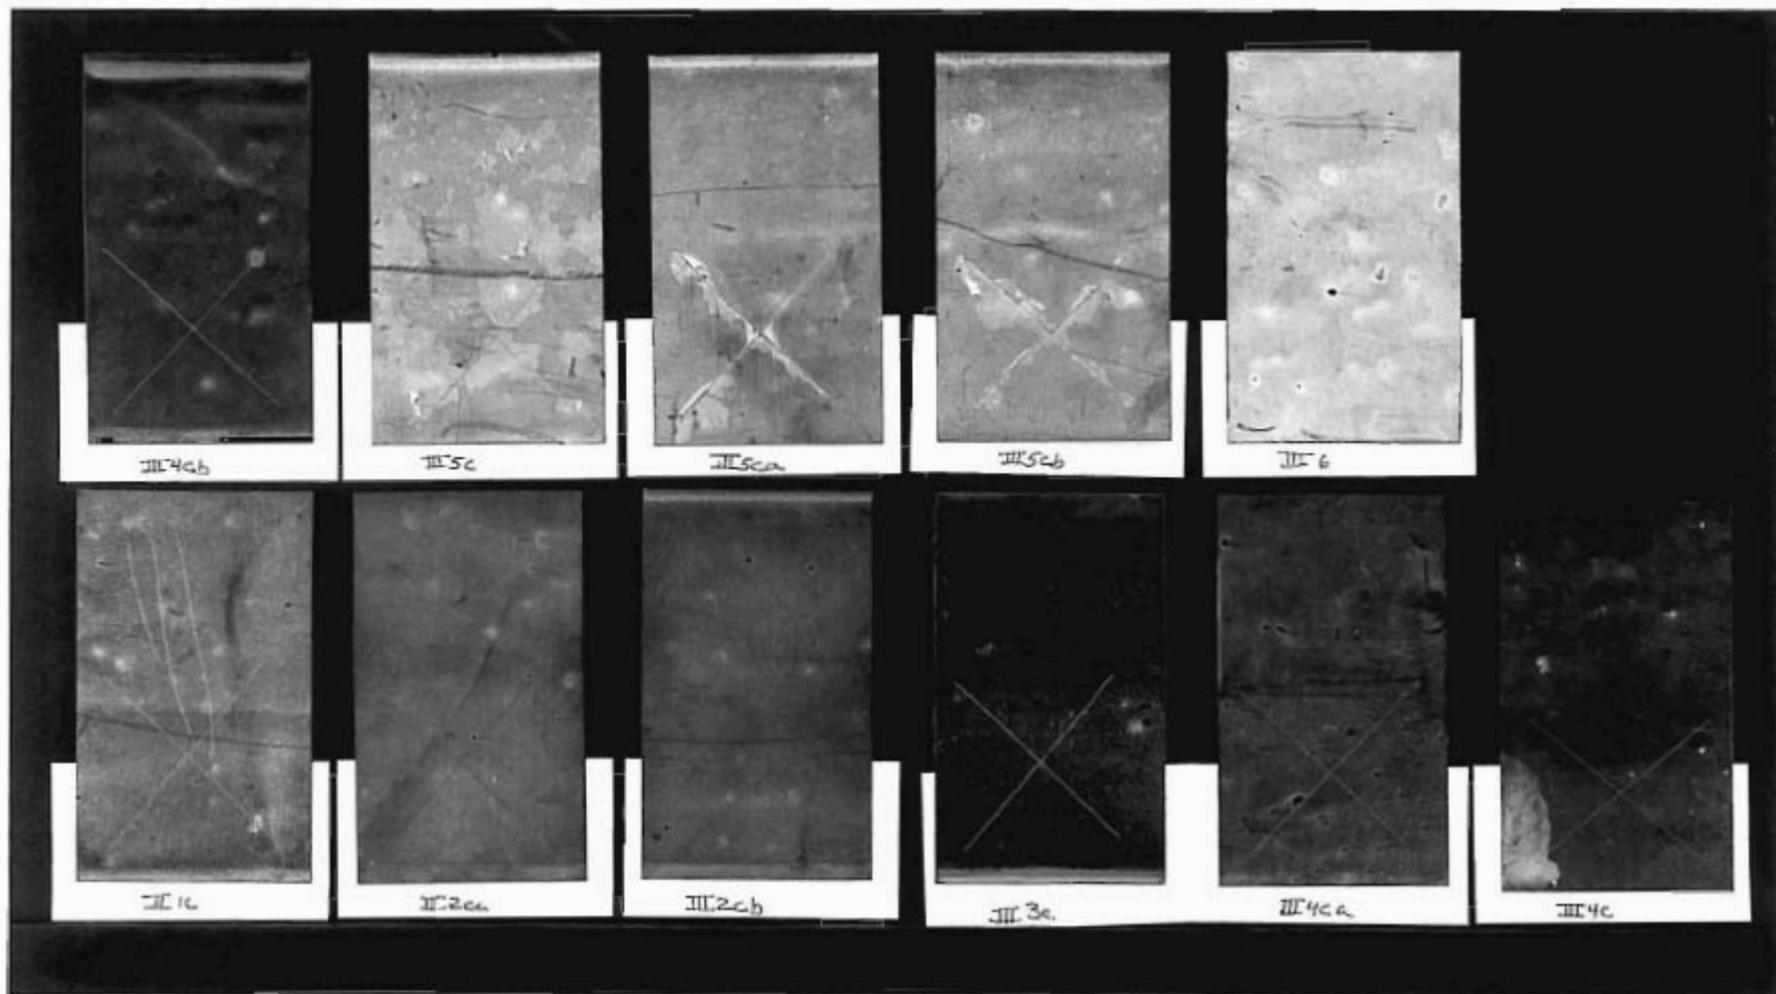
NATURALLY WEATHERED Water washed
copper roof samples.
After 1 year outside.

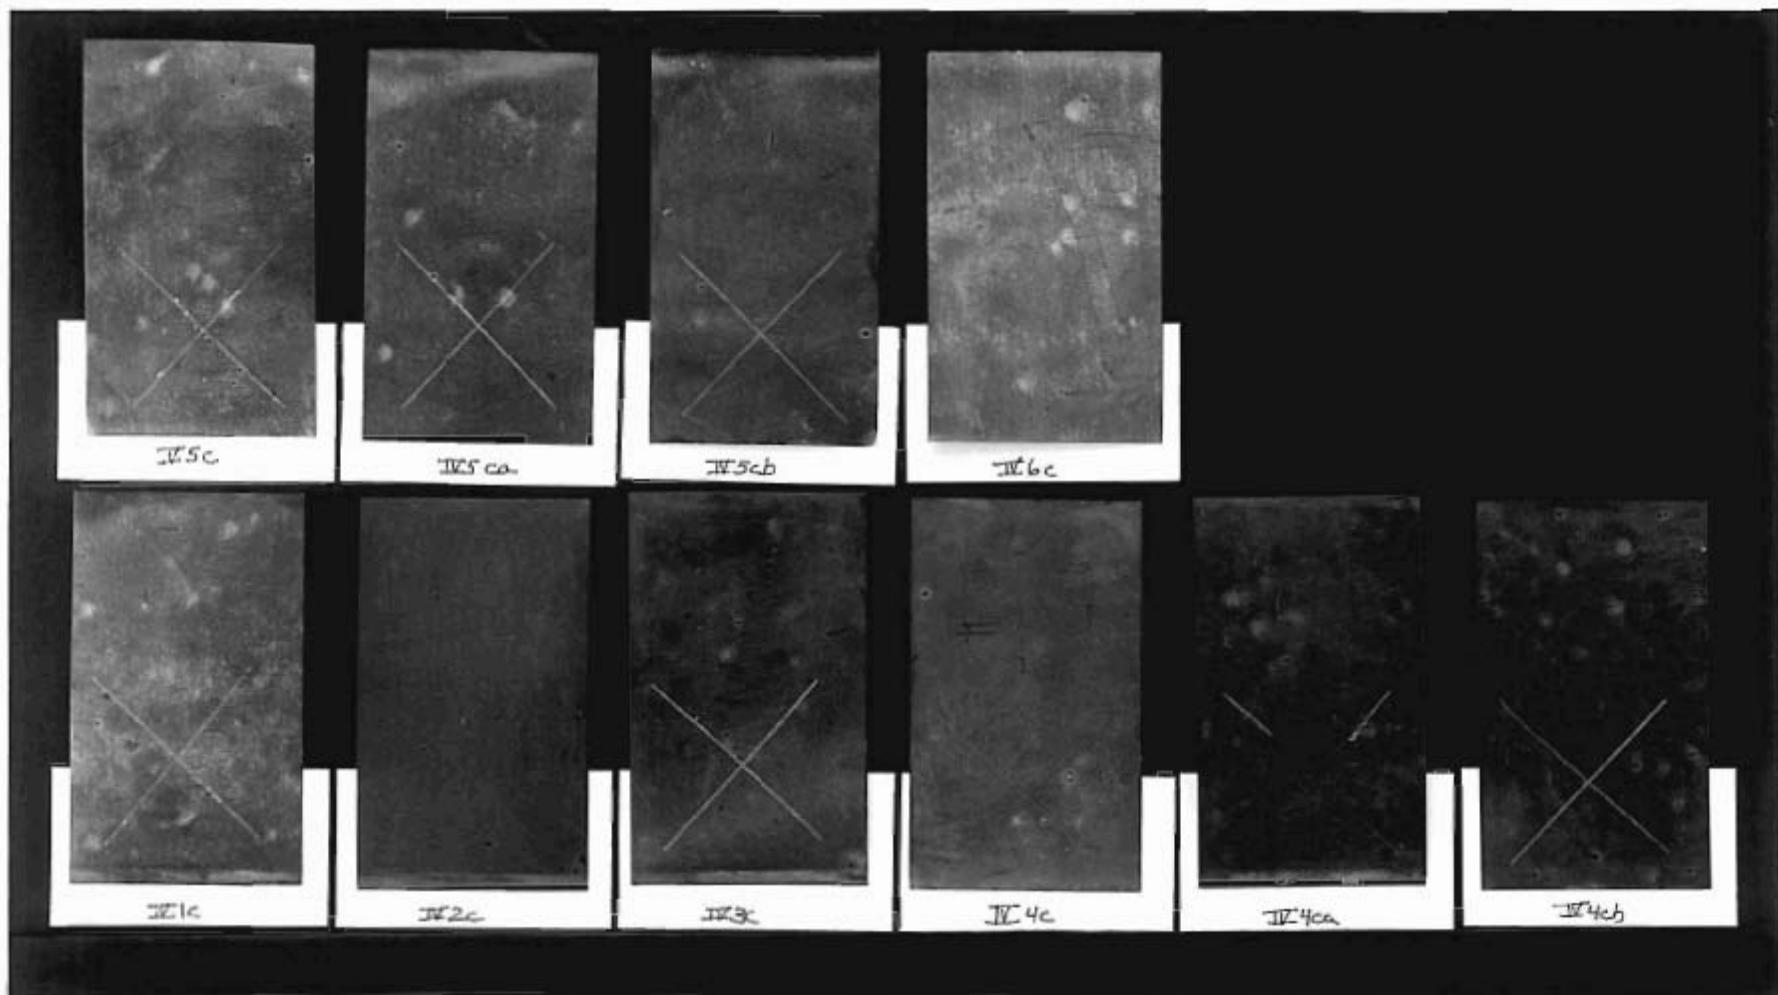
On the walnut shell-blasted copper roof, other than the wax the poor performance of coatings rose in part from scribe corrosion. The scribes mostly appeared to have dark green haloes, suggesting reprecipitation of the brochantite here from moisture/electrolyte ingress.⁹ Adhesion of the coatings, as measured at room conditions, did not appear to be much impaired, however (see Figure 4). The implication is that adhesion under wet conditions was poor in these systems. As reported previously,¹⁰ scanning electron microscopy /energy dispersive spectroscopy (SEM/EDS) of the walnut shell-blasted surface showed an aggravated porosity and non-homogeneity in the patina layer, as well as the new presence of carbonaceous material. Evidence in the analysis of this substrate was conflicting in terms of the presence of residual oil from blasting, however. The presumed residue of walnut oil from the blasting could not be confirmed either by FTIR of the patina nor by gas chromatography (GC) of patina extracts. While GC positively identified walnut oil from extractions of the shells used for blasting, results from patina extractions both before after blasting contained many acids, so that positive identification of walnut oil was not possible by this method. In either case, the above evidence indicates that the substrate was significantly destabilized in terms of corrosion potential.

On the remaining substrates, BTA/wax coatings had the above drawbacks plus allowed severe overall pitting corrosion in the form of light green, powdery spots to develop. This result was especially remarkable on the walnut shell-blasted copper roof substrate, where removal of a significant portion of the natural patina apparently resulted in a vulnerable surface on which the wax coating provided entirely insufficient protection.¹¹ Furthermore, results after slightly more than one year of outdoor weathering show that the waxed samples (excluding the absent polished bronze) are beginning to pick up in signs of deterioration. Upon examination under magnification, the waxed, polished bronzes in Phase I showed etching beneath the wax after relatively short exposures in the outdoors. The Phase I samples, despite a much thicker wax coating of the same material, also performed poorly in accelerated and natural weathering.¹²

NATURALLY WEATHERED Walnut-shell
blasted copper roof samples.
After 1 year outside.
