HISTORIC AMERICAN ROOF TRUSSES

IV. Composite and Raised Bottom Chord Trusses

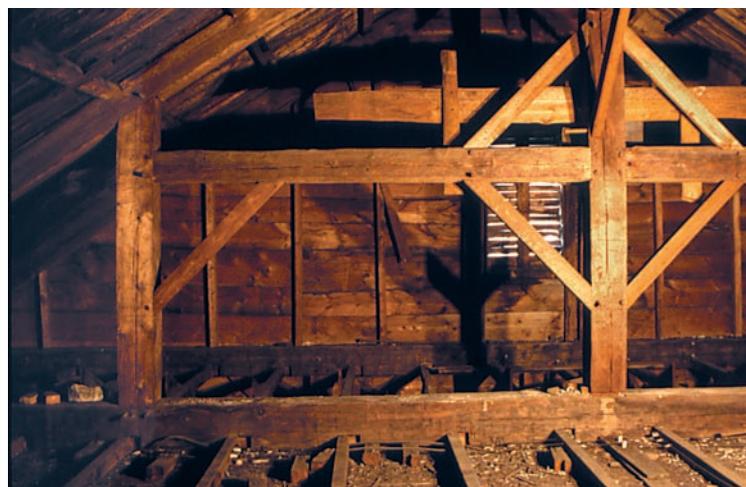
Fig. 3. Naïve truss at Newbury, Vermont, Methodist Church, 1829. Apparent queenpost merely adds unwanted load to truss chord.

The examination of church attics of notable span in eastern North America (qualified by the small percentage it is possible to see in one lifetime) generally reveals trusses so rationalized that we suspect the builders were very experienced and endowed with good structural instincts, or they were in possession of builders' guides that included sound truss designs. Exceptions exist. Puny raking struts or ties rising from tie beam to rafter in such roofs as at the Strafford, Vt., Town House (1799) or at the Windham, Vt., Congregational Church (1801), discussed in Part III of this series (see TF 72), are archaic holdovers that play no role or only a tiny one in the functioning of these otherwise completely realized trusses. Another puzzling example is the kingpost truss roof of the 1829 Newbury, Vt., Methodist Church, where 9x9 vertical members parallel the kingpost at the quarter points of the span, unsupported by struts or bracing, seemingly awaiting (nonexistent) gallery posts below to help them prop the midspan of the rafters. Without the gallery posts, these unsupported posts at Newbury serve merely to load and deflect the bottom chord at a point 10 ft. distant from the kingpost tension joint (Fig. 3).

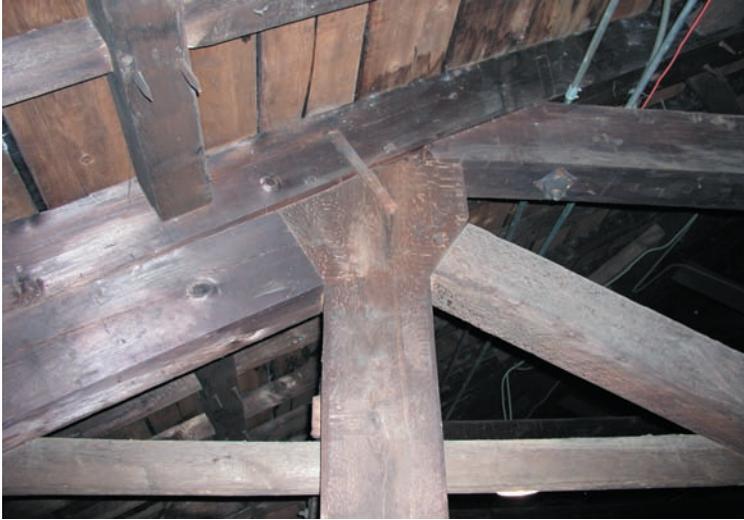
Fig. 8. Some queenpost heads at Central Moravian, obstructed by struts, cannot be bolted to the principal rafters and are stapled instead.

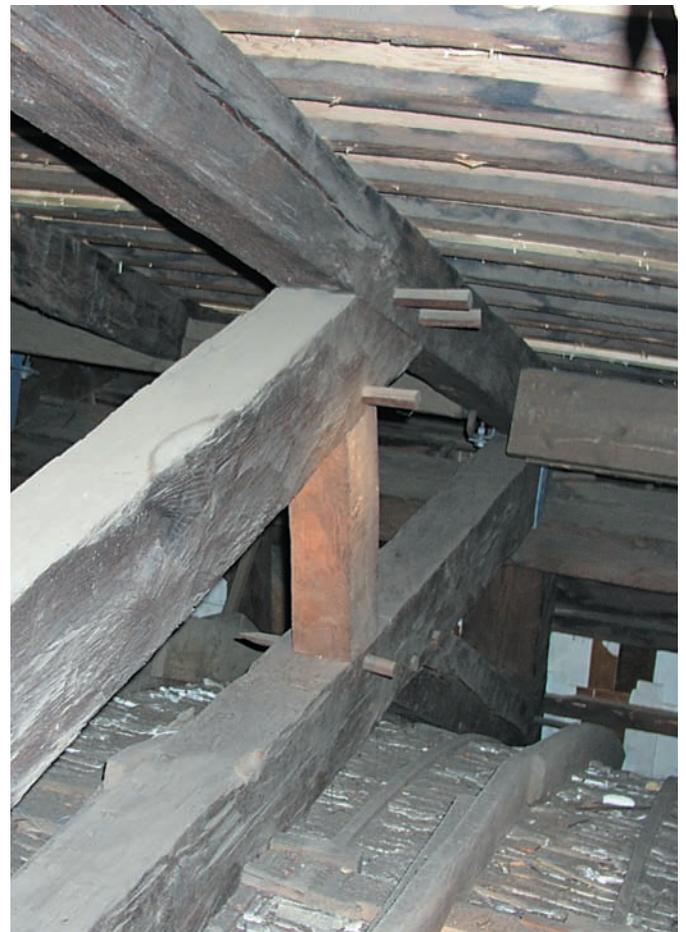
Fig. 22. Principal rafter at Shrewsbury descending past connection with raised chord to meet oblique tie over plate. Brace rises from post to oblique tie, and vertical strut connects latter and raised chord. Some back-primed shingles visible at wall.

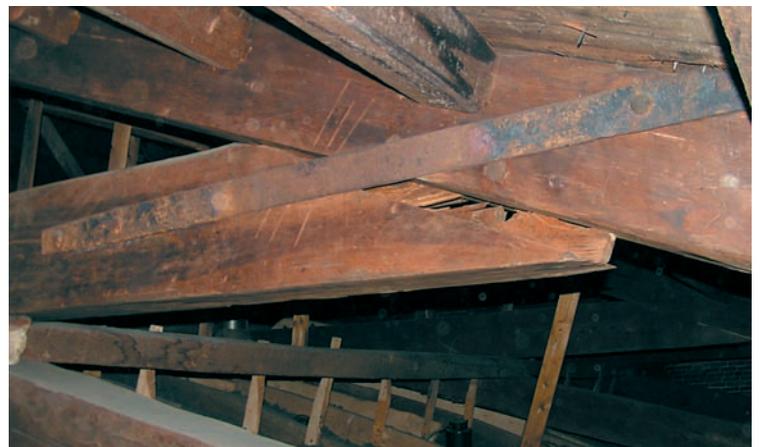
Fig. 29. Tenon destruction in raised chord withdrawn from principal rafter in St. John's truss. Strap may conceal shear failure in chord.

The problem at St. John's is that the gallery post extensions prop the principal rafters near midspan but do not directly or even closely support the raised bottom chord and its joints with the principal rafter. Perhaps consequent from this anomaly are the only failures we observed at St. John's: two separated junctions between raised bottom chords and principal rafters, one noteworthy and one resulting in complete destruction of the chord tenon at this pinned and strapped joint (Fig. 29 overleaf).

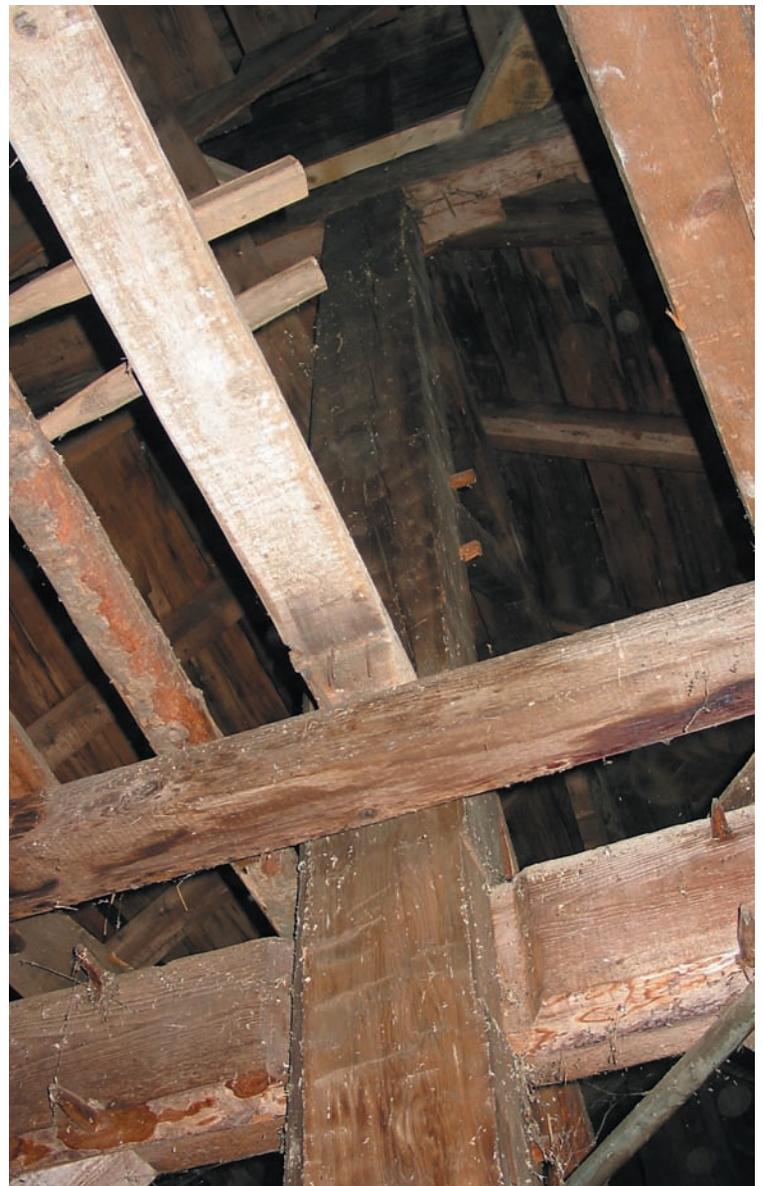
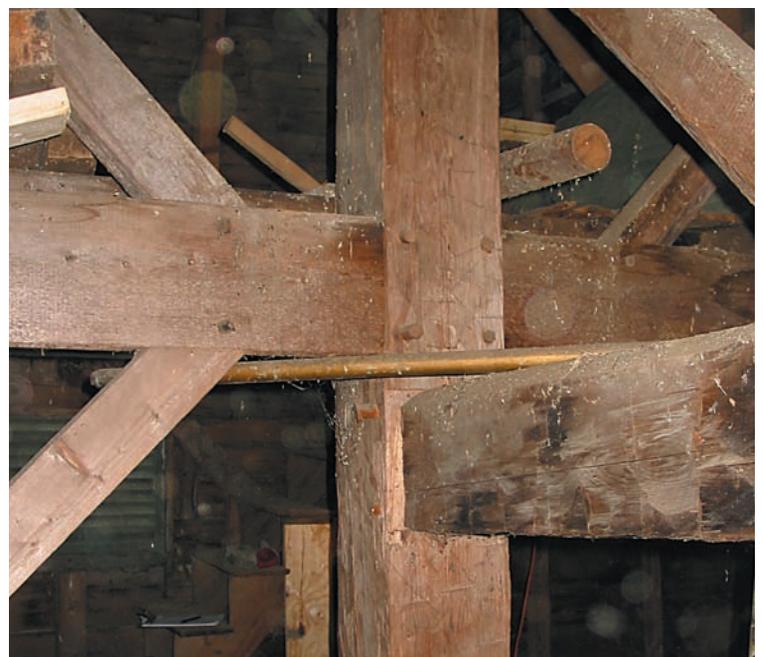
Figs. 33 and 34. Kingpost in tower truss at Sutton Baptist Church is supported by pins at the top and by the tenons of the braced beams seen near bottom of photo and also seen passing from left to right in the photo below. Below, the kingpost is linked and braced back to the bottom of the next kingpost truss via the lowest beam seen on the right.

The tower truss kingpost at Sutton now bears back heavily on its longitudinal brace and connector, and the thrust is carried through the connector and its lower diagonal brace to the foot of the next interior kingpost. The latter is through-tenoned to a tie beam carrying joists and a finished ceiling and thus quite capable of resisting the partly horizontal thrust. The longitudinal braces that rise toward the tower truss kingpost are very heavily compressed on their bearing shoulders, whereas the braces rising away are loose in their mortises.
