# Historic Concrete and Masonry Assessment by the Air-Coupled Impact-Echo Method | 2012-04

# Final Report

Historic Concrete and Masonry Assessment  
by the Air-Coupled Impact-Echo Method

Department of Architectural Engineering  
The Pennsylvania State University  
104 Engineering Unit A  
University Park, PA 16802

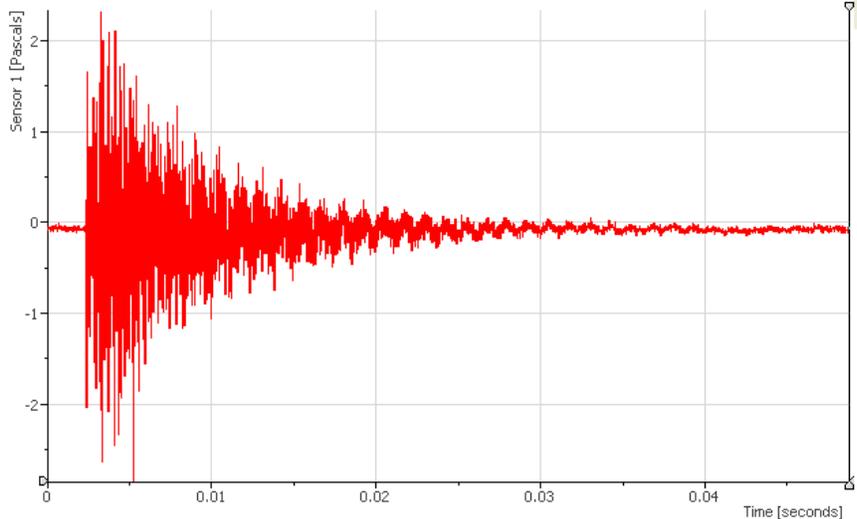
Figure 1.1: Typical time domain waveform

The IE method relies upon the gathering of frequency and wavelength data in order to detect flaws in concrete. For a digital computer to acquire this type of information, it first must collect it over a finite period of time. This data is referred to a time domain data since it is a measure of the amplitude of the sounds versus the length of time it was collected in. Figure 1.1 shows a typical time domain waveform. In order to make sense of the digitalized data, the data needs to be transformed to the frequency domain, which is amplitude plotted against frequency. Figure 1.2 shows the previous time domain data transformed into a frequency domain waveform.

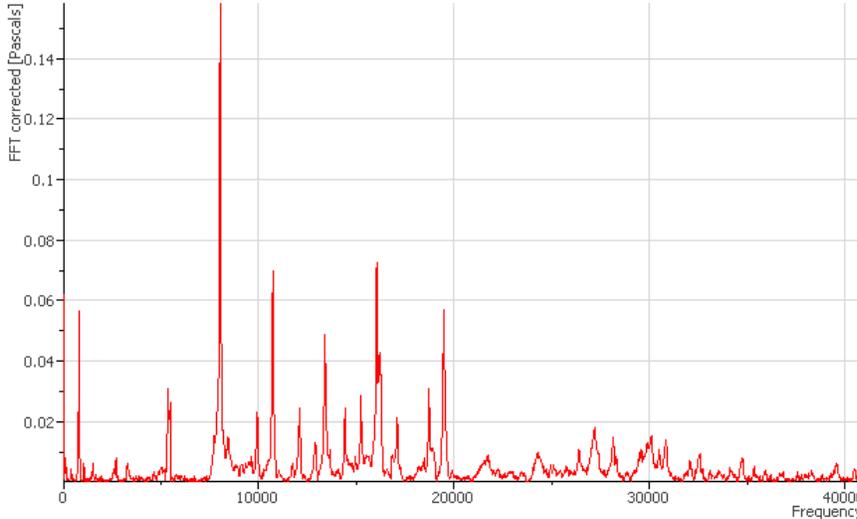
Figure 1.2: Typical frequency domain waveform

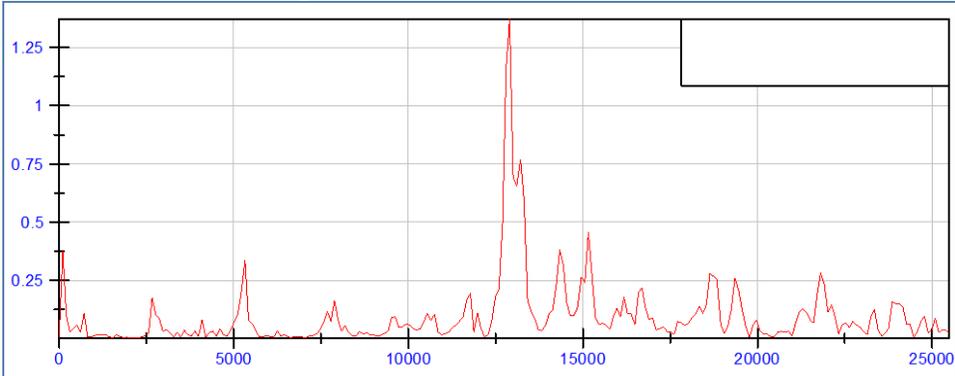
Figure 2.1: Frequency spectra with spring ball impactors at impact point 20 on undefected slab

Frequency peaks at impact point 20 were at 12902 Hz. At impact point 25, the frequency peak was at 12902 Hz. At impact point 49, the peak was at a frequency of 13209 Hz. The approximate average thickness frequency of 13 kHz results in an estimate of the P-wave velocity of 3400 m/s. The lower frequencies are considered to result from reflections from the sides of the slab.

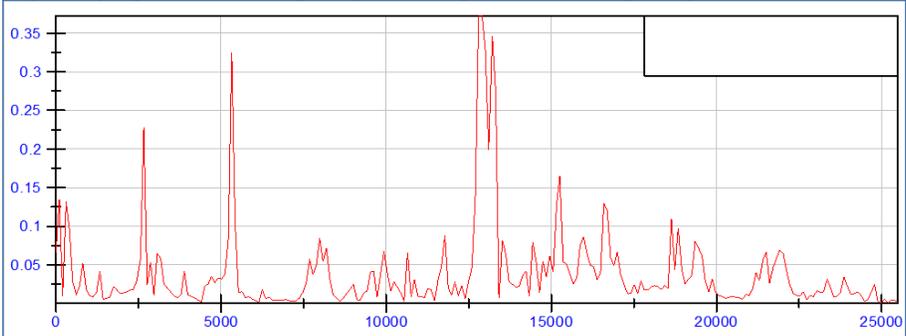
Figure 2.2: Frequency spectra with spring ball impactors at impact point 25 on undefected slab

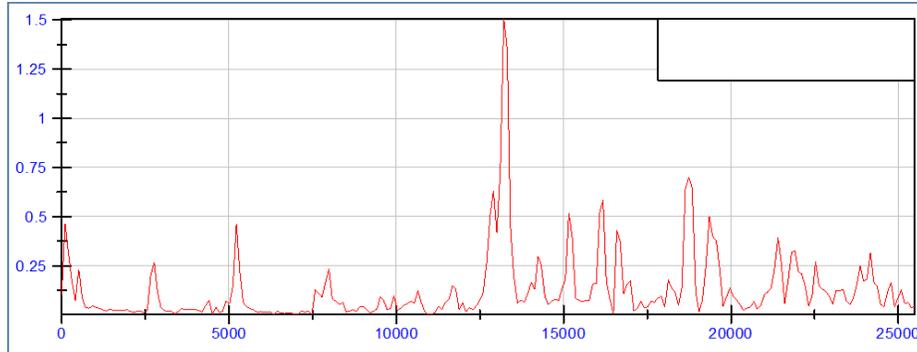
Figure 2.3: Frequency spectra with spring ball impactors at impact point 49 on undefected slab

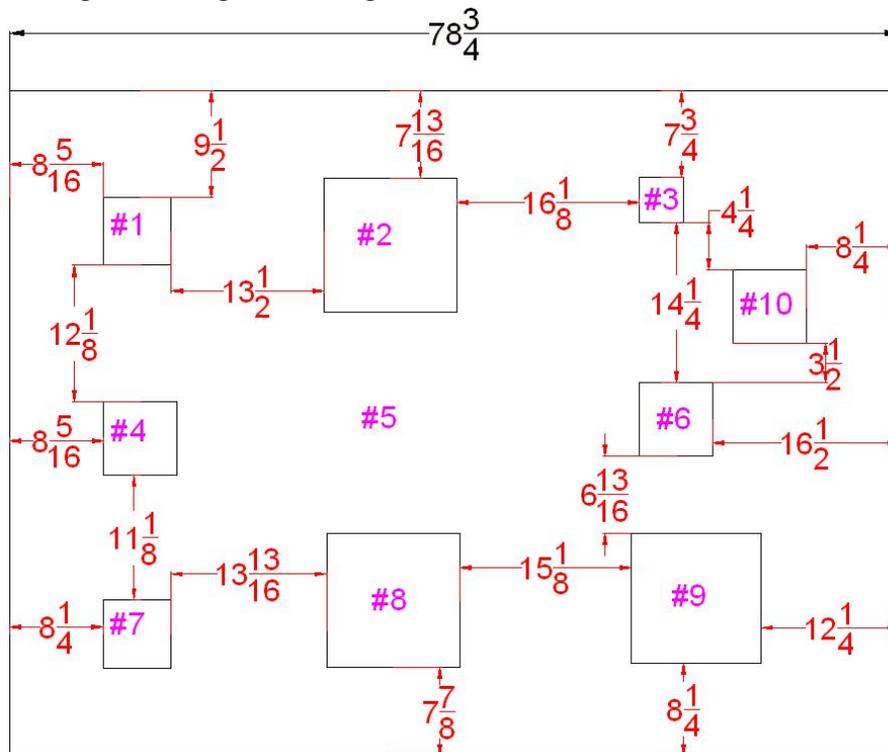
Figure 2.4: Defect locations and labels

**2.1.2 Defected Slabs** The second slab scanned was a reinforced 60×80×10” slab resting on a wood frame support system. This slab was modeled after the intentionally defected slab used by Zhu and Popovics (2007). This slab’s reinforcing was placed in both a top and bottom layer comprised of 6×6” wire mesh and #4 bars spaced at 16” o.c. along the long axis of the slab and at 20” o.c. along the length of the short axis with 2” cover. In addition to the two layers of reinforcing, nine intentionally defected areas were cast into the slab as well. The placement and type of defects are given in Figure 3.4, Figure 3.5, and Table 3.1.

Defect	Type
1	Rock Pocket
2	Delamination
3	Delamination
4	Foam Block
5	No Defect
6	Rock Pocket
7	Rock Pocket
8	Delamination
9	Rock Pocket
10	Foam Block

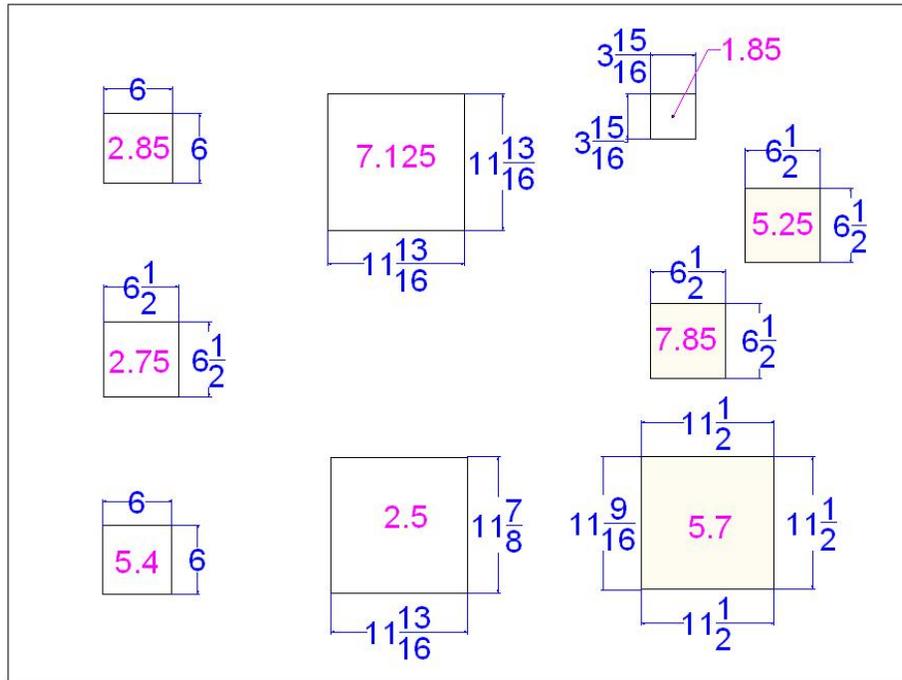
Figure 2.5: Defect size and depth from top of slab

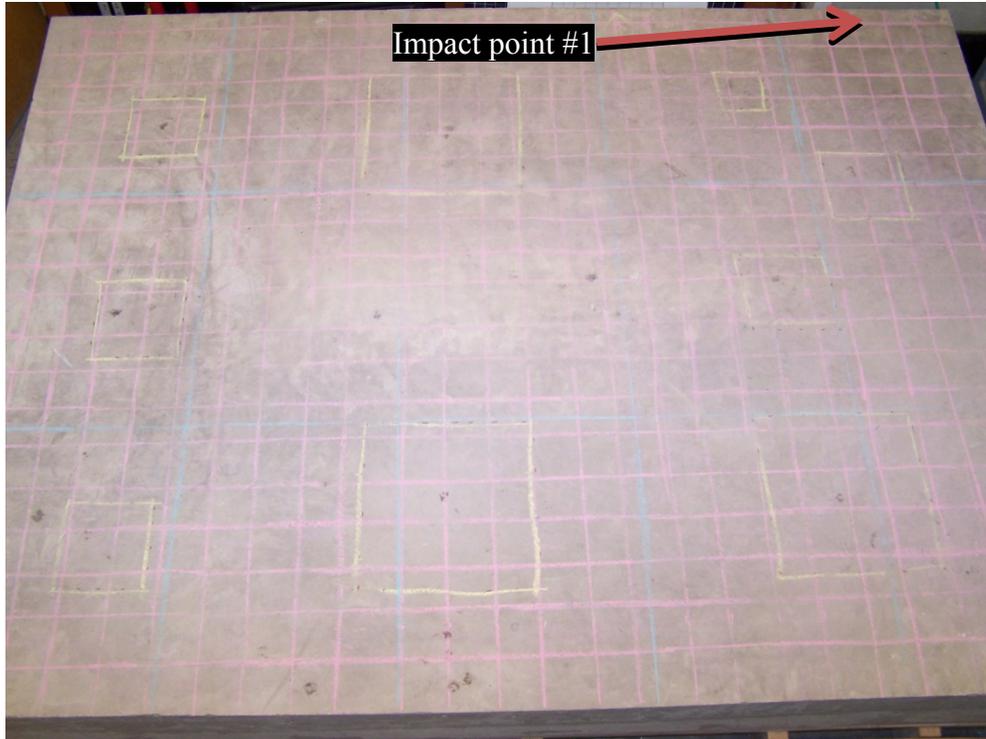
Figure 2.6: Testing grid layout on defected slab

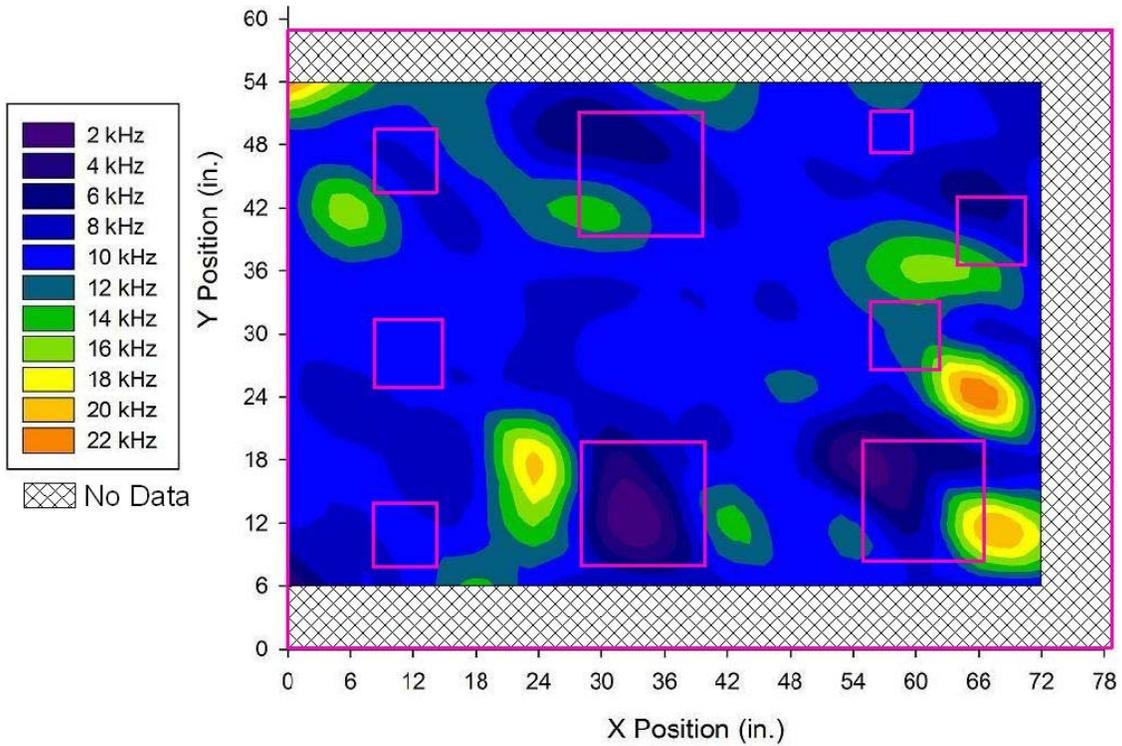
Figure 2.7: Contour plot of defected slab from IEI scan with 3/8" impactor at 6"o.c.

During the course of testing on the simple slab with the IEI system, it was noticed that the small size and thickness of the slab resulted in increased noise in the signal gathered by the system. As a result of the data being “noisy” in much the same way as the early scans with the AIS prototype were, the data set sample number was increased from 1024 to 2048 and a filter on data below 5 kHz was added within the IEI software. Results from the scans performed on the defected slab with both the IEI system and the AIS prototype are shown in Figure 3.7 for the IEI system, and Figure 23.8 through 23.12 for the AIS prototype.

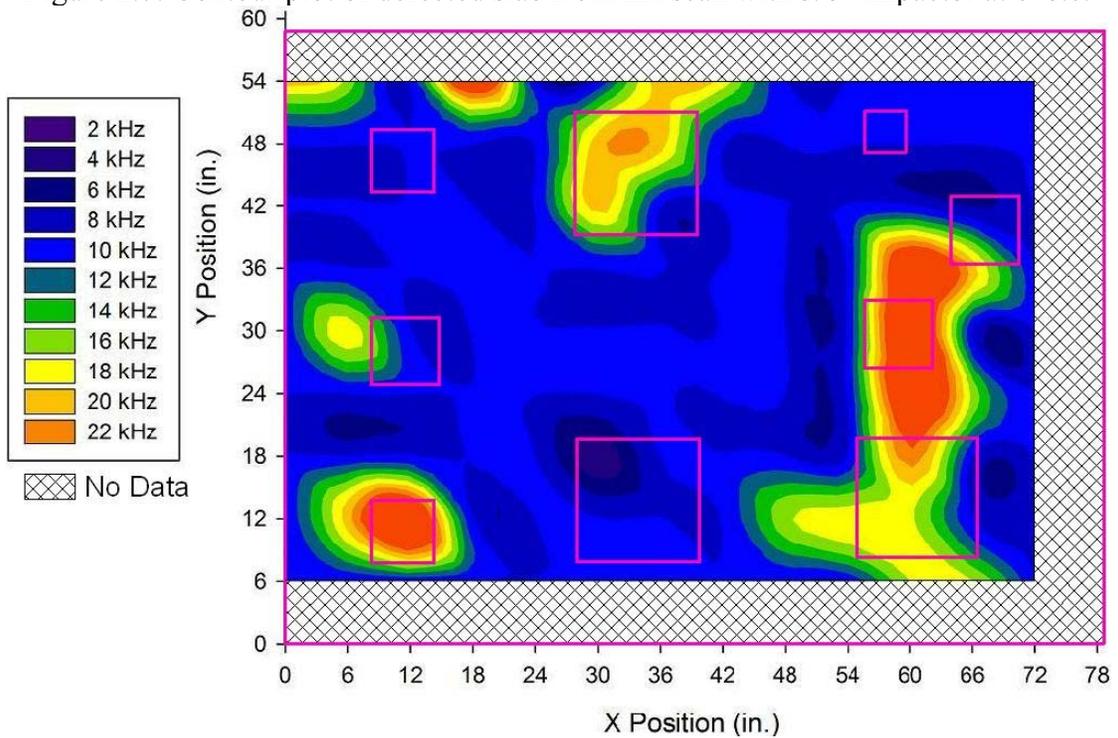
Figure 2.8: Contour plot of defected slab from AIS prototype scan with 3/8" impactor at 6"o.c.

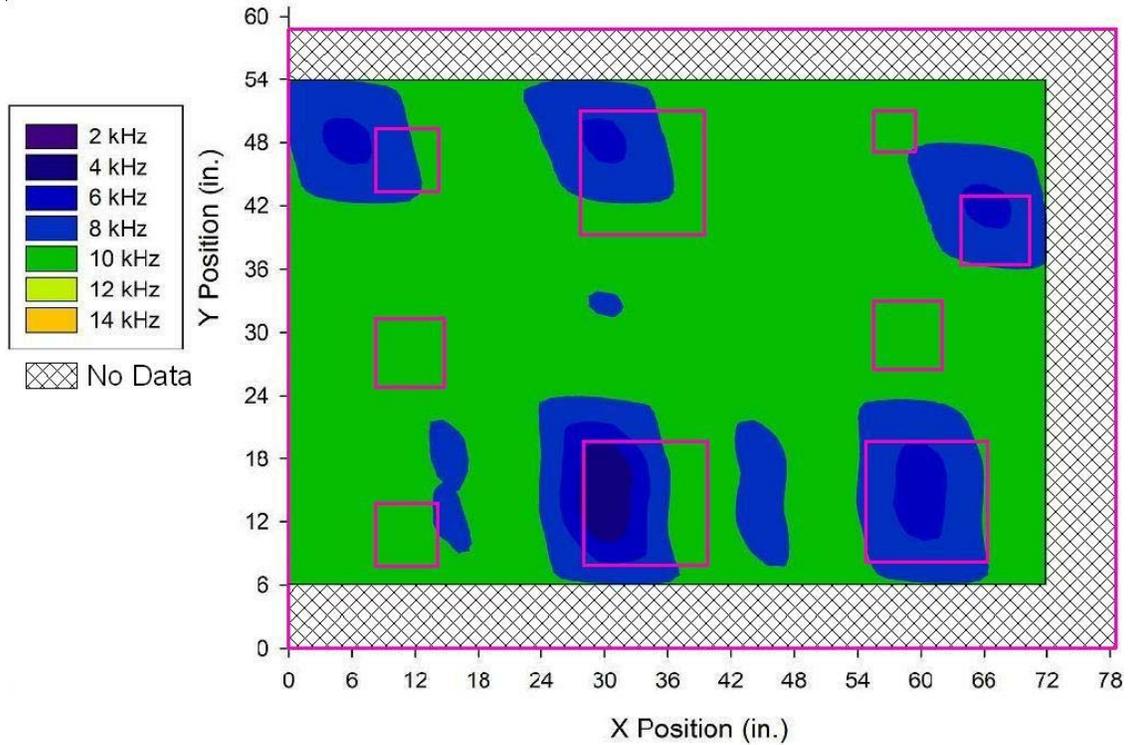
Figure 2.9: Contour plot of defected slab from AIS prototype scan with 5/8" impactor at 6"o.c.

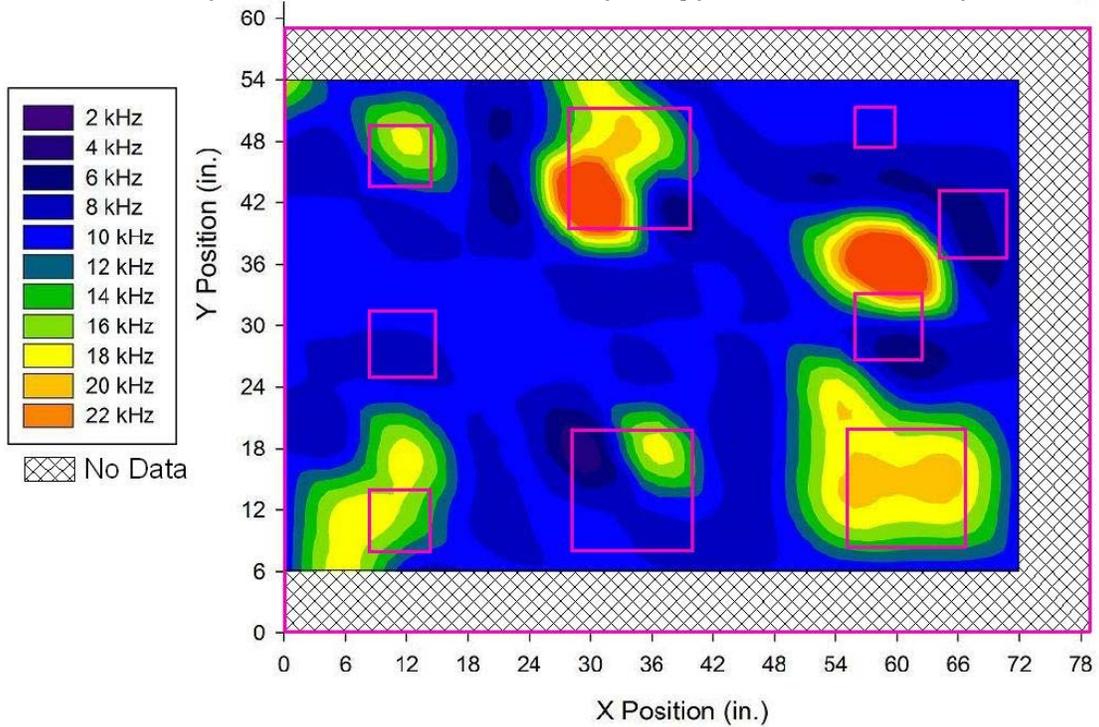
Figure 2.10: Contour plot of defected slab from AIS prototype scan with 5/16" impactor at 6"o.c.

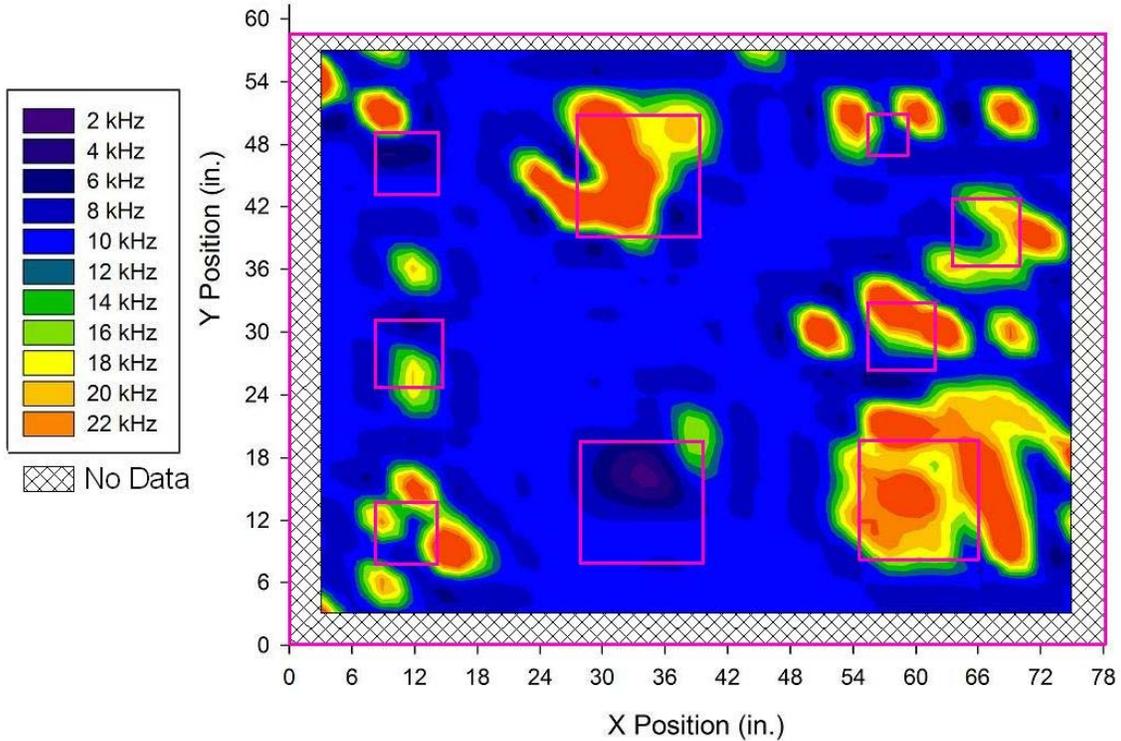
Figure 2.11: Contour plot of defected slab from AIS prototype scan w/ 5/16" impactor at 3" o.c.

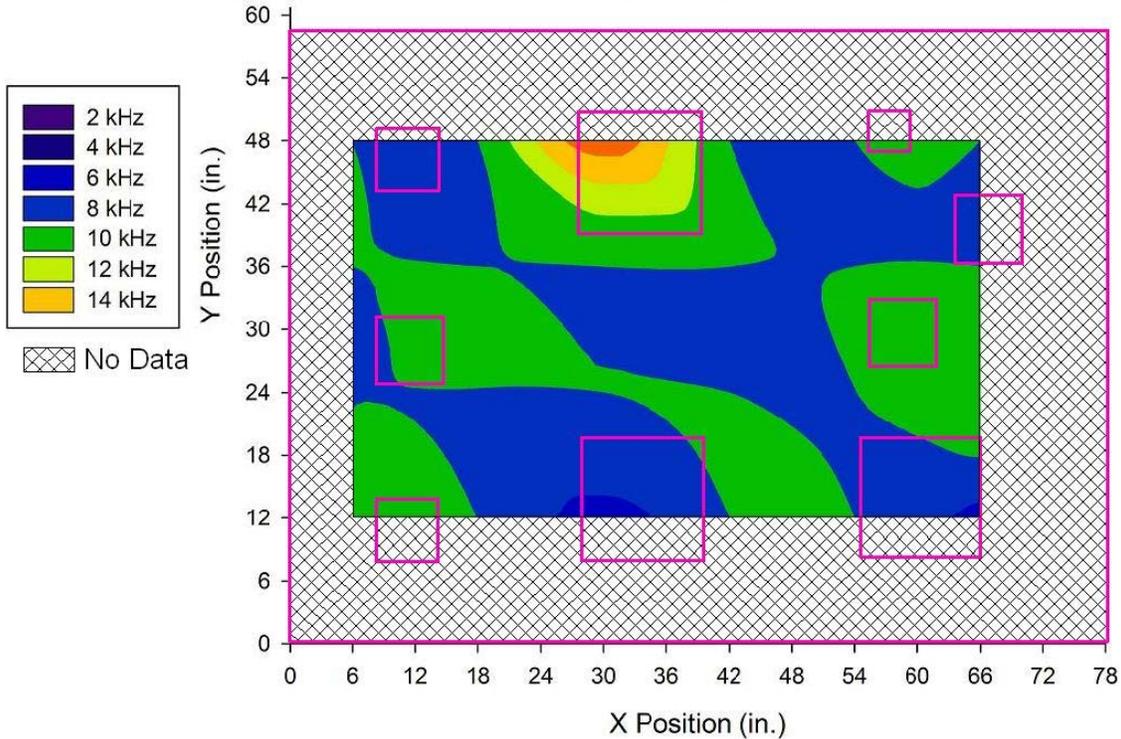
Figure 2.12: Contour plot of defected slab from AIS prototype scan w/ 1/2" impactor at 12" o.c.

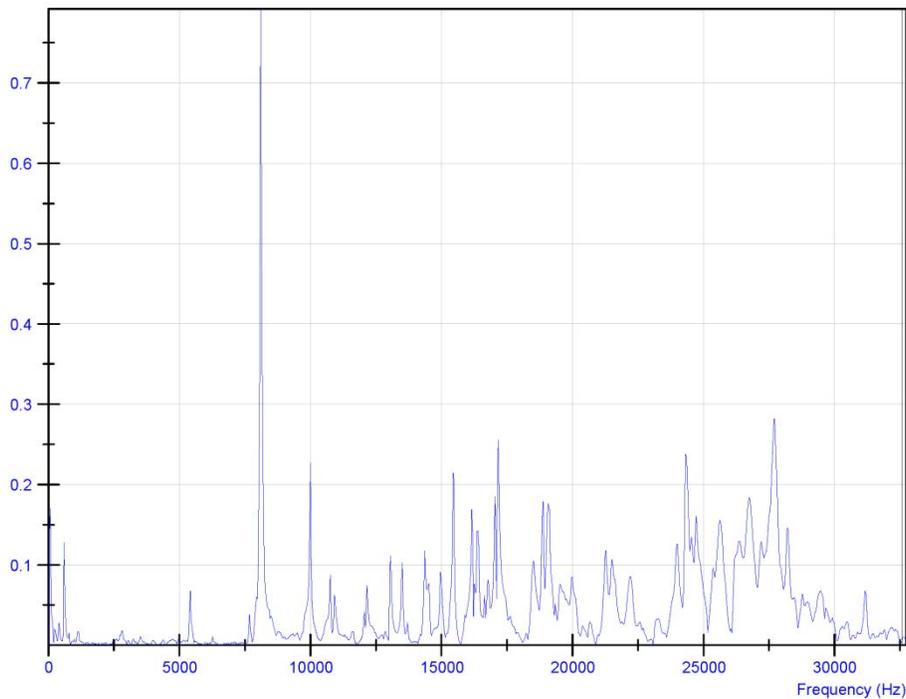
Figure 2.13: Example of a “clean” frequency spectrum from defected slab scan

An ideal scan of a slab would produce nothing but the type of frequency spectra as shown in Figure 2.13. However, the most common of spectra with anomalous frequency peaks was a spectrum with a sharp peak around 24 kHz. Sometimes these peaks were not the highest amplitude and sometimes they were as shown in Figure 2.14.

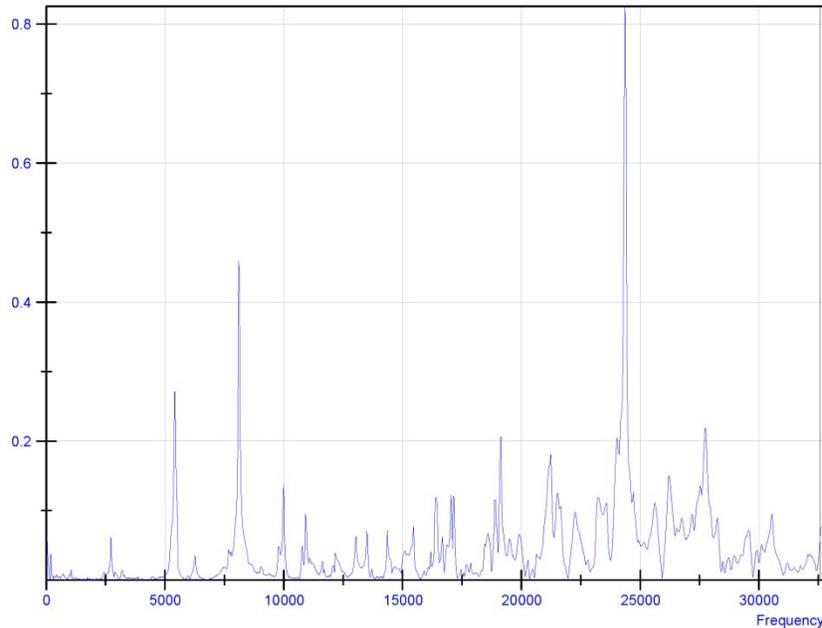
Figure 2.14: Example of a frequency spectrum from defected slab scan with a spike at 24 kHz

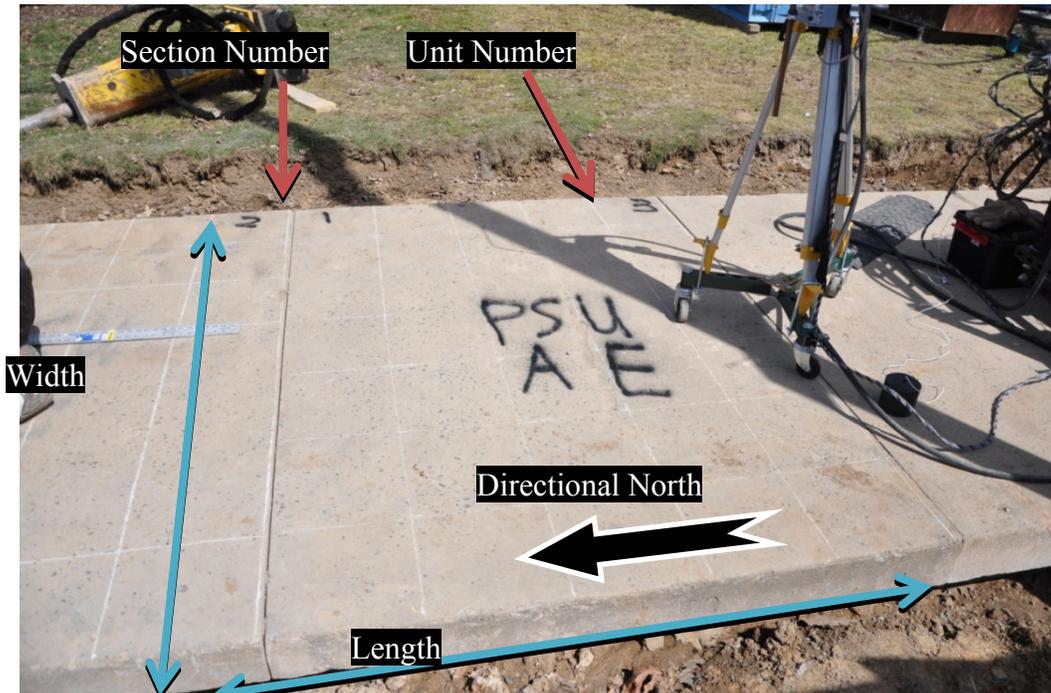
Figure 2.15 Layout of Section/Units

Section	Unit	Length (in.)	Width (in.)	Thickness (in.)	Reinforcing Type (per Fig. 6-2)
1	1	61	84	6.5	Double Mat
1	2	61	84	6.3	Double Mat
1	3	61	84	5.7	Double Mat
2	1	-	-	-	-
2	2	-	-	-	-
3	1	66	84	6.0	Single Mat
3	2	65	84	5.9	Single Mat
4	1	62	84	6.2	Single Mat
4	2	62	84	5.6	Single Mat
4	3	62	84	5.7	Single Mat
4	4	62	84	6.2	Single Mat
5	1	59	83	6.2	Single Mat
5	2	60	83	6.4	Single Mat
5	3	60	83	6.5	Single Mat
6	1	60	84	6.2	Single Mat
6	2	61	84	6.1	Single Mat
6	3	60	84	6.2	Single Mat

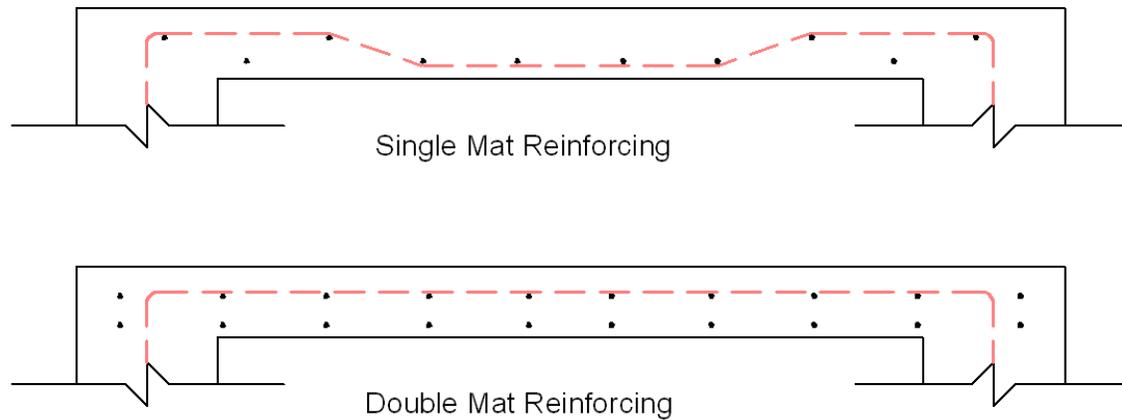
Figure 2.16: Single mat reinforcing and double mat reinforcing slab cross sections

9"o.c. located at the bottom of the slab. The second reinforcing layout was a double mat of #3 bars at 8"-9"o.c. located at the top and bottom of the slab with approximately 2" between the layers. In both cases, bottom cover was approximately 1.5"-2".

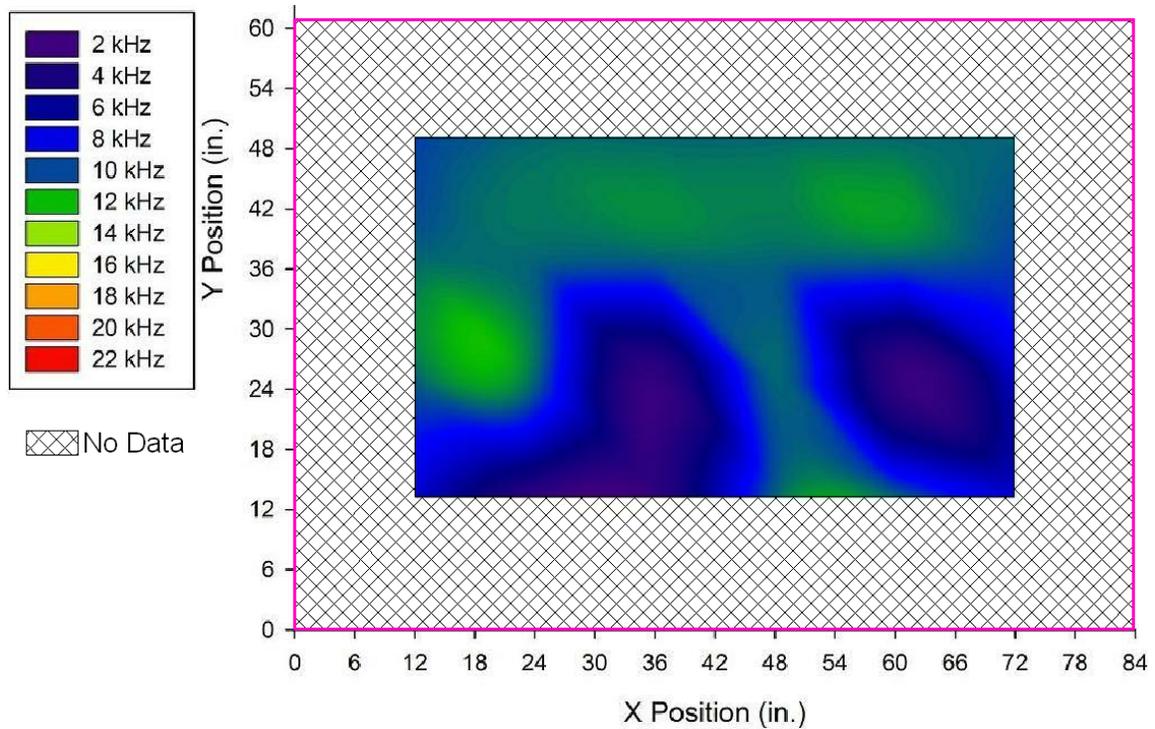
Figure 2.17: *In situ* data contour plot of Section 1 Unit 3 with 5/8" impactor at 12" o.c.

Data from the *in situ* testing was compiled into contour plots for each unit.

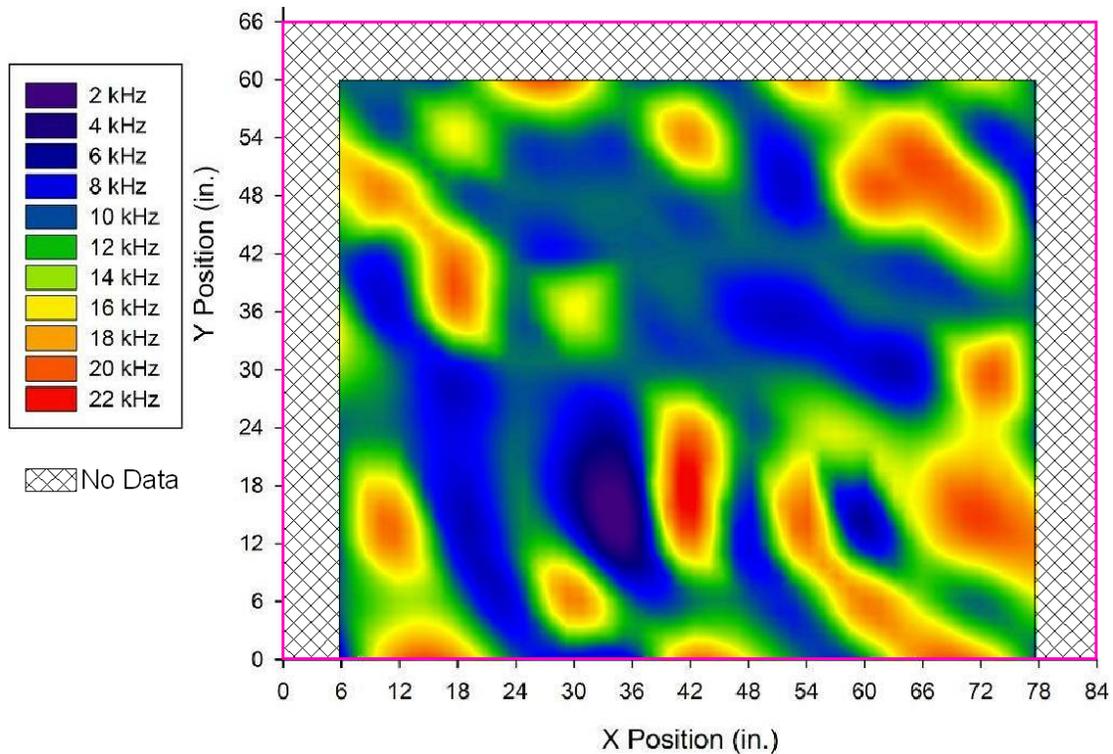
Figure 2.18. *In situ* data contour plot of Section 3 Unit 1 with 7/16" impactor at 6" o.c.

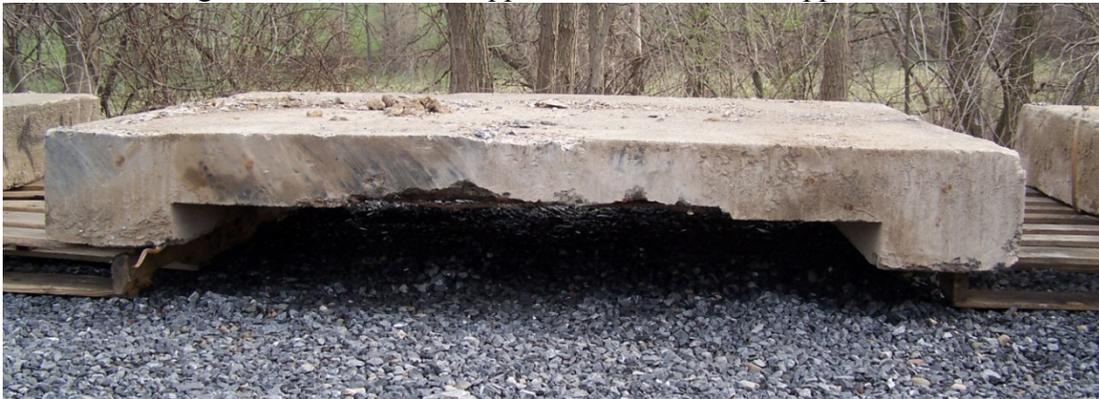
Figure 2.19: Slab off-site storage support condition

**2.2.2 Ex Situ Testing** Upon removal of the various slabs from their original location, the slabs were transported to off-site storage. Prior to removal, slabs were labeled with spray painted markings with the *in situ* section and unit numbers to allow for referencing of slab data between *in situ* and *ex situ* testing. The slab's *in situ* orientation with respect to directional north was also noted and labeled on the slabs. The slabs were supported by wood pallets placed at the edges of the slab, shown in Figure 3.19, in order to approximate the *in situ* support condition.

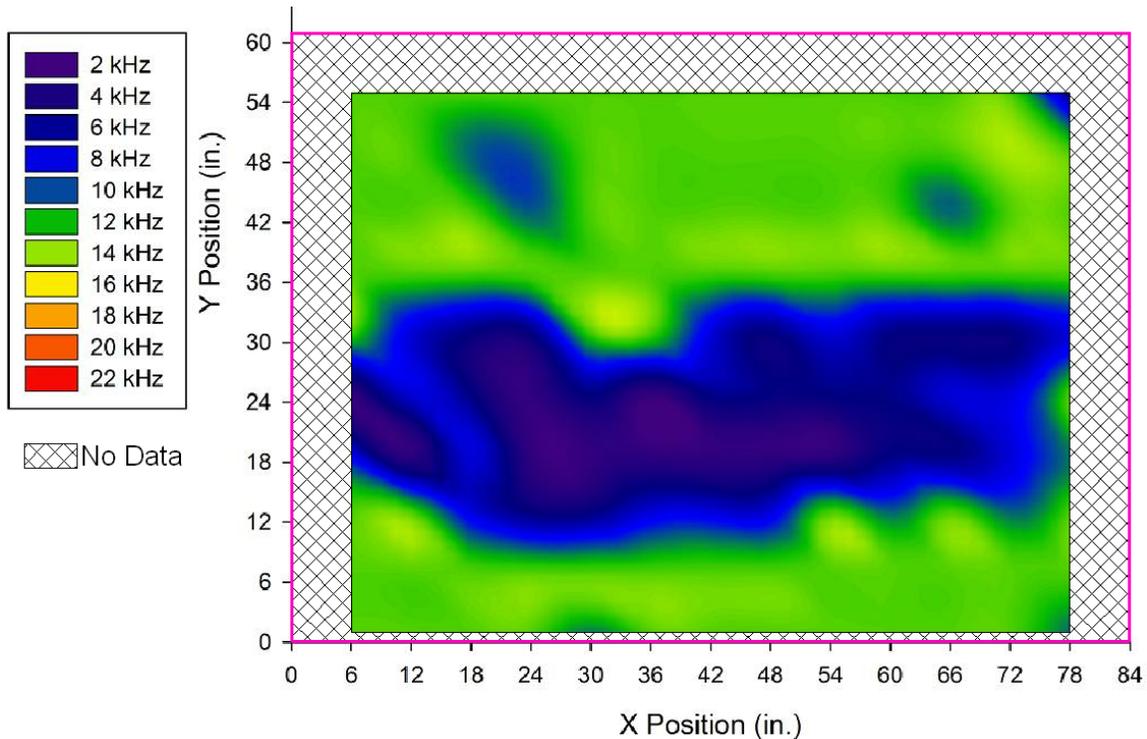
Figure 2.20: *Ex situ* data contour plot of Section 1 Unit 3 with 3/8" impactor at 6" o.c.

Data from the *ex situ* testing was compiled into contour plots for each unit in the same manner previously performed for both the laboratory and *in situ* testing.

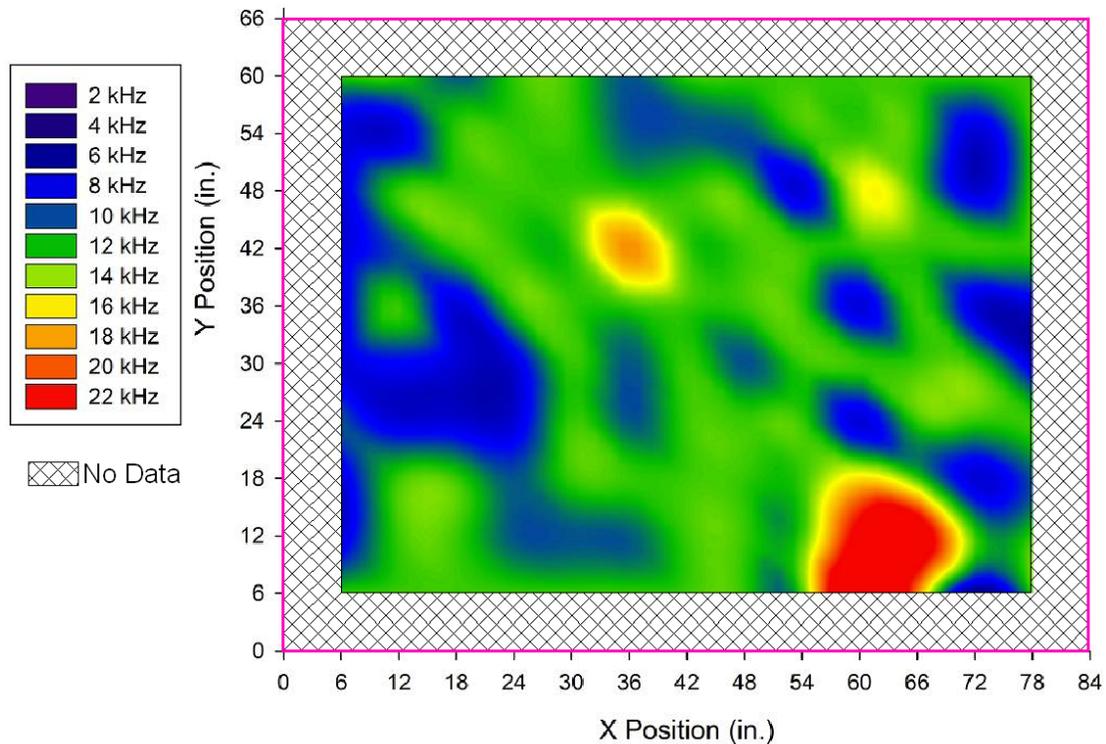
Figure 2.21: *Ex situ* data contour plot of Section 3 Unit 1 with 3/8” impactor at 6”o.c.

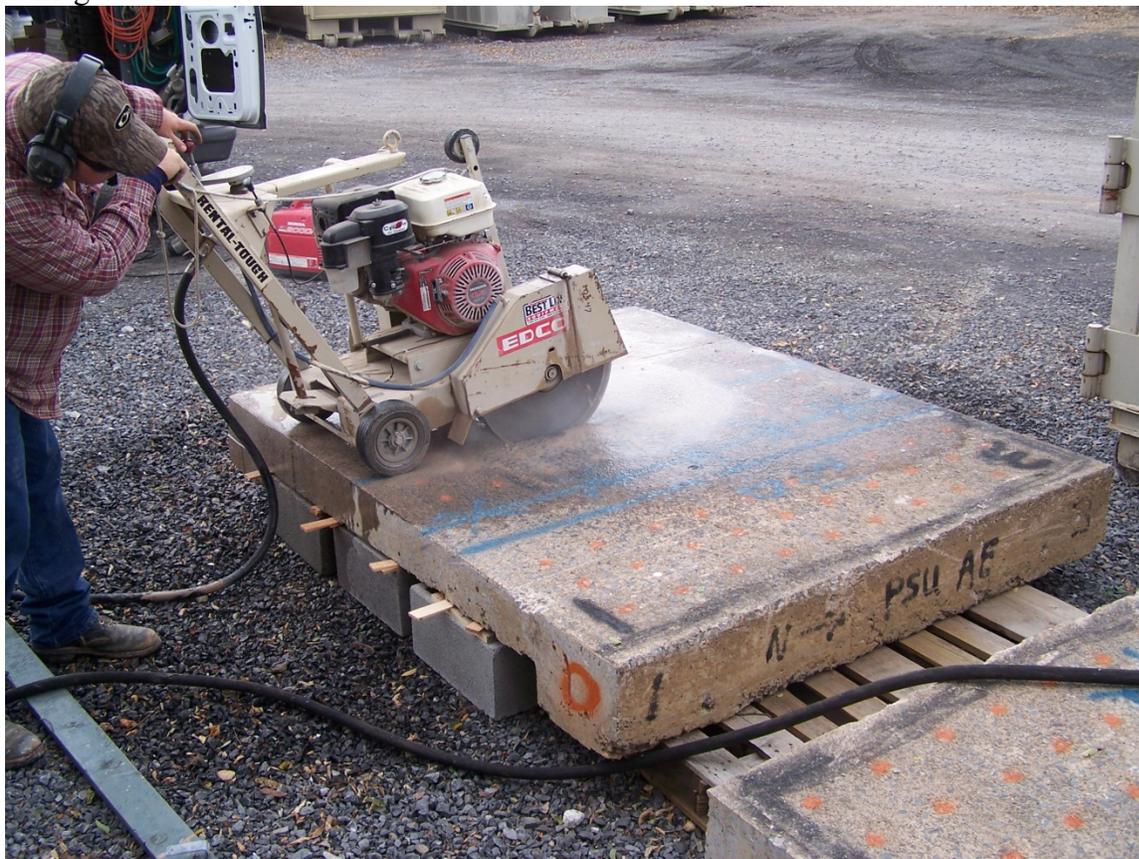
Figure 2.22: Saw cutting of slabs *ex situ*

The selected locations were then exposed for analysis by saw cutting of the concrete slab. Saw cutting of the slabs was determined to provide the best means of access to the desired locations in terms of expedience and minimizing damage from gaining that access to the surrounding areas of the slabs. The saw cutting was performed by PSU OPP using a walk behind concrete saw. During saw cutting, the slab was supported on opposing sides of the cut location with CMU blocking and shims to prevent the slab from falling in on itself and potentially causing additional damage to the slab.

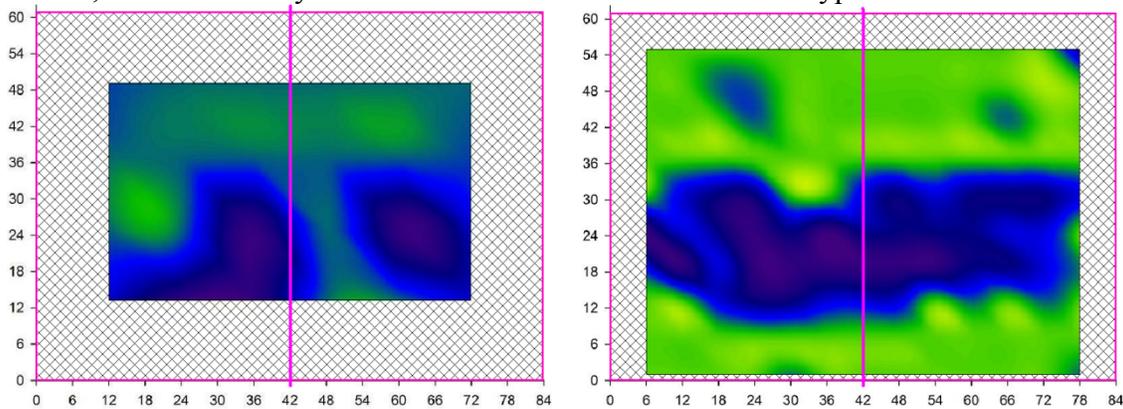
Figure 2.23: Saw cut locations on Section 1 Unit 3 (Left: *in situ* contour plot. Right: *ex situ* contour plot)

Section 1 Unit 3 was selected for a singular apparent defected band running along the slab at approximately mid span of the slab. Only a single cut location was selected, as indicated in Figure 3.23, due to the fairly uniform distribution of slab area with hypothesized defects.

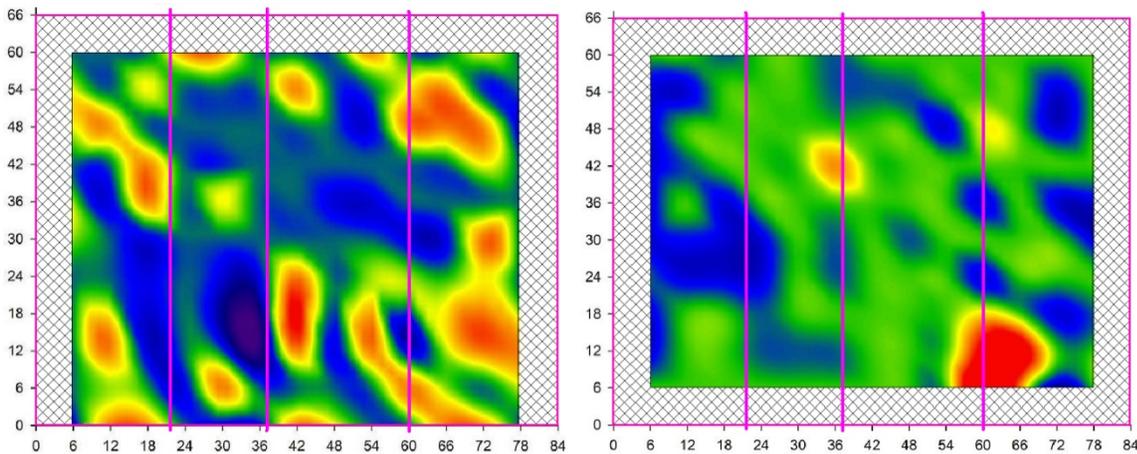
Figure 2.24: Saw cut locations on Section 3 Unit 1 (Left: *in situ* contour plot. Right: *ex situ* contour plot)

Section 3 Unit 1 was selected for the three cut locations shown in Figure 3.24 due to the seeming incongruity of the slab's condition between the *in situ* and *ex situ* contour plots. Given the grid spacing used (6" o.c. in each case) and the close nature of impactor diameter (7/16" for the *in situ* test and 3/8" for the *ex situ* test) it would be assumed that the contour plots from each test would have been more similar.

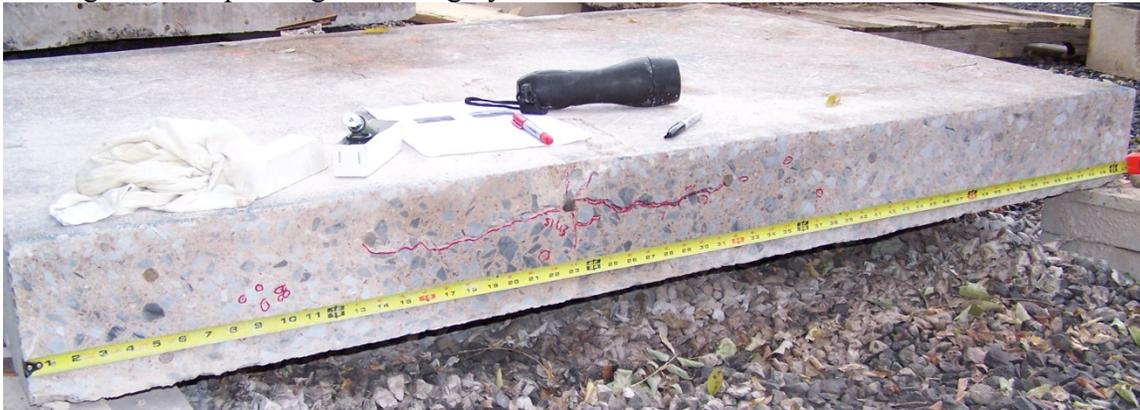
Figure 2.25: Cross section of Section 1 Unit 3 sub-unit A

During the forensic analysis of Section 1 Unit 3 the same features were examined in detail as in the analysis of Section 1 Unit 2, mainly the determination of whether a defect existed in the middle band of the slab as suggested by the contour plots from field testing. Visual inspection revealed a large horizontal crack within the slab at the mid span area as shown in Figure 7-13 and Figure 2.25 spanning from roughly 13” to 31” within the slab.

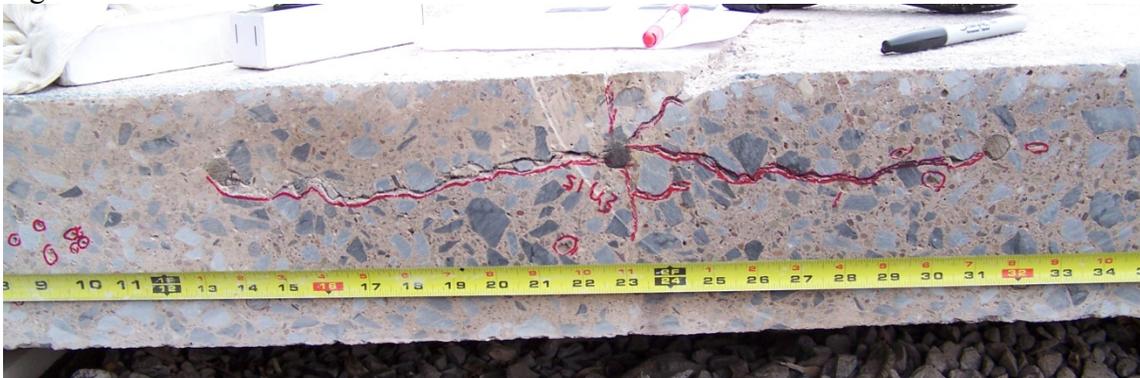
Figure 2.26: Close up of cross section of Section 1 Unit 3 sub-unit A

halfway up. Given their height, small nature, and locations, it is probable that these areas are actually the chairs that the slab's reinforcing was placed on during construction of the slab.

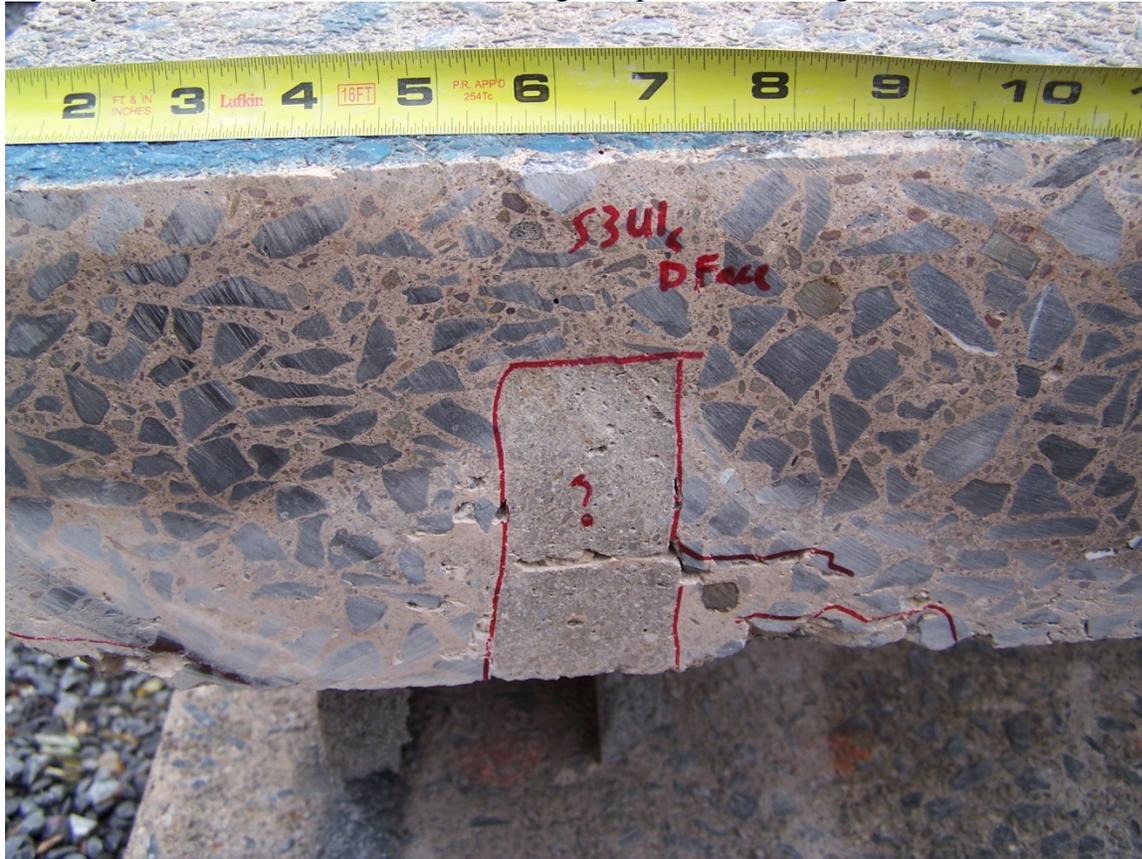
Figure 2.27: Close up of differing concretes in cross section of Section 3 Unit 1 sub-unit C

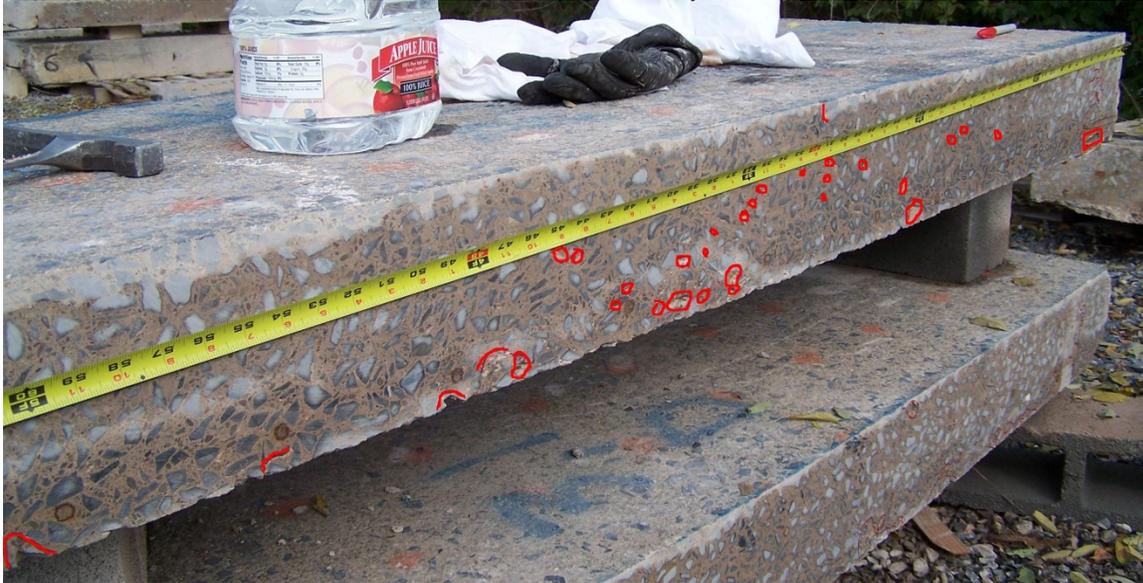
Figure 2.28: Cross section of Section 3 Unit 1 sub-unit C between B and C

No apparent defects were found in the cross section between sub-units A and B other than the aforementioned small change in concrete material located between 26" and 28". The cross section between sub-units B and C exposed a 1"×2" LLH tubular metal insert running from 3" to 5" and some small areas of unconsolidated concrete from 35" to 45" as shown in Figure 3.28.

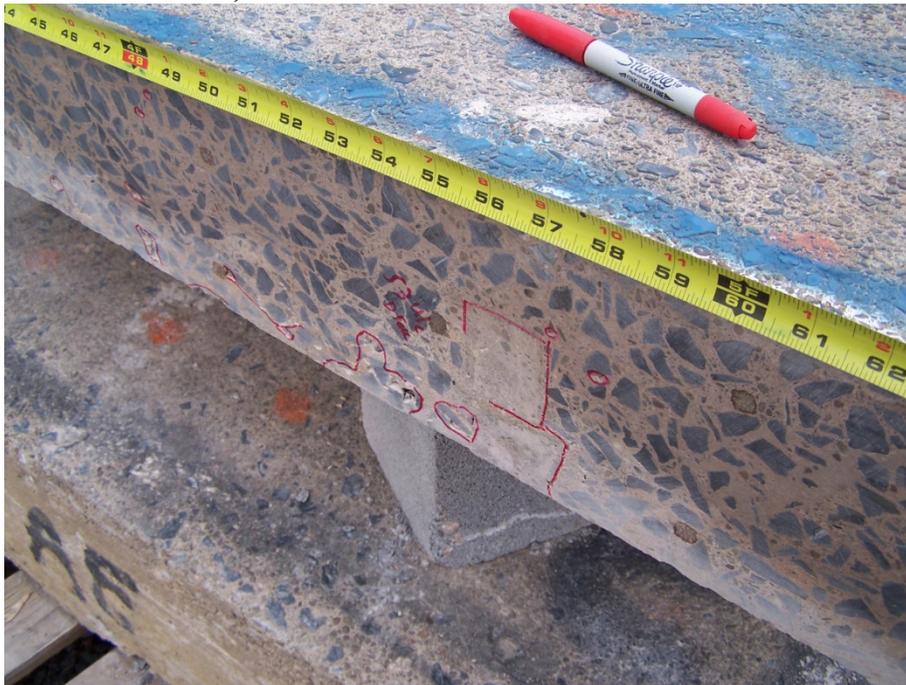
Figure 2.29: Cross section of Section 3 Unit 1 sub-unit C between C and D

The last cross section of this unit between sub-units C and D shown in Figure 3.29, again revealed presumed reinforcement chairs at 6" and at 56" accompanied by areas of unconsolidated concrete at 22", 31" and from 47" to 57".
