# Historic Concrete and Masonry Assessment by the Air-Coupled Impact-Echo Method | 2012-04

# Final Report

Historic Concrete and Masonry Assessment  
by the Air-Coupled Impact-Echo Method

Department of Architectural Engineering  
The Pennsylvania State University  
104 Engineering Unit A  
University Park, PA 16802

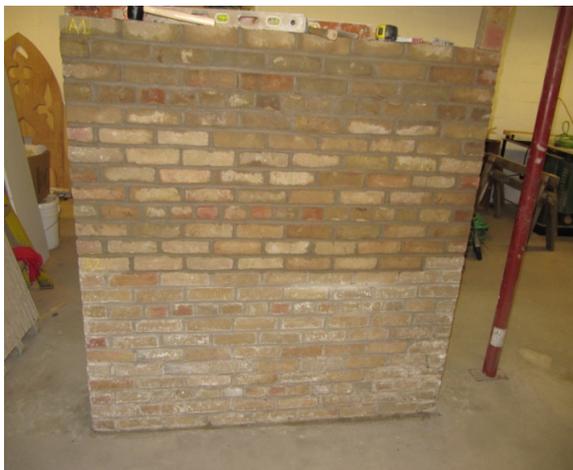
Figure 3.1: Wall Specimen A1, A2

Wall Specimen A.1 was built with an intentional bond disruption to imitate poor bonding. The mortar was allowed to partially set for a few hours and then manually shifted to disrupt mortar to brick bond. Wall Specimen A.2 has partially filled joints to replicate joints with poor bonding. The partially fill head, bed, and collar joints simulate poor workmanship. Wall Specimen B.1 has cored brick in lieu of the solid brick to be able to note the difference between a cored within the brick versus a bond disruption. Wall Specimen B.2 has unfilled collar joints to poor bonding between collar joints. Wall Specimen C.1 has a steel beam embedded within the brick. Wall Specimen C.2 has a historic terra cotta panel mounted to the brick. Wall Specimen C.3 contains normally laid solid brick with a header course. Wall Specimen C.4 has a 0.25 inch thick layer of stucco over the brick.

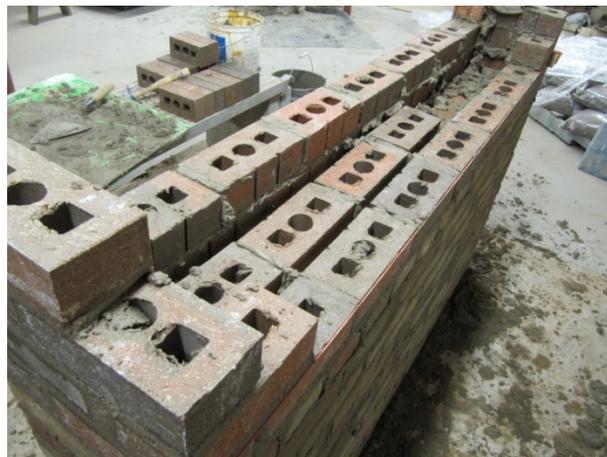
Figure 3.2: Wall A.1 – Bond Disruption

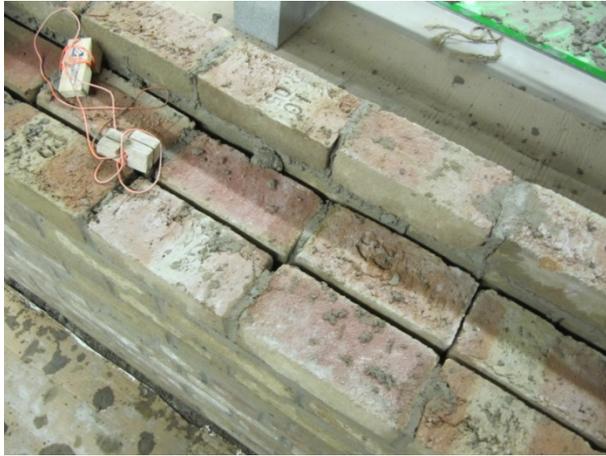
Figure 3.3: Wall A.2 –Partially Filled Joints

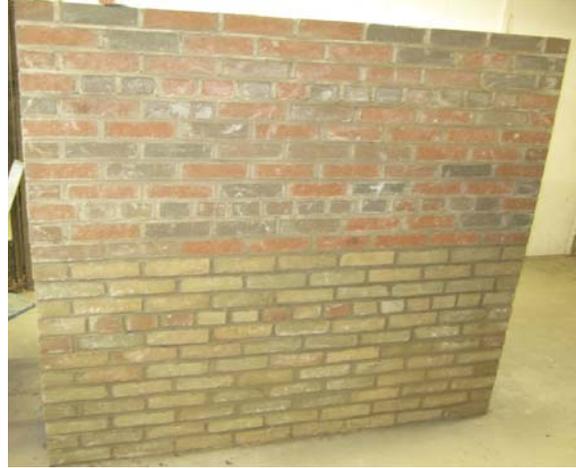
Figure 3.4: Wall Specimen B1, B2

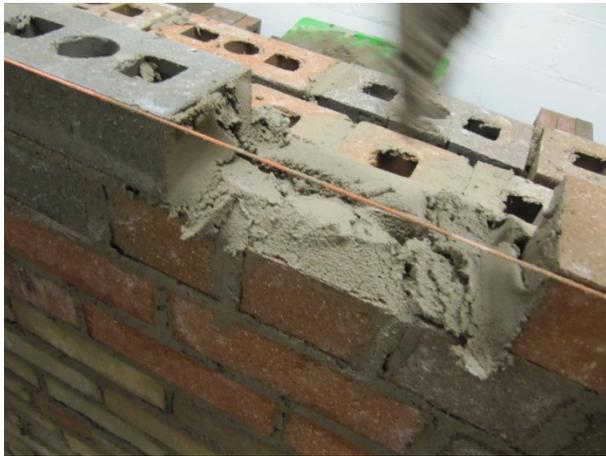
Figure 3.5: Wall B.1 – Cored Brick

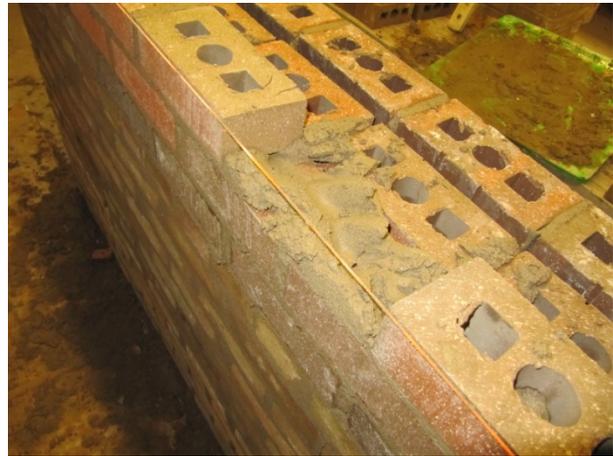
Figure 3.6: Wall B.2 –Unfilled Collar Joints

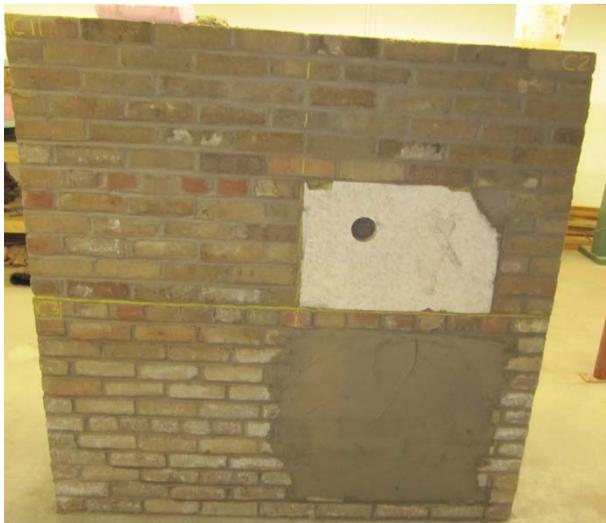
Figure 3.7: Wall Specimen C.1, C.2, C.3, C.4

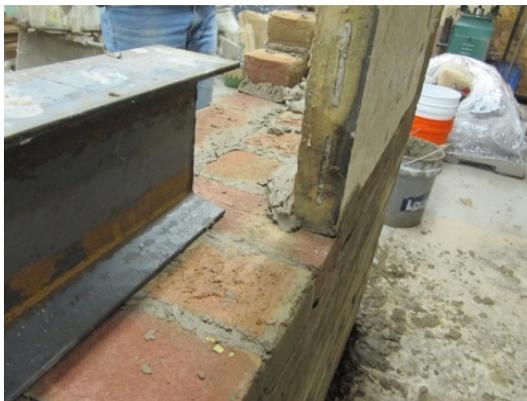
Figure 3.8: Wall Specimen C.1 – Steel Beam and Wall Specimen C.2 – Terra Cotta Panel

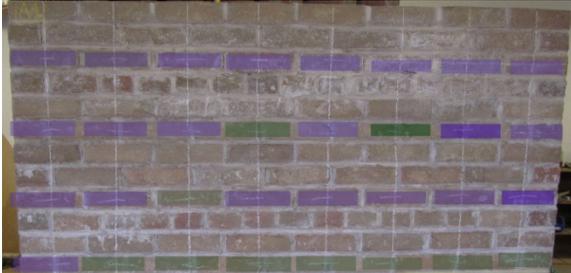
Figure 3.10: Wall Specimen A.1-Bond Disruption\_Test 1 Results

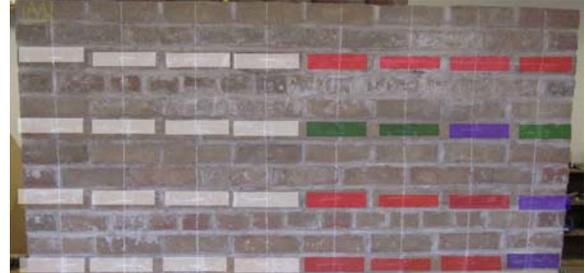
Figure 3.11: Wall Specimen A.1 Bond Disruption\_Test 2 Results

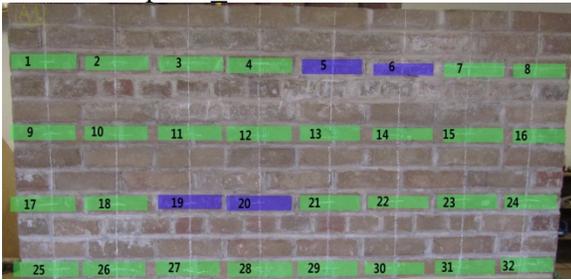
Figure 3.12: Wall Specimen A.1 Bond Disruption\_Test 3 Results

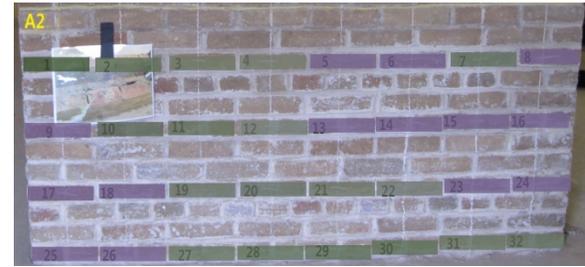
Figure 3.13: Wall Specimen A.2 Partially Filled Joints\_Test 1 Results

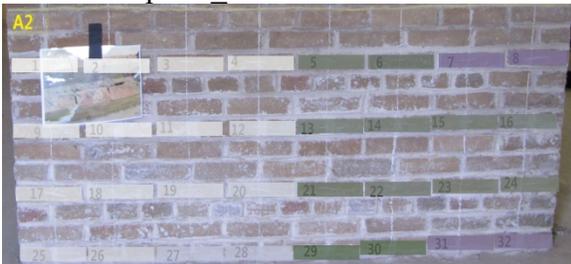
Figure 3.14: Wall Specimen A.2 Partially Filled Joints\_Test 2 Results

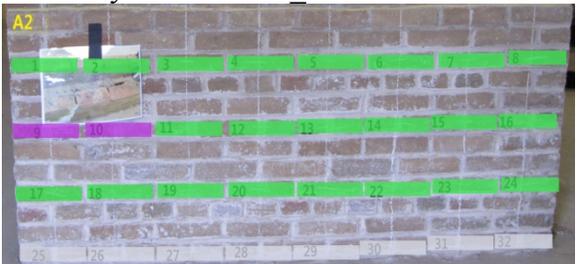
Figure 3.15: Wall Specimen A.2 Partially Filled Joints\_Test 3 Results

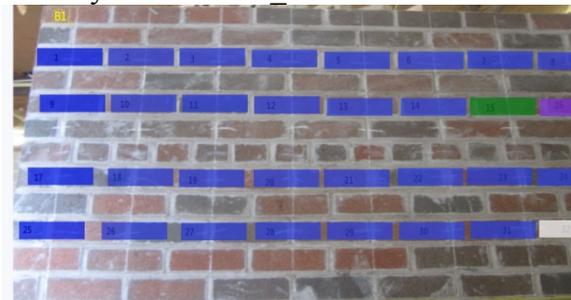
Figure 3.16: Wall Specimen B.1 Cored Brick\_Test 1 Results

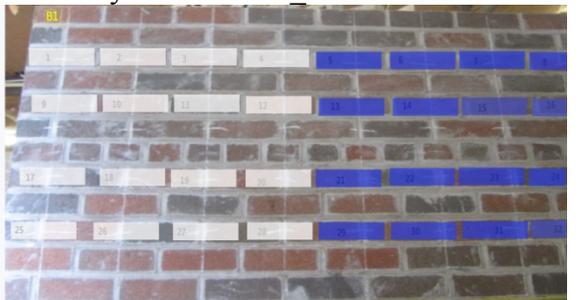
Figure 3.17: Wall Specimen B.1 Cored Brick\_Test 2 Results

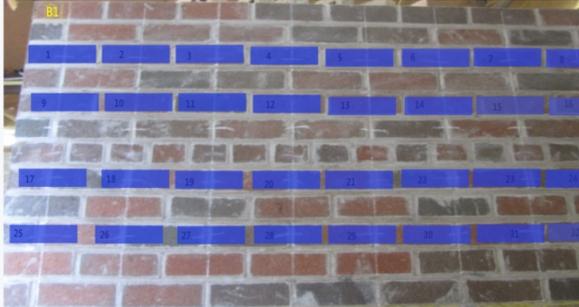
Figure 3.18: Wall Specimen B.1  
Cored Brick\_Test 3 Results

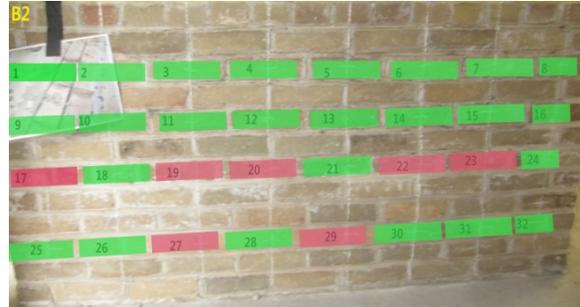
Figure 3.19: Wall Specimen B.2  
Unfilled Collar Joints\_Test 1 Results

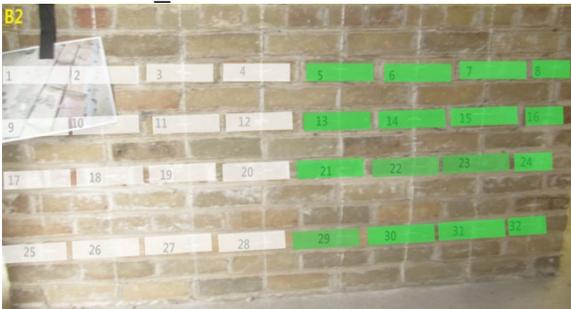
Figure 3.20: Wall Specimen B.2\_Test 2 Result  
Unfilled Collar Joints\_Test 2 Results

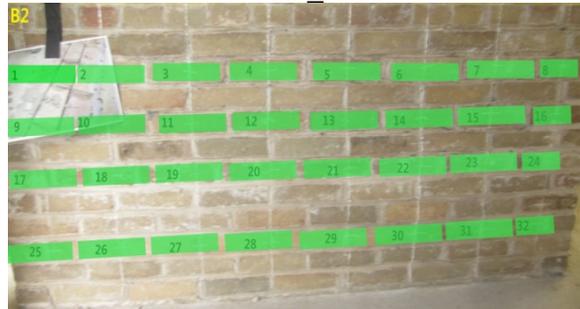
Figure 3.21: Wall Specimen B.2  
Unfilled Collar Joints\_Test 3 Results

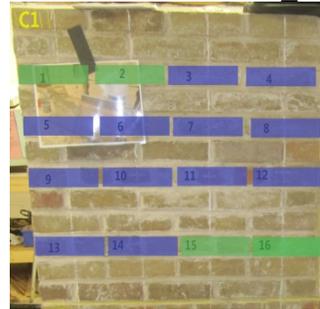
Figure 3.23: Wall Specimen C.1  
Steel Beam\_Test 2 Results

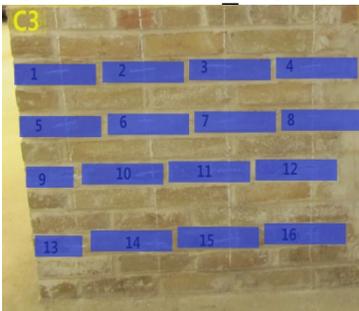
Figure 3.27: Wall Specimen C.3  
Control Test 1 Results

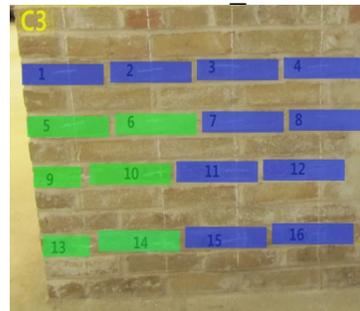
Figure 3.28: Wall Specimen C.3  
Control Test 2 Results

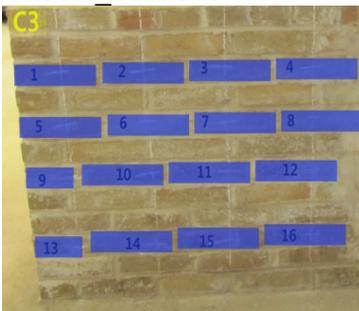
Figure 3.29: Wall Specimen C.3  
Control Test 3 Results

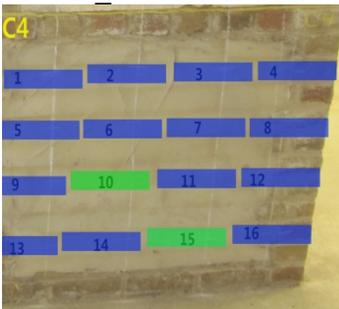
Figure 3.30: Wall Specimen C.4  
Stucco Test 1 Results

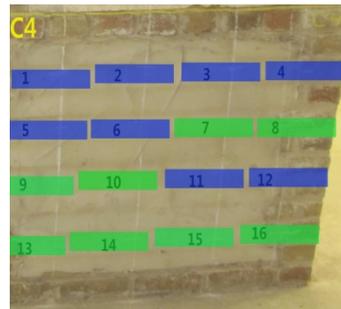
Figure 3.31: Wall Specimen C.4  
Stucco Test 2 Results

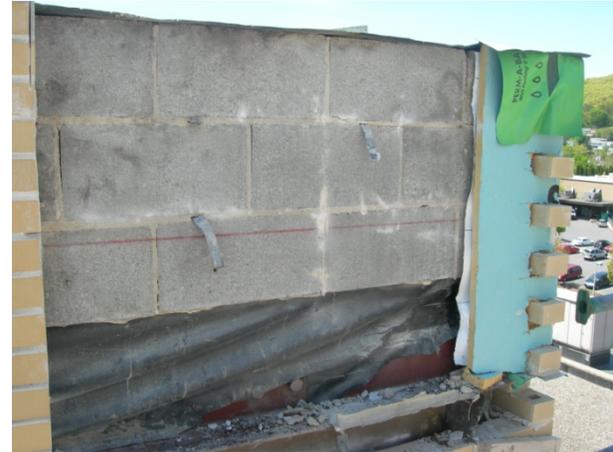
Figure 3.33: Removed brick at test site.

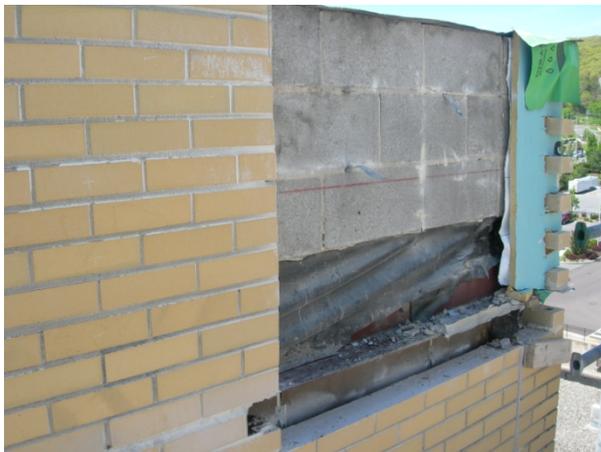
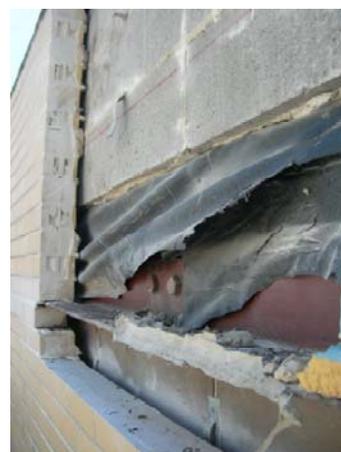
Figure 3.34: Wall tested: a) Lateral view.

b) Wall Section.

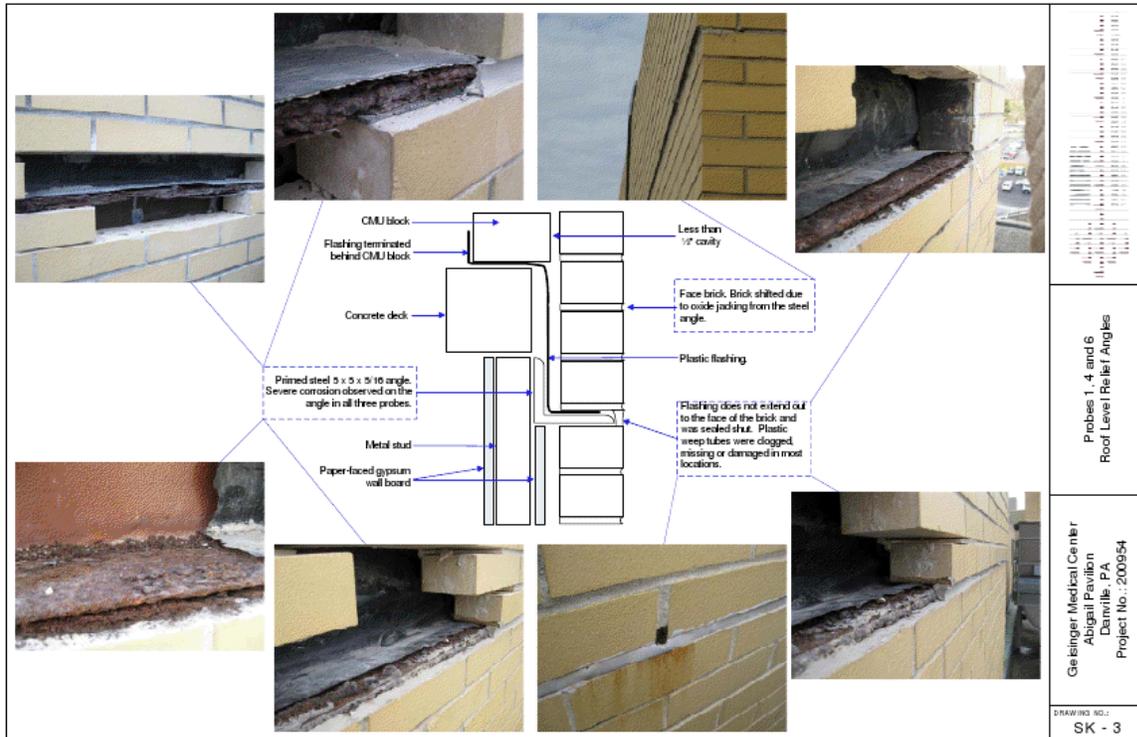
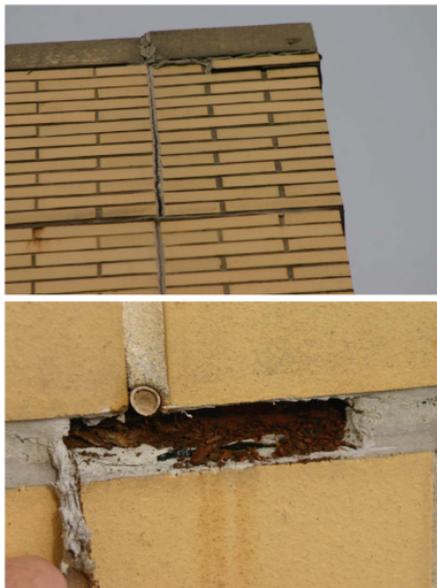
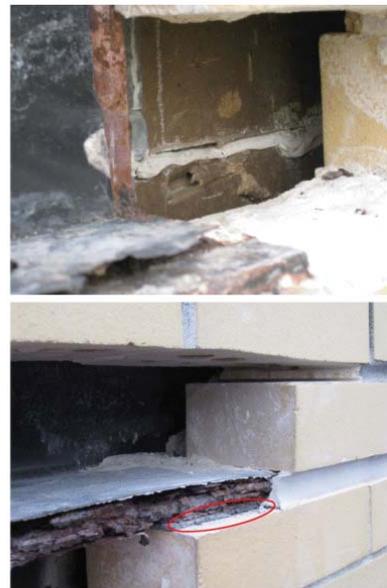
Figure 3.35: Masonry Preservation Services Report (2010) Roof Level: a) Wall section. b &c) Photographs of old building before renovation.

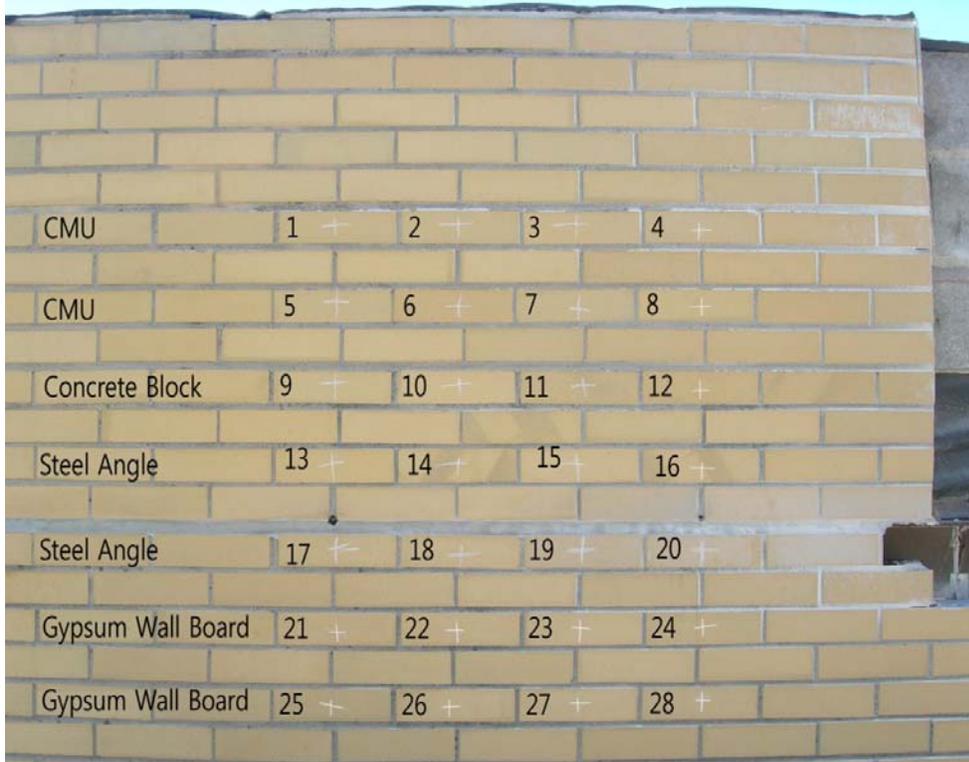
Figure 3.36: Roof Level Wall with Relief Angles Testing Grid

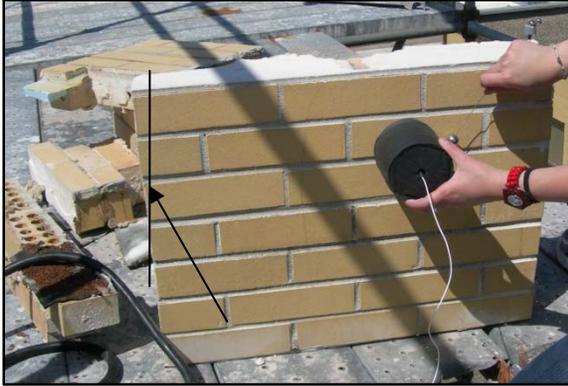
Figure 3.37: Single Wythe 10-celled brick wall.

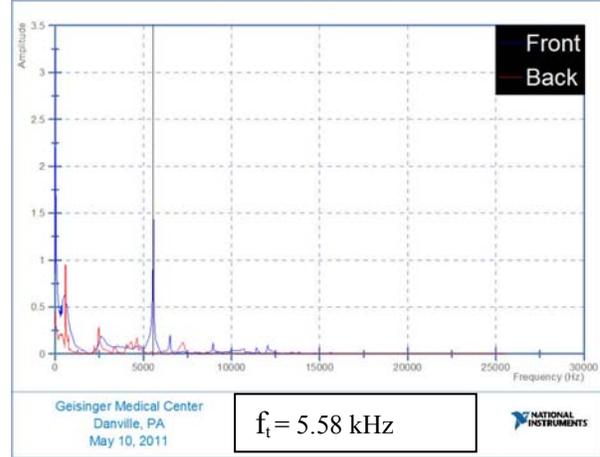
Figure 3.38: Impact echo response for single wythe 10-celled brick wall.

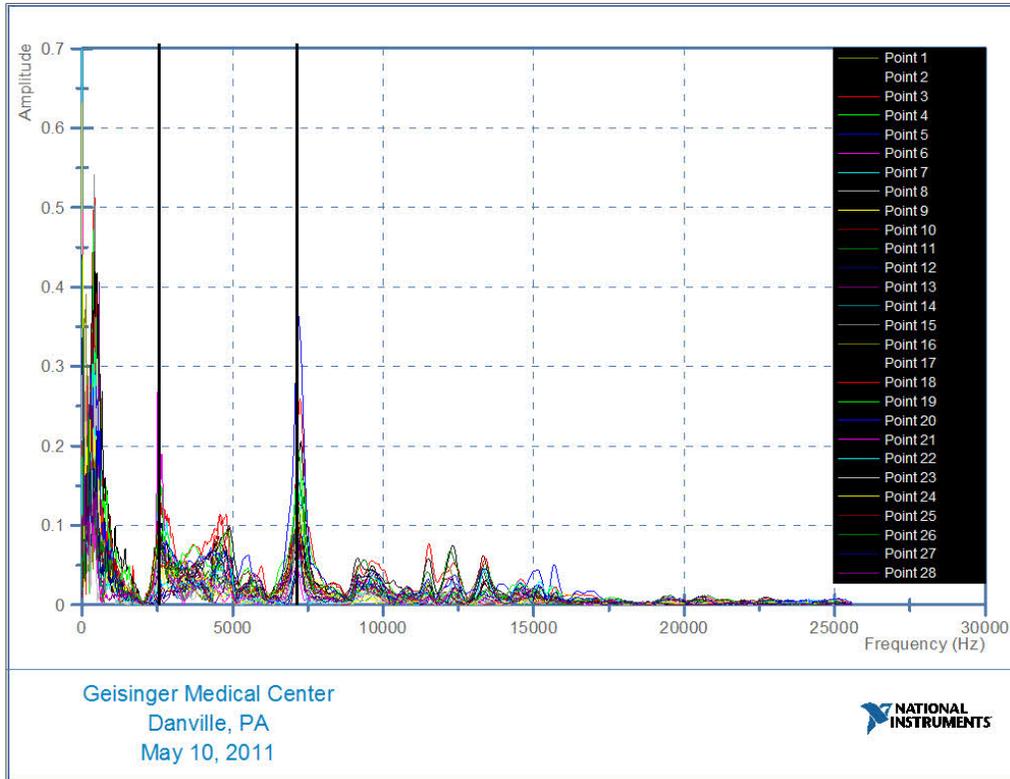
Figure 3.39: Impact echo responses for points 1 to 28. Peak 1 is at 2.5 kHz. Peak 2 is located at 7.1 kHz.

CMU	$\beta$	$C_p$	T	Gypsum Wall Board	$\beta$	$C_p$	T
Concrete Block	0.96	3440 m/s	0.092 m	Gypsum Wall Board	0.96	3200 m/s	0.0254 m
Air	0.96	3960 m/s	0.030 m	Steel Stud	0.96	6100 m/s	0.0015 m
Brick	0.96	1304 m/s	0.0920 m	Brick	0.96	1304 m/s	0.013 m
Mortar	0.96	3020 m/s	0.013 m	Mortar	0.96	3020 m/s	0.013 m
$f_t = 2.50$ kHz				$f_t = 5.78$ kHz			
CONCRETE BLOCK	$\beta$	$C_p$	T	Steel Angle	$\beta$	$C_p$	T
Concrete Block	0.96	3440 m/s	0.030 m	Concrete Block	0.96	3440 m/s	0.0127 m
Grout	0.96	3960 m/s	0.032 m	Brick	0.96	1304 m/s	0.092 m
Concrete Block	0.96	3440 m/s	0.030 m	Mortar	0.96	3020 m/s	0.013 m
Brick	0.96	1304 m/s	0.092 m	Steel Angle	0.96	6100 m/s	0.0079 m
Mortar	0.96	3020 m/s	0.013 m	Steel Stud	0.96	6100 m/s	0.0015 m
$f_t = 4.78$ kHz				$f_t = 5.97$ kHz

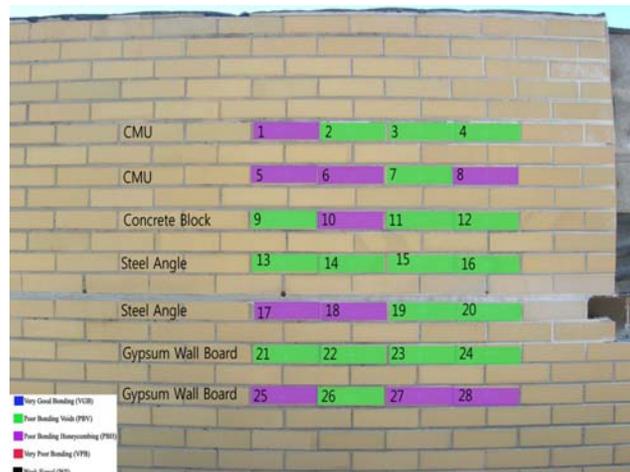
Figure 3.40: Geisinger Medical Center Test Results

Using the Bonding Classification from Sadri (2003) in Figure 3.9 on page 42, the wall was classified as having poor bonding voids and poor bonding honeycombing. The results demonstrated that even with different materials, the air-coupled impact echo system was able to detect poor bonding between the brick veneer and back material. This area of the Geisinger Medical Center had not been renovated, so it was expected to detect poor bonding throughout the wall.
