# Dendrogeomorphological Investigation of Earhwork Stability at Poverty Point SHS, Louisiana | 2013-08

# Dendrogeomorphological Analysis of Earthwork Stability at Poverty Point SHS, Louisiana

MT-2210-11-NC-09

Diana Greenlee  
University of Louisiana at Monroe

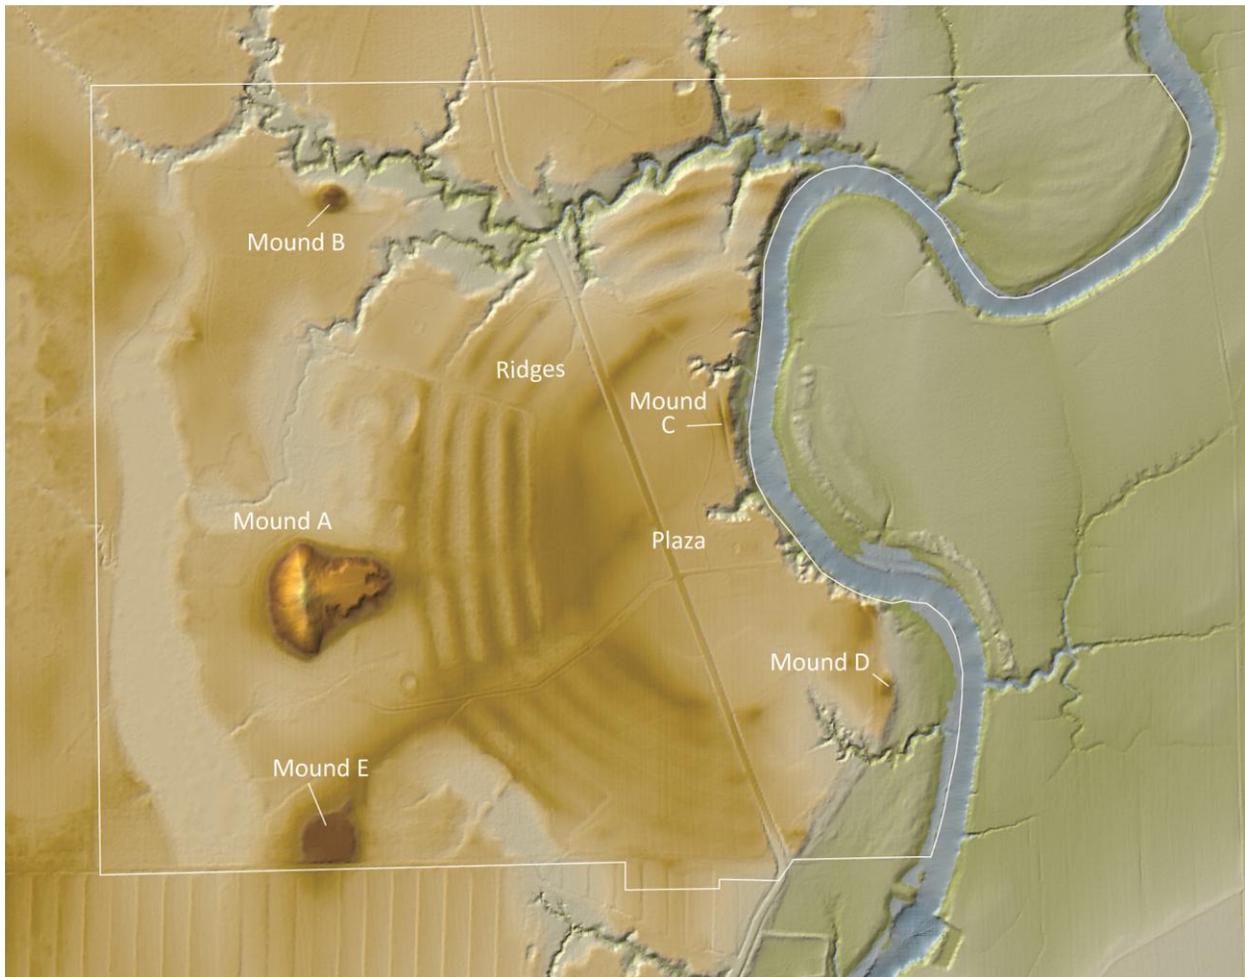
Figure 2. LiDAR map of Poverty Point, with earthworks labeled. LiDAR data are available courtesy of the State of Louisiana and the Federal Emergency Management Administration (FEMA), and are distributed by “Atlas: The Louisiana Statewide GIS,” LSU CADGIS Research Laboratory, Baton Rouge, Louisiana.

The Poverty Point archaeological site, located in northeast Louisiana (Figure 1), is a monumental earthworks site dating to 3700-3100 years BP. The original site plan (Figure 2) included four earthen mounds; six concentric, semi-elliptical earthen ridges; and a large, flat, interior plaza that contained large circles of wood posts. A fifth mound was added by a later culture in about 700 AD. The massive scale and elaborate design of this created landscape makes it unique in the world. That it was built by hunter-gatherers without the benefit of domesticated animals or wheeled carts renders it truly remarkable.

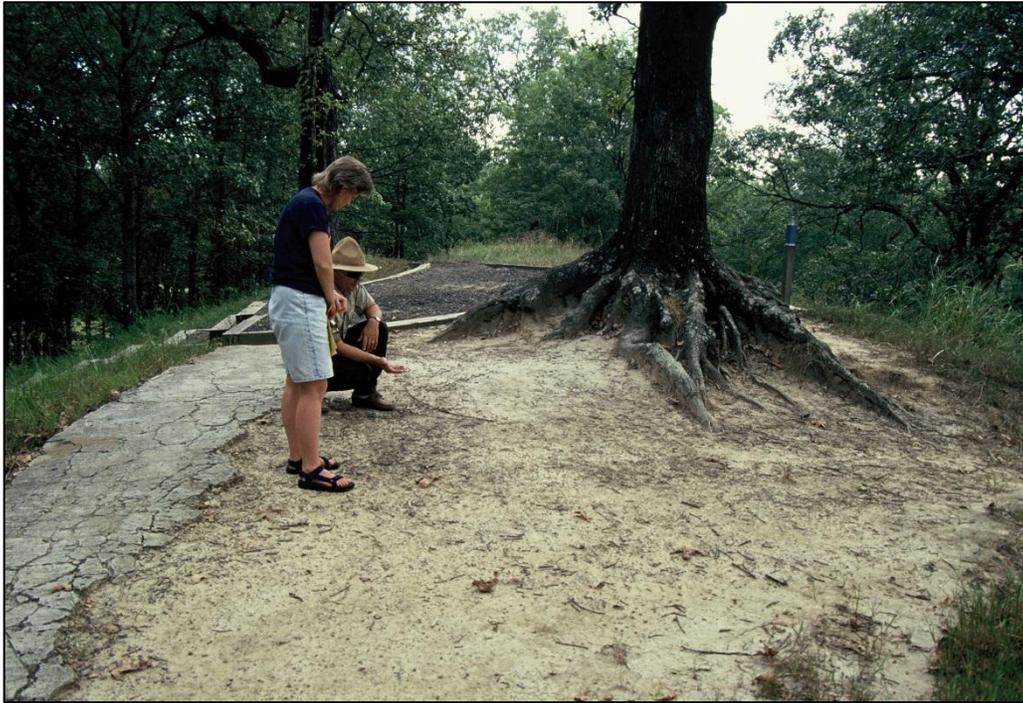
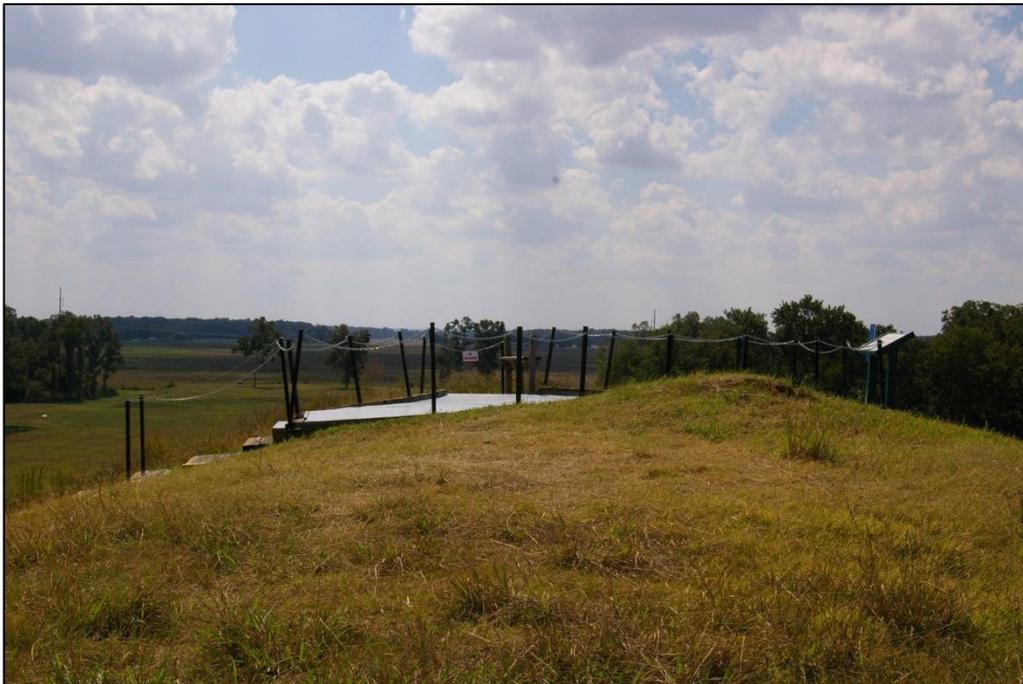
Figure 3. Top: Photograph of the apex of Mound A in 1993, with exposed roots indicative of significant sheet erosion (Photo courtesy of Kevin L. Jones/New Zealand Winston Churchill Trust). Bottom: The apex of Mound A in September 2013.

That the existing tree cover was not entirely effective in protecting the earthworks is clear. Since 1975, the Office of State Parks had, on several occasions, filled gullies on Mound A and pushed eroded material back into place.<sup>2</sup> Figure 3, a photograph taken at the apex of Mound A in 1993, shows a tree with severely exposed roots; Jones (1994) estimated that roughly 40 cm of soil erosion was lost during the approximately 50-year life span of that tree. In 1995, the Office of State Parks added soil to the top

of the mound in an effort to replace the loss. Thus, there has clearly been erosion on the mound, but how much and at what rate it occurred are unknown.

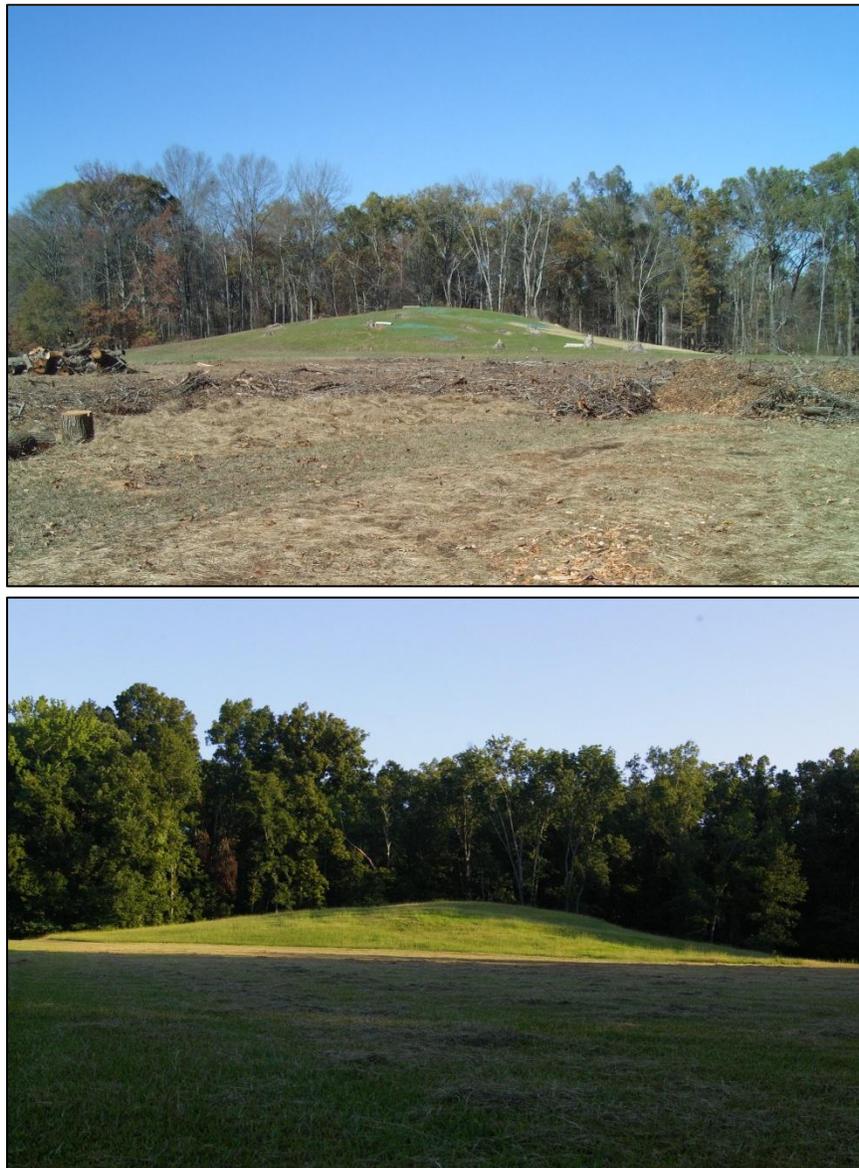
Figure 4. Above: Mound B with jute and excelsior blankets and sprouting rye grass in December 2010. Below: Mound B under a thick coat of grass in August 2013.

After the trees were cut on each mound, and even before clean-up was complete, all bare areas were covered with woven jute or excelsior erosion blankets and seeded with rye grass, which sprouted quickly and helped to stabilize the mound surfaces during the first winter (Figure 4). Small rolls of excelsior blankets were employed as debris dams on the steepest slopes. All stumps were to be trimmed to 1-2” above ground surface to allow mowing equipment to pass over them; most, except those on the steepest slopes, were leveled with a stump-grinder. Debris clean-up and stump trimming was completed for all mounds in February 2012. A thick growth of native grasses and herbaceous plants has largely taken over the mounds.

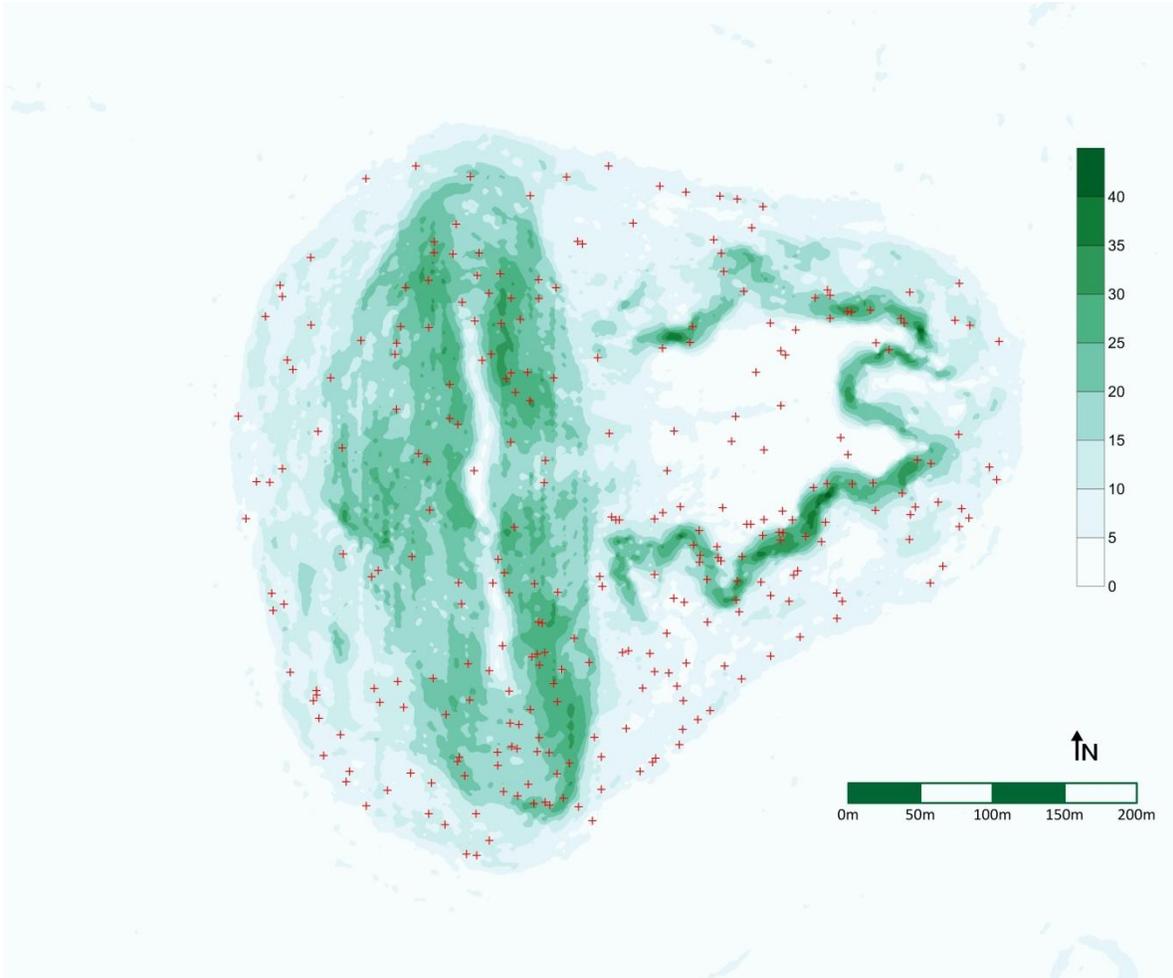
Figure 5. Distribution of trees removed from Mound A at Poverty Point. Base map shows terrain slope (%).

As the trees were removed, each stump was numbered with indelible ink<sup>3</sup> and located using a Trimble GeoXT handheld GPS so that maps could be generated of the former distribution of trees on the four mounds (Figure 5). Stump diameter and height above ground surface were recorded. Wood wedges were obtained from a sample of trees for later taxonomic identification. Most of these basic field data were collected as the trees were cut, but that was not always possible due to safety concerns or scheduling conflicts.

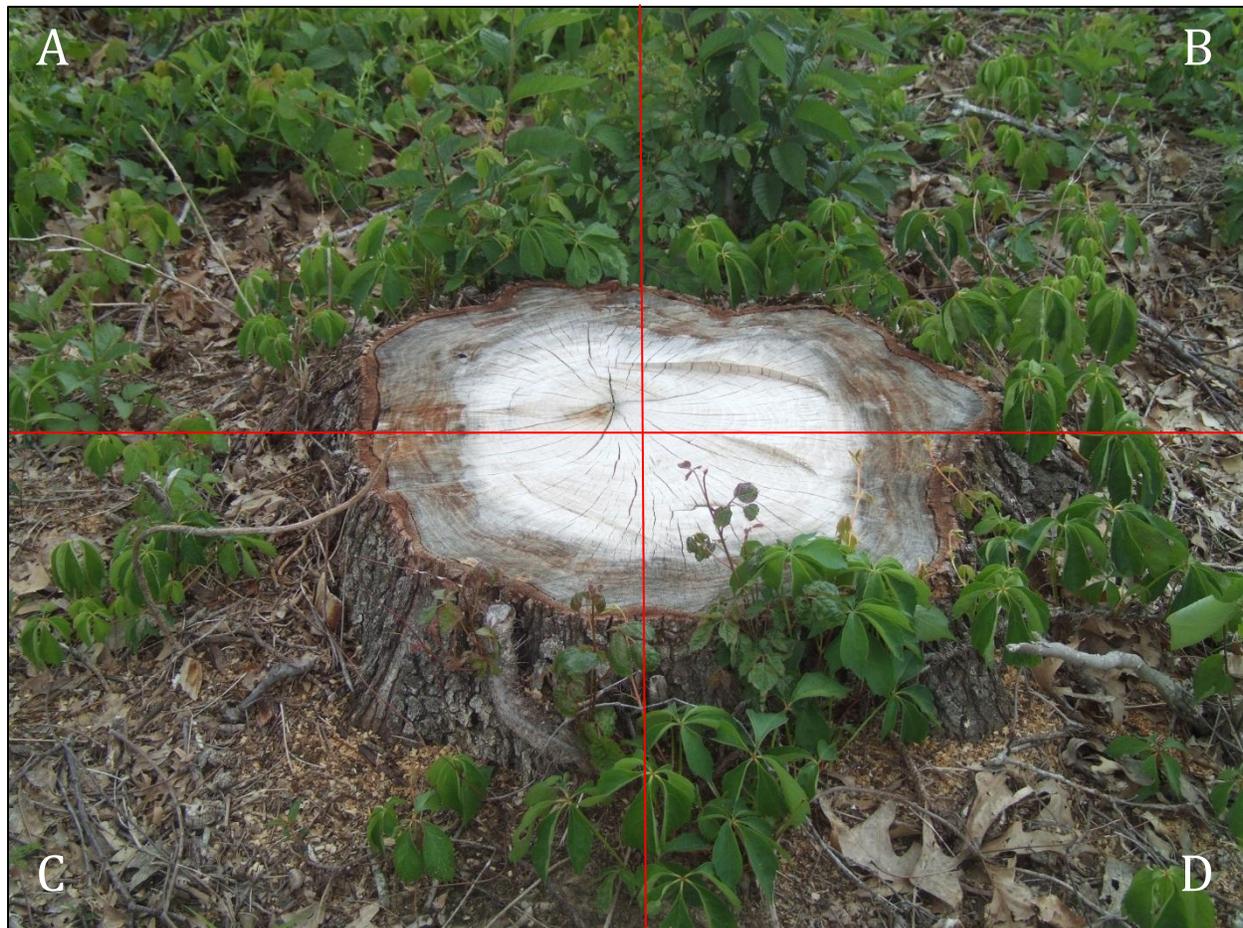
Figure 6. Quadrant system for counting exposed roots. A and B quadrants are upslope of the stump, and C and D quadrants are downslope from the stump.

Mound A stumps received a more detailed field treatment as part of the initial survey for the dendrogeomorphological research. Taxonomic identification, stump diameter, and azimuth were recorded for each of 207 stumps. This was followed by a careful ring count, using a magnifying glass when necessary, to determine age for 179 of the trees not affected by heart rot. Exposed roots around each stump were counted using a quadrant system in which quadrants A and B were positioned upslope

from the stump and quadrants C and D were downslope (Figure 6). Next, the maximum length and diameter were measured for the largest exposed root. Finally, the presence/absence of colluvial damming (the piling of sediments behind an impediment [e.g., a tree] to downslope transport), and other remarks were recorded.

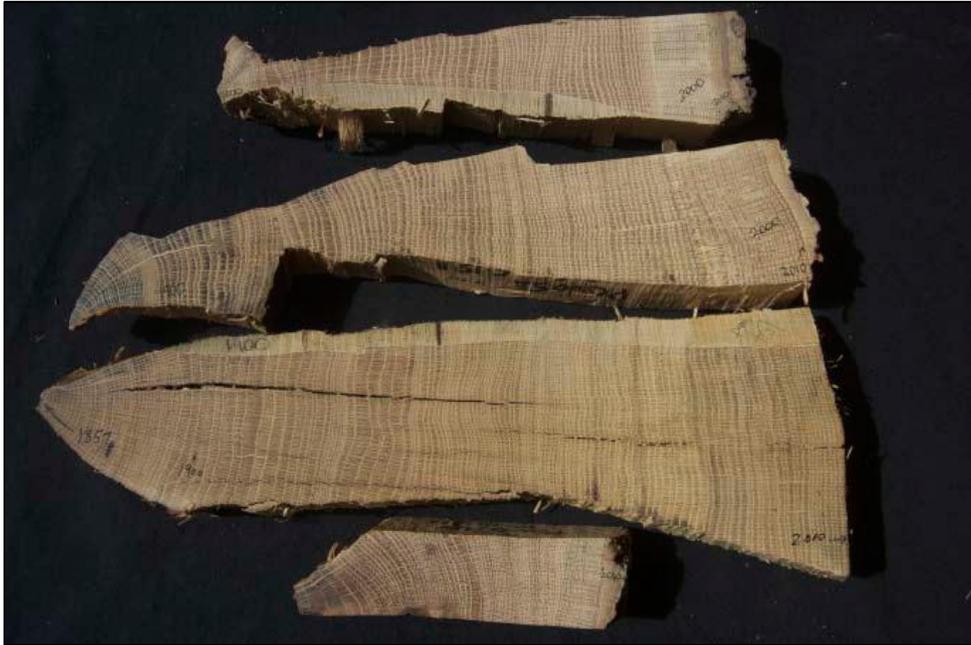
Figure 7. Sanded and tree-ring dated white oak cross sections from Poverty Point. Photo courtesy of David Stahle.

Sixteen stem cross sections for tree-ring dating were obtained from a subset of the white oak trees felled on Mound A. The stem cross sections were returned to the University of Arkansas Tree-Ring Laboratory where they were sanded to a fine polish to expose the wood anatomy (Figure 7). As described by Stahle et al. (2013:5-6):

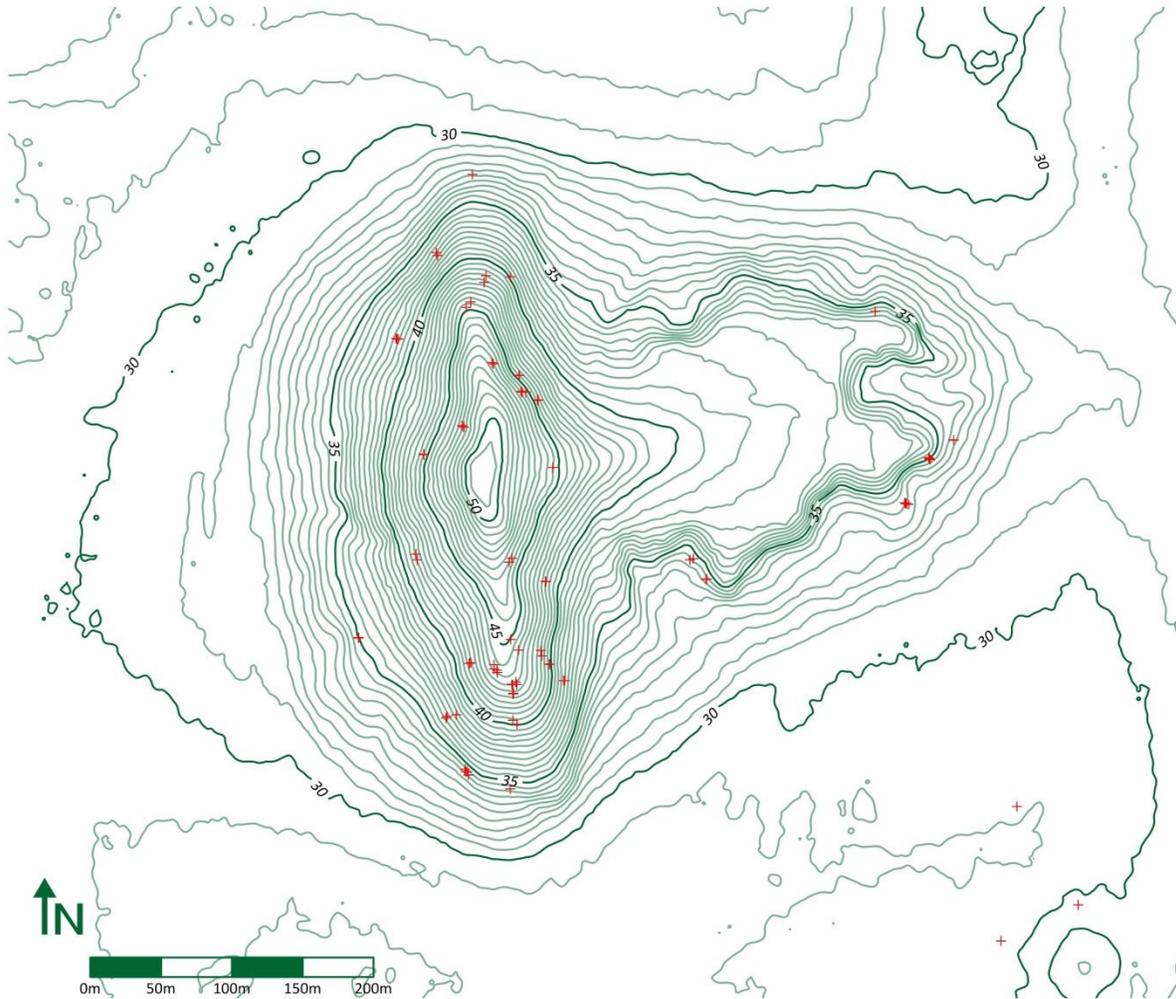
Figure 8. Map of Mound A showing locations of exposed roots removed for dendrogeomorphological analysis. Twelve samples from six control roots in flat, off-mound contexts were also removed; only three of those locations are shown here. The base map was created using LiDAR data (available courtesy of the State of Louisiana and FEMA, and distributed by “Atlas: The Louisiana Statewide GIS,” LSU CADGIS Research Laboratory, Baton Rouge, Louisiana). Contour interval is 50 cm.

Cross sections of exposed roots were acquired from Mound A (Figure 8). Each was extracted with a chainsaw (Figure 9). Prior to sampling, the soil contact locations on both sides were marked with acrylic polymer nails. In some cases, sediments encasing the bottom of the root cross sections were excavated before taking the sample; the disturbed area was documented (width, length and depth) and sediments were replaced after the sample was taken. Each root cross section was labeled, the soil contact locations were marked in ink as a backup to the nails, and other information (e.g., distance from the cross section to the stump, the slope angle and the diameter of the root at the cut) was recorded. A total of 100 root samples were taken from 40 different trees of various genera, including *Quercus*, *Prunus* and *Carya*. Eighty-eight samples were removed from slopes of the mound, while twelve were taken from flat, off-mound contexts. A total station was used to determine the precise location of each root sample and photographs were taken to document the sample context.

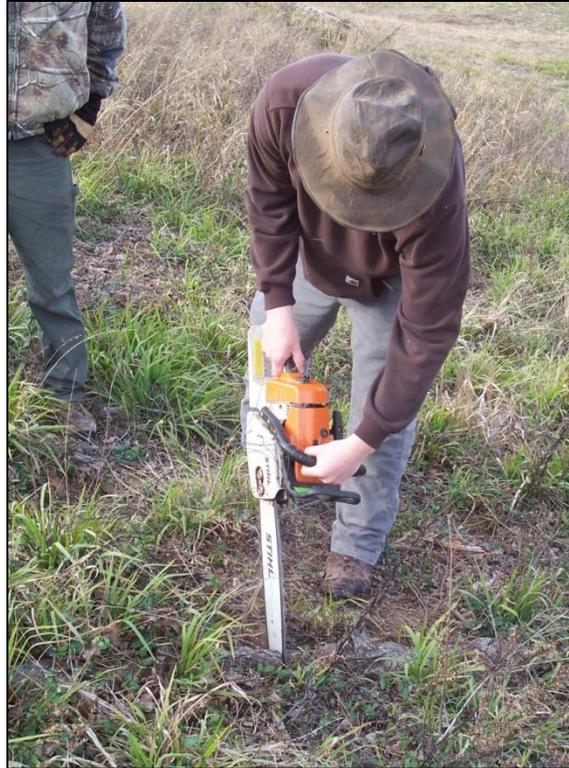
Figure 9. Jessie Edmondson using a chainsaw to remove a cross section of an exposed root on Mound A.

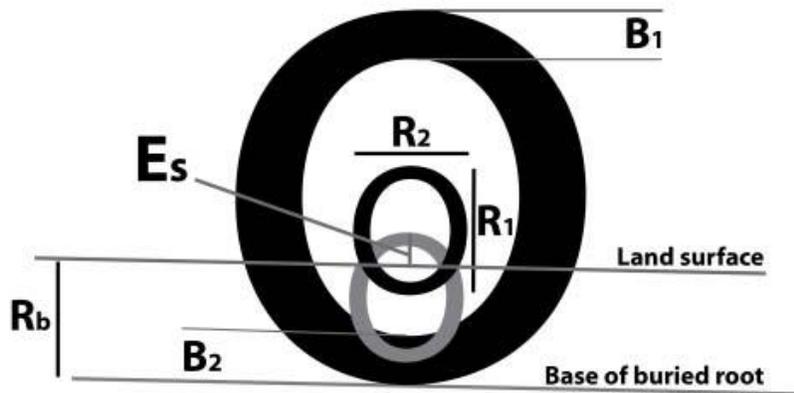
$$(1) \quad E_s = \left[ R_m + \left( \frac{B_1 + B_2}{2} \right) \right] - R_b$$

Figure 10. Schematic diagram of a root cross section with the measurements used to calculate the amount of total soil lost.  $R_1$  = maximum root diameter at year of exposure (not including bark);  $R_2$  = minimum root diameter at year of exposure (not including bark);  $R_m$  = mean of  $R_1$  and  $R_2$ ;  $B_1$  = thickness of upper bark;  $B_2$  = thickness of lower bark;  $R_b$  = depth of buried root at time of sampling (from base of root to modern soil surface, including mean bark thickness). In the equation (1) above,  $E_s$  = thickness of eroded soil using  $R_m$  as the average of the original root diameter at the time of exposure. From Stahle et al. (2013:20).

Multiple measurements were taken from the root samples using a modified version of the method described by Gärtner (2007). These measurements and the equation used to compute the total depth of soil eroded from the exposed roots ( $E_s$ ) are described in Figure 10. The root samples with sufficient growth rings for tree-ring crossdating were dated against the master chronology for Poverty Point. When possible, the inner and outer ring dates, and the year of root exposure were exactly dated and labeled on the root samples. The ring-width series on some root specimens were too distorted or otherwise compromised to permit exact dating, but, in many of these cases, approximate dates could be determined using simple ring counts.

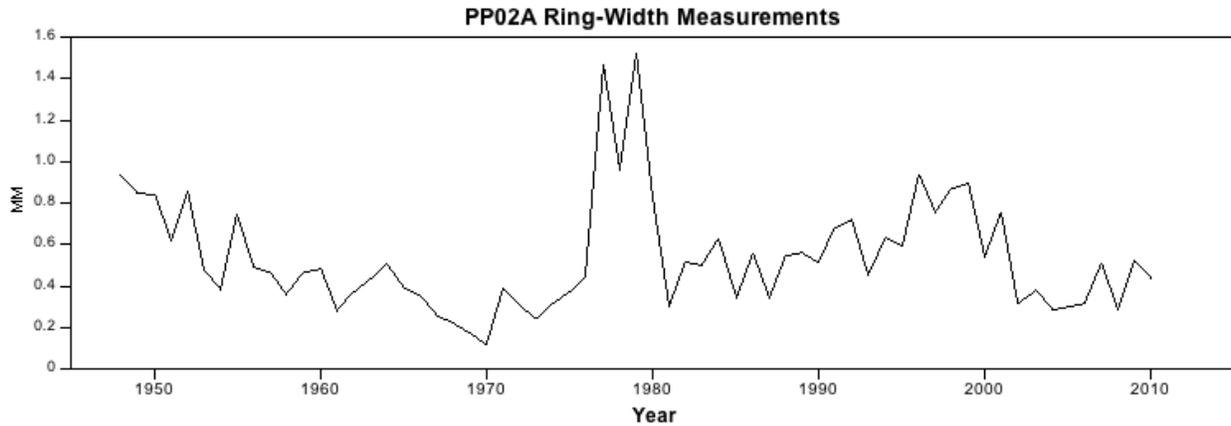
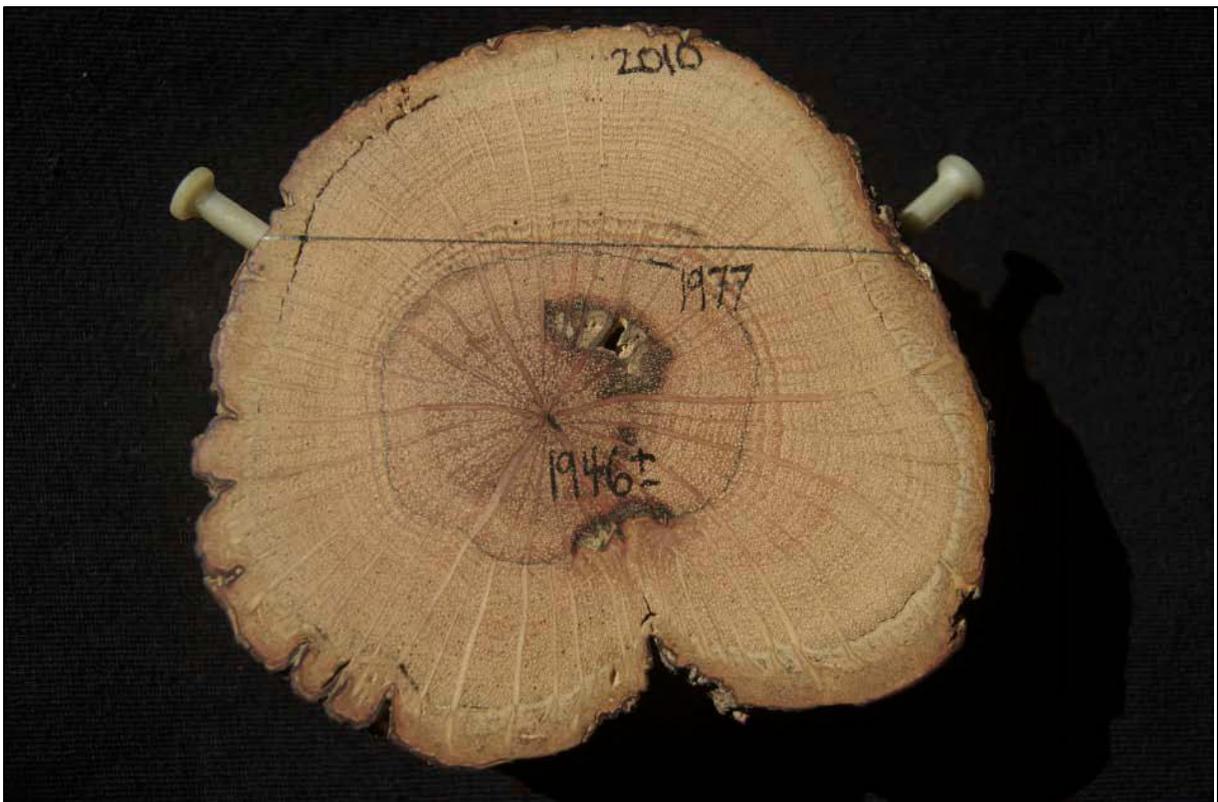
Figure 11. Raw ring-width measurements are plotted for white oak root sample PP02A (graph at top, in mm). Note the surge in ring widths that mark 1977 as the year of exposure. This is also apparent in the photo below. The acrylic nails indicate the soil contact at the time of sampling (bottom photograph, exact dating from 1977-2010, approximate dating from 1946-1976). The top portion of this root was exposed above the ceramic nails. Notice the differences in bark thickness and ring anatomy between the stem wood (above the pencil line) and root wood (below the line). From Stahle et al. (2013:24).

The approximate location in the ring sequence on the polished roots where exposure occurred was determined on the basis of field observations that marked the surface of the mineral soil on the edge of the root. Several ring width and anatomical features preserved on the exposed root specimens then helped to specify the exact year of exposure, and these ring width features generally agreed closely with the field observations on the point of exposure (Figure 11). None of these ring width or anatomical features were universally present on all the exposed roots, and they are listed below by their approximate frequency and usefulness:

1. An increase in ring width at or soon after exposure
2. Discoloration of the polished wood at the point of exposure
3. A change from more or less diffuse porous to ring porous wood anatomy at the time of exposure (on ring porous species only)
4. Thickening of the latewood zone upon exposure, sometimes including tangential bands of fiber cells
5. An increase in vessel diameter on recently exposed root wood
6. Scarring of the cambium and a wound response on the upper surface of the root near the time of exposure

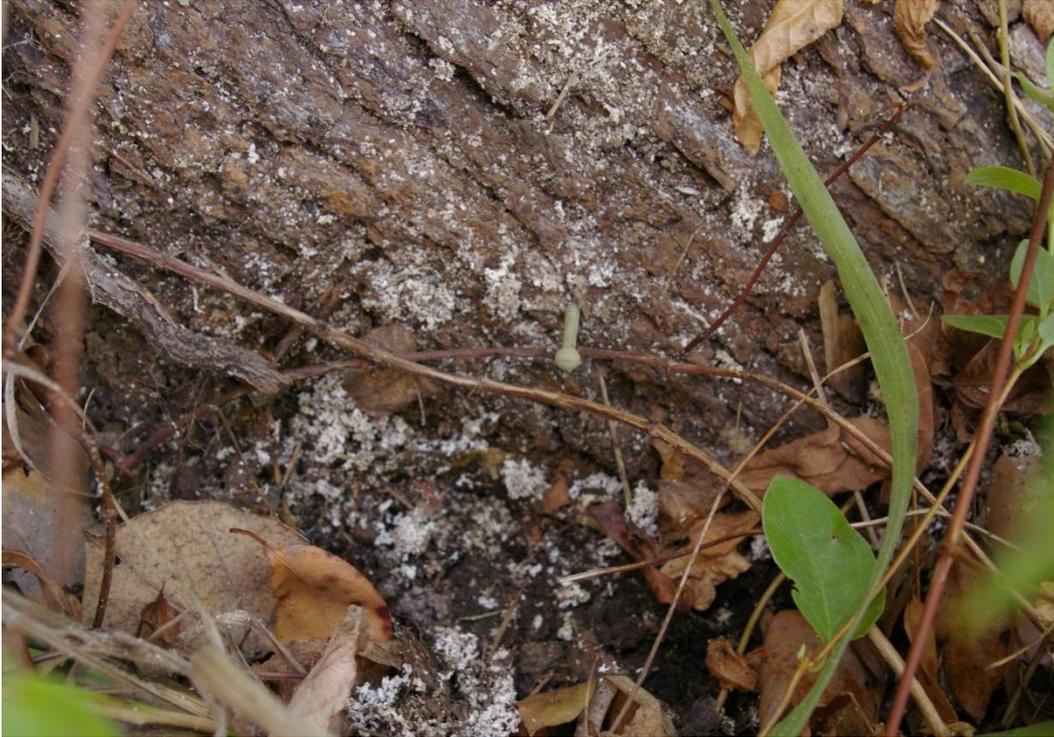
Figure 12. Stump (root flare) with polymer nail marking the location of the stump/ground surface intersection at the beginning of project. Although difficult to tell in this photograph, the ground surface is 7 cm below the nail. The faint orange discoloration to the upper left of the nail is the originally applied orange spray paint.

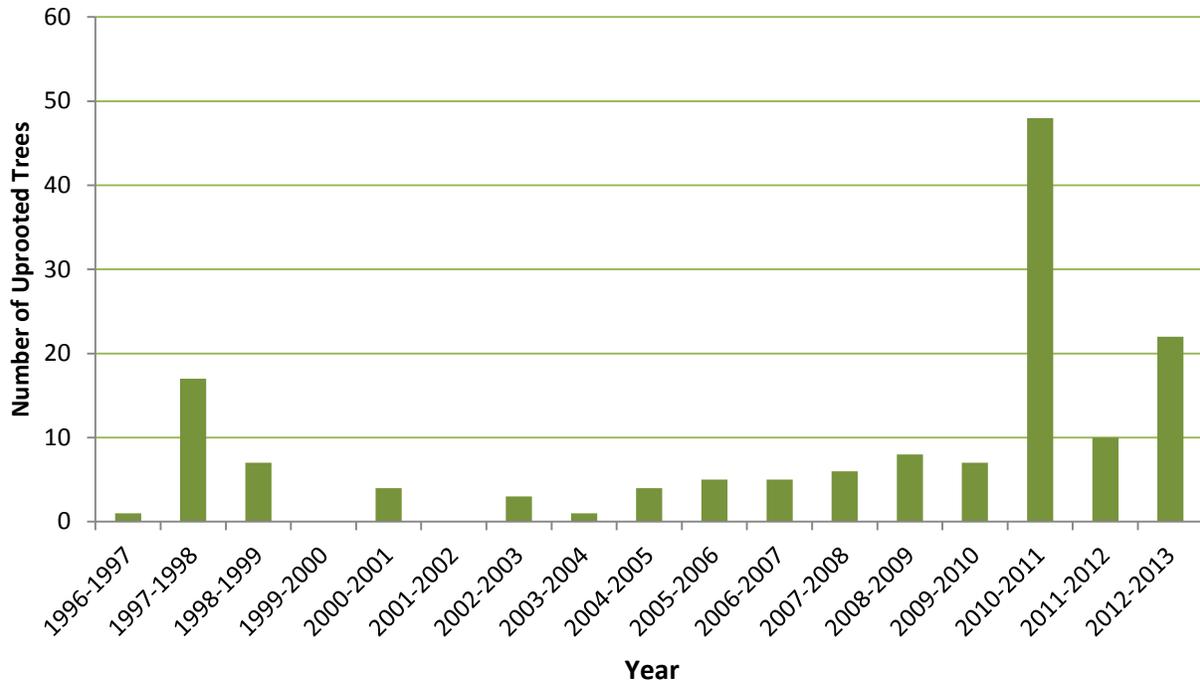
Figure 13. Number of windthrown trees per year at Poverty Point State Historic Site.

Since 1997, the Poverty Point Station Archaeology Program has maintained records for windthrown, or uprooted, trees in the park. These records include the number of downed trees per year (Figure 13) and, for each tree, its location, the dimensions of the rootball (or root plate), the dimensions of the roothole (or pit), and the archaeological impact. The number of windthrown trees appears to be increasing slightly over time, except for those years with catastrophic wind events, such as in the years 1997-1998 and 2010-2011. The high tree casualties in 2010-2011 were almost certainly a result of the tree removal project, which exposed previously sheltered trees to greater wind forces than they were acclimated to (Sellier and Fourcaud 2009). Over the past ten years, there has been a statistically significant upward trend in the number of trees being uprooted each year, excluding the extreme 2010-2011 year (adj.  $R^2 = 0.695$ ;  $F = 19.201$ ;  $p = 0.003$ ).

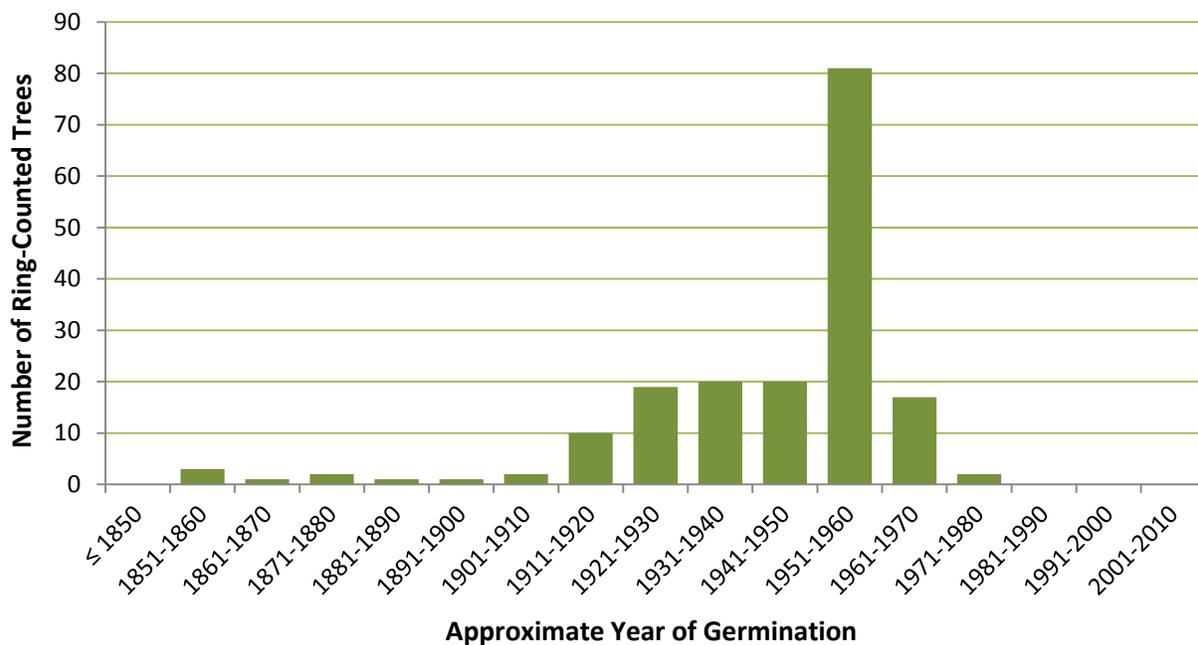
Figure 14. Frequency of 179 cut trees on Mound A by approximate year of germination.

Ring-counted age estimates were obtained from 179 tree stumps on Mound A. The trees ranged in age from 40 to 156 years at the time they were cut, with an average age of 67.2 years (Stahle et al. 2013). Because the rings were so well-defined and the stumps were cut very near the ground surface, the ring-counted ages are likely close to the true germination age of these trees. Figure 14 plots the trees on Mound A according to their approximate year of germination. These data are consistent with descriptions of how the forest cover on the mounds was managed. It is clear this was not a mixed-age stand that would characterize a stable forest.

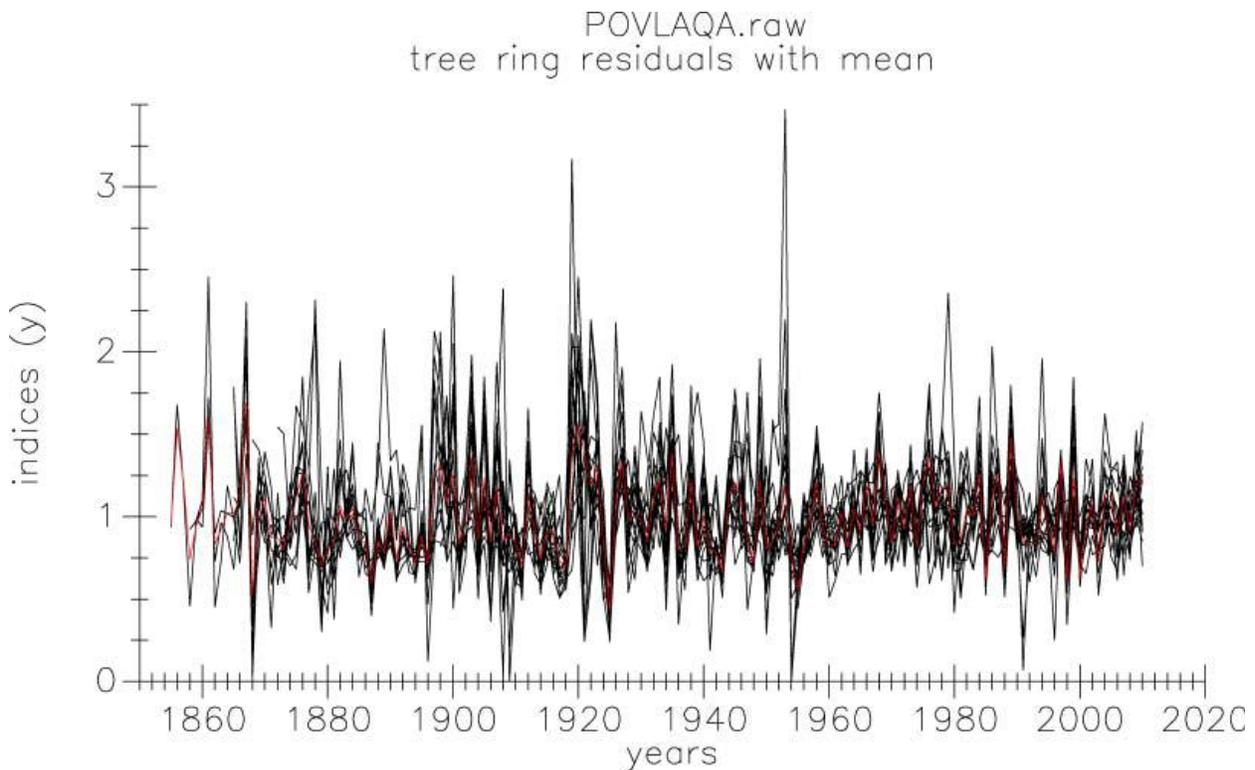
Figure 15. The individual dated ring-width time series (black lines) are plotted with their mean (red line), after detrending and the removal of low-order growth persistence (Cook et al. 2007). Note the strong correspondence among the individual time series, especially during the severe and widespread droughts of 1925, 1955, and 1985 over the southern United States (the average correlation among the 16 ring-width time series is +0.41 [RBAR, Cook et al. 2007]). From Stahle et al. (2013:16).

The individual chronologies for sixteen tree-ring dated white oak radii (all probably *Quercus alba*) are plotted in Figure 15 and illustrate the strong crossdating of interannual ring-width variability among these sample trees and radii. The standard tree-ring chronology derived for white oak at the Poverty Point site is plotted from 1855 to 2010 in Figure 16. The radial growth of most upland oak species in the southcentral United States tends to be positively correlated with precipitation and negatively correlated with temperature during the growing season (Blasing et al. 1988; Stahle and Cleaveland 1988; Haavik et al. 2011). The tree-ring chronology developed for white oak at Poverty Point is correlated with other oak chronologies from Arkansas (e.g.,  $r = 0.43$  for a comparison between the Poverty Point and Lake Winona, AR, white oak chronologies for the period 1901-1980). We have not specifically modeled the climate signal in the white oak chronology from Poverty Point, but the chronology certainly records some of the major droughts that afflicted northeast Louisiana during the 20<sup>th</sup> century (e.g., 1918, 1925, 1955, 1956, 1988, 1998, and 2000; Figure 6; growing season droughts identified in the instrumental Palmer Drought Severity Indices for Louisiana Climate Division 2, National Climatic Data Center, NOAA).

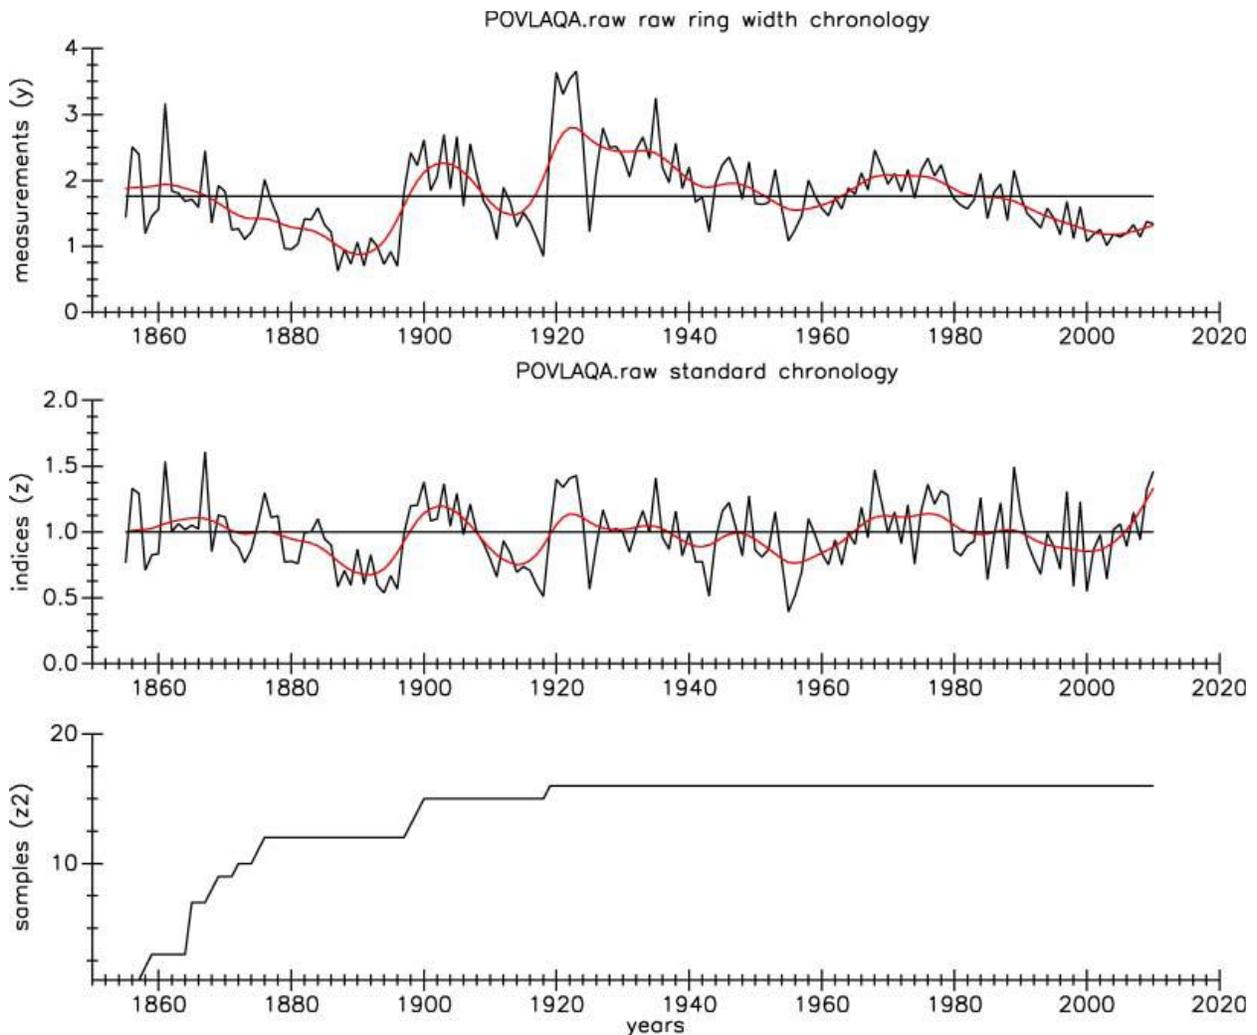
Figure 16. The mean ring-width chronology for the sixteen white oak series from Mound A Poverty Point is plotted from 1855-2010 (top plot, in mm, without any detrending or standardization). The standardized ring width chronology for Poverty Point is plotted in the middle time series, after detrending and standardization (achieved by fitting a smoothing spline with a 50% frequency response of 50 years to the raw measurements and dividing the measured ring width value by the value of the fitted curve at each year [Cook and Peters 1981; Cook et al. 2007]). The sample size for each year is plotted in the bottom series (i.e., the number of dated radii per year). Drought years and poor growth are indicated in the middle plot by values below the mean of 1.0, wet years and favorable growth by values above the mean. Note the low growth in 1918, 1925, 1943, 1954-56, 1985, 1988, 1998 and 2000. From Stahle et al. (2013:17).

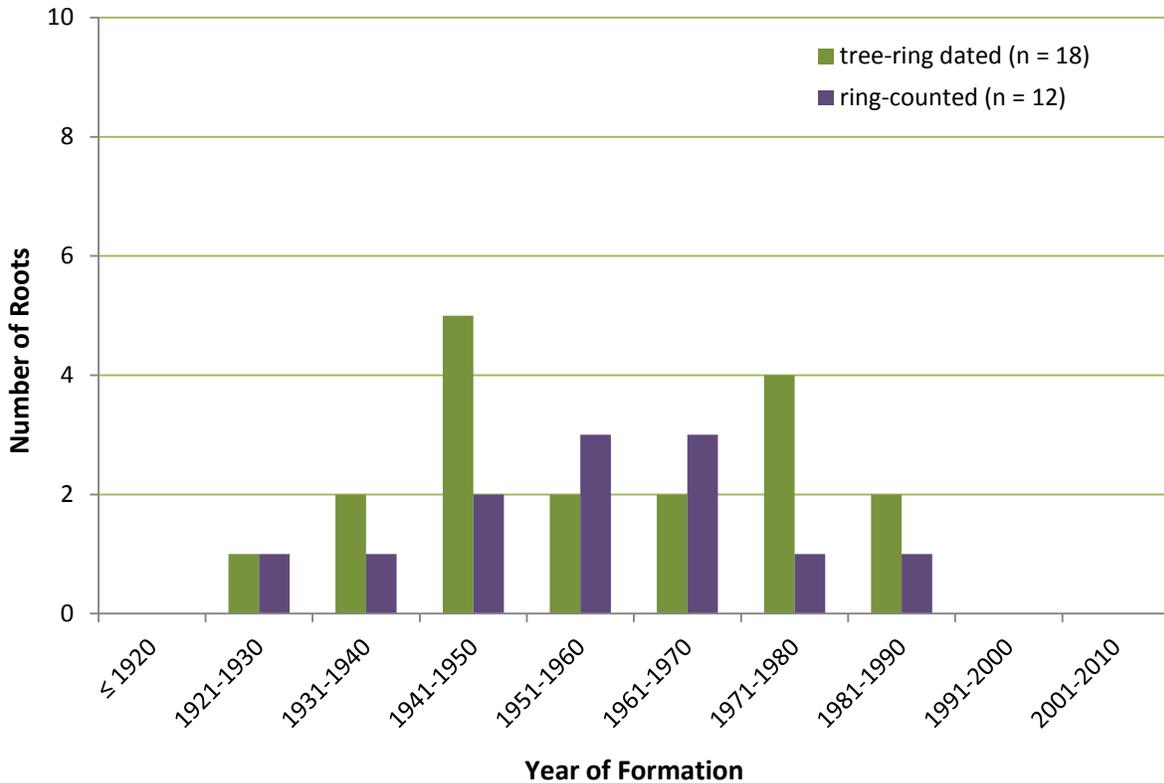
Figure 17. Year of formation for thirty exposed roots as determined through tree-ring crossdating with the Poverty Point chronology and/or ring-counting. In a few cases, the year of pith formation was closely approximated.

The ages of eighteen roots acquired for dendromorphological analysis were exactly determined by crossdating with the 156-year long Poverty Point tree-ring chronology (Figure 17). Twelve additional roots were aged using ring counts. The dates range over 64 years, from 1923 to 1987. Eighteen tree-ring dated roots may not sound like a significant accomplishment, but, according to Stoffel et al. (2013), roots have never been successfully crossdated before. Without the ability to use tree-ring chronologies to date dead roots, studies of erosion history have been constrained to living roots.

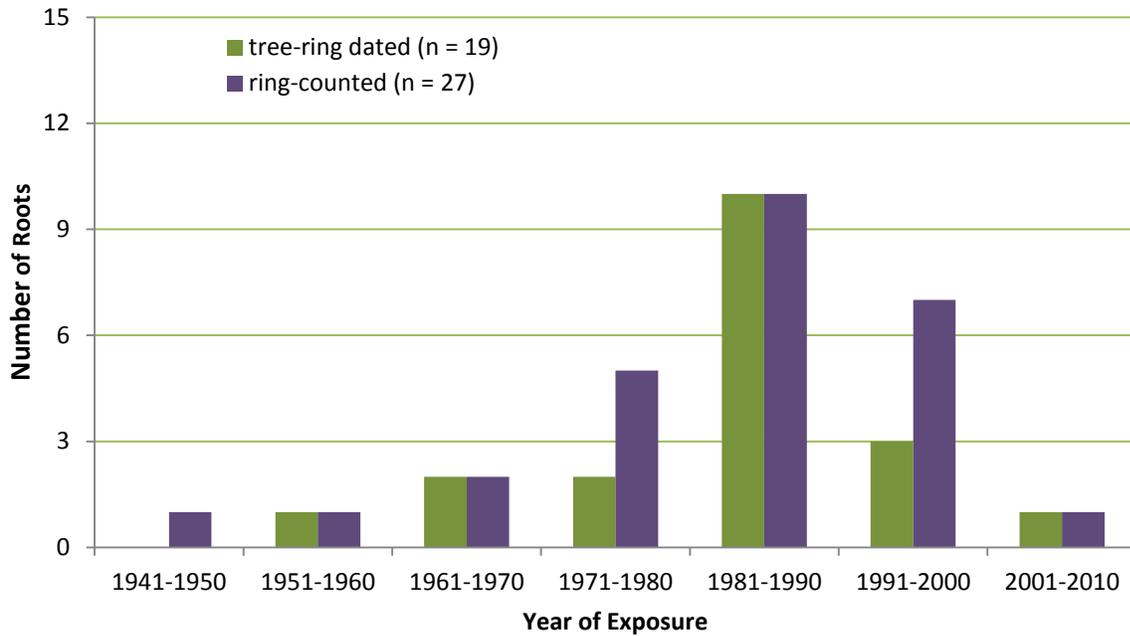
Figure 18. Year of exposure at the surface of Mound A for forty-six roots obtained for dendrogeomorphological analysis as determined through cross-matching with the Poverty Point tree-ring chronology and/or ring-counting.

More important than the age of the roots is the year they were exposed at the ground surface of Mound A. The years of exposure, as indicated by visible anatomical changes, for nineteen tree-ring dated and twenty-seven ring-counted roots are shown in Figure 18. Roots in this sample were exposed as early as 1949 and as late as 2003, with a peak in the 1980s. Indeed, the average date of root exposure was 1983. Stahle et al. (2013) note that there is no evidence for root age as a factor in determining exposure; roots ranged in age from 6 to 46 years at their first exposures.

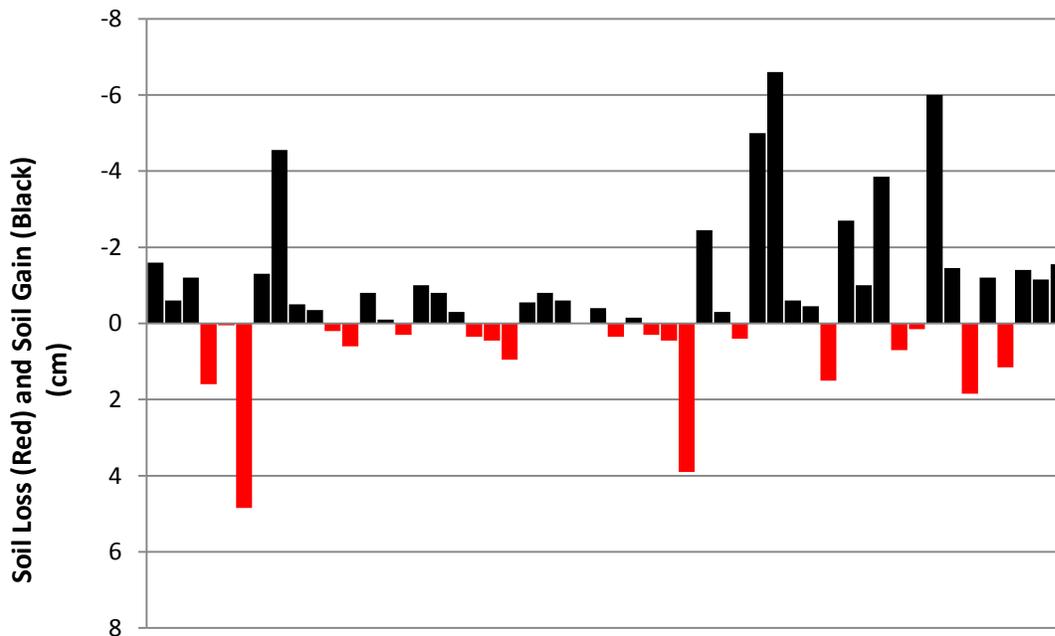
Figure 19. The distribution of calculated  $E_s$  values for fifty-two exposed roots taken from Mound A and nearby flat areas. Positive  $E_s$  indicates soil loss (red) and negative  $E_s$  indicates soil gain (black).

Most of the 100 exposed roots collected on and around Mound A were not useful for examining erosion history because they had multiple piths or severe scarring, did not display a clear reaction to surface exposure or were missing wood. Soil loss could be calculated using Equation (1) for fifty-two roots; of those, the year of exposure was determined for forty-six.  $E_s$ , the amount of eroded soil, is positive when soil has eroded around the exposed root. Negative values of  $E_s$  indicate that soil has accumulated around the exposed root; the most likely scenario for this situation is that, once exposed, the root continued to grow out of the ground and served as a dam or sediment trap. Figure 19 plots  $E_s$  for the

root samples. More exposed root samples exhibit soil gain rather than loss, and the average amount of soil gained is greater than the average lost (1.5 vs. 1.06 cm).
