# Dendrogeomorphological Investigation of Earhwork Stability at Poverty Point SHS, Louisiana | 2013-08

# Dendrogeomorphological Analysis of Earthwork Stability at Poverty Point SHS, Louisiana

MT-2210-11-NC-09

Diana Greenlee  
University of Louisiana at Monroe

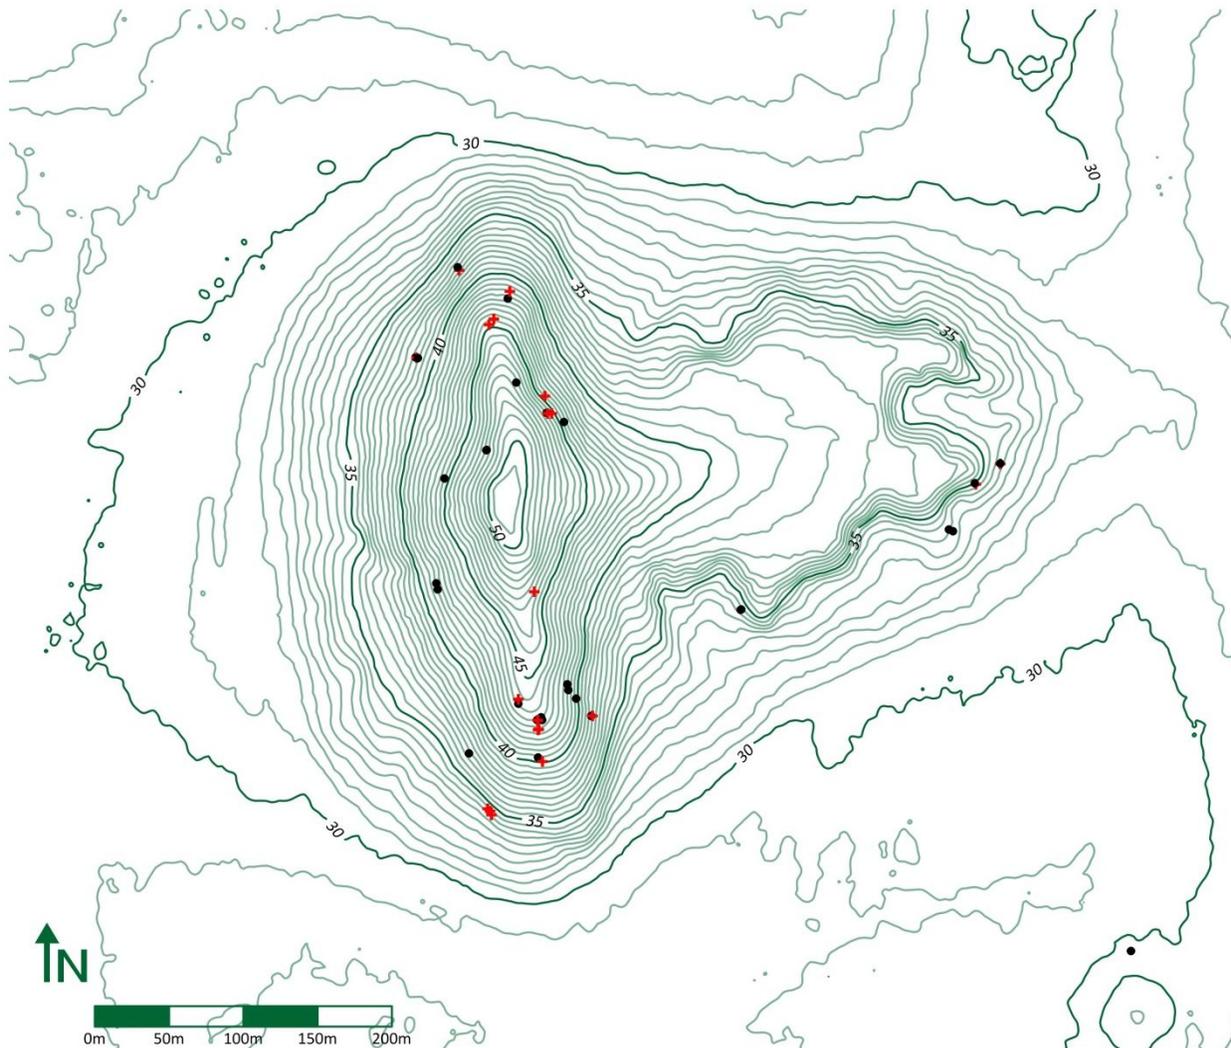
Figure 20. Distribution of exposed roots on Mound A, classed by soil gain (+) and soil loss (•).

One possibility was that there was some topographic component determining which roots showed evidence of soil loss and which showed soil gain. For example, the roots showing soil gain might be located on gentler slopes toward the margins of the mounds, and the roots showing soil loss might be on the steeper slopes closer to the mound apex. Figure 20 plots the distribution on Mound A of roots showing soil loss and gain. There is no obvious spatial component. Further efforts to resolve the variation according to location relative to the tree stump does not offer a consistent explanation.

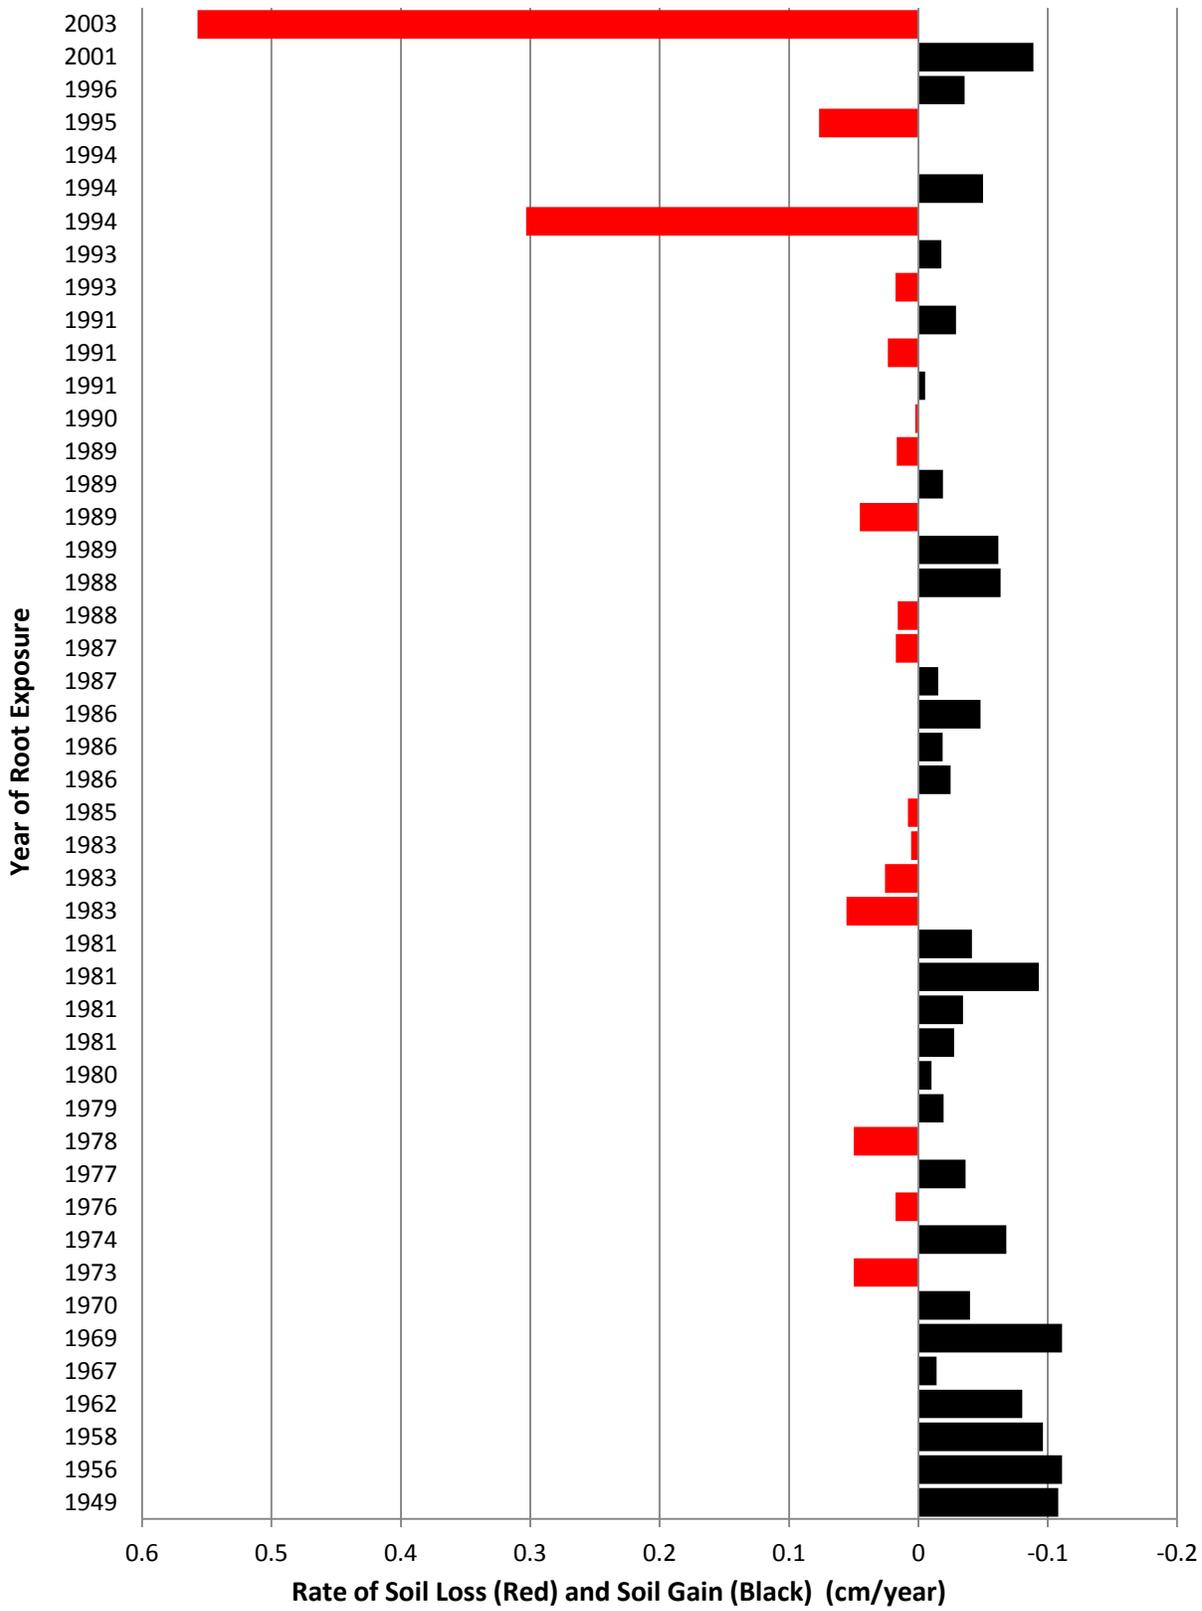
Figure 21. Rate of soil loss and gain per root sample by year of exposure.

The rate of soil loss/gain indicated for each root cross section could be related to the year of exposure. Years with more extreme rain events or that were subject to processes that strongly impacted slope stability might produce an episodic record. Figure 21 plots soil loss/gain rates by year of exposure. Roots with the two highest loss rates were exposed in 1994 and 2003, but one can hardly identify a trend toward greater erosion based on two points. All of the soil loss rates are within the range of rates for sheet erosion documented by other researchers (Stoffel et al. 2013). The soil gain rates would appear to provide at least equivocal, if not contradictory, information.

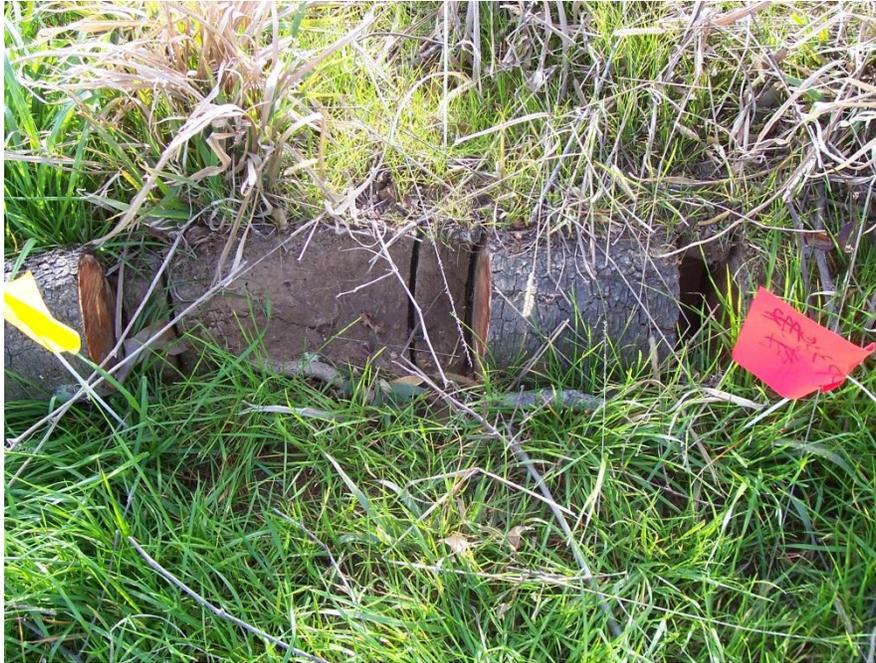
Figure 22. Exposed root on Mound A with a perpendicular orientation to the slope that has been sampled for geomorphological analysis.

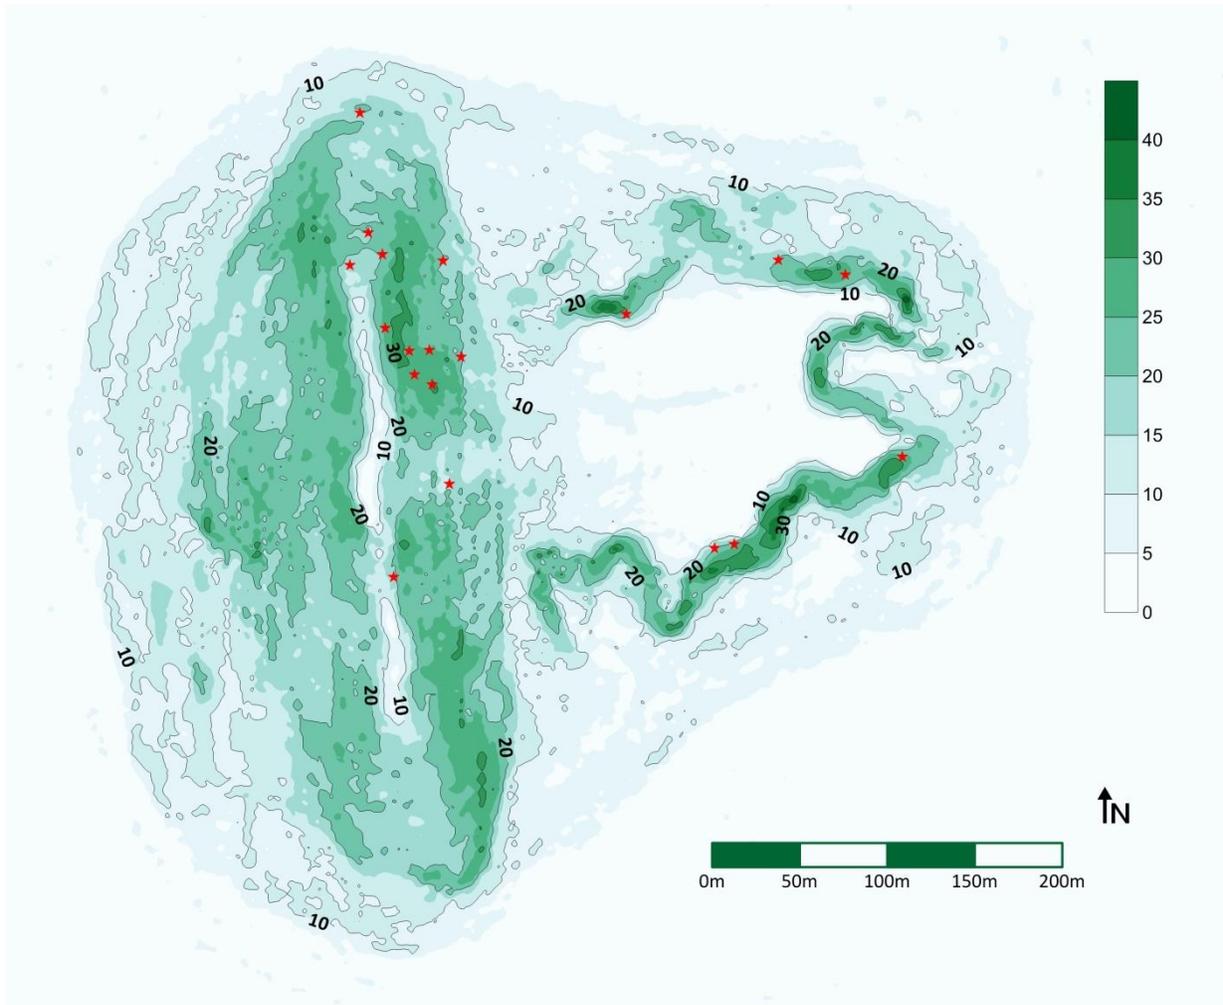
Figure 23. Slope map of Mound A, showing distribution of trees exhibiting colluvial damming (red stars).

The final data set relevant to understanding the erosion history of Mound A at Poverty Point draws on observations of uneven slope surrounding the cut tree stems. On some stumps, there is a gentler slope against the upslope side and a steeper slope leading from the downslope side. This has been attributed to colluvial damming, wherein the tree stem acted as an impediment to the downslope movement of sediment, trapping it upslope of the stem. Erosion was not similarly dampened on the downslope side, allowing a steeper slope to form. It is not surprising that these features appear to be associated with steeper slopes on Mound A (Figure 23).

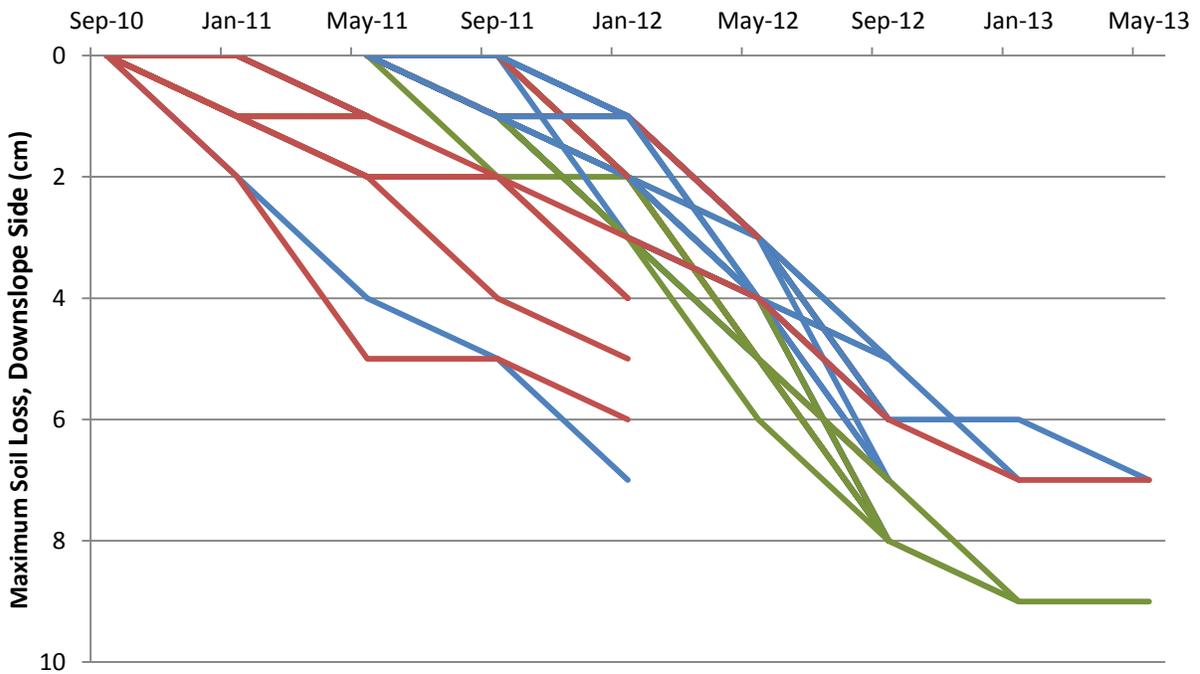
Figure 24. Soil loss data as measured for nails placed in the downslope side of stumps on mounds A, B and C. The data are color-coded by slope, with flat slopes (0-10%) in red, moderate slopes (10-25%) in blue, and steep slopes (>25%) in green.

Figure 24 plots the maximum soil loss measured per stump, coded by slope. As might be predicted from the results of the root exposure/quadrant analysis and the colluvial damming observations (but not anticipated before the experiment began), the downslope nails consistently showed the greatest soil losses, whereas the upslope nails were relatively quickly covered with sediment and vegetative debris. This, of course, did not happen with nails on flat slopes. The records of the lateral nails varied, depending on whether they were upslope or downslope of roots or lobes in the stem.

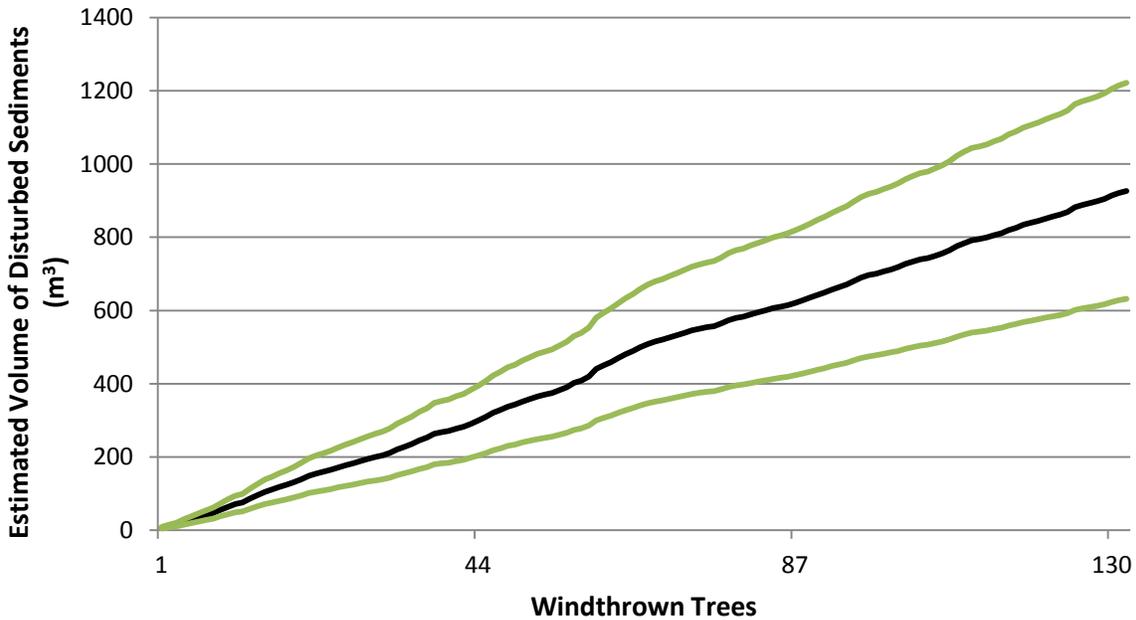
Figure 25. Estimated cumulative volume (average  $\pm$  95% confidence interval) of sediments that would be disturbed as trees are selected by random number generator to be “uprooted.” The total sample represents a 75% sample of stumps on Mound A with documented diameters.

Had the trees not been removed from the mounds, it is likely that uprooting would have resulted in significant damage to the mounds. The correlation between stump diameter and roothole volume allows estimation of damage to the mound that could have occurred. Figure 25 models cumulative sediment disturbance as trees on Mound A, up to a 75% sample, selected by a random number generator, are “uprooted.” This estimate does not attempt to deal with the potential impact of erosion beyond the initial windthrows; an uprooted tree on a steep slope may represent an initial erosional scar that can increase greatly in scope.
