# HISTORIC AMERICAN TIMBER JOINERY

## A Graphic Guide

### *II. Tying Joints: Tie at Plate*

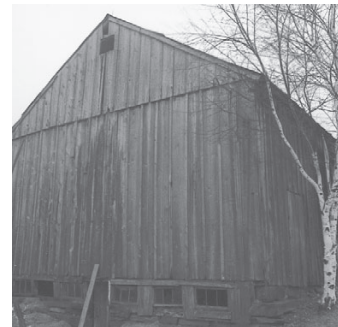
*Boarding lapped at tie beam.*

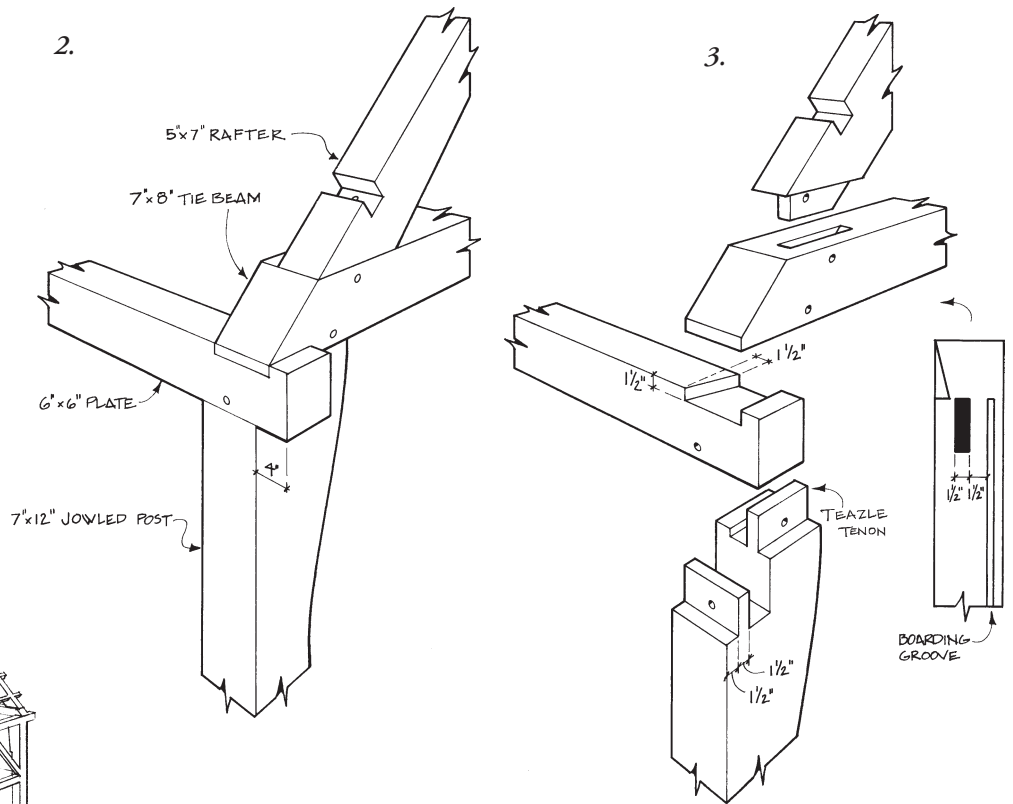
Figs. 1-3. Below, side-entrance, three-bay 23x32 barn in southeastern Massachusetts, ca. 1680. This barn has a steep 52-degree roof with 2x3 common purlins 24 in. on center trenched through rafters set about 6 ft. apart. A collar beam joins each pair. Unusually, one tie beam doesn't receive a rafter pair. At right, English tying joint with half-dovetail at the gable end. The plate, originally longer, now extends only 2 in. past the tie beam. A groove in the underside of the tie beam (Fig. 3) accepts the boarding.

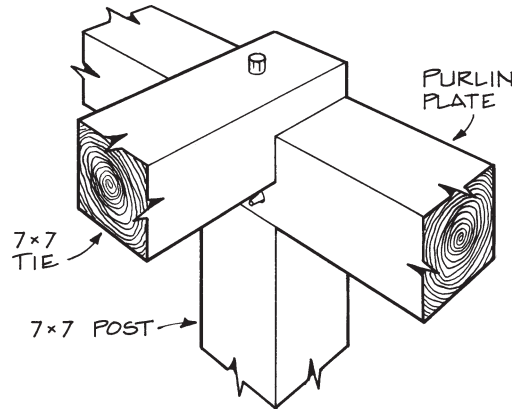
Fig. 24. This tenoned tie connects purlin plates in a barn in Goshen, Massachusetts. It also has an additional pin shearing plane in the tying joint.

Second, the tie beams can be offset from the posts. But end wall tie beams are outside of the plank wall and the plates cantilever out to support them. Again, braces can't be framed to them. On intermediate tying joints, a through tenon with two or more pins can be used or, better yet, a wedged through half dovetail (Fig. 23). Third, the plate can be raised and the tie beam deepened so that the post tenons into the tie beam instead of the plate. This tie to plate joint is an improvement over the normal mortise and tenon. Instead of the tie beam pins having two shear planes, they have three (Figs. 25-27). These mortise and tenon tying joints require a different raising technique. The plates must be slid horizontally onto their respective tenons and plate bracing is tricky to insert. A fourth method is to raise the tie beam above the plate (Fig. 24).

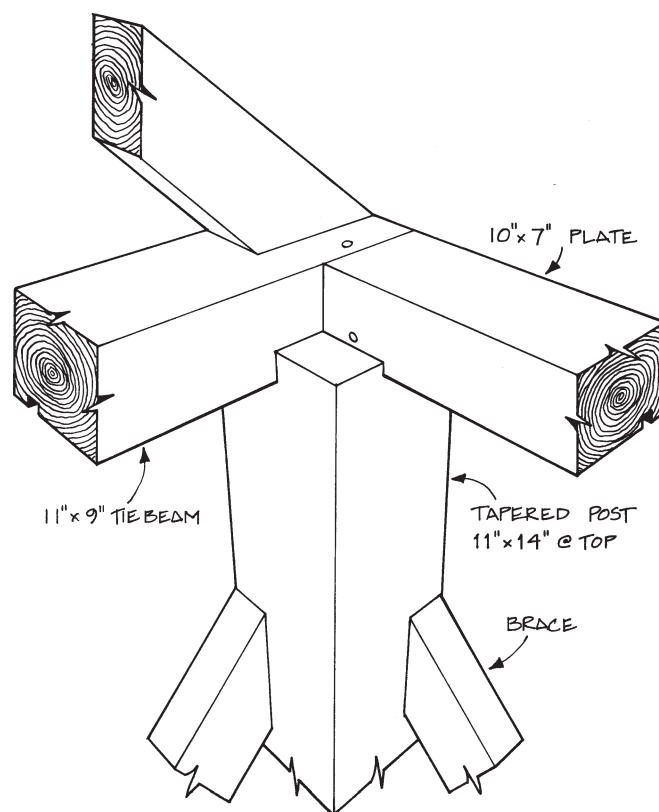
*Figs. 28 and 29. This triple bypass corner tying joint was found in an early scribe rule (late 1700s) four-bay, side-entrance barn in Hoosac, New York. The 36x49-ft. barn appeared to be Germanic in origin, with purlin plates and a ridge beam. Intermediate ties were the dropped type. Long braces extended German-fashion from the sill up to the corner posts. These undoubtedly helped stabilize the structure during the setting of the plates. Boarding grooves were worked in both plate and tie. This barn was carefully dismantled but unfortunately burned while in storage.*

**T**RIPLE BYPASS. This is arguably the most perplexing of tying joints located thus far. It is found along the border of New York and New England in four states. Some refer to it as *secret* joinery because it can mystify the casual observer. Its name, coined by Don Carpentier of Eastfield Village in East Nassau (Rensselaer County), New York, is apt. The connection has three mortise and tenon joints, not counting the rafter joint (Figs. 28-30). In Buskirk, New York, a barn with all of its tying joints of this type shows evidence of having been dismantled previously. All the tie beam tenons are inserts (free tenons). Undoubtedly the dismantler was perplexed at how to take the barn apart. He cut the tenons off (a hanging offense in my book) and then spent considerable time putting tenons back on.

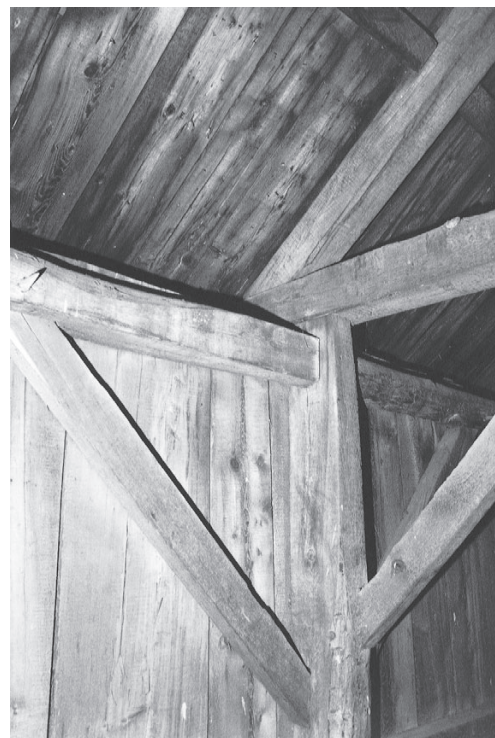
*The English tying joint tradition lives on even with interrupted plates in this Newfields, Maine, aisled barn. The plates tenon into the side of the post and a flying plate (not visible) is supported by the tie beam ends.*
