SMITHSONIAN INSTITUTION
CONSERVATION ANALYTICAL LABORATORY

**Development of an Evaluation
Methodology for Cleaning Damage Assessment**

FINAL REPORT

June 1996

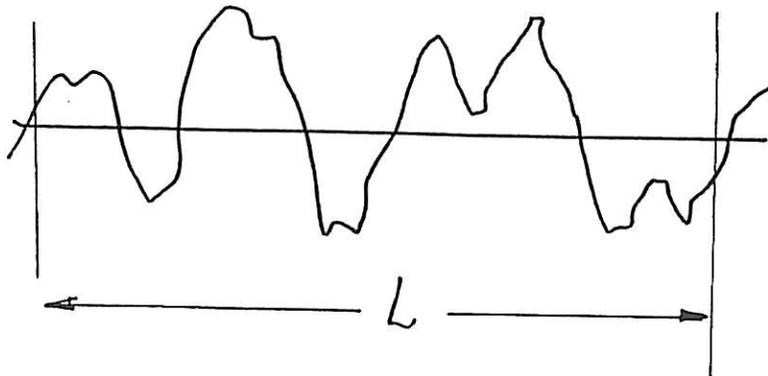
$$R_q = [1/L \int_0^L y^2(x) dx]^{1/2}$$

where $y(x)$ is the surface profile, sampled by a set of N points y_i over the length L as shown in the diagram below:

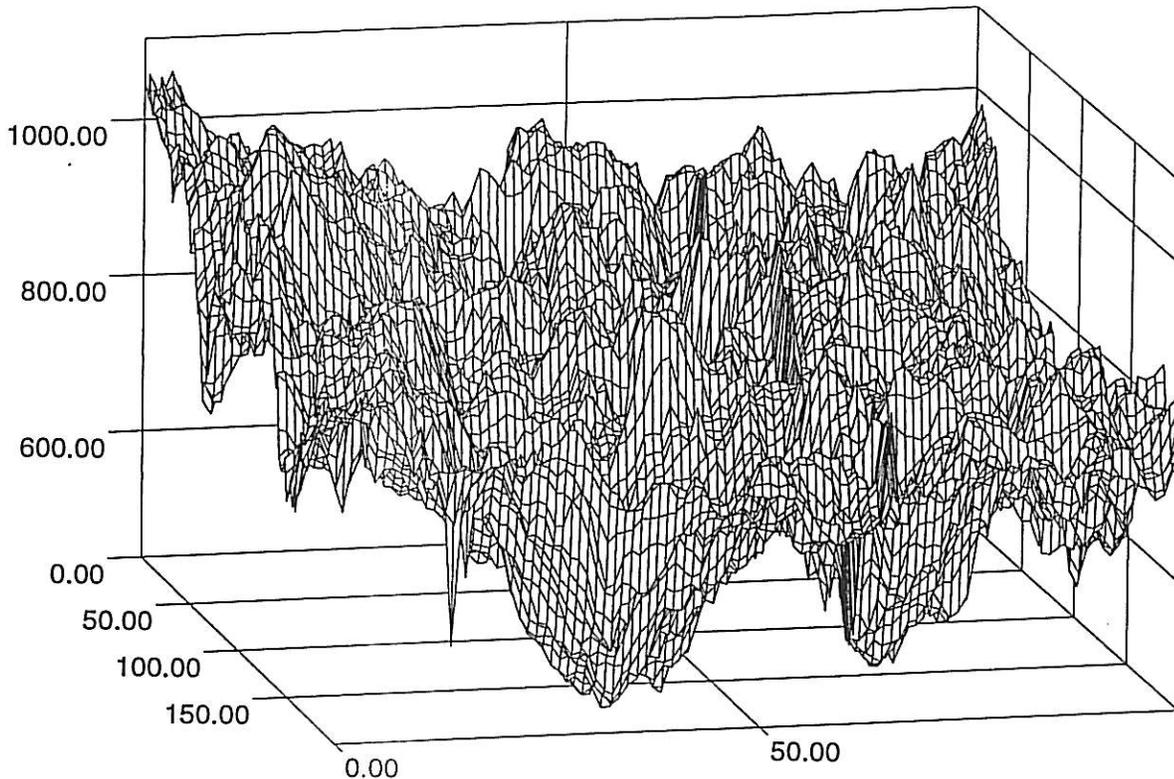
FIGURE 1. Surface profile of an area encompassing part of the control and part of the blasted area. The measurements were taken on a red replica of the flame finished granite sample (FGBI) blasted with Black Beauty at high pressure (100 psi).

The surface represented is 8 cm² and it was scanned along 4 cm (200 points) bridging the interface between the control and the blasted areas and along 2 cm (100 points) in the other direction. Each point measured was 200 μm.
(Courtesy of D.Oursler at Johns Hopkins University).

The interface runs parallel to the z-axis at about the 50.00 value on the x-axis. The right side is the control area and the left side is the blasted area. The deep peaks and pits that result from the flamed finish are lost and the surface is actually smoother after the blasting.

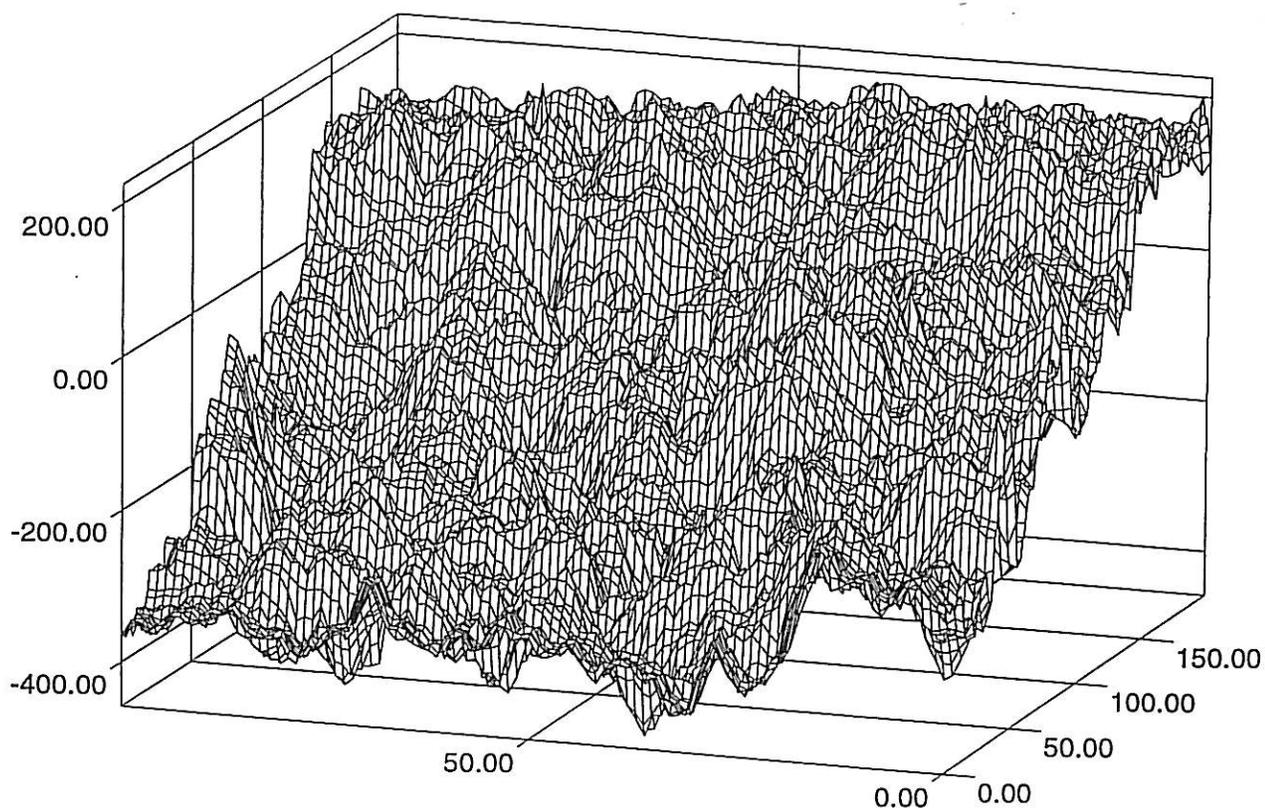
FIGURE 2. Surface profile of an area encompassing part of the control and part of the blasted area. The measurements were taken on a red replica of the sawn sandstone sample (SSBI) blasted with Black Beauty at high pressure (100 psi).

The surface represented is 0.5 cm^2 and it was scanned along 1 cm (200 points) bridging the interface between the control and the blasted areas, and along 0.5 cm (100 points) in the other direction. Each point measured was $50 \mu\text{m}$.
(Courtesy of D.Oursler at Johns Hopkins University).

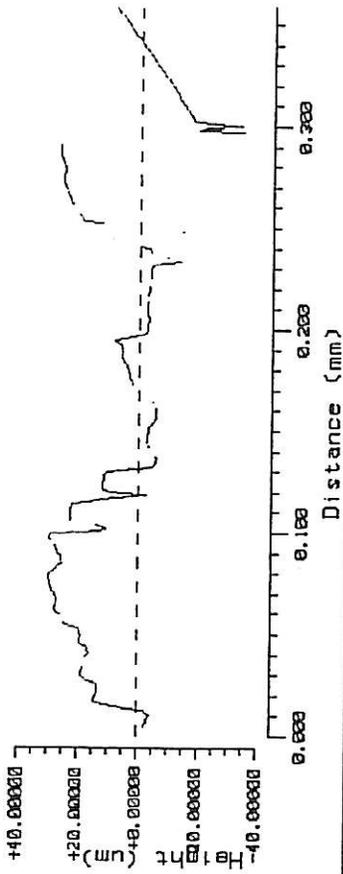
Surface Profile

PV 64.360 um
 rms 14.273 um
 Ra 12.498 um

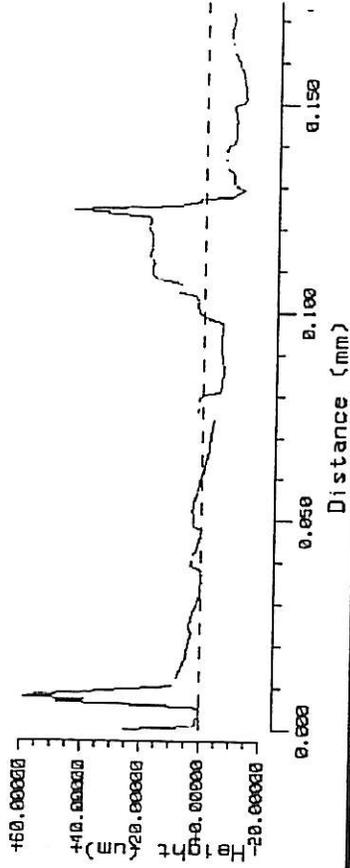
Surface Profile

PV 72.070 um
 rms 11.337 um
 Ra 7.697 um

Silicone Rubber Replica - High Relief Area

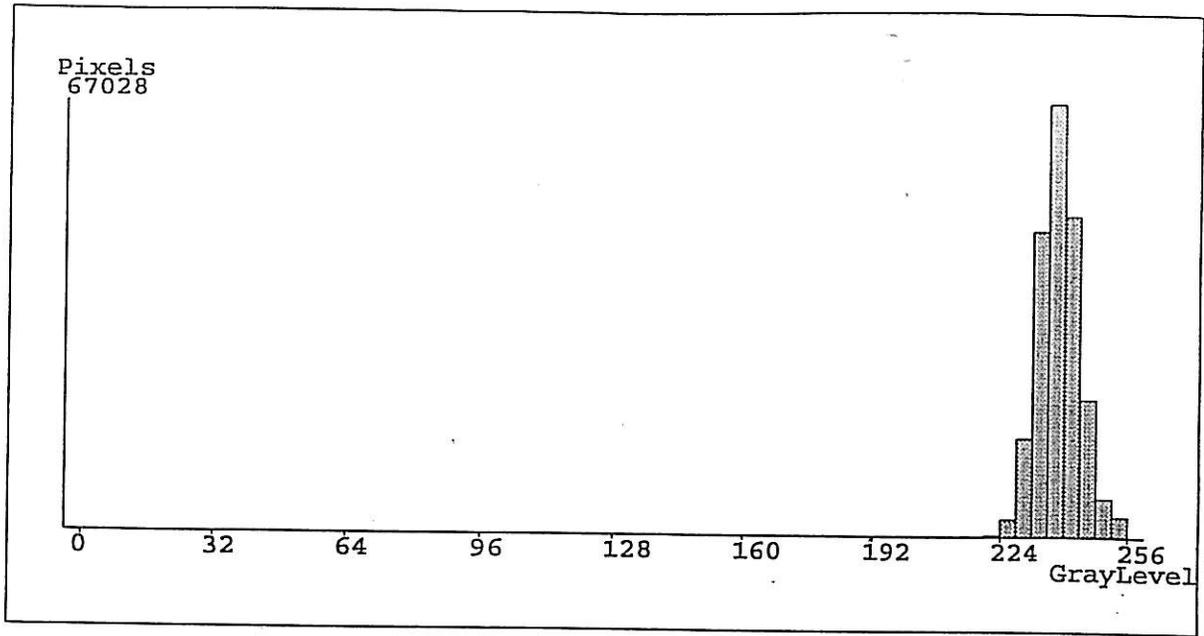
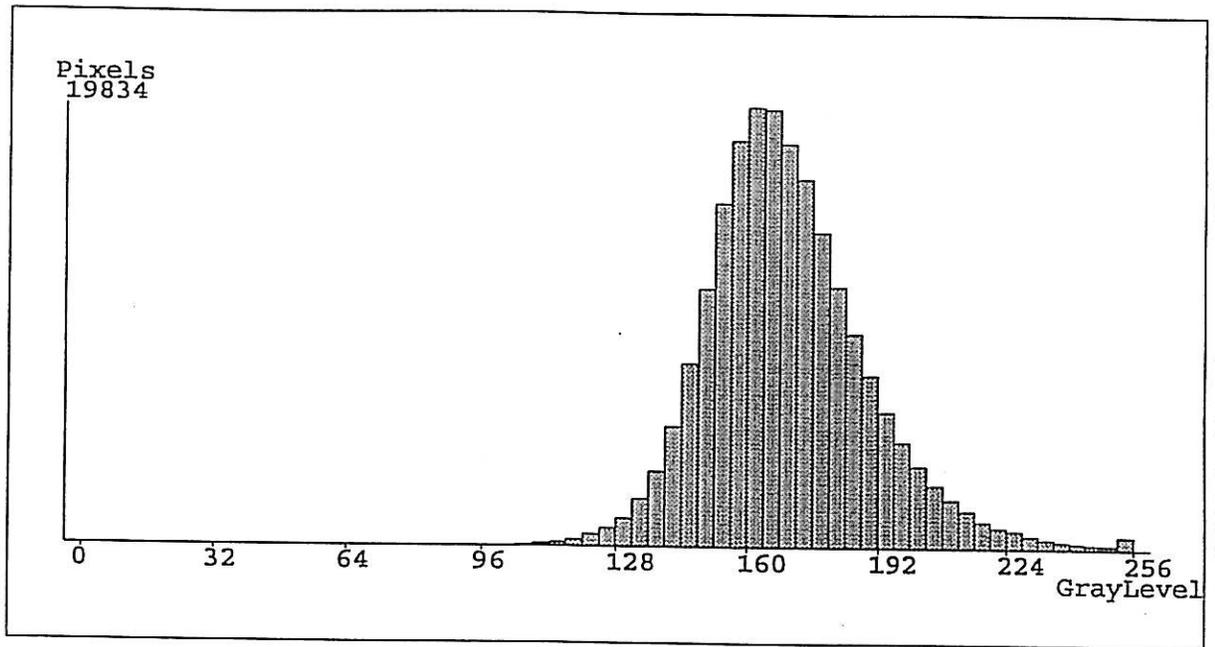
Figure 1. RLIA histograms for replicas of a marble surface blasted with glass beads, made of (a) white silicone rubber and (b) red silicone rubber

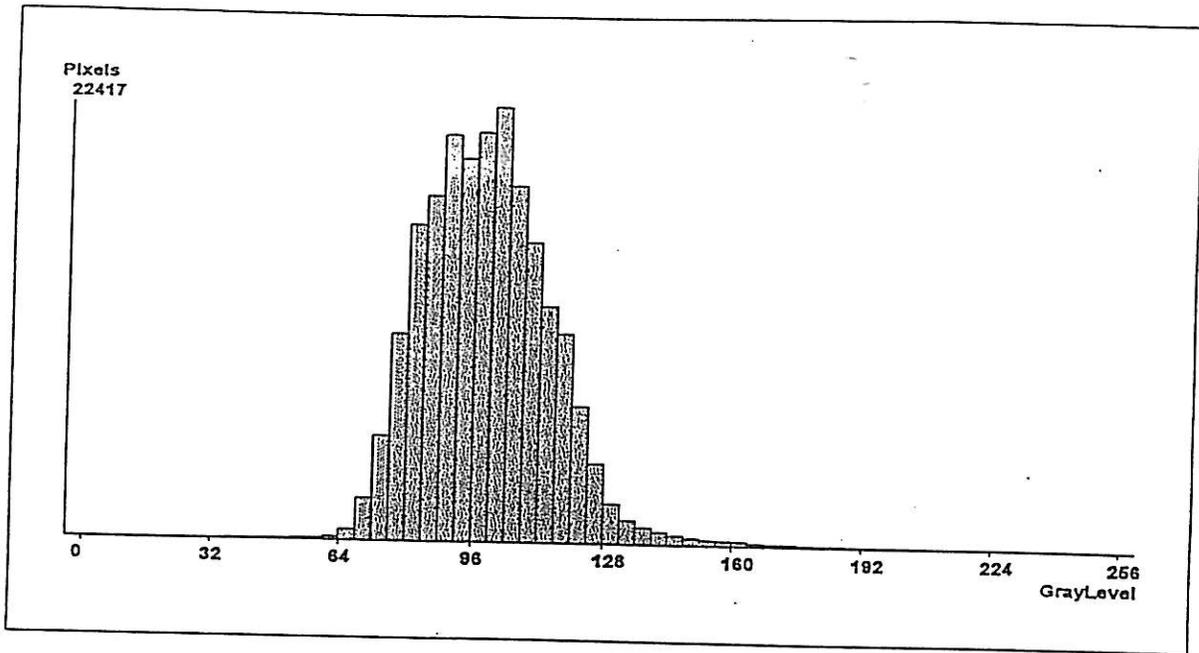
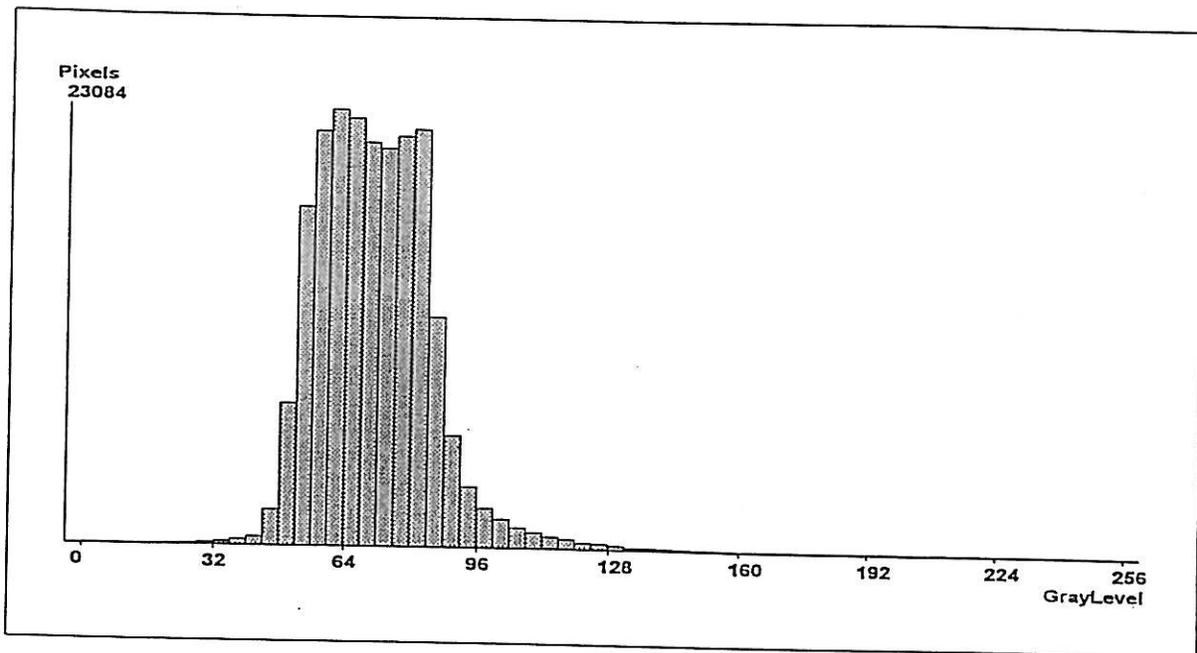
Figure 2. RLIA histograms for red silicone rubber replicas of a polished marble surface measured at different light intensities: (a) higher and (b) lower

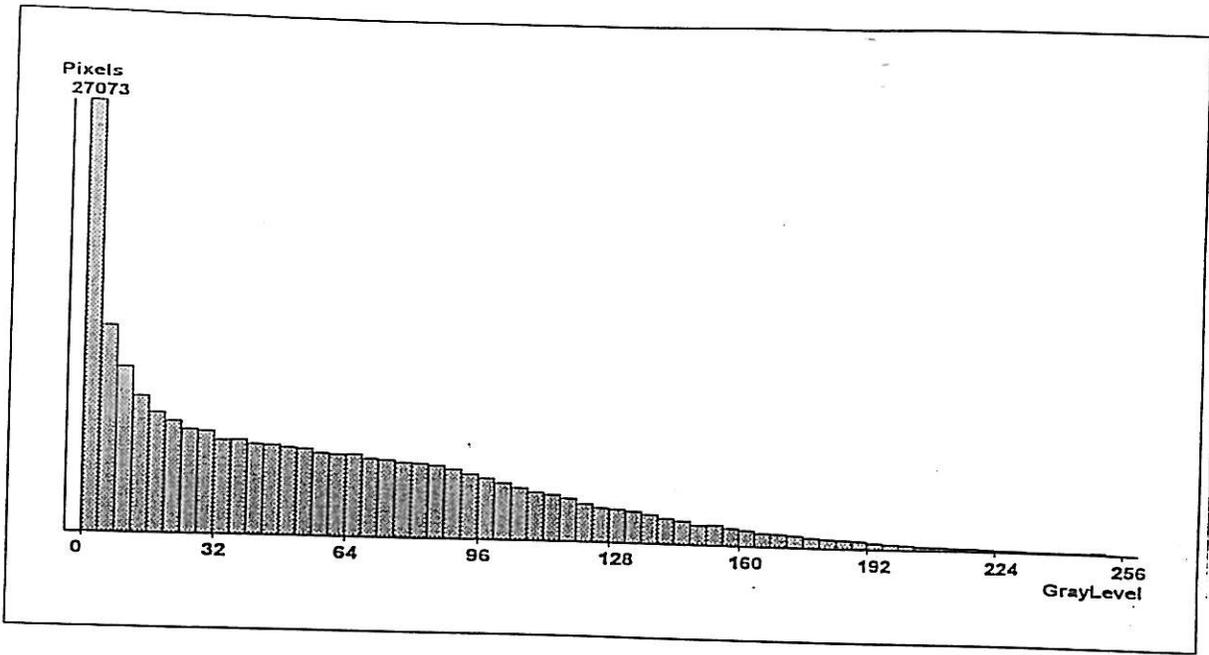
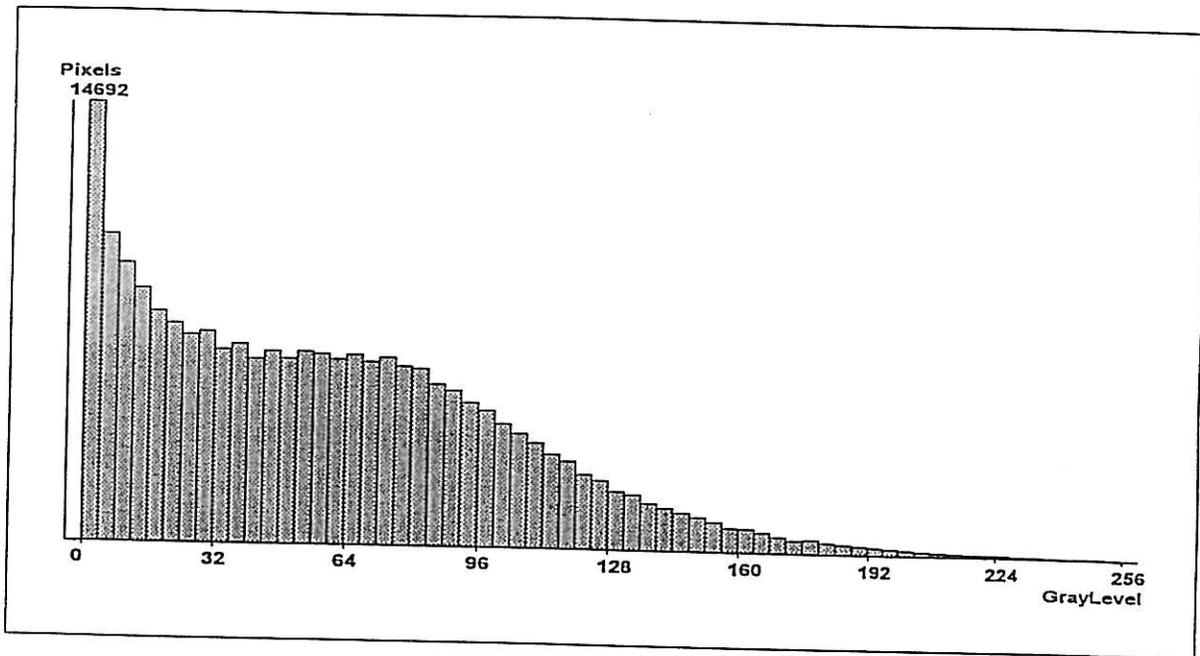
Figure 3. RLIA histograms for red silicone rubber replicas of limestone blasted with alumina powder measured at slightly different tilts

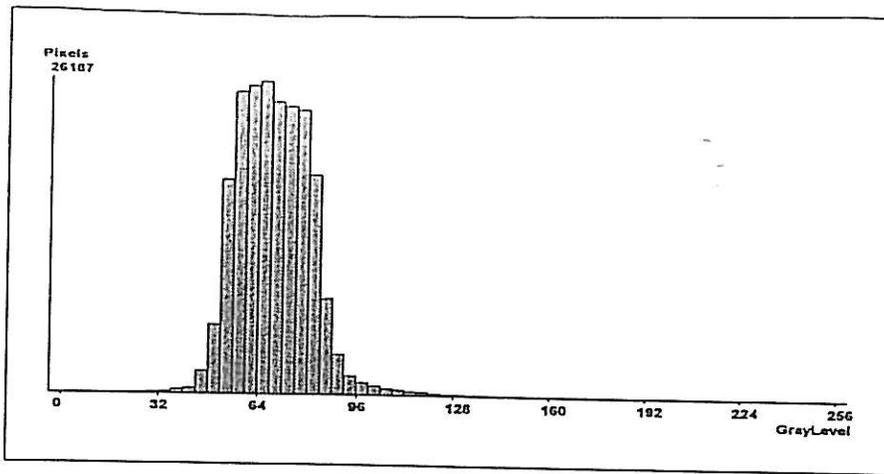
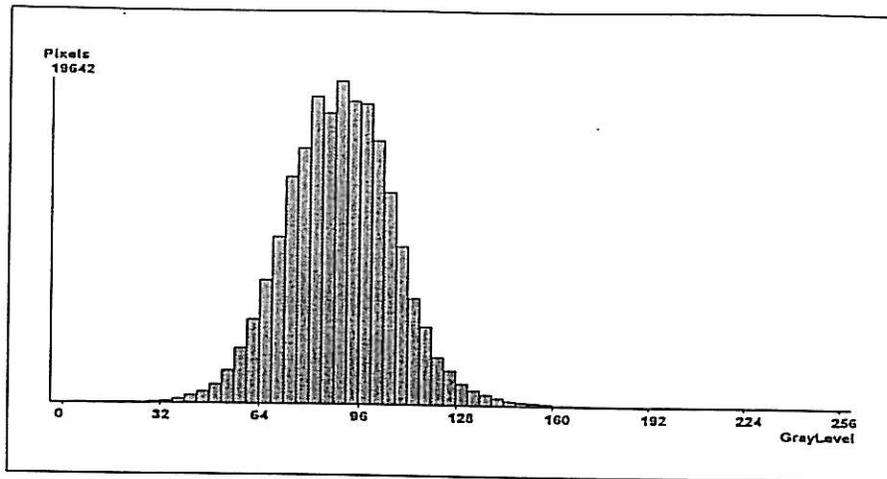
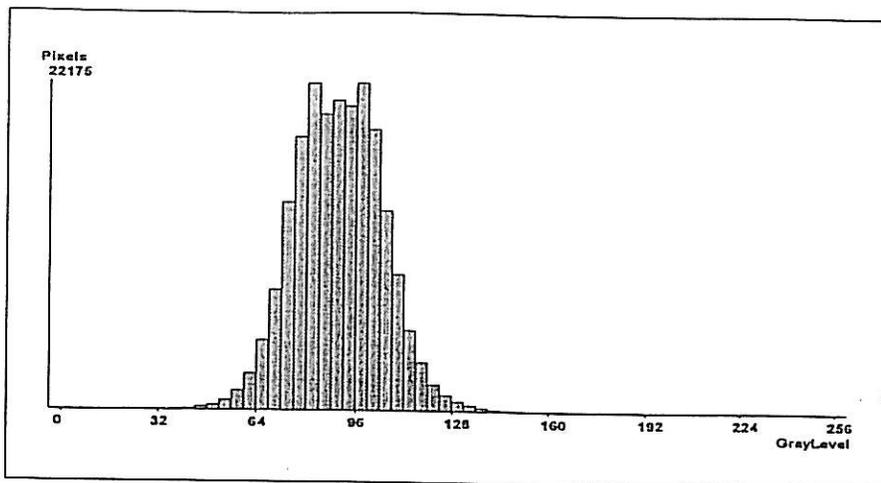
Figure 4. RLIA histograms for red silicone rubber replicas of polished marble: (a) control, (b) glass bead-blasted area, and (c) alumina powder-blasted area

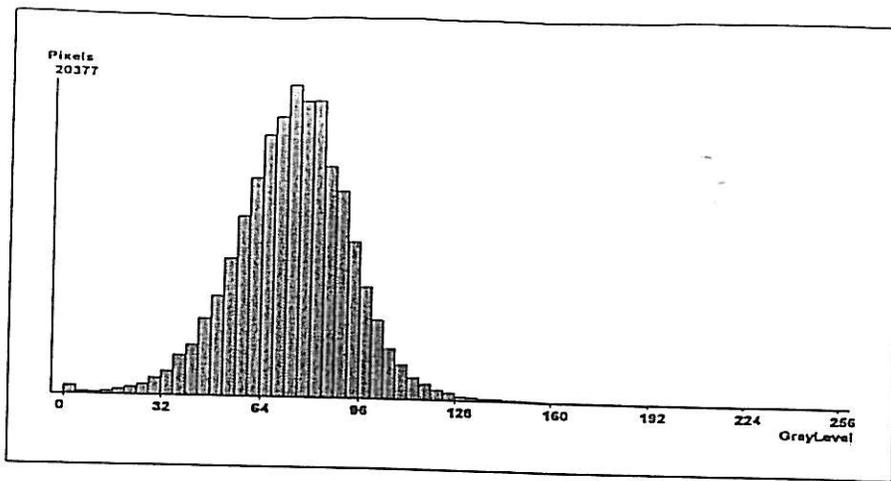
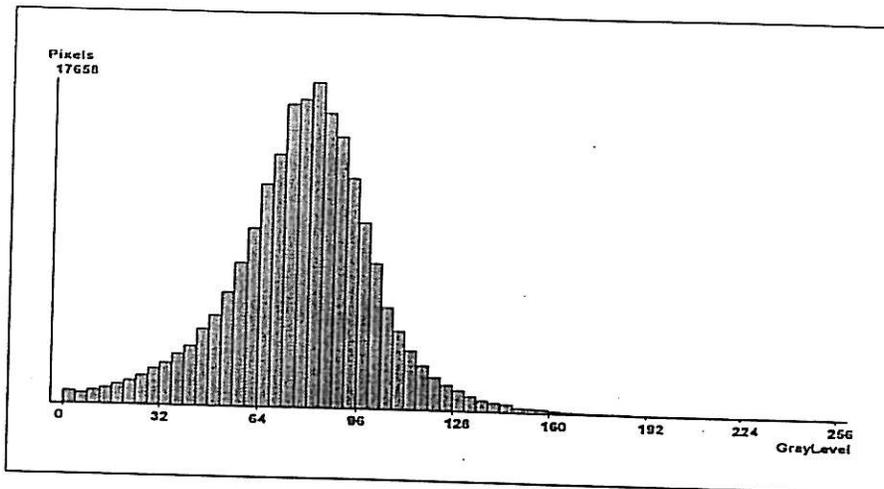
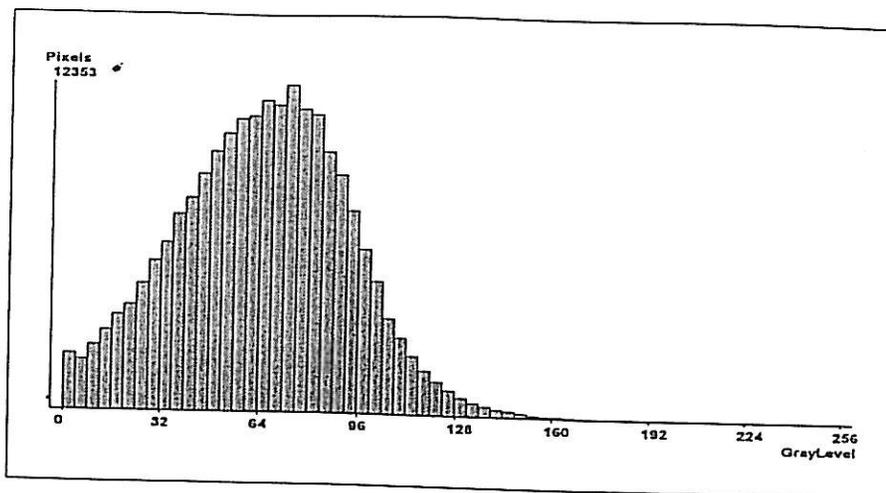
Figure 5. RLIA histograms for red silicone rubber replicas of a brick paver: (a) control, (b) glass bead-blasted area, and (c) alumina powder-blasted area. Note that the y axes are not on the same scale.

Figure 5. RLIA histograms for red silicone rubber replicas of a brick paver: (a) control, (b) glass bead-blasted area, and (c) alumina powder-blasted area

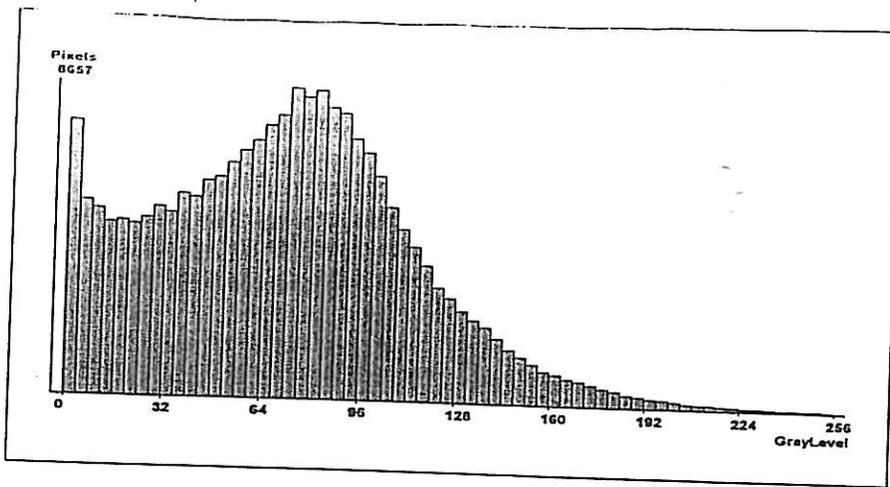
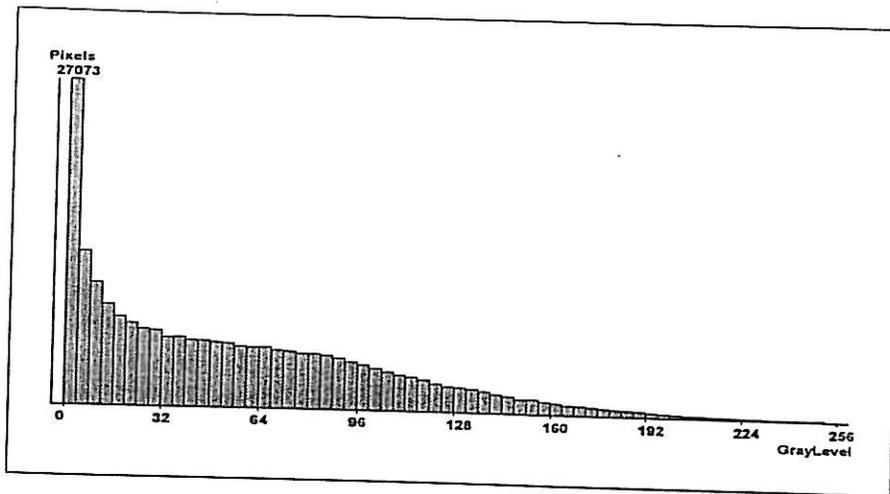
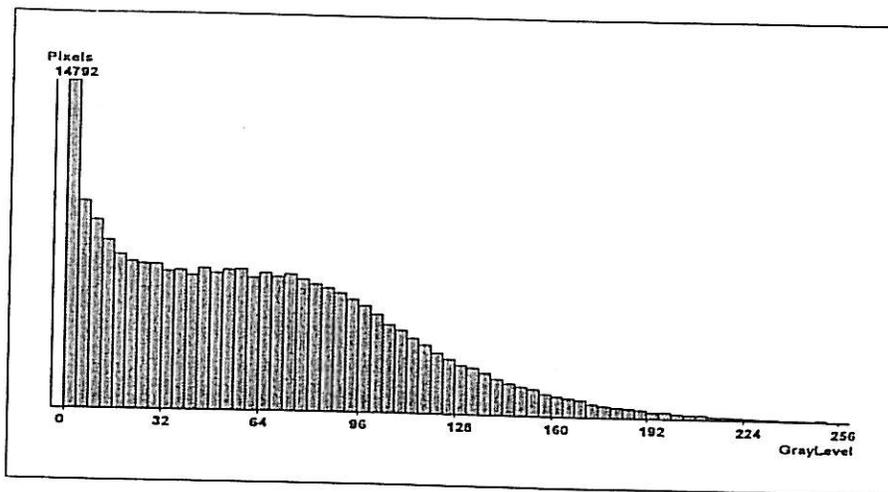
Figure 6. RLIA histograms for red silicone rubber replicas of sawn limestone: (a) control, (b) glass bead-blasted area, and (c) alumina powder-blasted area. Note that the y axes are not on the same scale.

Figure 6. RLIA histograms for red silicone rubber replicas of
sawn limestone: (a) control, (b) glass bead-blasted area,
and (c) alumina powder-blasted area

Limestone: the RLIA histograms for the selected limestone samples show both the problems and information possibilities of this technique. A smooth-sawn limestone surface shows a bell-shaped histogram, which as the surface roughens, broadens and flattens (Figure 4a). With increasing roughness, a spike at the black end of the spectrum makes its appearance.

The silicone replicas of the Phase I limestone samples abraded with glass beads and alumina, show a flatter curve with a larger spike at the black end compared with samples from Phase II blasted with glass beads or high pressure water. Part of the problem may be attributed to the inadequate levelling of the replica surface during the measurements, but the rest may well reflect differences in texture due to unevenness in abrasion. It is possible that the stylus profilometer measures the same roughness on two samples which have different texture, i.e., fewer but deeper pits. If the pits are too deep, the stylus profilometer "skids" over the sample and does not measure it, but RLIA will "see" a large increment in shadows. For example, the limestone sample blasted with walnut shells at high pressure also shows a large spike at the black end of the histogram, however, roughness evaluated by touch or measured with the profilometer, does not "see" these.

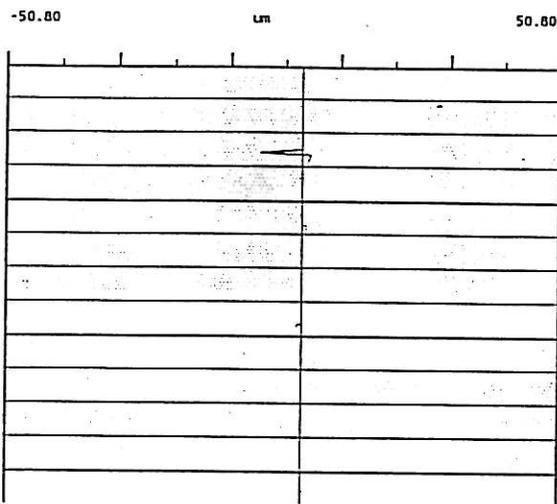
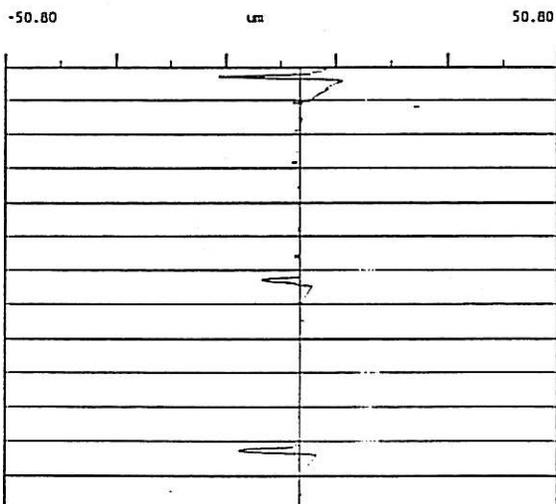
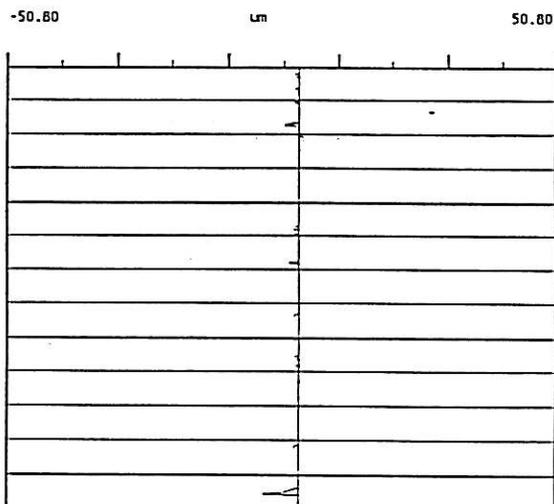
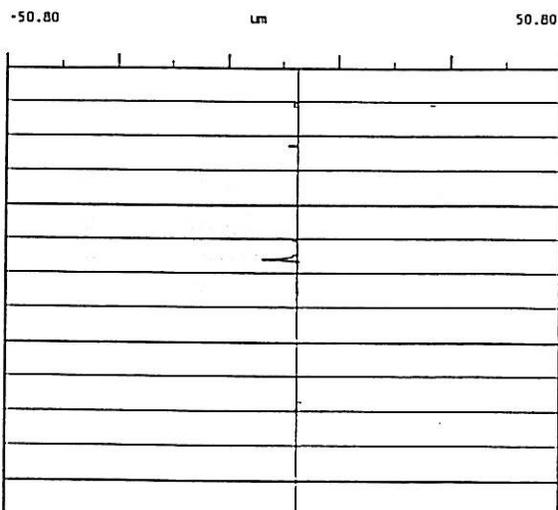
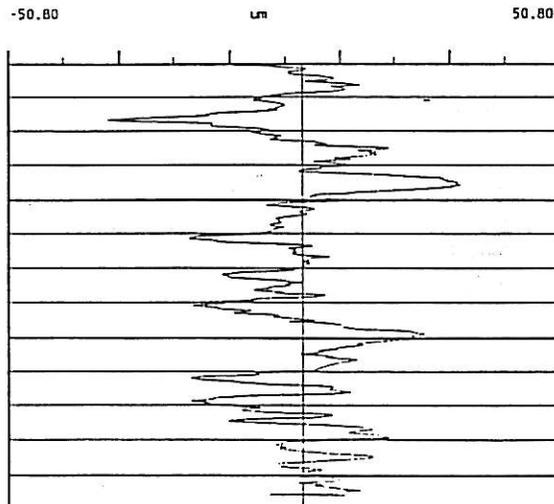
Polished Granite - Roughness profiles for control and areas blasted at high pressures (100 psi for powdered materials, 2000 psi for water).
Vv x 1000 Vh x 20

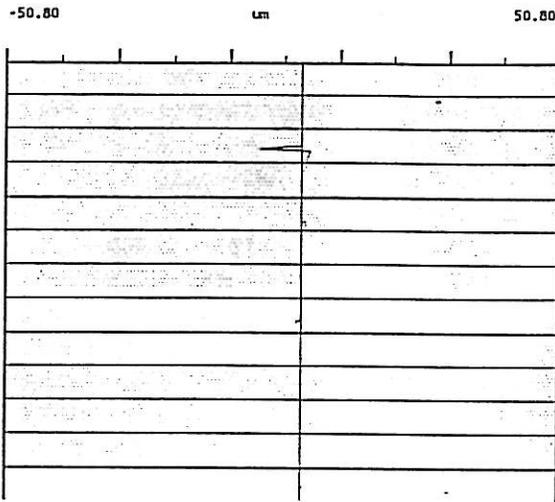
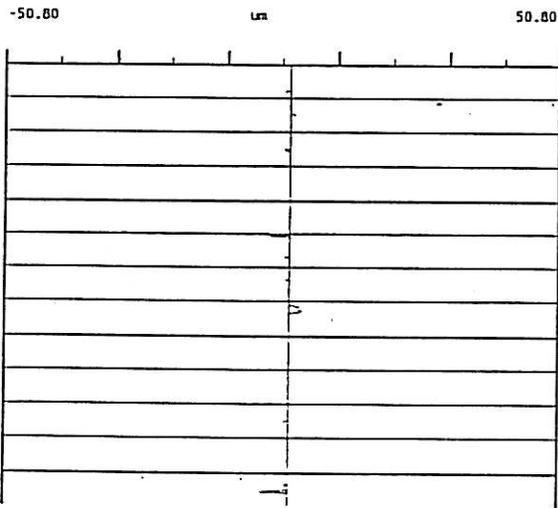
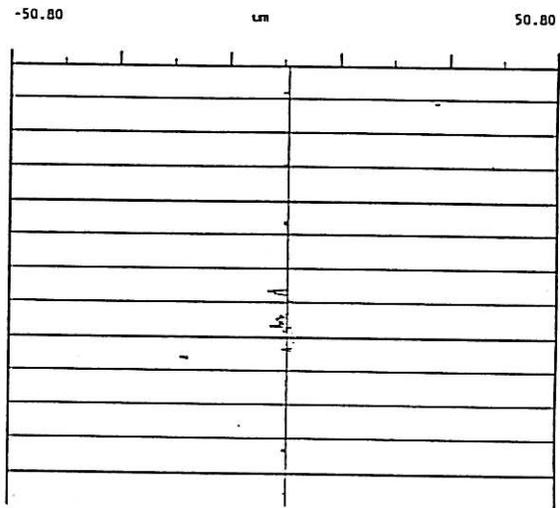
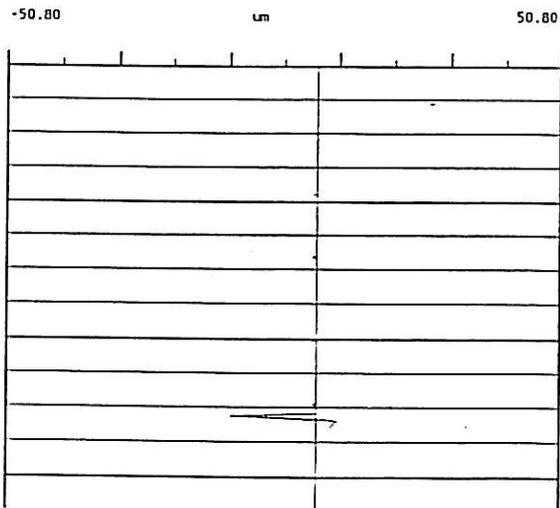
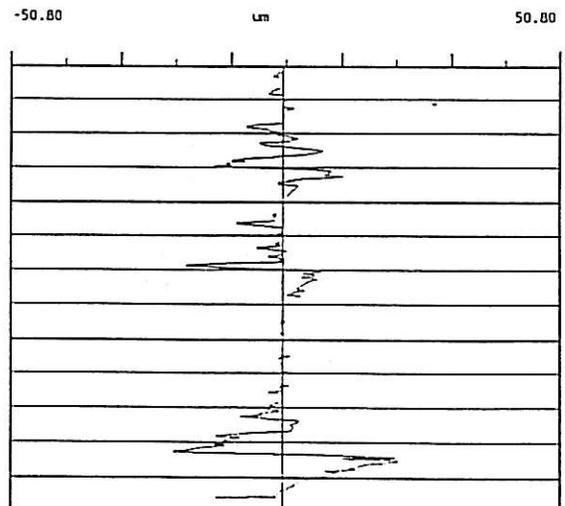
Polished Granite - Roughness profiles for control and areas blasted at low pressures (50 psi for powdered materials, 1000 psi for water).
Vv x 1000 Vh x 20

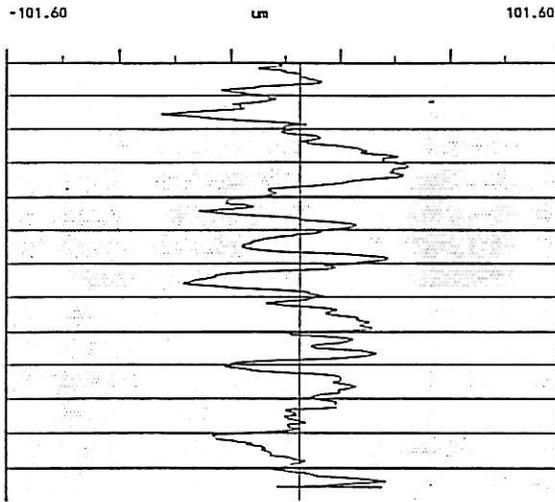
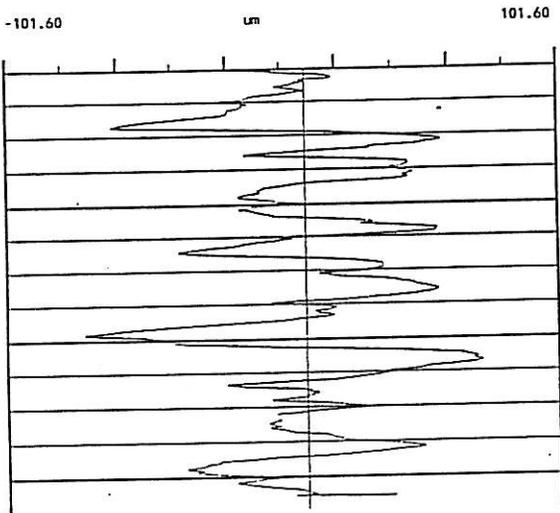
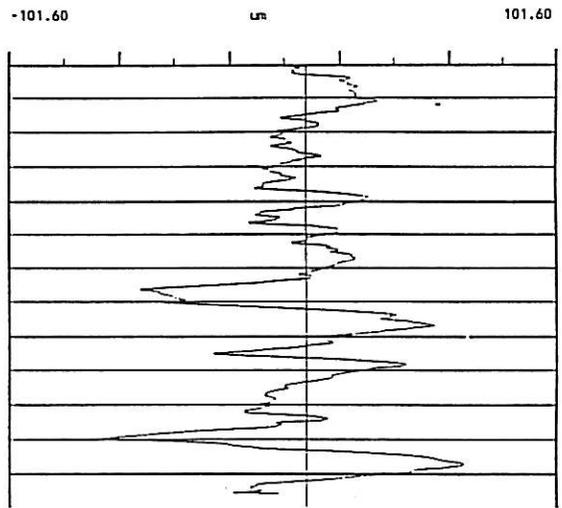
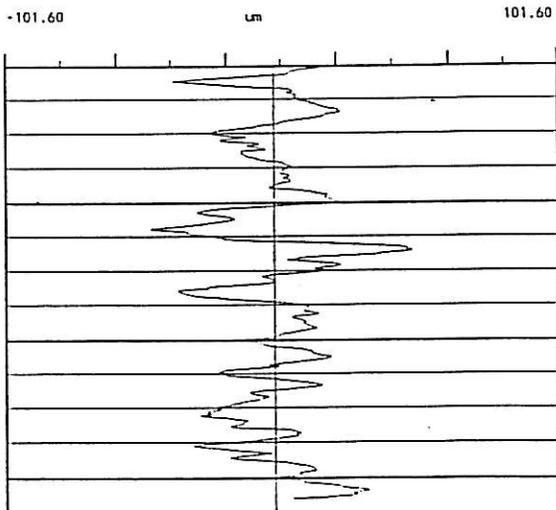
Sawn Limestone - Roughness profiles for control and areas blasted at high pressures (100 psi for powdered materials, 2000 psi for water).
Vv x 500 Vh x 20

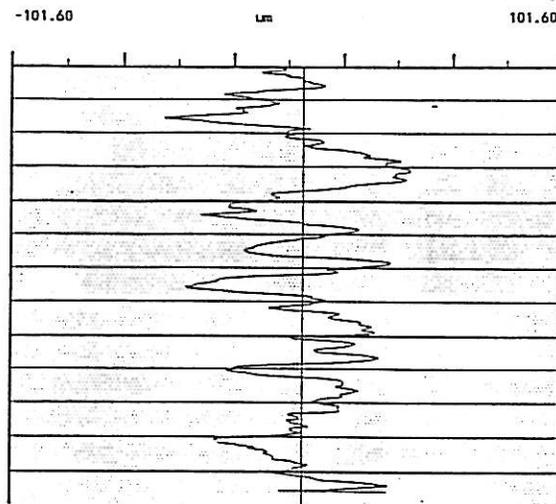
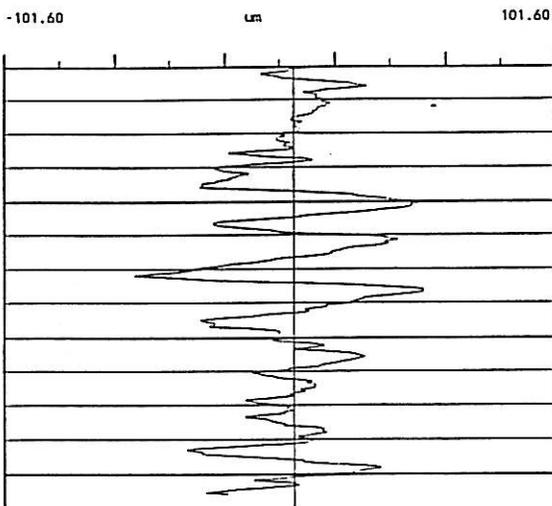
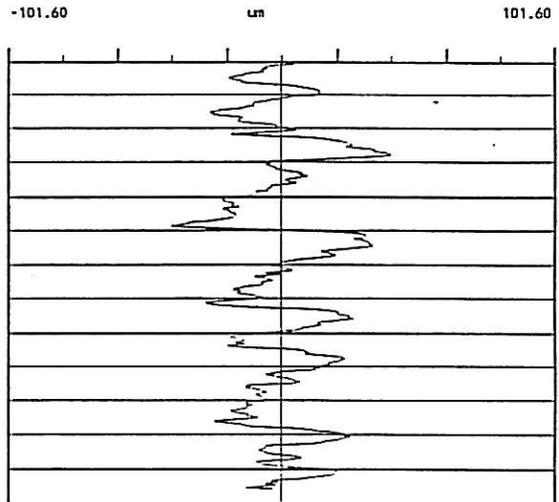
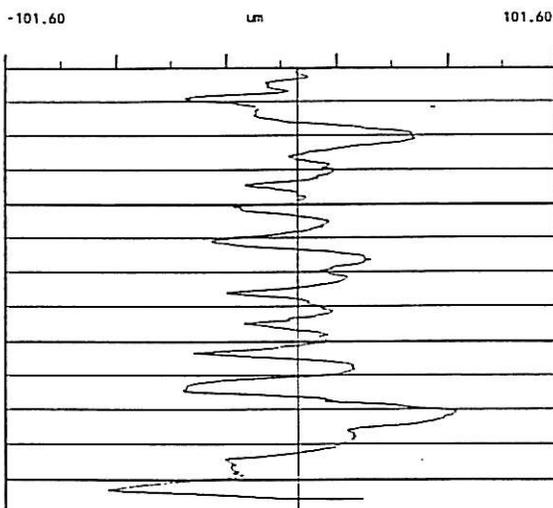
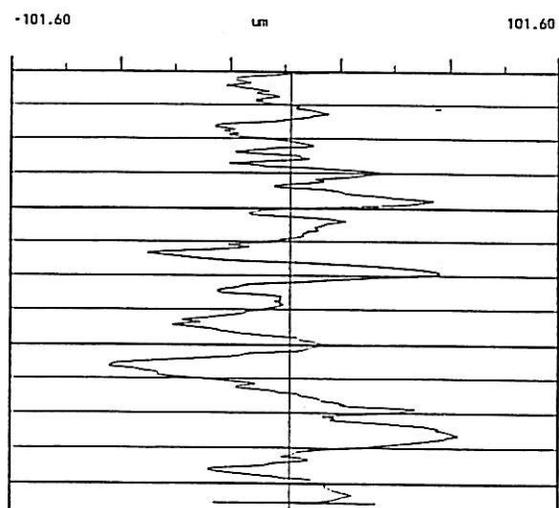
Sawn Limestone - Roughness profiles for control and areas blasted at low pressures (50 psi for powdered materials, 1000 psi for water).
Vv x 500 Vh x 20

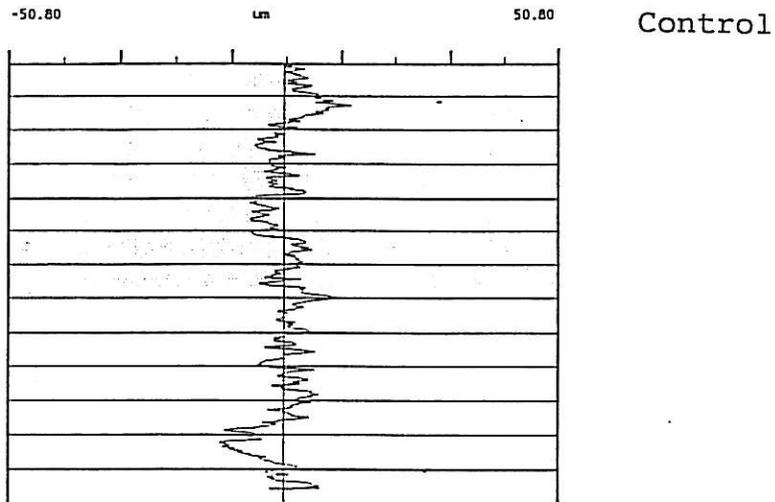
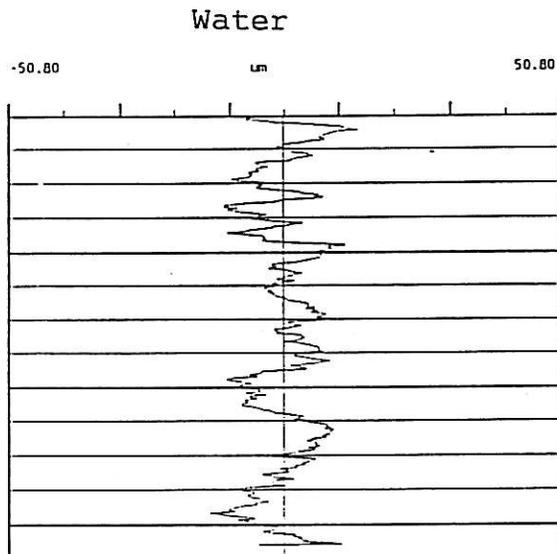
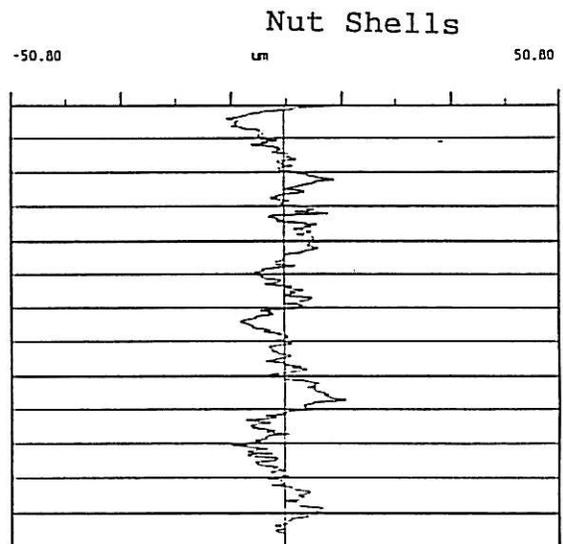
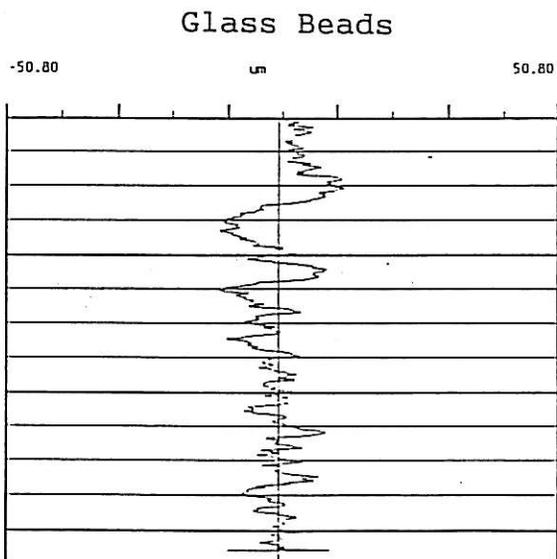
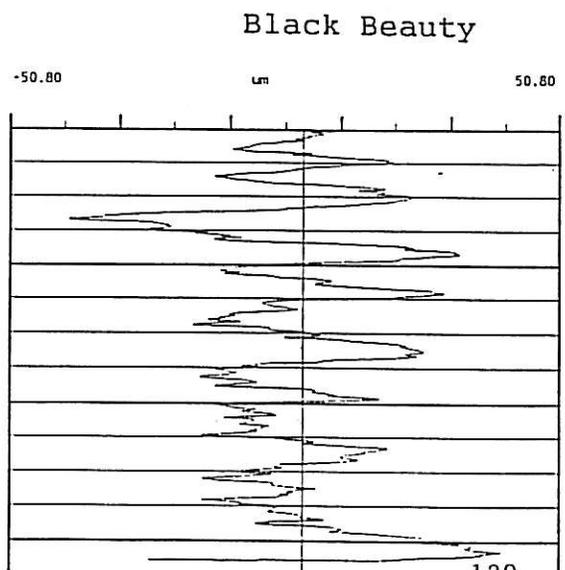
Quarry Tile - Roughness profiles for control and areas blasted at high pressures (100 psi for powdered materials, 2000 psi for water).
Vv x 1000 Vh x 20

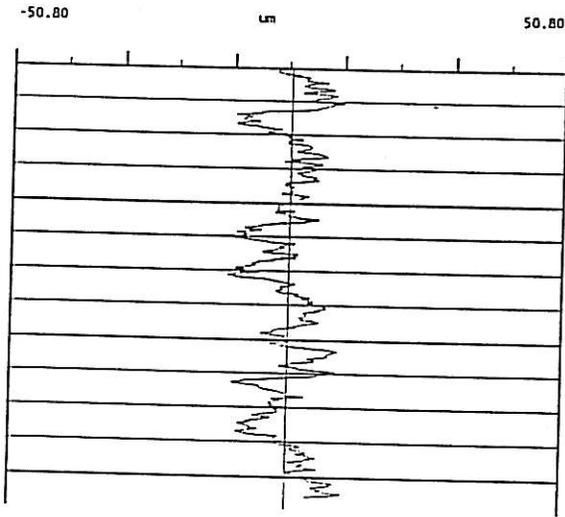
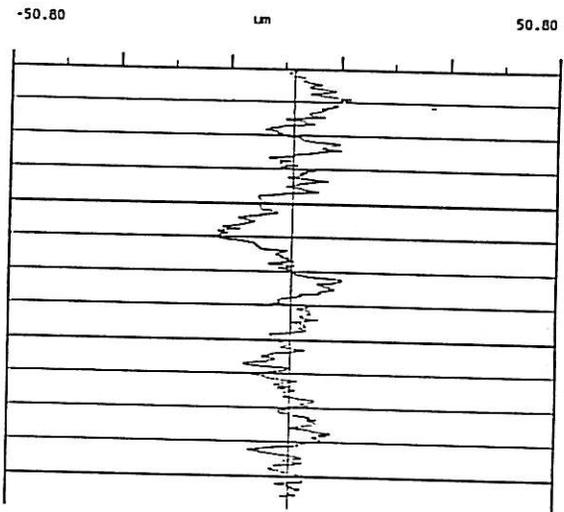
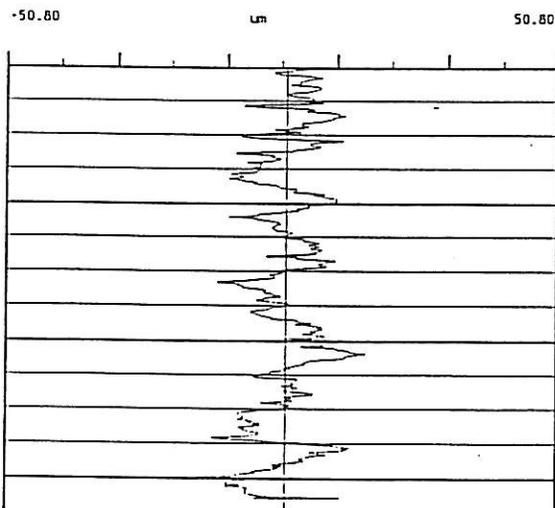
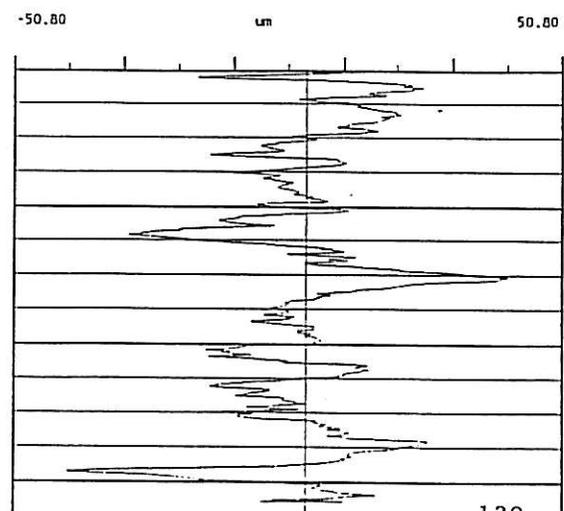
Quarry Tile - Roughness profiles for control and areas blasted at low pressures (50 psi for powdered materials, 1000 psi for water).
Vv x 1000 Vh x 20
