Guide for Replacement Bricks in Restoration of Masonry in Historic Buildings

Denis Brosnan, Ph.D., P.E.*

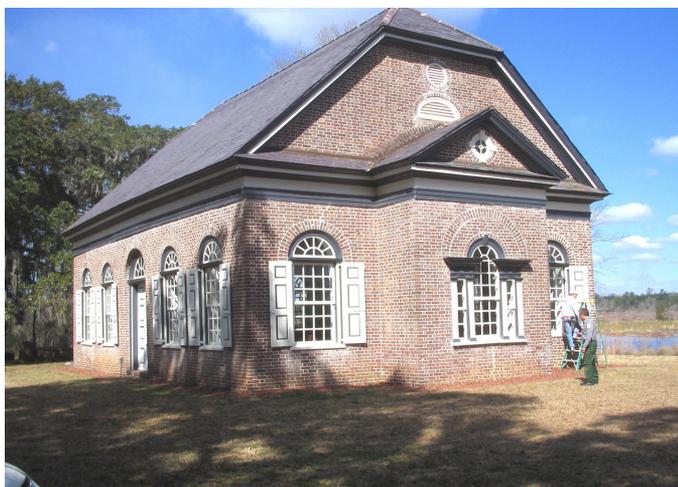
2010 Restoration of Pompion Hill Chapel, Upper Santee, SC
(Structure Erected 1763)

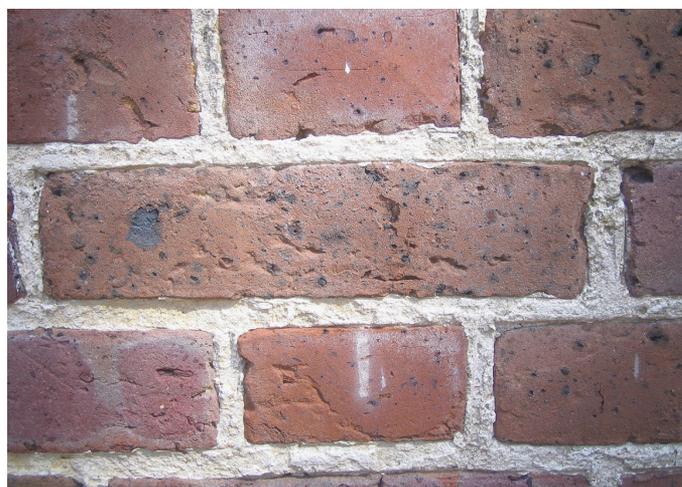
Detail of Handmade Bricks, Pompion Hill Chapel after Pointing

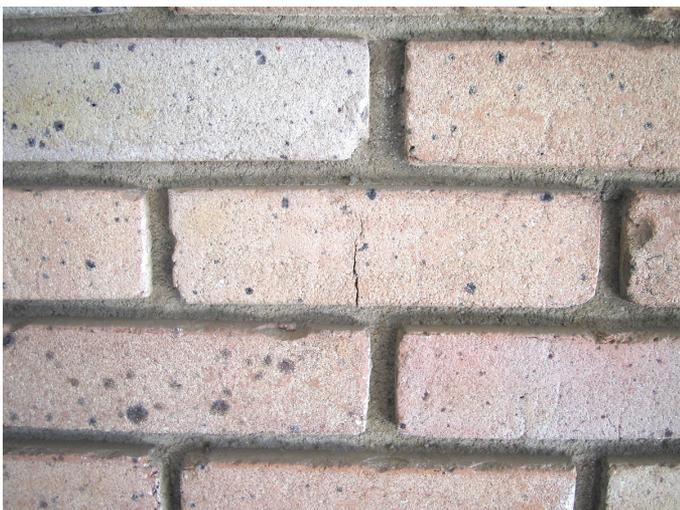
Machine Molded Bricks with Raked Mortar Joint
(Clemson House, Clemson University, 1950)

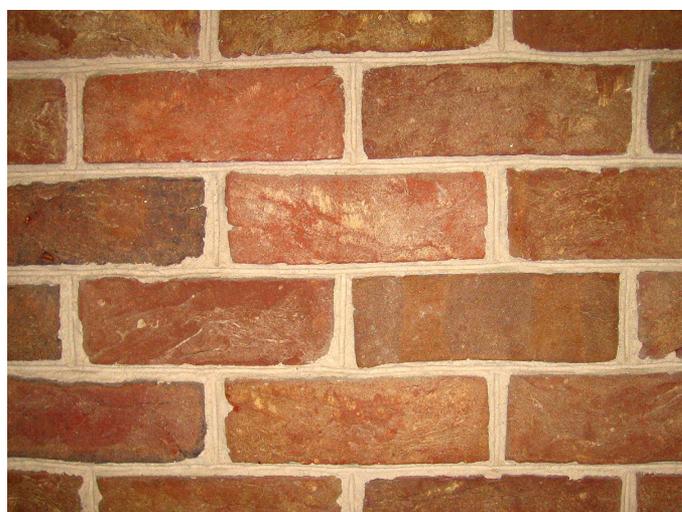
Modern Handmade Bricks

Characteristics of Historic Bricks by Forming Method			
Manufacturing Method	Dimensional Precision	Usual Characteristics	Comment
Hand Molded	Low	Folds of clay visible on surface, rounded corners. May be sand coated (sand struck) or smooth (water struck).	Most brick made in North America prior to about 1850. Still available from some manufacturers.
Machine Molded	Low	Rounded corners, possible non-prismatic shape, frogged (depression in) face possibly with a brand marking, other face with typical look of “smeared clay.” May be sand coated (sand struck) or smooth (water struck).	Introduced in North America with advents of steam power and later electricity. Still produced in locations like the North Eastern United States.
Pressed	Very High	Uniform in shape and physical dimensions.	The peak production of pressed bricks was in the early 1900’s. Currently available from only a limited number of manufacturers. Contact the Brick Industry Association for availability.

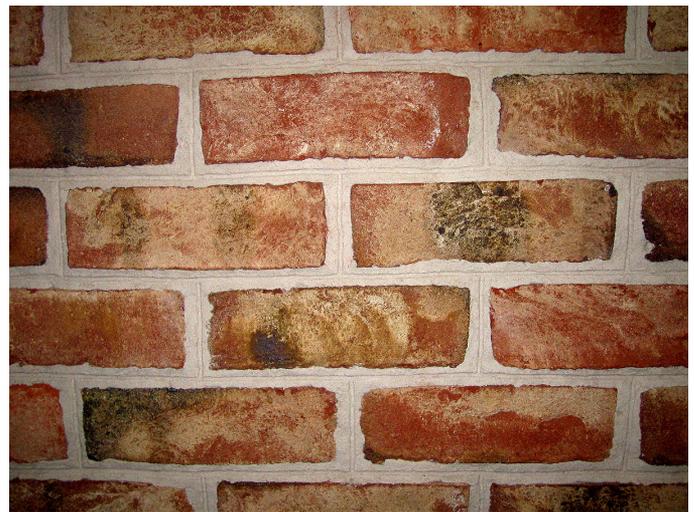
Modern Machine Molded Bricks or “Woodmold Bricks”

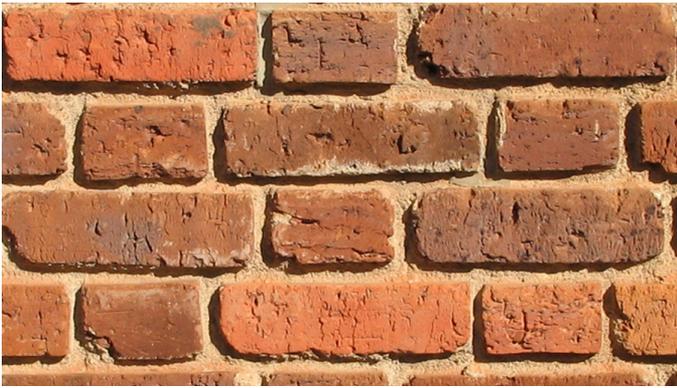
**Extruded Bricks Before Advent of Vacuum Extrusion
(Riggs Hall, Clemson University, 1920)**

End Extruded	Medium	May contain striations/scratches along faces parallel to the long dimension of the brick.	Production ceased prior to about 1960.
Extruded	Medium to High	Can exhibit no coring/perforations or can typically exhibit 3 or 10 holes on a bedding face. Can exhibit coatings or engobes to create color and texture. Some brick may be “tumbled” to round corners.	Introduced in North America with advents of steam power and later electricity. Improvements in density (and reduction in absorptions) were attained through vacuum extrusion (after about 1950). Stiff extrusion is employed in the USA and Canada (while soft extrusion may be used in other parts of the world).

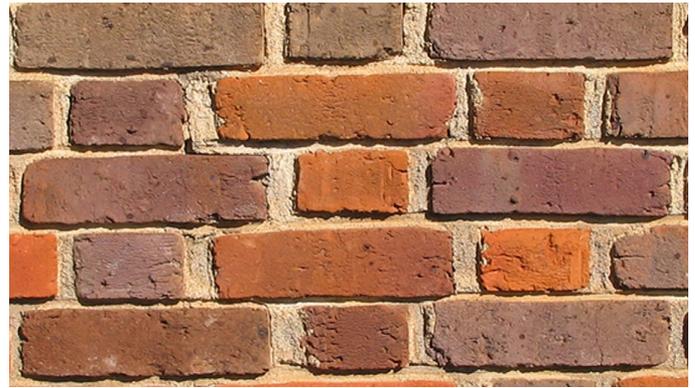
**Extruded Bricks Made with Vacuum Extrusion
(Sirriner Hall, Clemson University, 1930)**

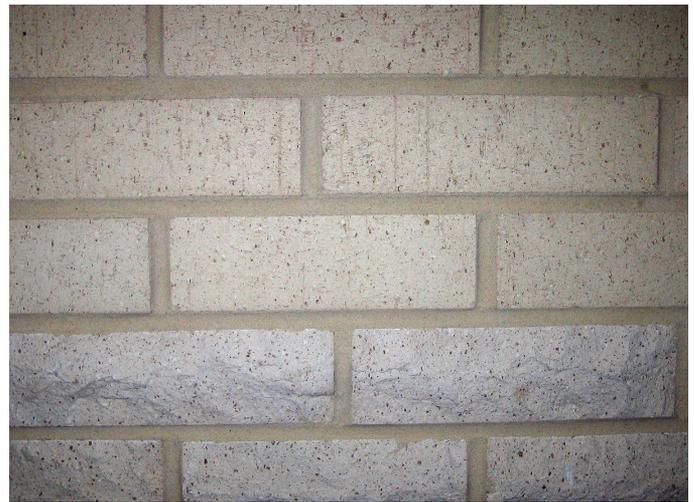
Extruded Bricks with Rockface (lower)

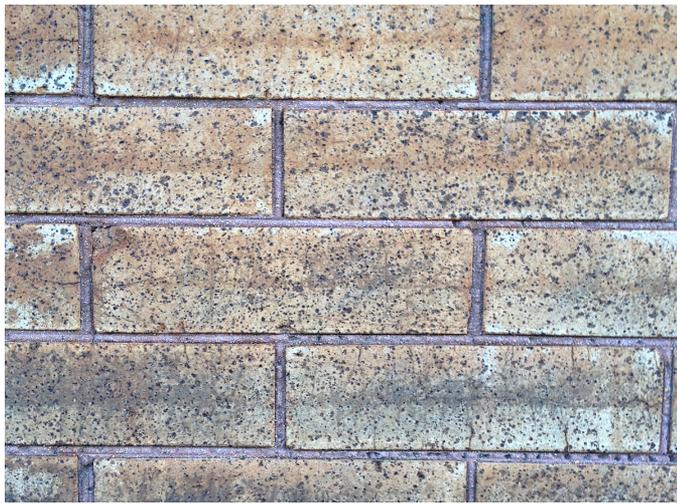
Dry Pressed Facing Bricks with “Thinline” Mortar Joints

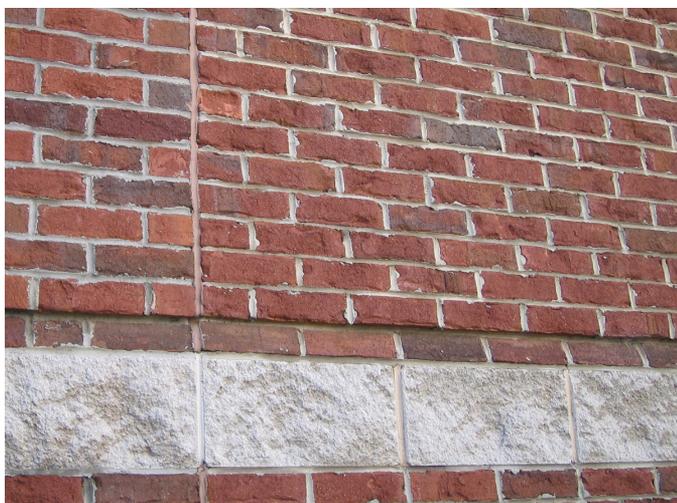
Modern Extruded Bricks Produced to Resemble Woodmold Bricks (Dormitory, Clemson University, about 2000)
