# Narrative Final Report (Attachment E Part 3) NCPTT 2016 Grants

## **Navajo Nation ‘Train-the-Trainers’ Traditional Hogan Retrofits and Manual Development**

**Prepared for: National Park Service - National Center for  
Preservation Technology and Training**

**Prepared by: iCATIS, with support of The Forgotten People,  
Purpose Focused**

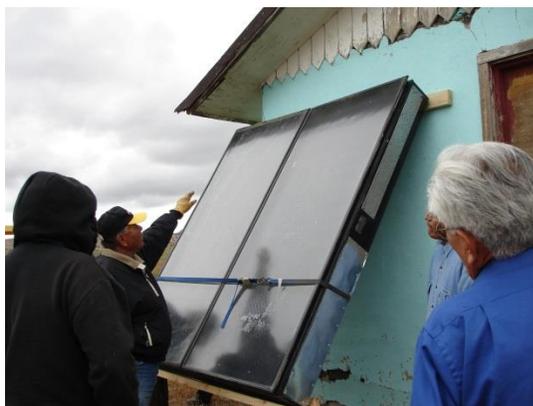
**Figure 1: Navajo Nation Solar Thermal Collector Installation Workshop**

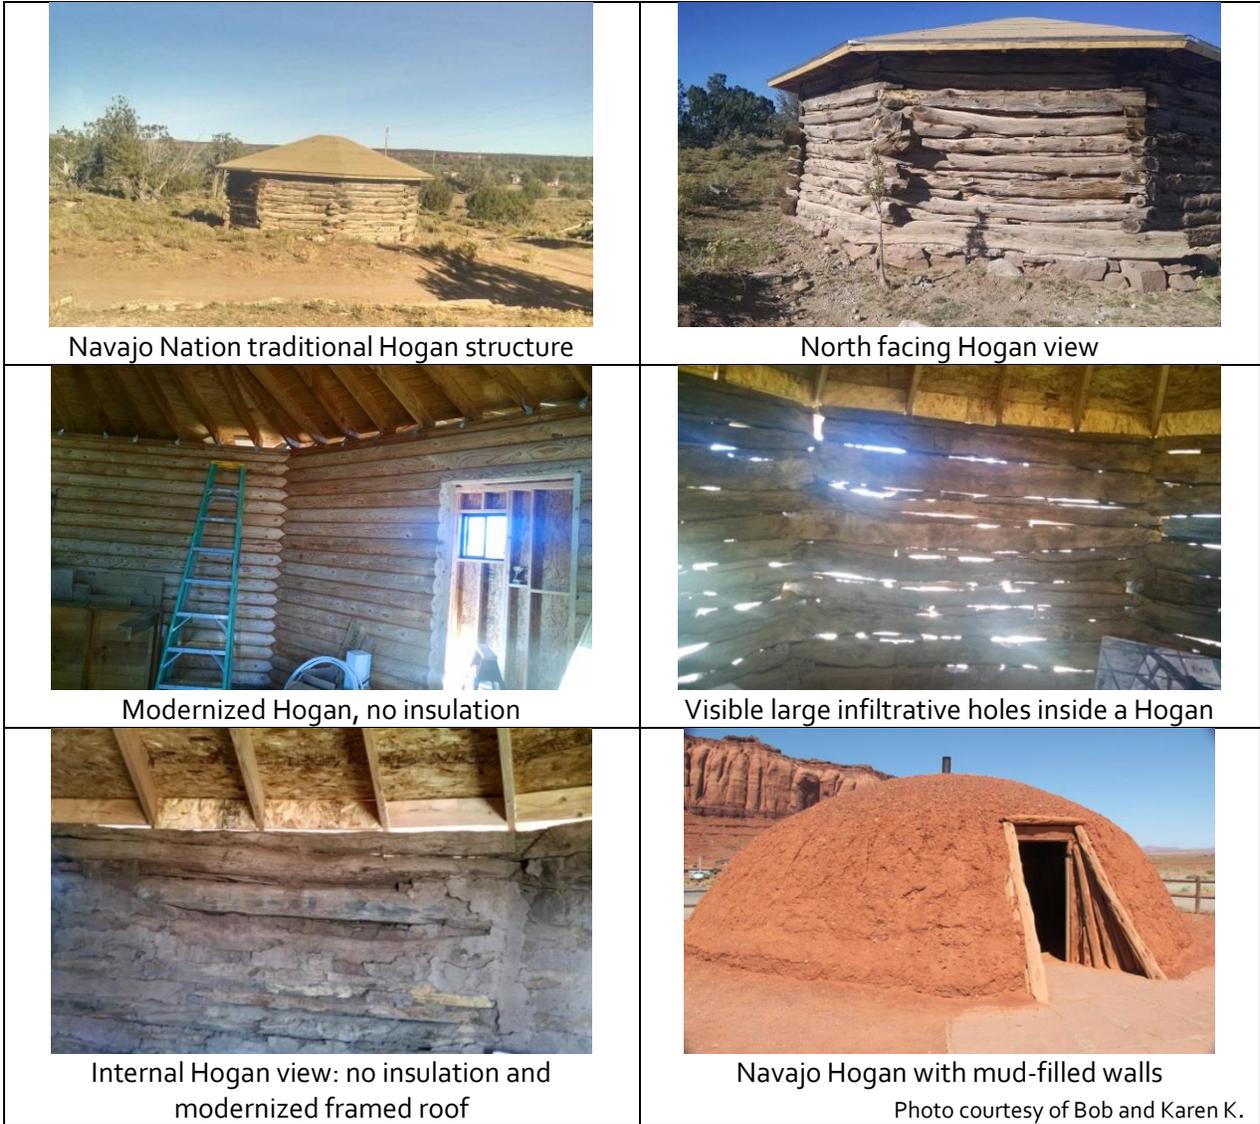
Included in the IHSCD's sustainable vision is preservation of existing, traditional Hogan structures, but retrofitting them to be energy efficient, safe living spaces (Figure 2). Hogans often have high infiltrative heat losses (Figure 2, middle right), inadequate stove ventilation, and lack a sustainable way to heat their homes.

**Figure 2: Different Views of Navajo Nation Traditional Hogan Living Structures**

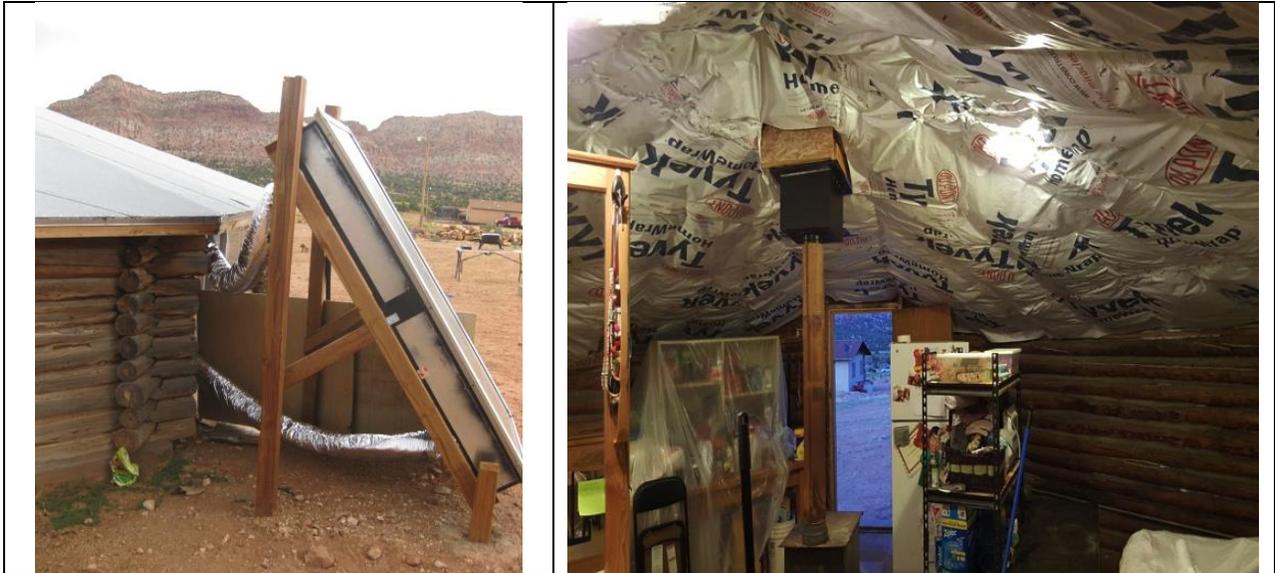
Hogan 1 was located at a family residence. Tremendous infiltration occurred both through the exterior and interior building envelope, and most noticeably where the heating stove chimney pipe exited through the Hogan roof. Daylight was visible through multiple locations within the Hogan.

**Figure 4: Hogan 1 Solar Thermal Collector (Left) and Stove Chimney Exhaust, Insulation, Tyvek Weatherization (Right)**

To remedy, our team began by spraying expandable liquid foam insulation into envelope holes, noted during the initial energy audit. This included holes from cable line access and where the roof rafters met the vertical walls. Next, our team caulked the spacing between all logs used to make up the vertical walls, both on the interior and exterior. Next, we caulked and sealed all windows and door. Following, we installed ceiling insulation and overlaid the insulation with Tyvek building wrap as an additional infiltrative barrier. Homeowners plan to add stucco or drywall to preserve the internal historic integrity of the Hogan. To remedy the excessive infiltrative losses surrounding where the stove pipe exited the Hogan, new stove chimney pipe was installed, including triple wall insulated stove pipe and interior and exterior flashing (Figure 4). Lastly, the stove chimney continued over three feet above the highest nearby roof surface and a spark arrestor was installed. As a final measure, a solar thermal collector was installed to provide a supplemental heat source (Figure 4).

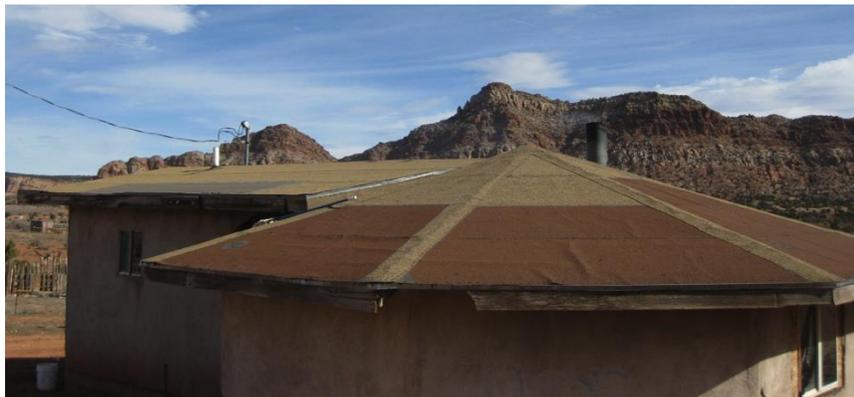
Hogan 2 was located at a family residence (Figure 5). Similar to Hogan 1, tremendous infiltration occurred both through the exterior and interior building envelope. Hogan 2 also had large missing interior walls and large cracks and broken windows. Daylight was visible through multiple locations within the Hogan.

**Figure 5: Hogan 2 – Family Residence**

Our team began with spraying expandable liquid foam insulation to locations noted during the initial energy audit, including spraying foam insulation into envelope holes, cracks in the plaster, and along where the roof rafters met the vertical walls. We also noted significant

infiltration surrounding the window frame and consequently, sprayed liquid foam insulation there as well. We also added clear plastic infiltration barriers to any window with cracks. Next, our team caulked along all windows and doors, along gaps where the vertical walls met the

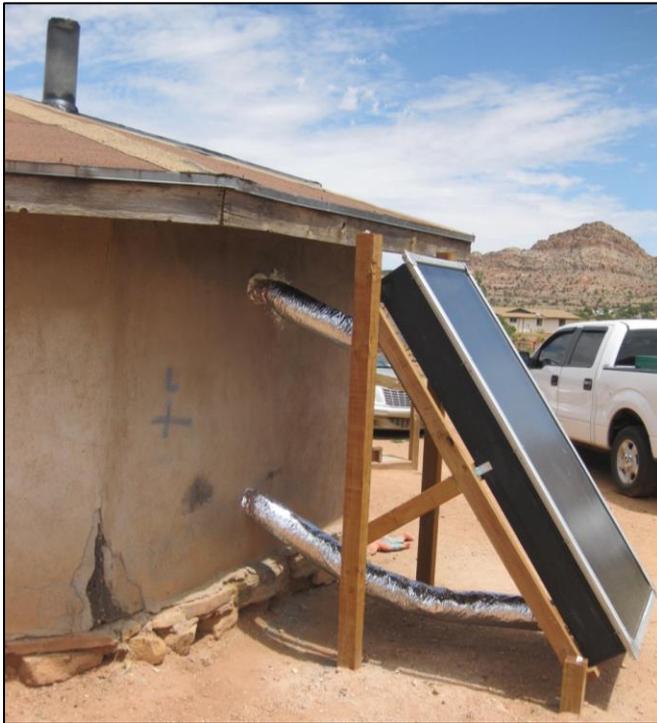
**Figure 6: Hogan 2 Solar Thermal Collector**

roof rafters and along any other noticeable joints, both on the interior and exterior. Following, we installed plywood and framing over the large hole of the original door frame and on multiple large holes near the main entrance. As a final measure, a solar thermal collector was installed to provide a supplemental heat source (Figure 6).

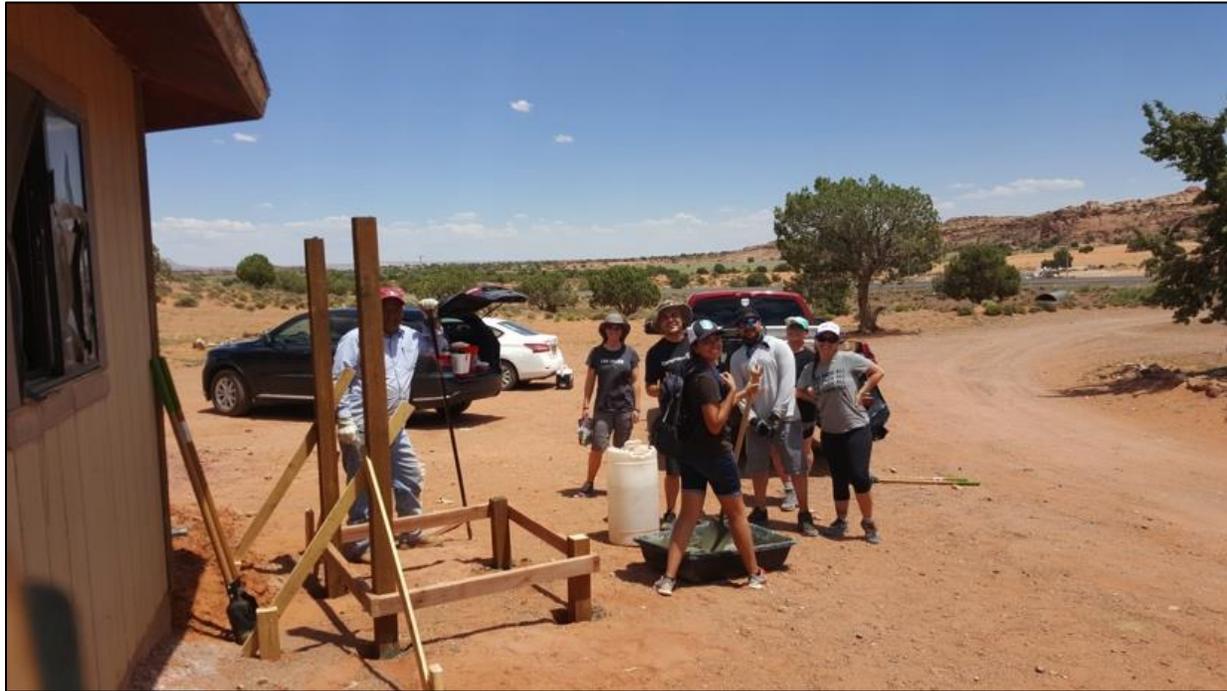
Hogan 3 was located at a family residence. Tremendous infiltration occurred where the heating stove chimney pipe penetrated through the Hogan roof. Additional infiltration was noted in some exterior and interior locations along the building envelope and where roof rafters met the vertical wall, where daylight was visible. Hogan 3 also had cracked and broken windows.

**Figure 7: Amizade Team During Installation of Solar Collector Frame at Hogan 3**

Weatherization improvements began with using spray expandable liquid foam insulation along exterior roof rafters, along with caulking interior and exterior cracks as well as surrounding windows and doors. We also added clear plastic infiltration barriers to any window with cracks. Like Hogan 1, to remedy the excessive infiltrative losses surrounding where the stove pipe exited the Hogan, new stove chimney pipe was installed, including triple wall insulated stove pipe and interior and exterior flashing. Lastly, the stove chimney continued over three feet above the highest nearby roof surface and a spark arrestor was installed. As a final measure, a

solar thermal collector was installed to provide a supplemental heat source. Figure 7 shows the Amizade volunteer support team during the installation of the solar collector wooden frame.

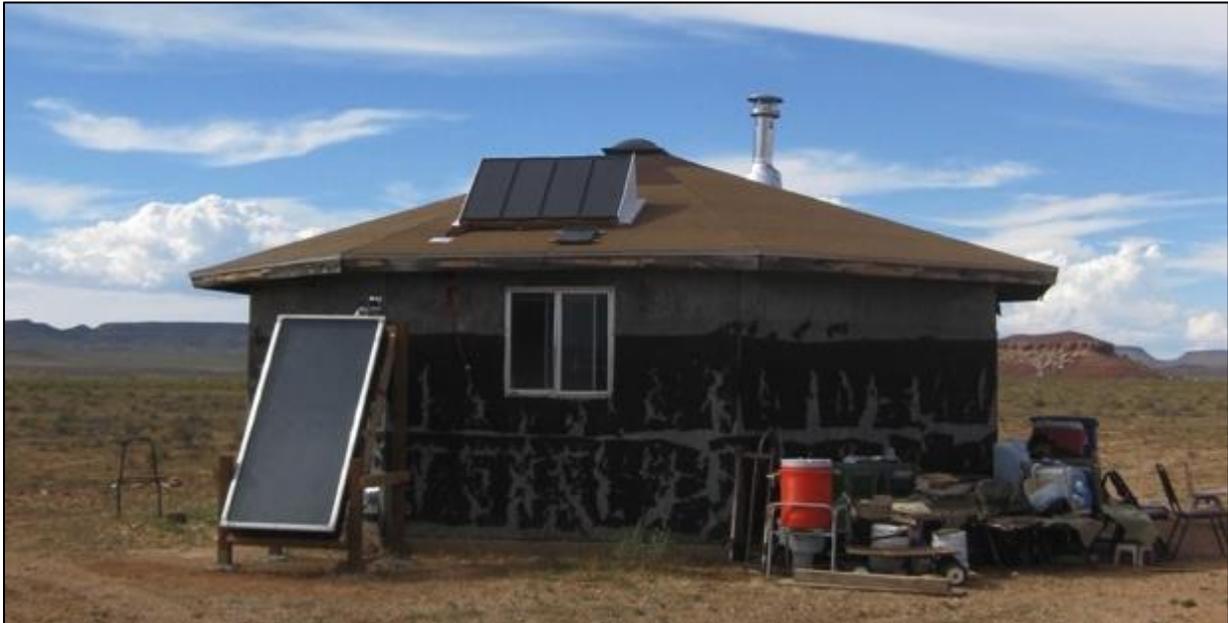
Hogan 4 was located at a family residence. Significant infiltration was noted in some exterior and interior locations along the building envelope and where roof rafters met the vertical wall, where daylight was visible. Overall, Hogan 4 was in fairly good shape, with insulation already existing in ceilings and exterior walls. While cracking of the exterior stucco is visible (Figure 8), no cracking penetrated through the exterior building envelope. The Hogan 4 family was advised to monitor the exterior stucco and recoat the stucco when cracking penetrates through the exterior building envelope.

**Figure 8: Hogan 4 Solar Thermal Collector and Solar Photovoltaic Systems**

Weatherization efforts began by using spray expandable liquid foam insulation along roof rafter gaps and caulking interior and exterior gaps, windows, and doors. As a final measure, a solar thermal collector was installed to provide a supplemental heat source (Figure 8). Because of the remoteness of Hogan 4, the Hogan does not have grid supplied electricity. Consequently, to power the blower in the solar collector, a solar photovoltaic (PV) system was installed. The PV system provides battery backup to run the solar collector blower during cloudy and overcast conditions, as well as after the sun goes down when still some stored heat

remains in the collector. In addition, the PV system also provides power for basic household lighting.

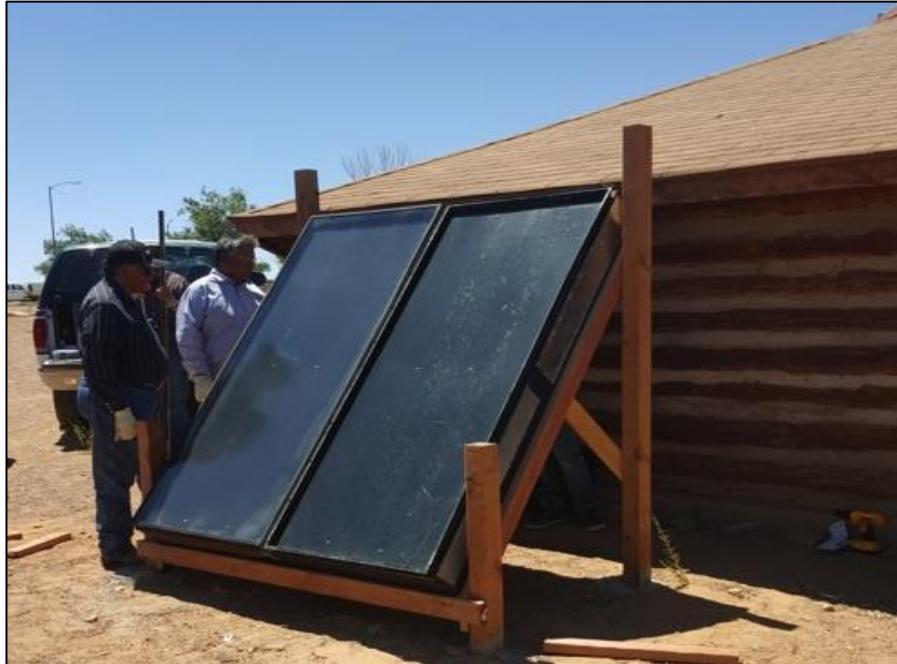
Hogan 5 was located at the Grey Hills Academy High School (GHAHS). This Hogan was chosen to be the model Hogan because the Hogan itself was in very good initial condition and because of its location it naturally will lead to significant public exposure and educational tours. This Hogan had exemplary window and door seals, chimney exhaust and no visible cracking of the exterior and interior envelopes. Further, this Hogan had extremely low leakage during the blower door energy audit testing. Consequently, there were no visible signs for weatherization improvements, except for the need for ceiling insulation. Because of the need to replace the roof shingles and some roofing boards, GHAHS and the business leads will integrate future roof replacement and insulation into a future course project. Hogan 5 did need an alternate heat source and as a result, solar thermal collectors were installed. Because the floor area exceeded 300 ft<sup>2</sup>, two solar thermal collectors were needed (Figure 9). In order to protect the solar collector when not in use, and to keep the solar collector from overheating in the summer months, our team also built a cover that is placed over the glass of the solar collector when not in use.

Figure 9: Model Hogan 5 Solar Thermal Collectors (Top) and the Amizade Team (Bottom)
