NATIONAL REGISTER OF HISTORIC PLACES
REGISTRATION FORM

historic name Canute Service Station

state Oklahoma code OK county Washita code 149

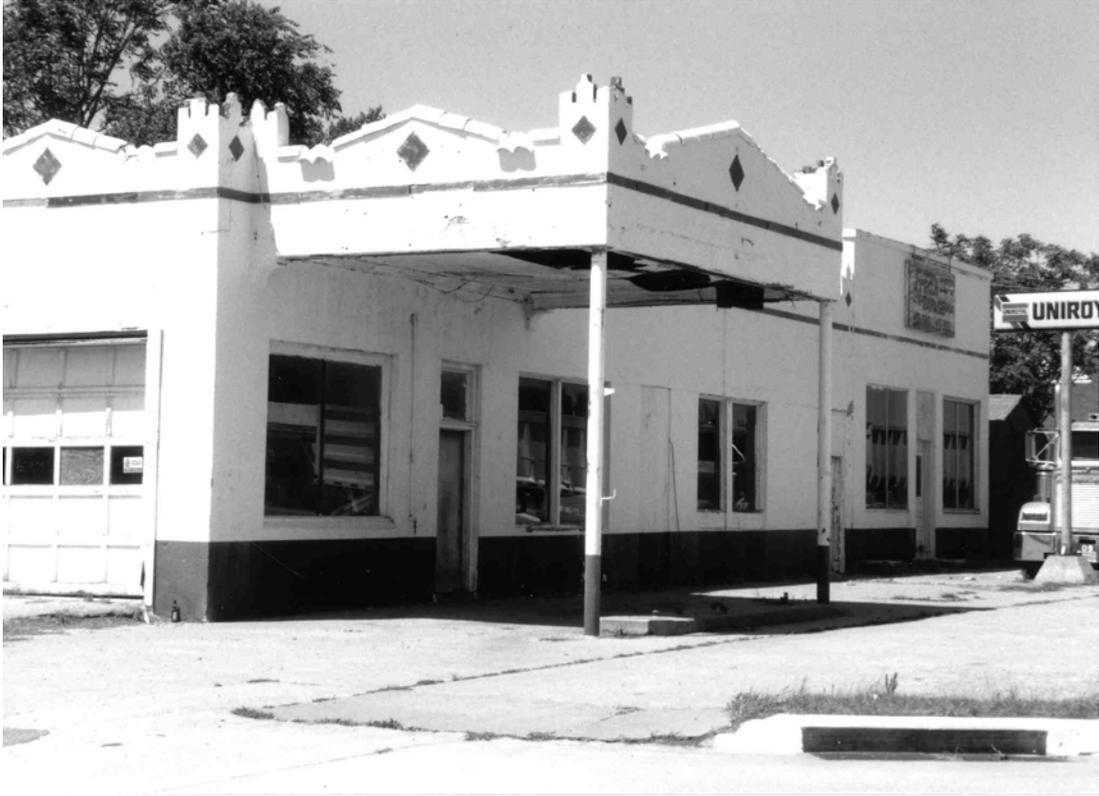
Canute Service Station

The Canute Service Station, a vernacular interpretation of the Pueblo Deco style, is a one-story, stuccoed, rectangular-shaped building. It is comprised of a storefront with an extended canopy. A gabled, concrete block building with a stuccoed false front is also part of the property and is attached to the service station at the west end. A recent metal addition has been made on the southwest corner of the building. The entire building is stuccoed with a continuous stuccoed belt course stretching across the entire front elevation.

At each corner of the building and at each corner of the canopy are castellations alternating with triangular pediments caped with tile coping. A single tiled diamond is also located on each side of the castellated corners and beneath the peak of each pediment.
