Mind the Gap

The Need to Supplement Laser Scan Data in HABS Documentation Projects

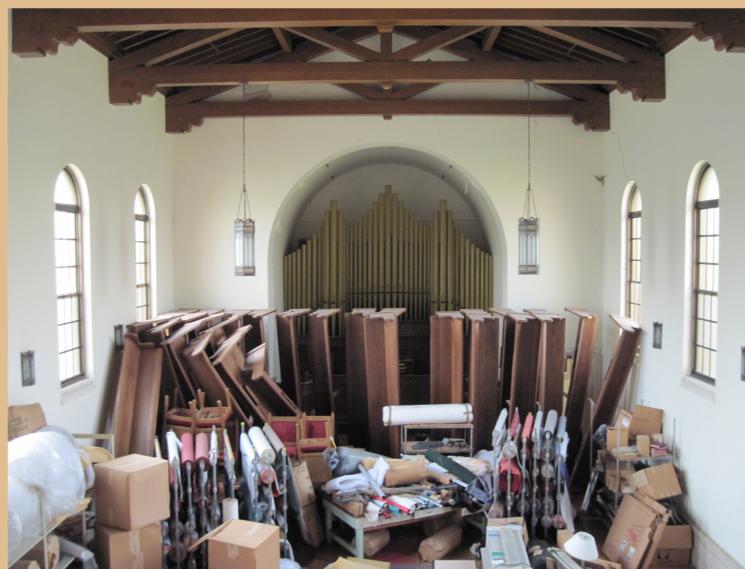
Some minor obstructions (Chapel, Mountain Home VAMC, Johnson City, TN)

Laser scanning building interiors divided into many rooms is at this time still impractical and time consuming. In addition to the multitude of stations one would have to set up, break down, and tie together in order to generate a complete plan, some of the spaces to be documented may be too small to operate the scanner in, or full of furniture that obstructs lines of sight. Measuring rooms by hand remains the most efficient way to gather the needed dimensions.

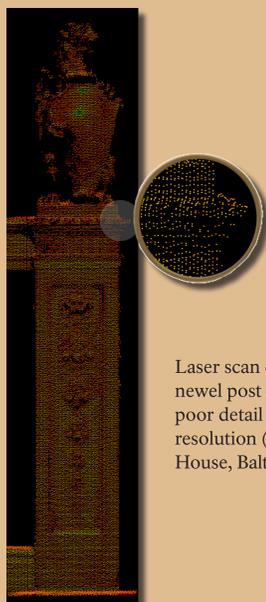
Laser scan of a carved newel post showing poor detail even at high resolution (Evergreen House, Baltimore, MD)

Rectified digital photography is often used in areas of sculptural relief, where a laser scanner may fail to provide a high enough resolution to ascertain minute changes in elevation (left).

Detail may also be lost due to the object returning too few points, either because of the object's color (blacks and reds are particularly problematic) or a glossy surface. A well-lit photograph, on the other hand, is highly legible and easy to decipher in CAD. The point cloud may still serve to locate the detail in the final drawing.

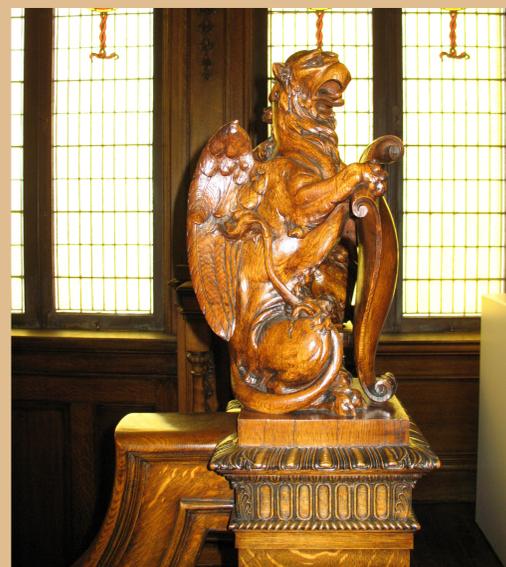
Detail photograph of gryphon

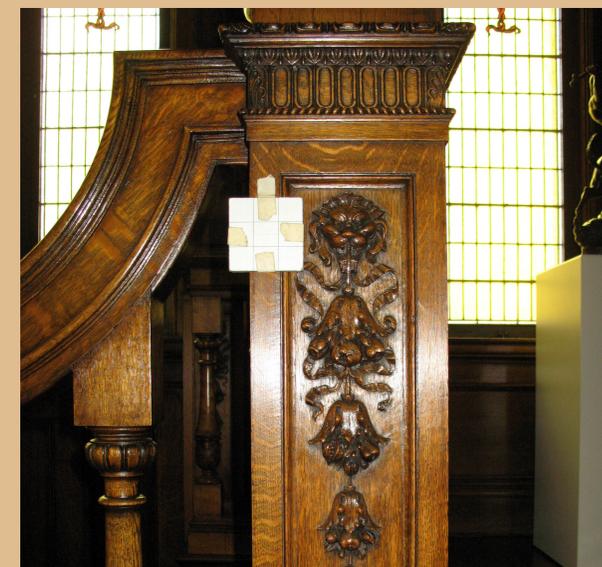
Detail photograph with 3-inch square for scale

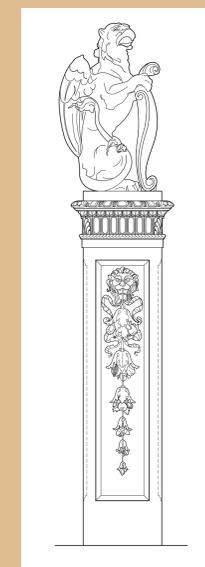
Finished elevation drawn in CAD

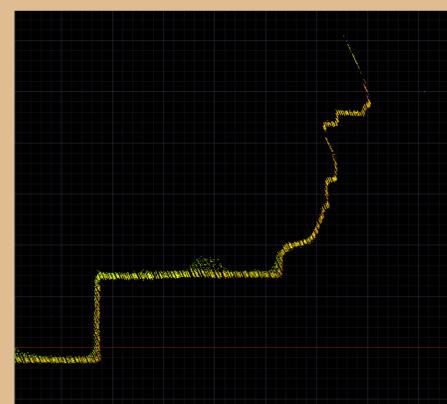
Typical laser scan of an exterior window jamb (Ward Memorial Hall, Zablocki VAMC, Milwaukee, WI)

Scanning often presents difficulties in determining the profiles of molding and door and window jambs due to poor edge definition (left). The use of a molding comb (right) is faster and less expensive, providing a higher-quality result. It also gives the user the opportunity to interpret the original condition of the detail through many layers of paint. The sketched field note, (center right), is easy to translate into a CAD drawing and serves as an archival record of the detail.

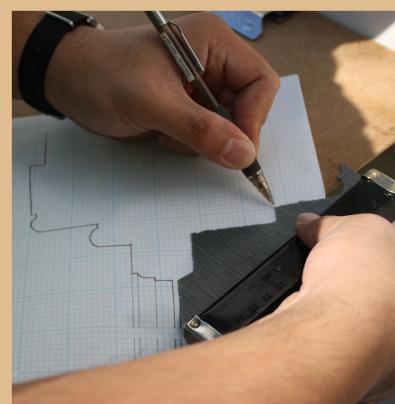
Using a profile comb to record a window detail (Best Farm, Monocacy National Battlefield, Frederick, MD)

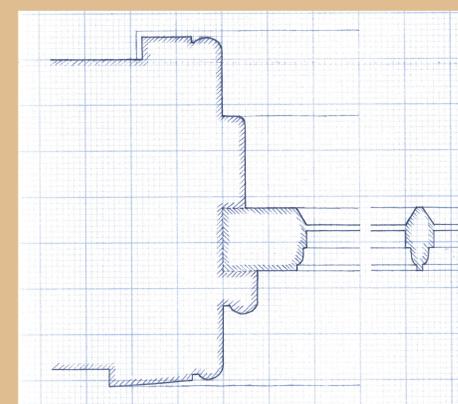
Field note sketched on archival paper

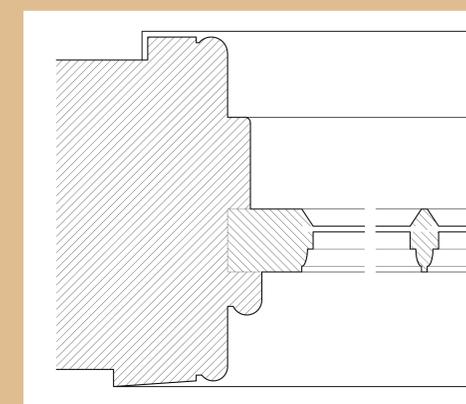
Finished detail drawn in CAD
