PROTECTIVE GLAZING STUDY

National Preservation Center

Inspired Partnerships, Inc.

March, 1996

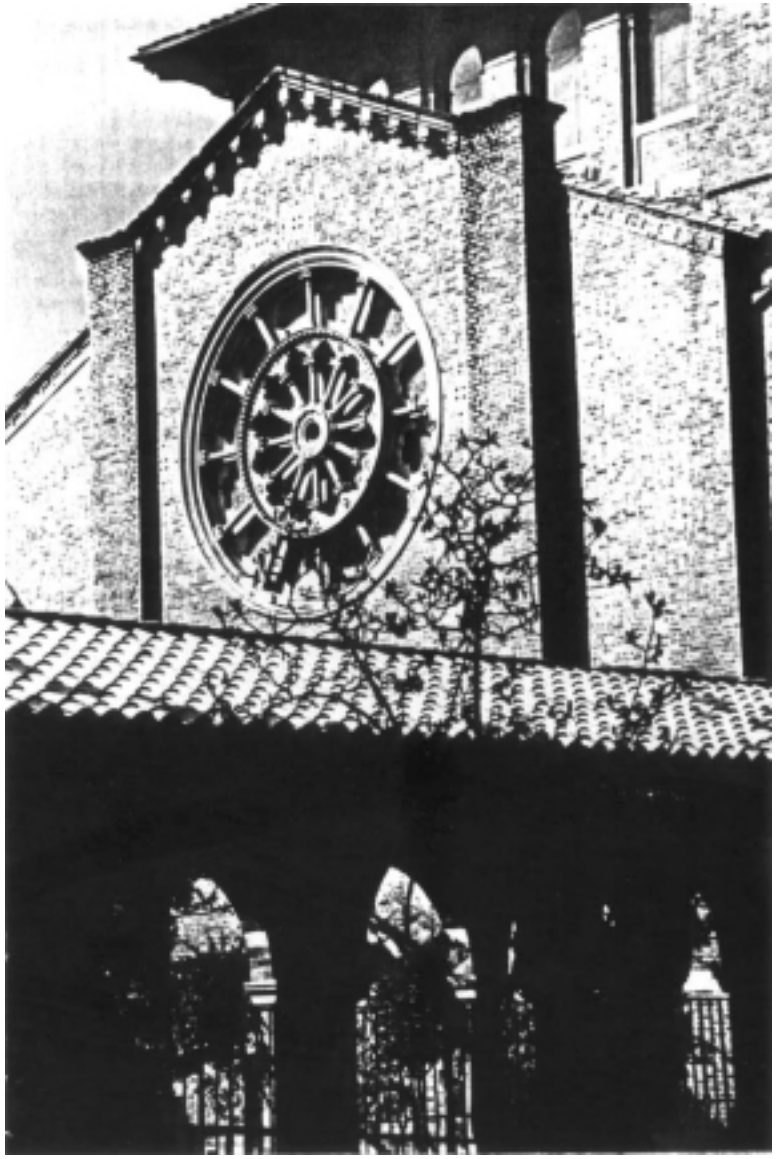
Fig 3. Security was not an issue for most of the windows.

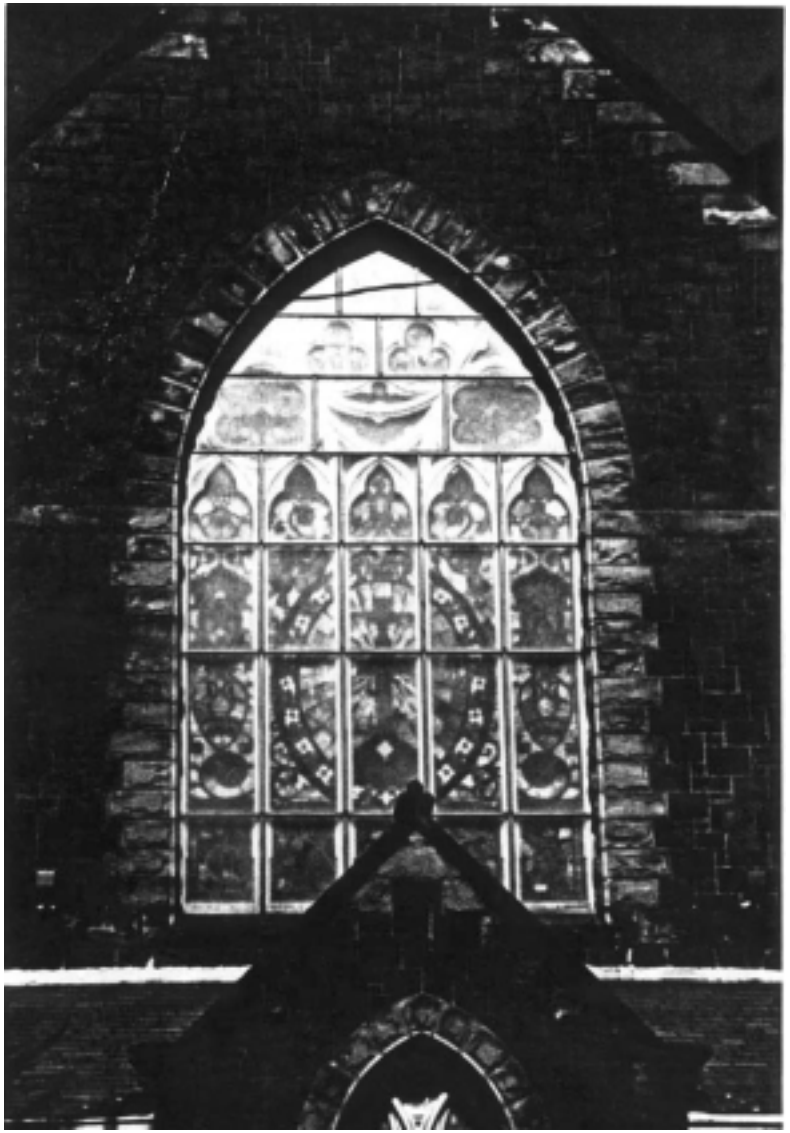
Fig 4. Nearly all plastics have badly hazed and yellowed.

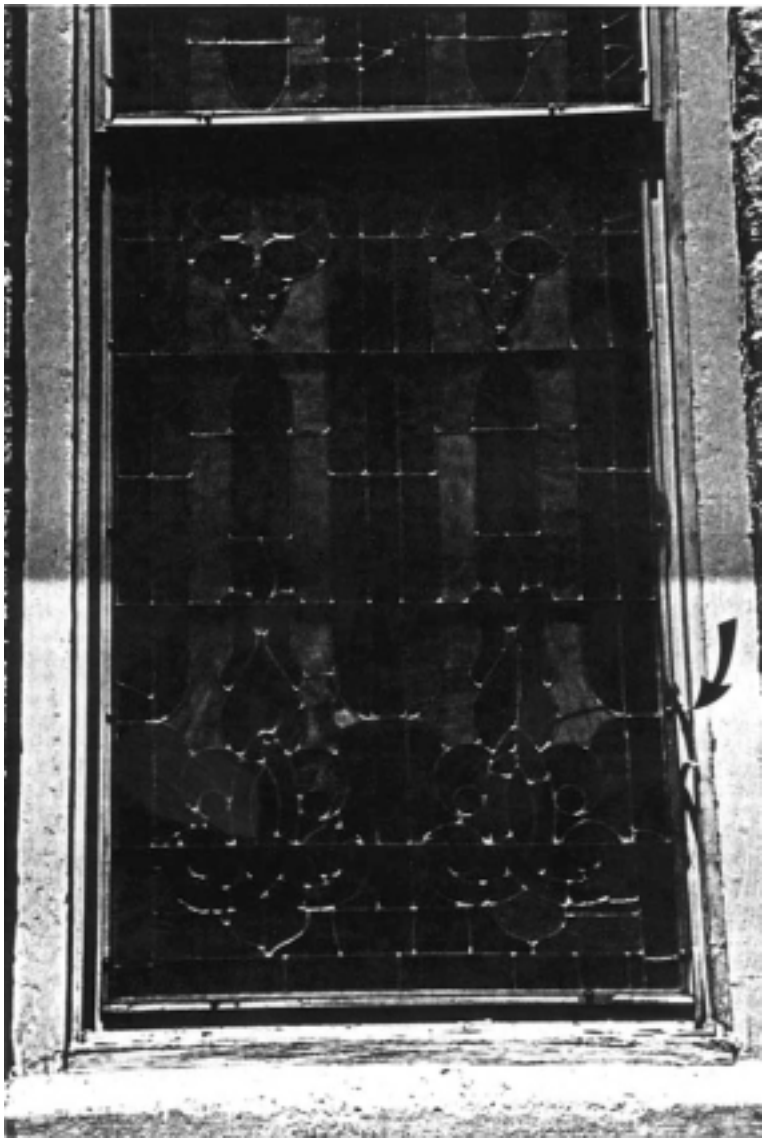
Ironically, although response to the questionnaire signify that most studios vent their PG installations, only 4% of those surveyed in the field were intentionally vented **[FIG 5.]**. Another 19 have self-vented over time due to deteriorated sealants or broken glazing **[FIG 6.]**. The depth of the air space varies greatly and is usually contingent upon the window frame and ease of installation, over 75% are set more than 1" from the stained glass. Condensation is unquestionably a problem with PG installations as evidence of condensation was found in nearly 70% of the windows; while 10% of the windows were too obscured to see at all. As expected, the Southwest installations, that are located in regions where the average relative humidity is below 20%, generally had little or no evidence of condensation. Glass temperatures, measured in direct sunlight were always higher than ambient indoor or outdoor temperatures, averaging between 18°F and 21°F higher. The temperatures varied depending on the color of the glass, wind speed, and how long the window had been exposed to direct sunlight at the time of testing.

Fig 6. Many windows have self-vented as sealants breakdown.

Polymer sheets, such as acrylic and polycarbonate, have a much greater coefficient of thermal expansion than glass, and sheets may bow and break sealant joints if the secondary glazing is improperly installed **(see Fig 6.)**. Even when PG is properly mounted in a removable sash, leakage behind the sash is likely to be a recurring problem. Small cracks in the sealants allow a surprising amount of water to collect behind the glazing in areas subject to runoff or wind-driven rain. Unvented PG does not allow water to drain or evaporate, and trapped moisture leads to condensation and high humidity in the interspace. Protective glazing, whether vented or not, alters the drip details at the window sill, sometimes creating a dam for ponding water unless weep holes are added to drain water away.

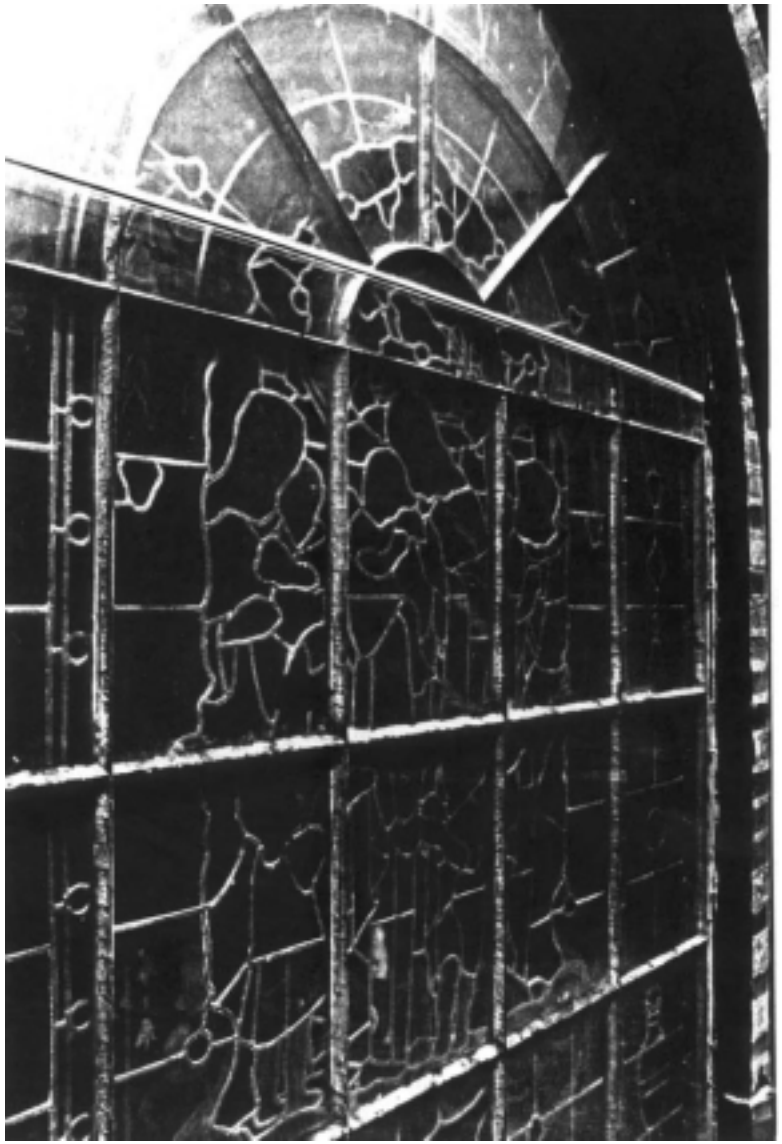
Fig 7. Glazing sealants and frames often deteriorate behind PG.

Nevertheless, the waterproofing (cement) was missing in areas on 40% of the windows and had completely failed on another 22% -- regardless of their quality. Moreover, the perimeter sealants had partially or totally failed on half of the PG installations. The PG definitely prevents proper window maintenance; approximately one-third of the windows surveyed required maintenance to the metal or wood frames, which were not accessible due to the PG **[FIG 7.].**

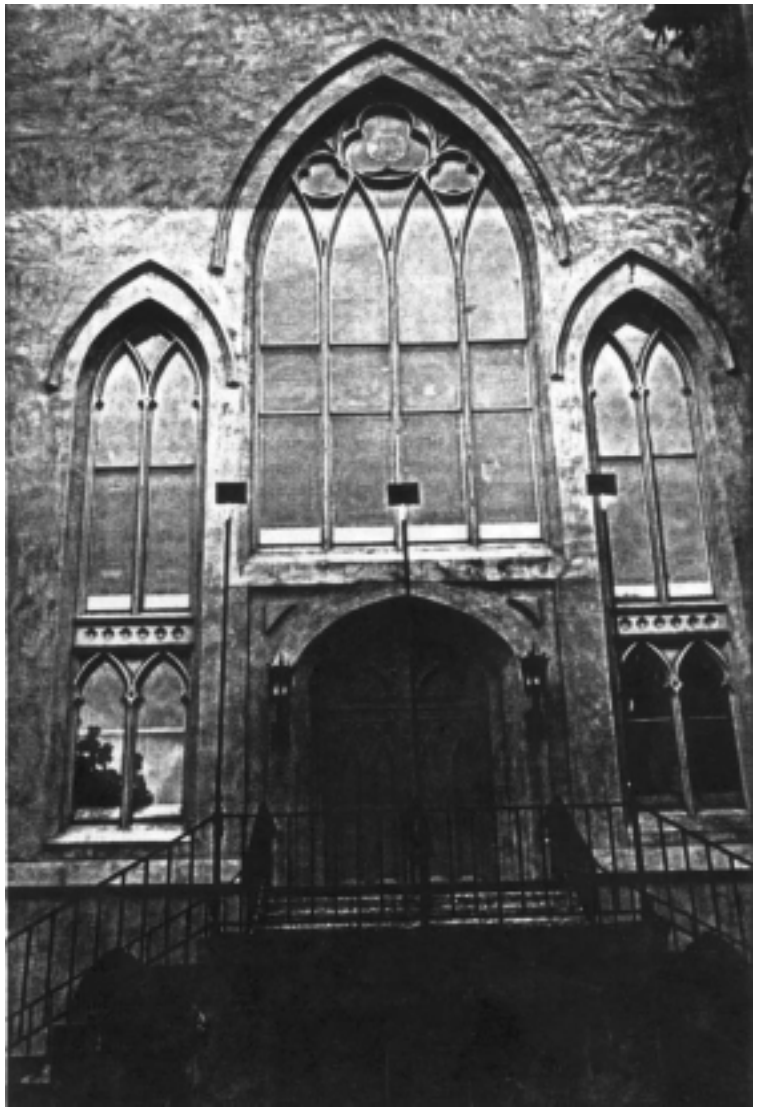
Fig 8. PG can be integrated with the original tracery.

Charleston, SC, and Savannah, GA were selected for their concentration of historic churches, strong preservation movement, good church documentation, and vulnerability to hurricanes. Surprisingly, several of the churches without PG suffered no stained glass damage from Hurricane Hugo in 1989. Other windows covered with PG actually had the entire window (frame and all) blown out of the window opening. Exposed stained glass is very resistent to wind pressure, but is vulnerable to flying objects. The vast majority of stained glass damage resulting from Hurricane Hugo was caused by flying roofing and siding materials, branches or debris hurled into the windows as opposed to wind or rain from the storm itself. All but one of the Southeast churches were air conditioned, and most of air conditioning systems were on during the field survey. Combined with high relative humidity, which averaged between 50% and 60%, the air conditioned interiors were causing the worst condensation problems observed anywhere. Congregations located in strong preservation communities like Charleston and Savannah, tend to integrate PG more carefully within the original window frame and tracery **[FIG 8.].**

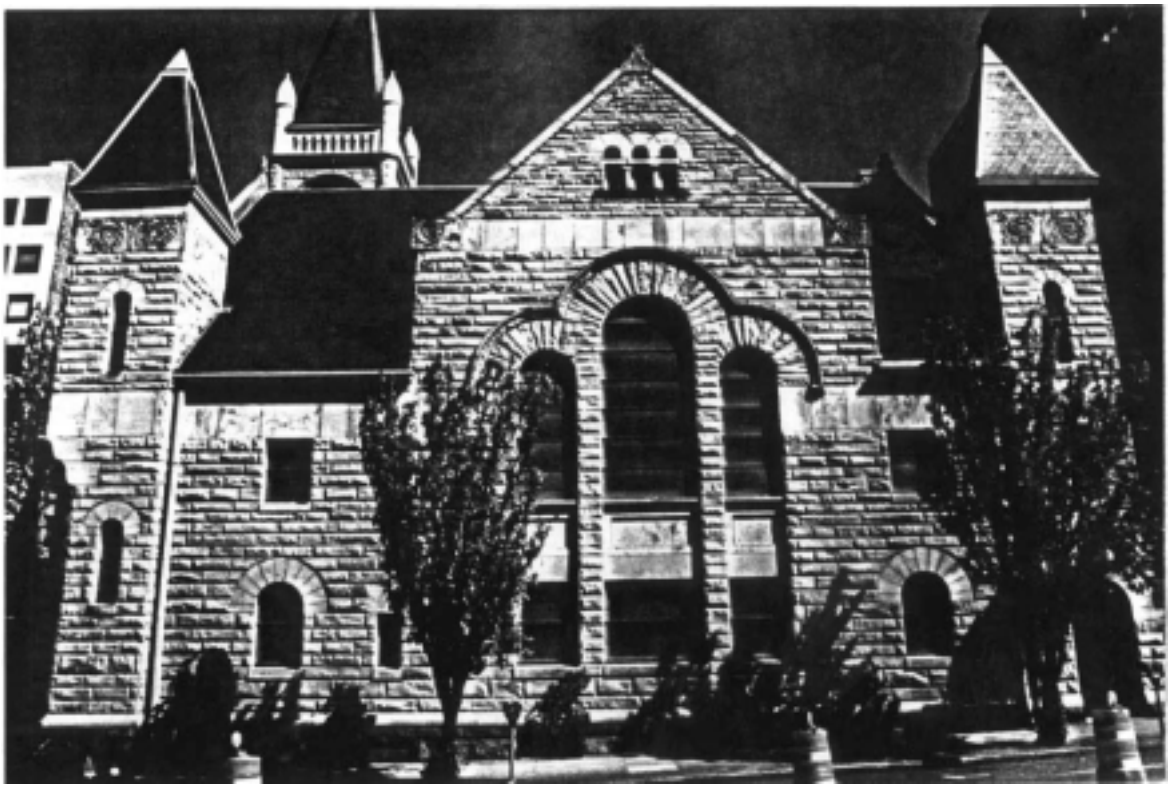
Fig 25. Romanesque Revival churches rely on the shadow effect of deep, recessed windows.

Fig. 26. Due to cloudy PG, these windows no longer read as apertures in the wall.

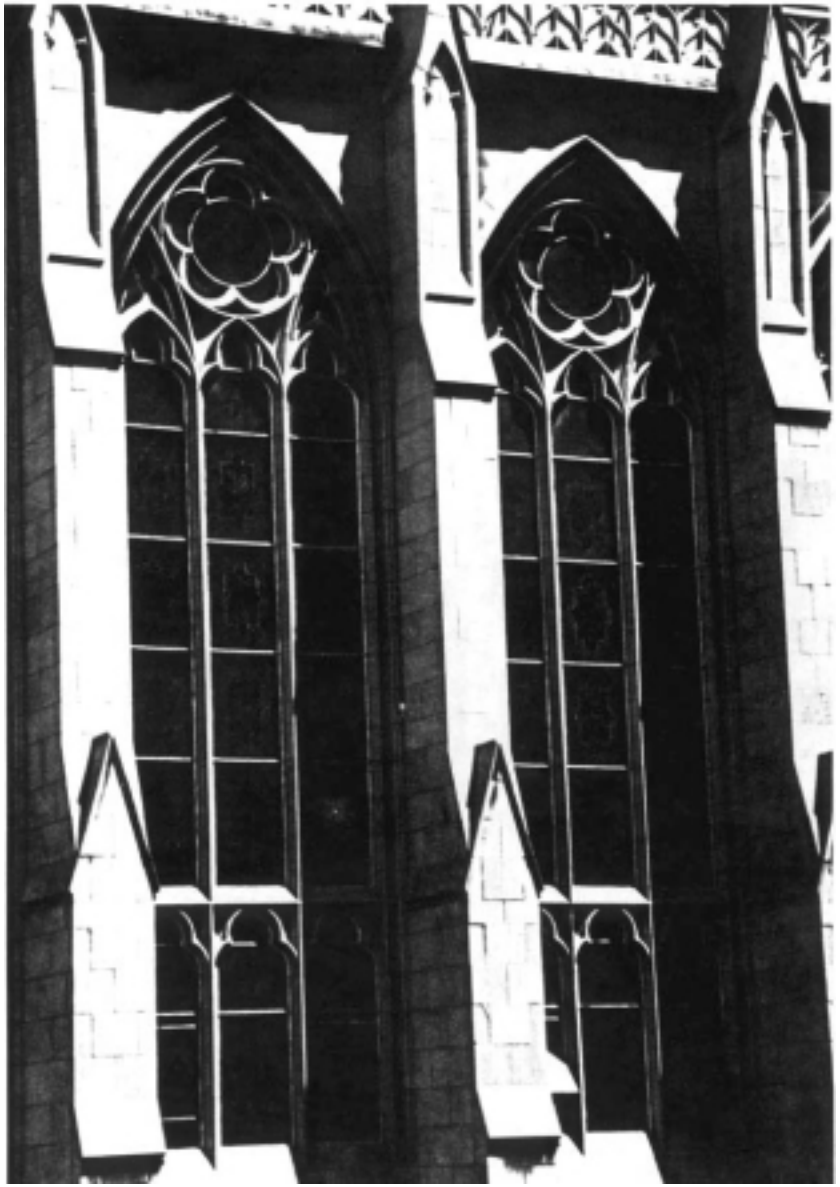
Fig 23. PG over the tracery would alter these windows.

Fig 24. The delicate tracery of this window is completely hidden

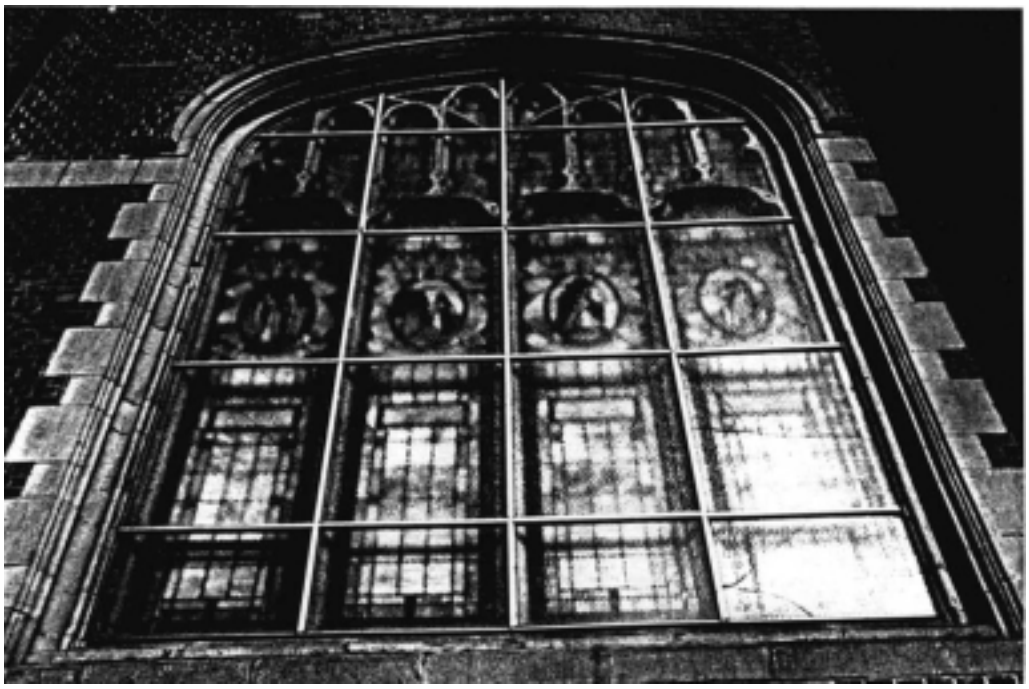
Fig 27. The art glass in this installation is blurred by glare and textured PG.

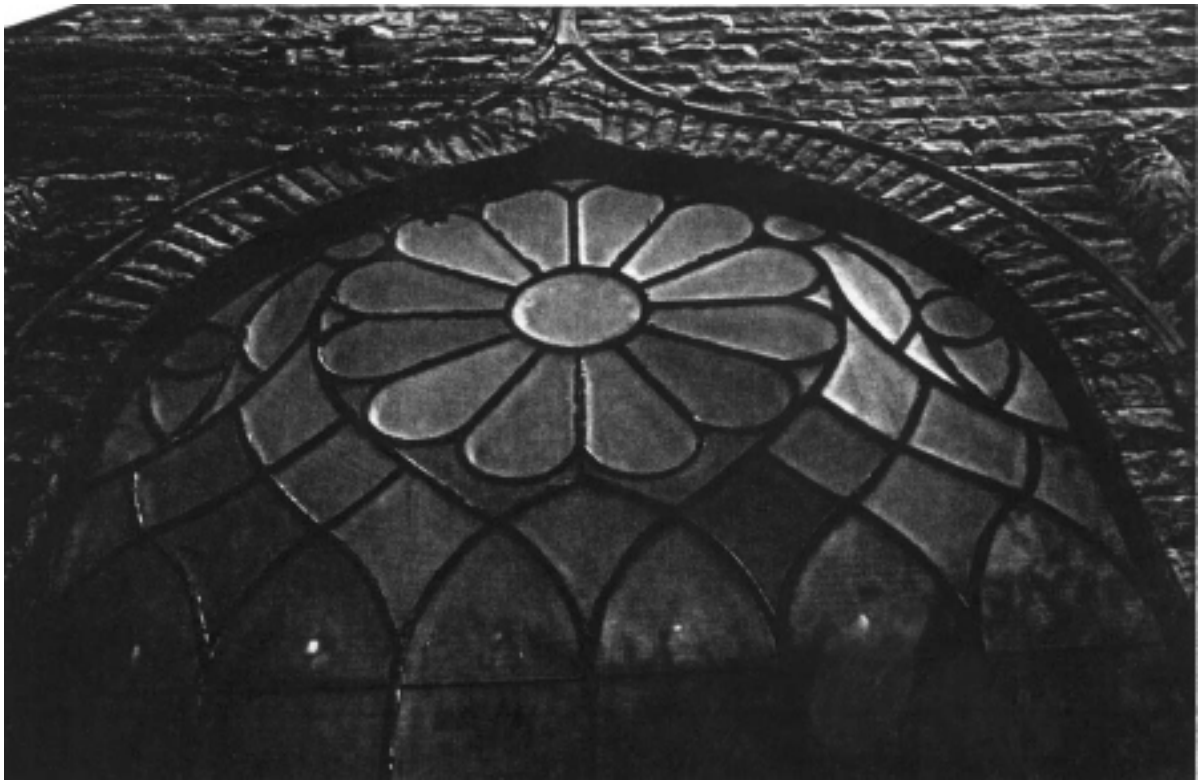
Window Framing: The design of the PG framework should be compatible with the design, materials and color of the original stained glass window frame. Installations in which the glazing is cut to fit within the existing mullions or conform to the tracery are visually most successful **[Figs 28. & 29.].** Linear frames or grids are faster, easier and cheaper to install than curvilinear frames and have become a popular method of installing PG. Of the 100 installations randomly surveyed, 64% had PG frames which did not conform to the original window frame; most of the remaining 36% had simple shapes without any interior framing. Moreover, the color of the PG frame clashed with that of the stained glass window frame in 42% of these installations. An advantage of wood and steel PG frames is that they can be painted to match or compliment the original frame and surrounding trim. Aluminum frames do not hold paint well but are available in anodized colors, typically ranging from silver to bronze to black **(see Appendix B).** Materials should be selected carefully to enhance rather than detract from the windows and architecture; aluminum or silver metallic colors should generally be avoided.

Fig 28. This PG needs maintenance, but the muntins conform to the tracery.

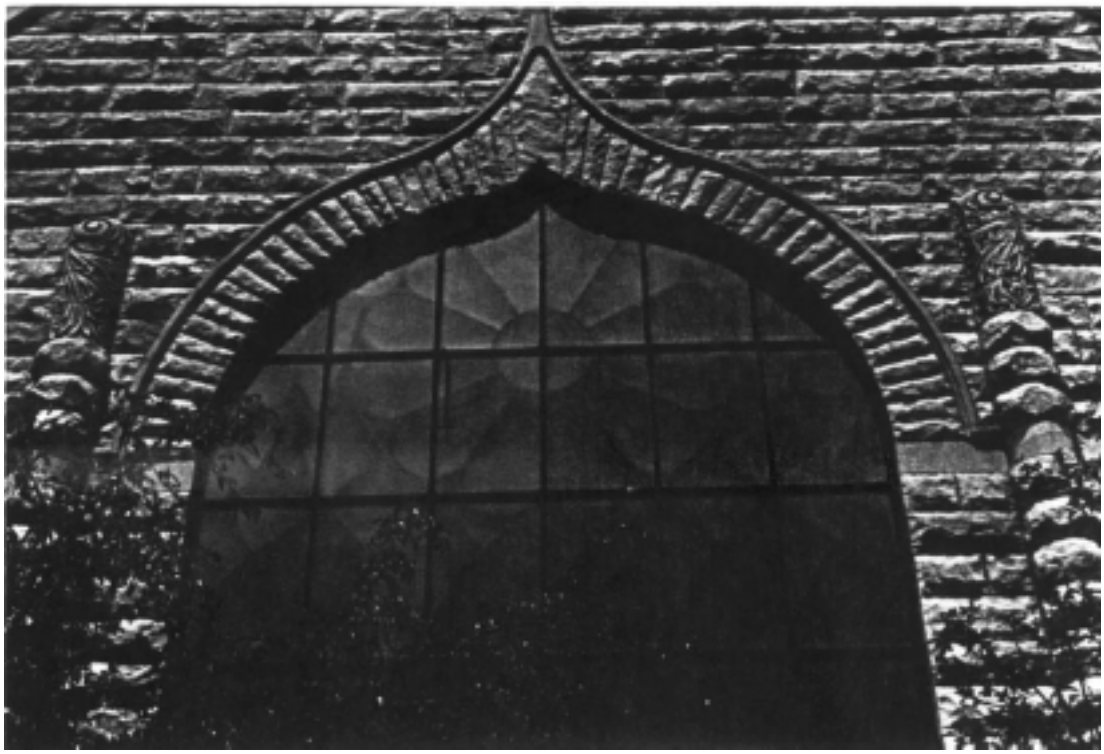
Fig 29. Another PG installation on the same building disregards the tracery.

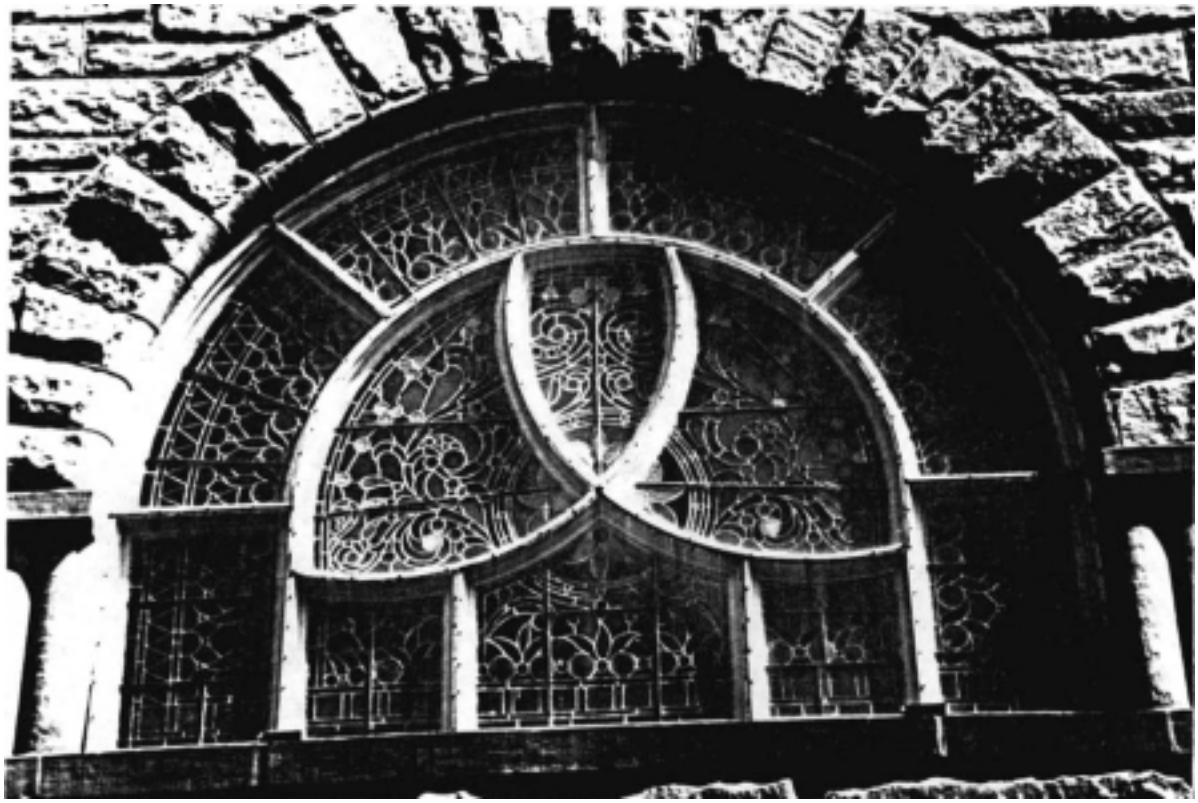
A subtle but important factor in the design of secondary glazing systems is the extent to which the installations reduce the apparent depth of the window opening. Because PG frames are often set against outer moldings, or the PG is merely screwed directly into the frame, it may be nearly flush with exterior wall surfaces **[Fig 30.].** The window is no longer perceived as an aperture or an opening, and the building appearance may be dramatically altered. It is therefore important to install PG within the window opening, maintaining at least a 1” interspace between the PG and the stained glass.

Fig 30. Only a few years old, this PG will haze and obscure the window reveal.

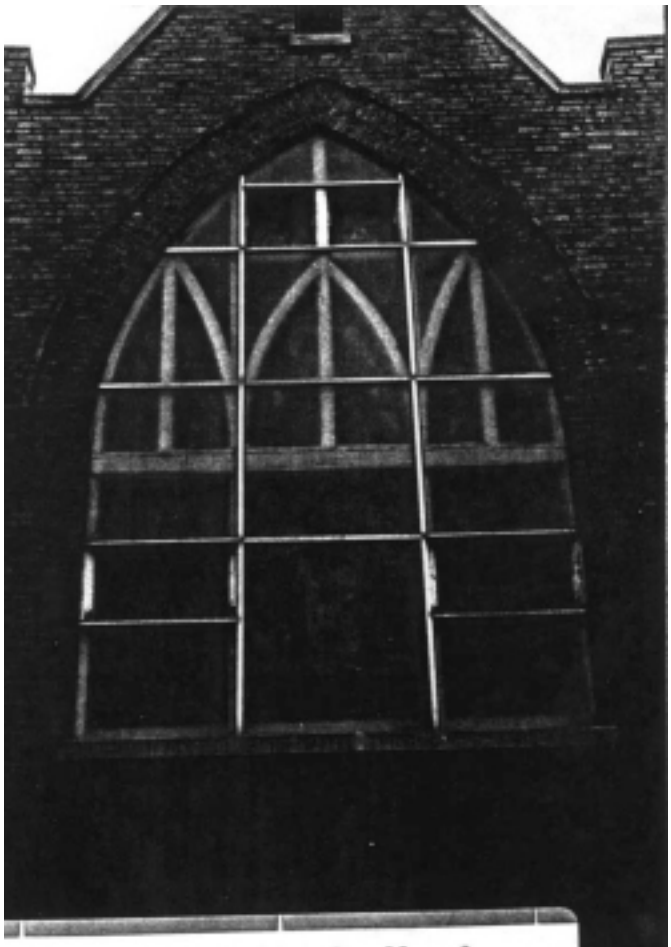
The aluminum grid and yellowed glazing ruins this art glass window.

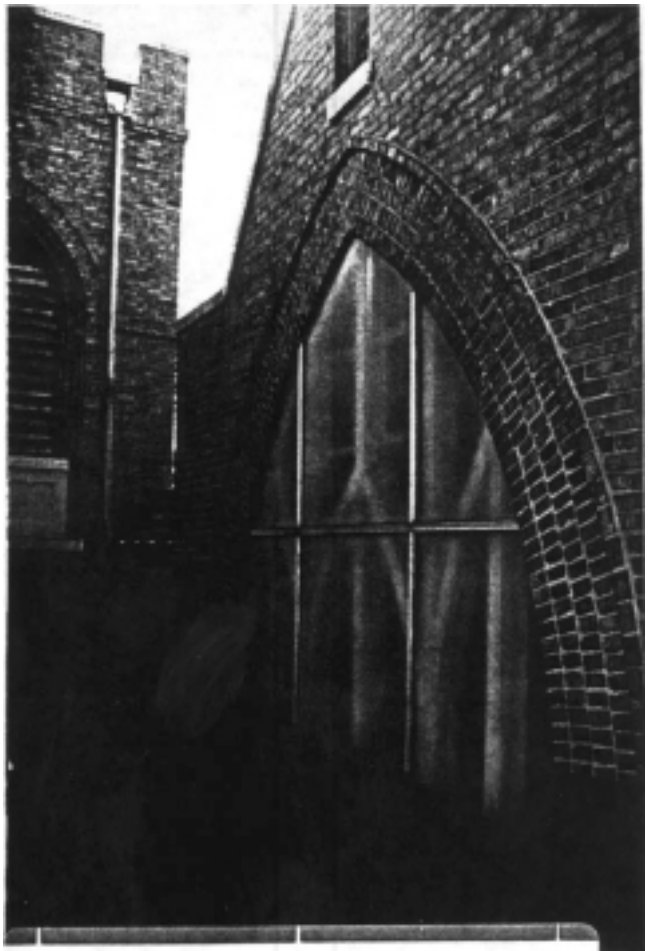
Poor flashing details at the roof are allowing the wood sill to rot.

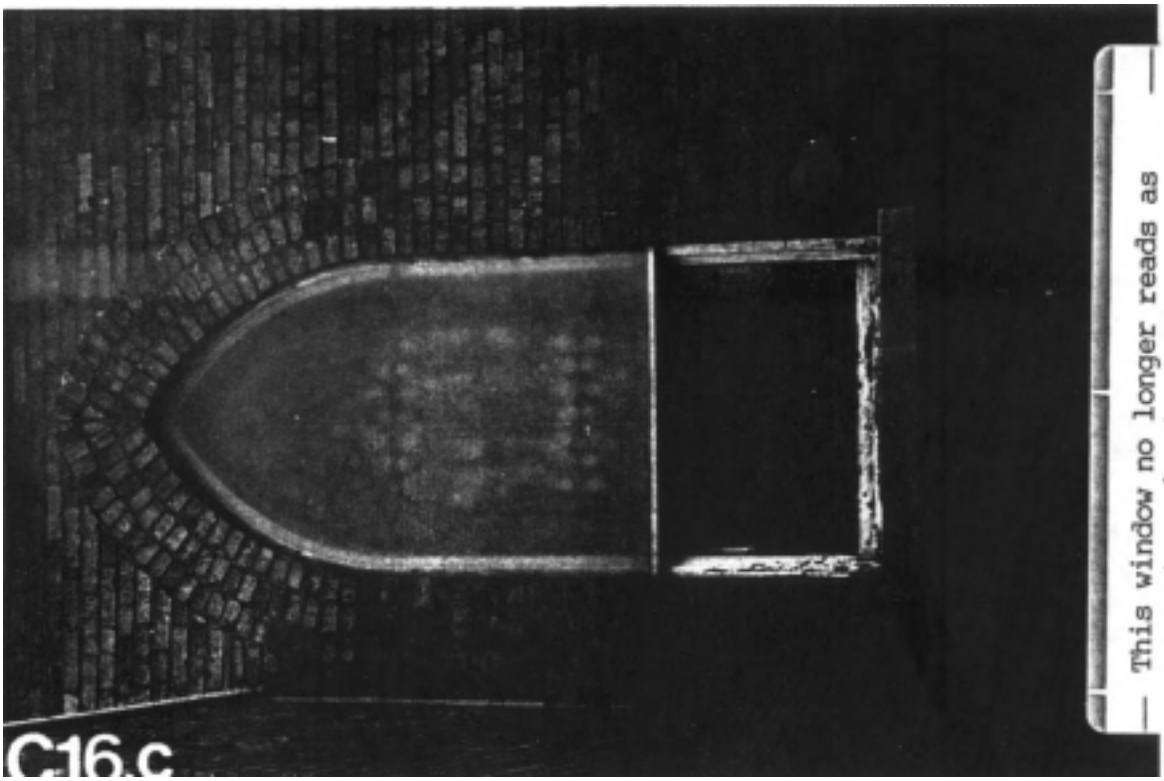
This window no longer reads as an apeture in the wall.

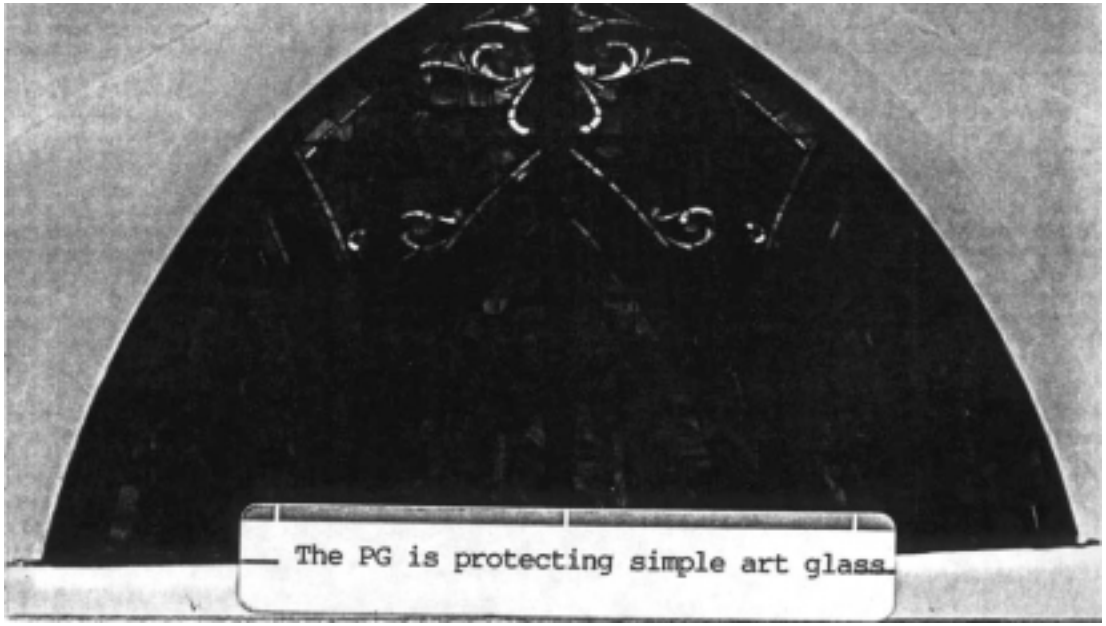
The PG is protecting simple art glass.

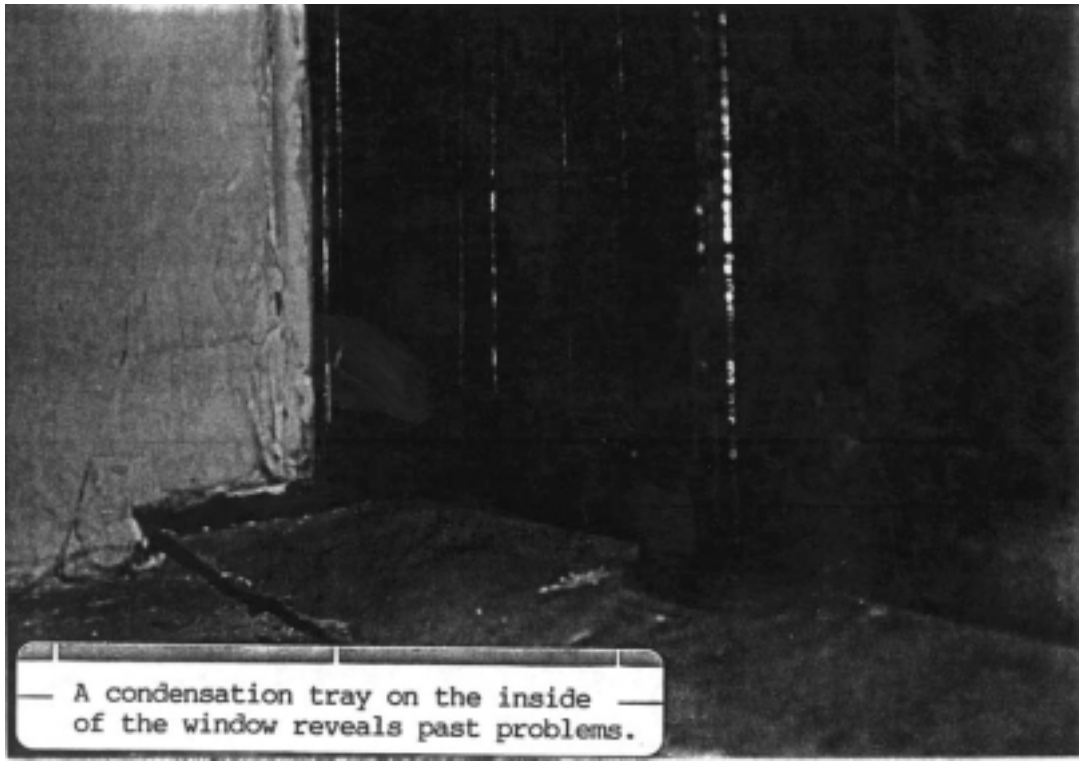
A condensation tray on the inside of the window reveals past problems.

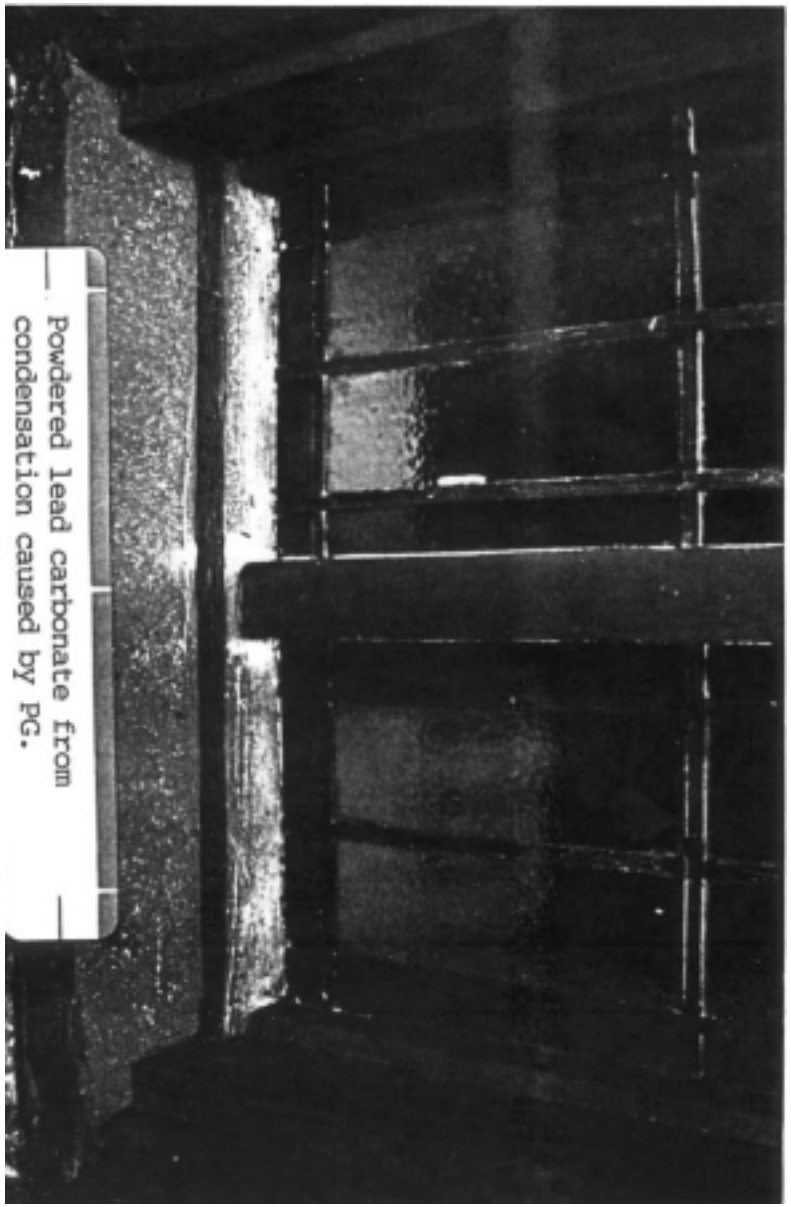
Powdered lead carbonate from condensation caused by PG.

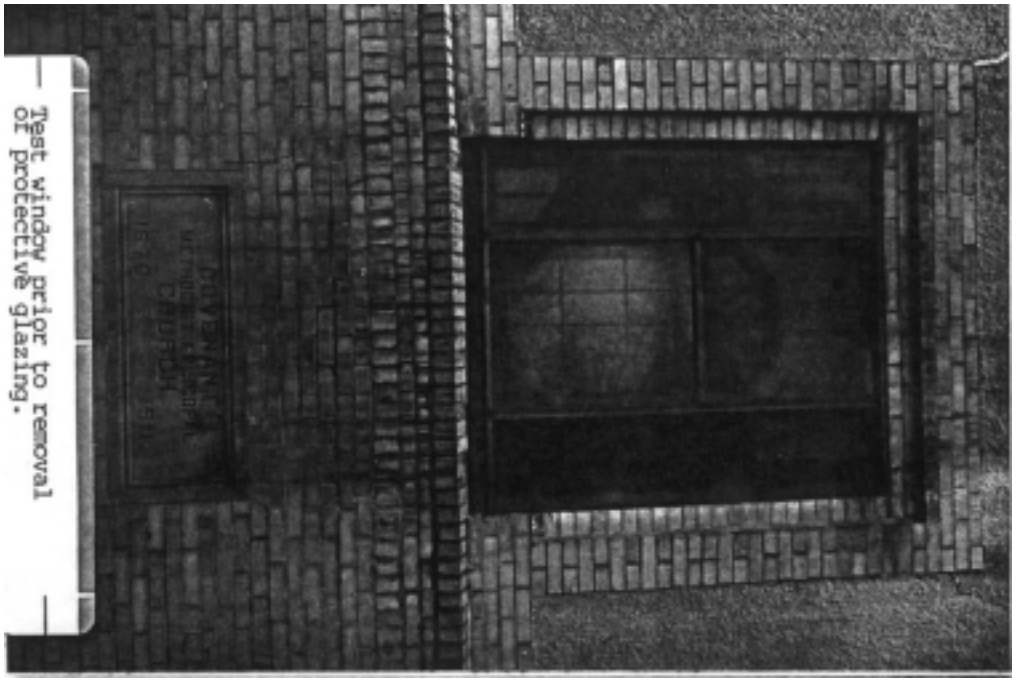
Test window prior to removal of protective glazing.

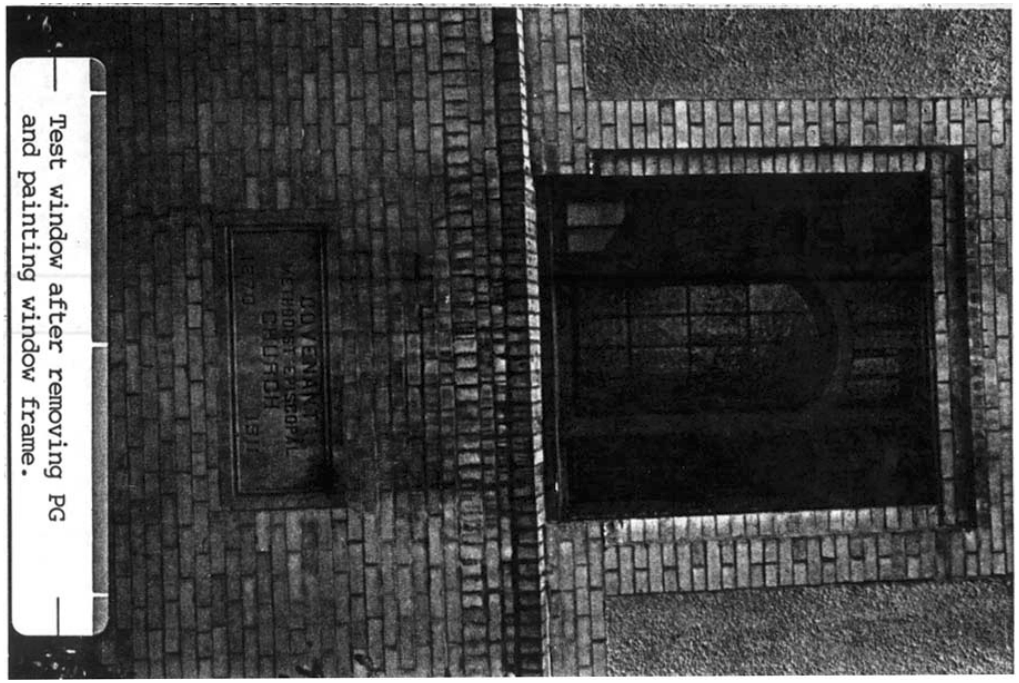
Test window after removing PG and painting window frame.

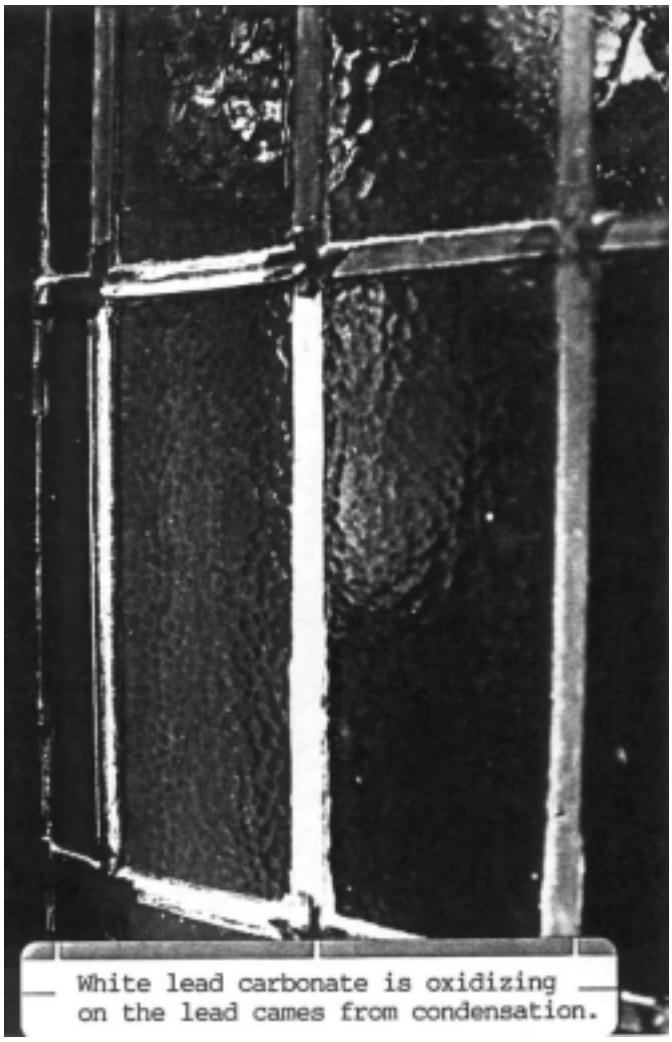
White lead carbonate is oxidizing on the lead cames from condensation.

Refurbishing this window cost $250.

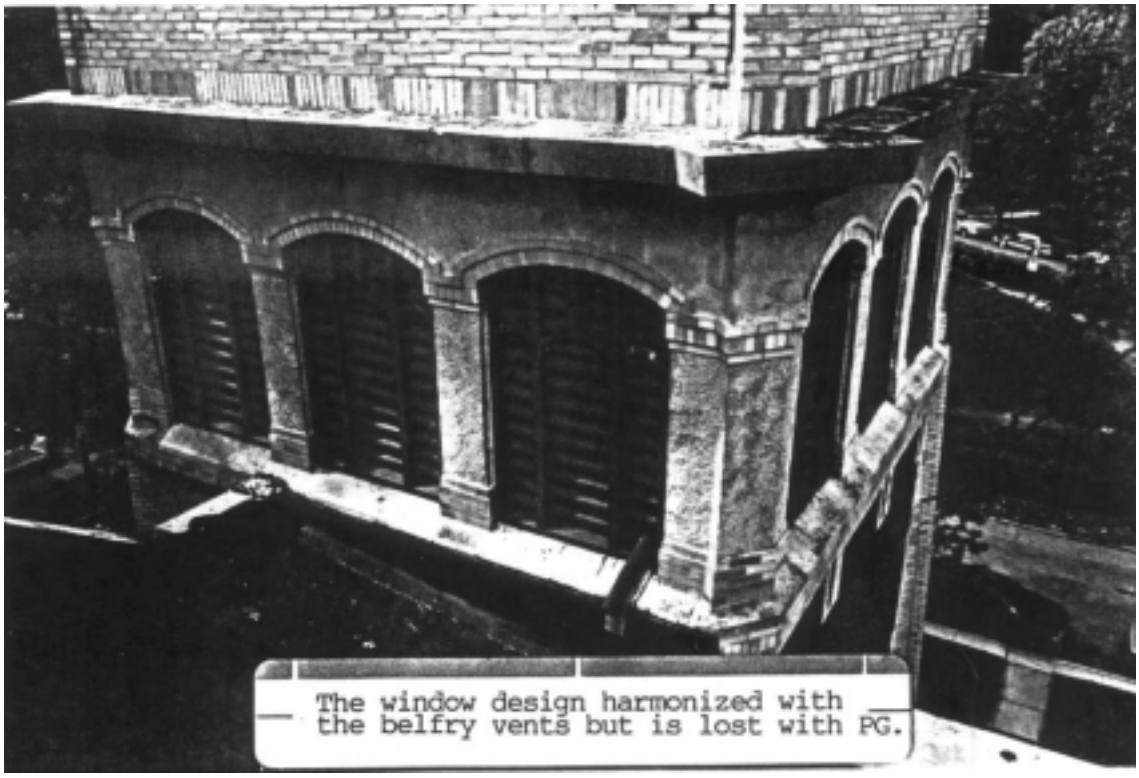
The window design harmonized with the belfry vents but is lost with PG.

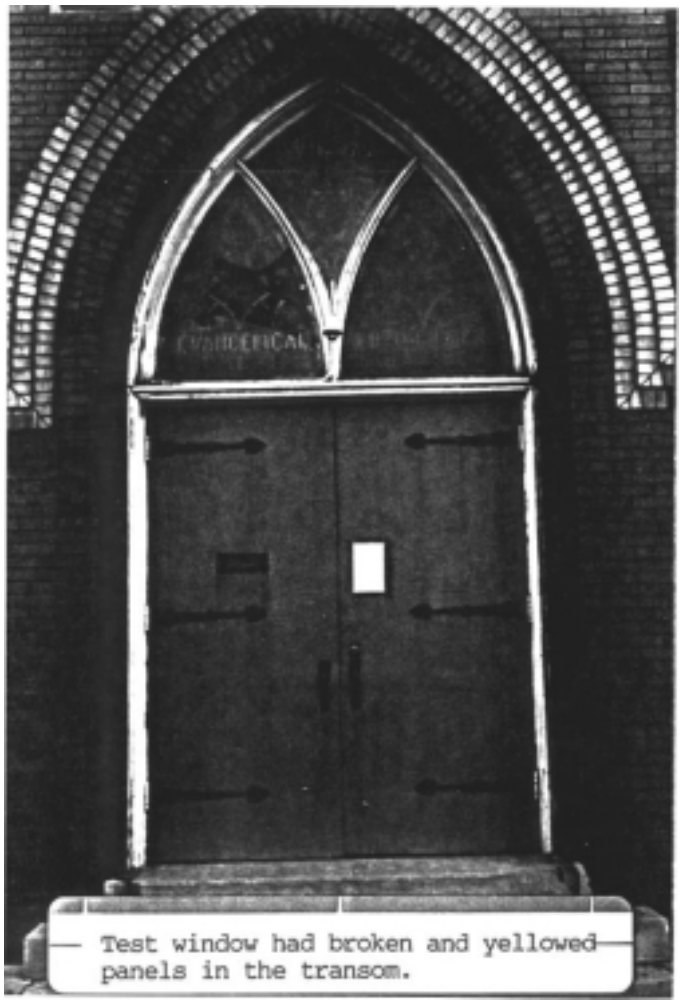
Test window had broken and yellowed panels in the transom.

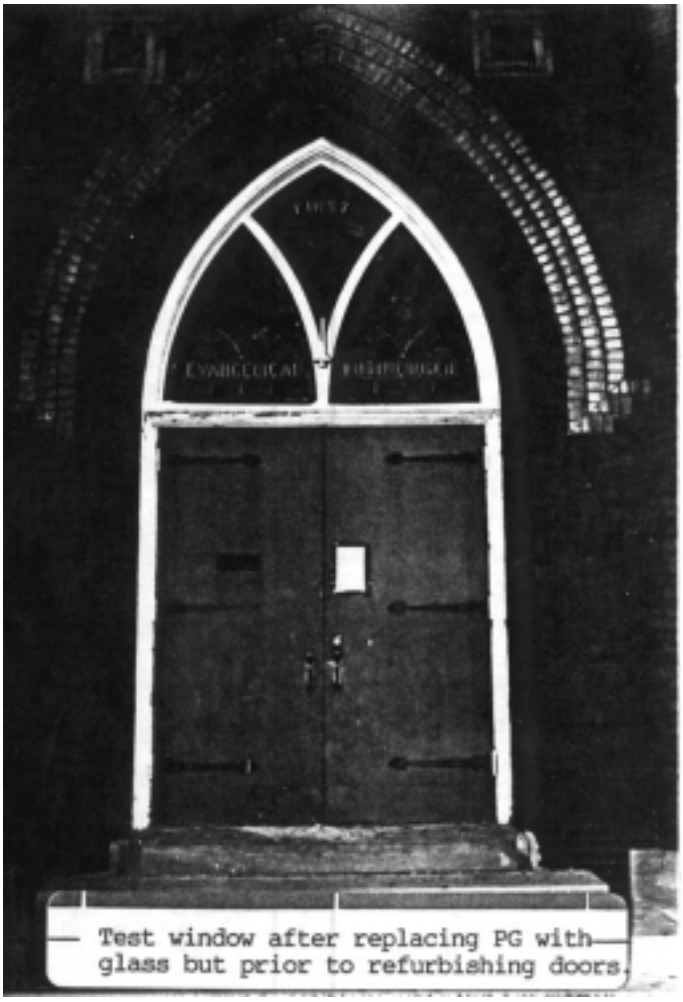
Test window after replacing PG with glass but prior to refurbishing doors.

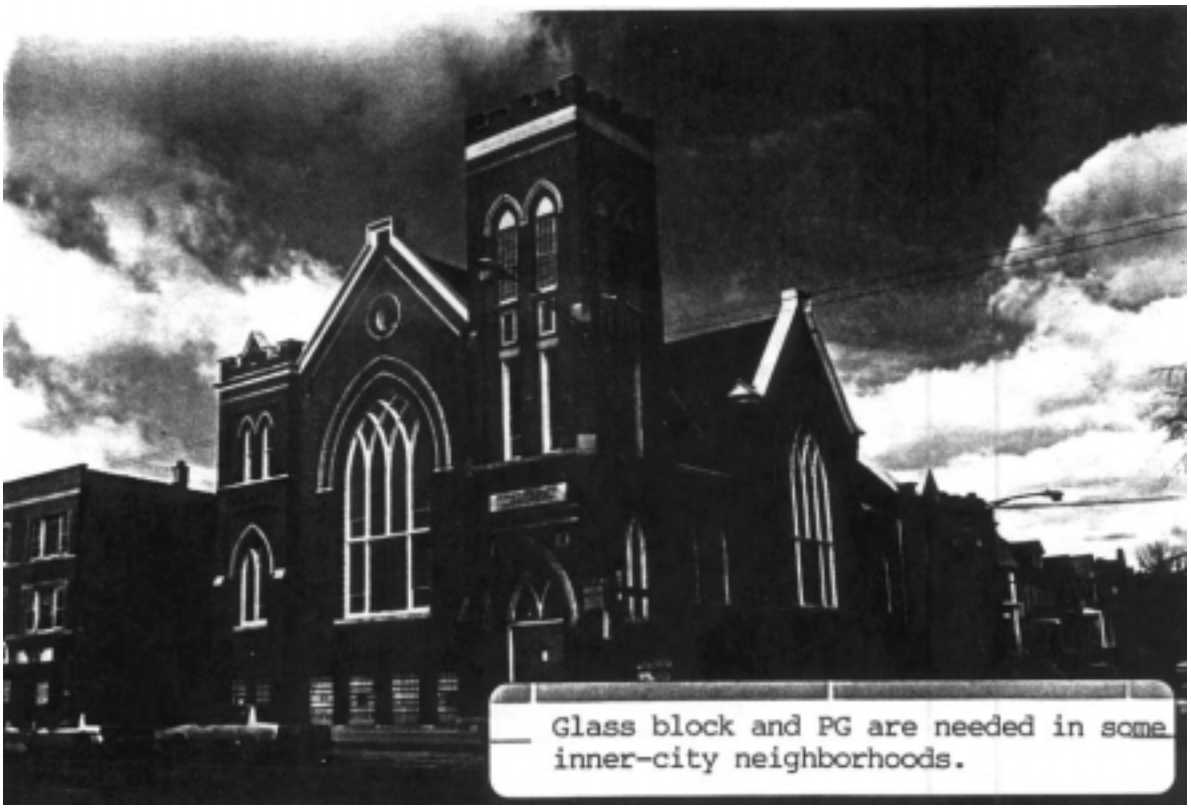
Glass block and PG are needed in some inner-city neighborhoods.

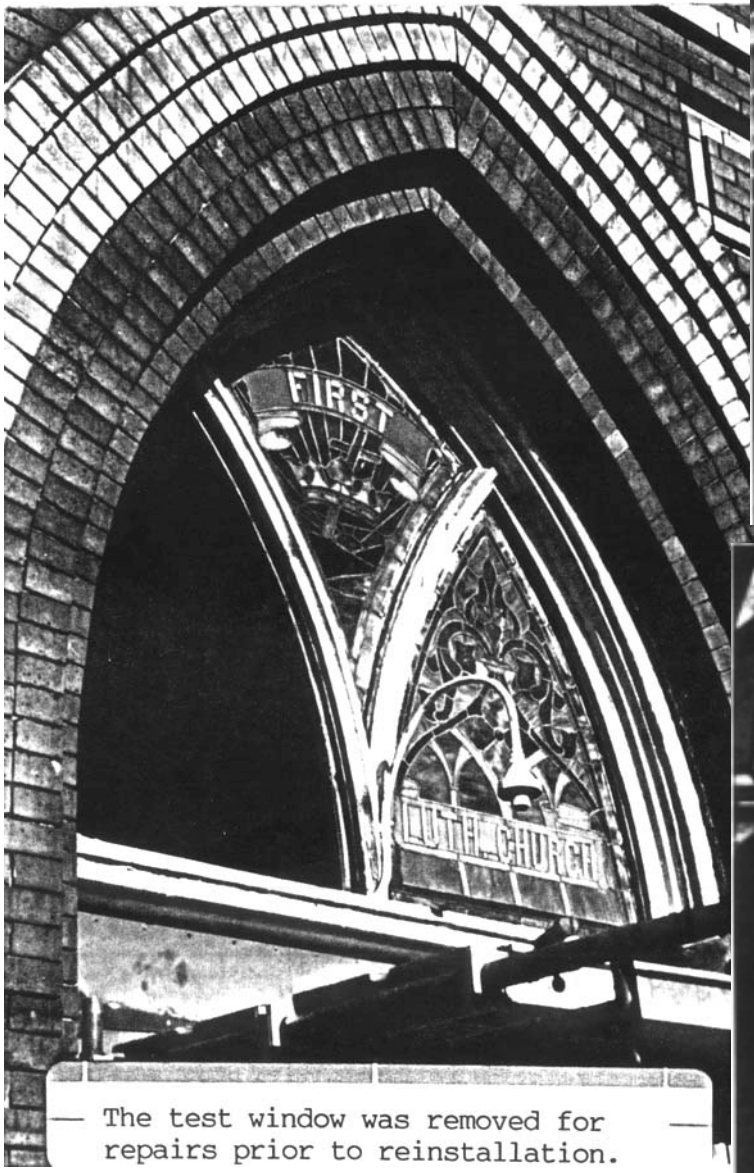
The test window was removed for repairs prior to reinstallation.
