PROTECTIVE GLAZING STUDY

National Preservation Center

Inspired Partnerships, Inc.

March, 1996

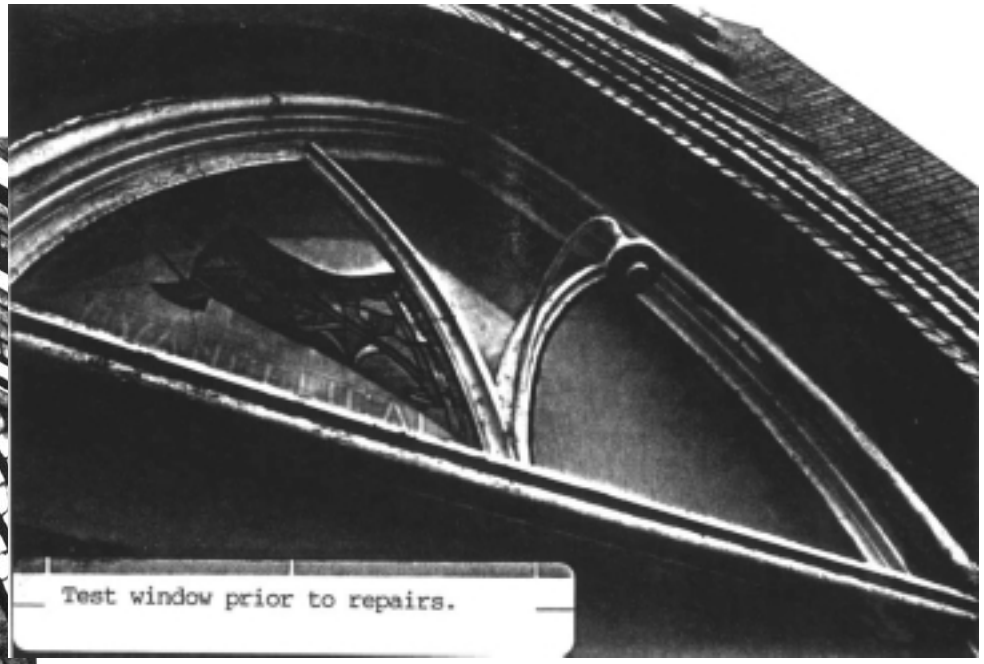
Test window prior to repairs.

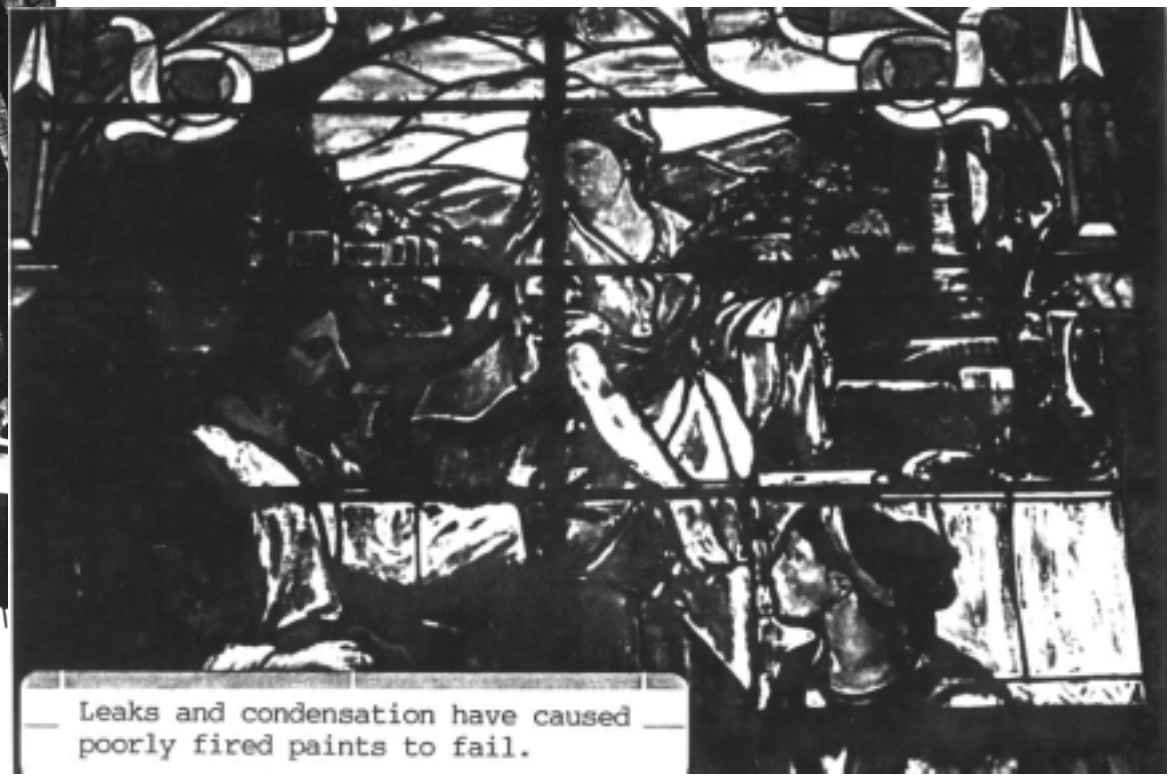
Leaks and condensation have caused poorly fired paints to fail.

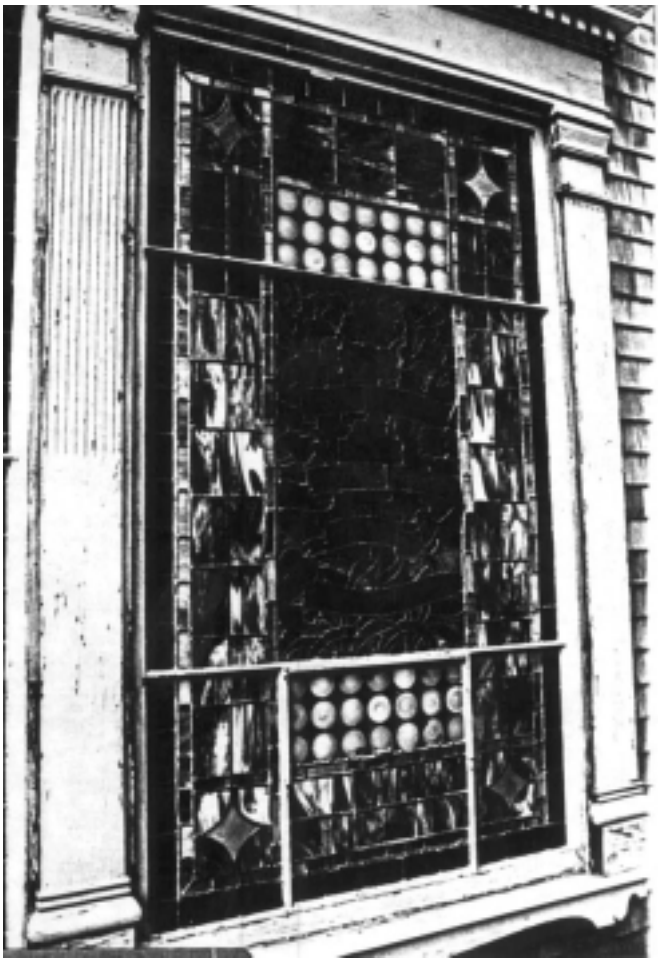
—Removal of the hazed PG revealed the --brightly colored class behind.

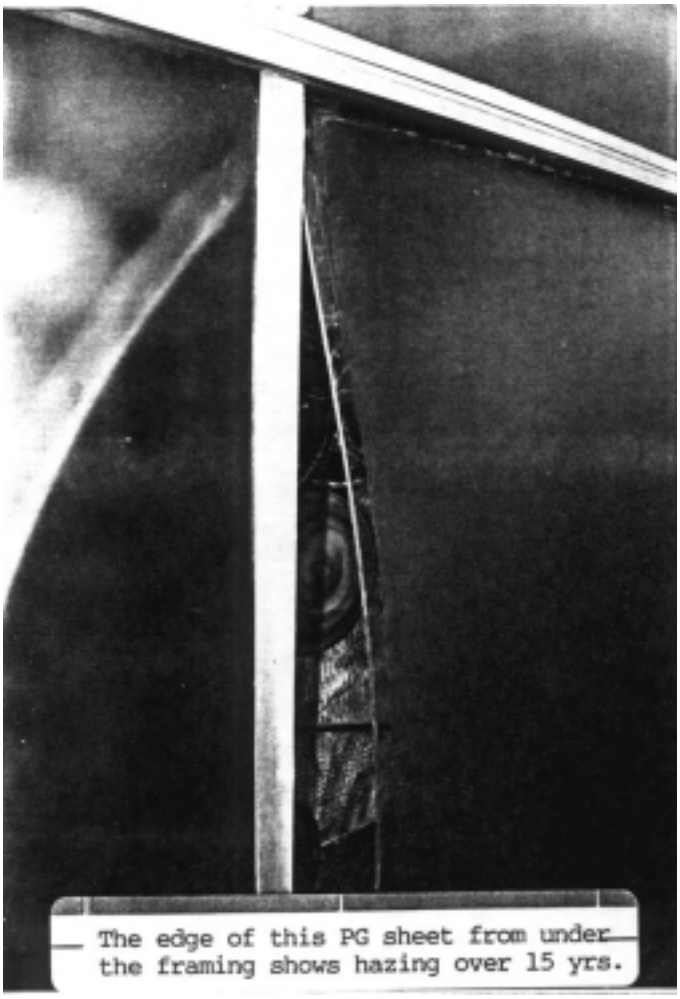
The edge of this PG sheet from under the framing shows hazing over 15 yrs.

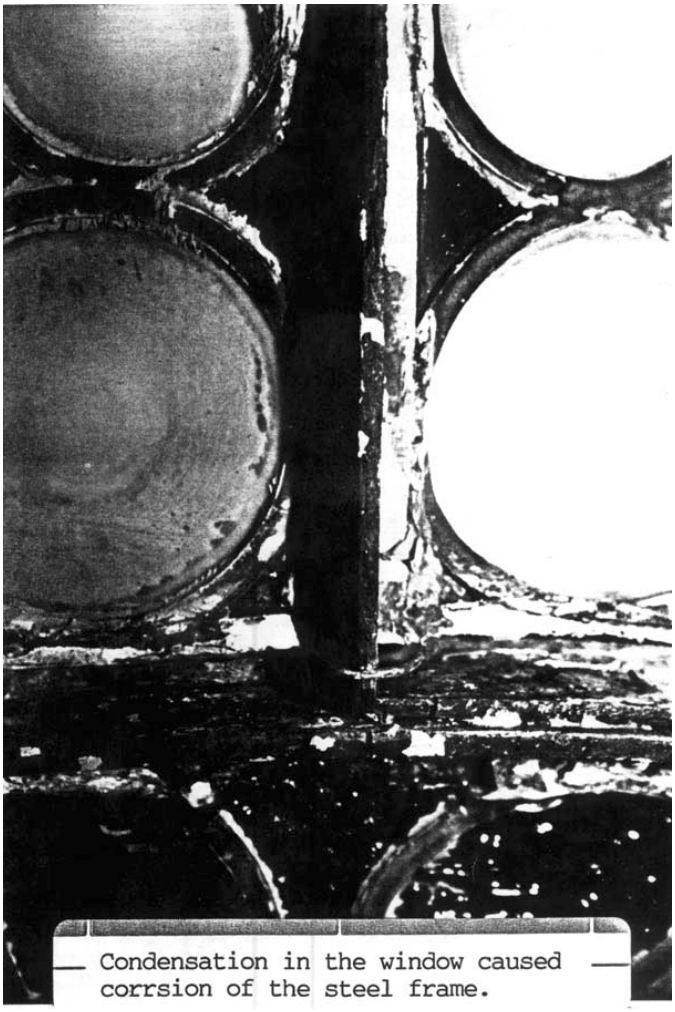
Condensation in the window caused corrsion of the steel frame.

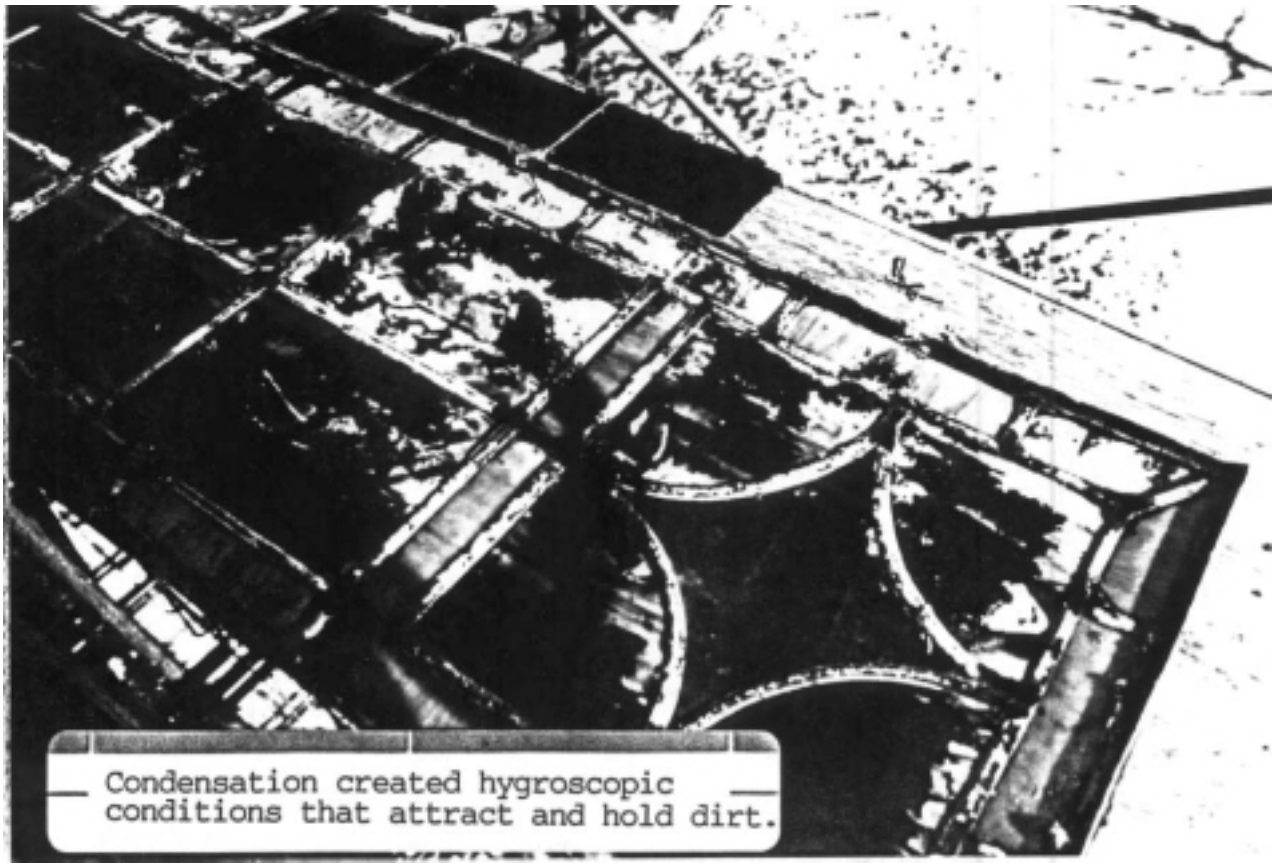
Condensation created hygroscopic conditions that attract and hold dirt.

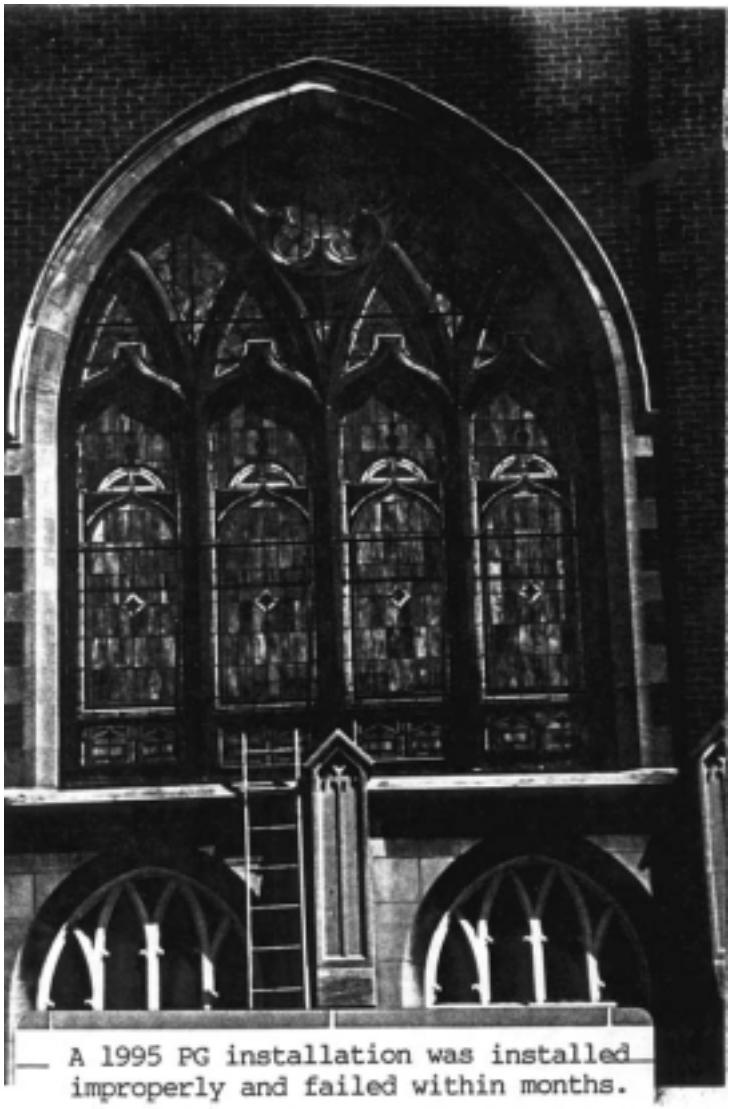
A 1995 PG installation was installed improperly and failed within months.

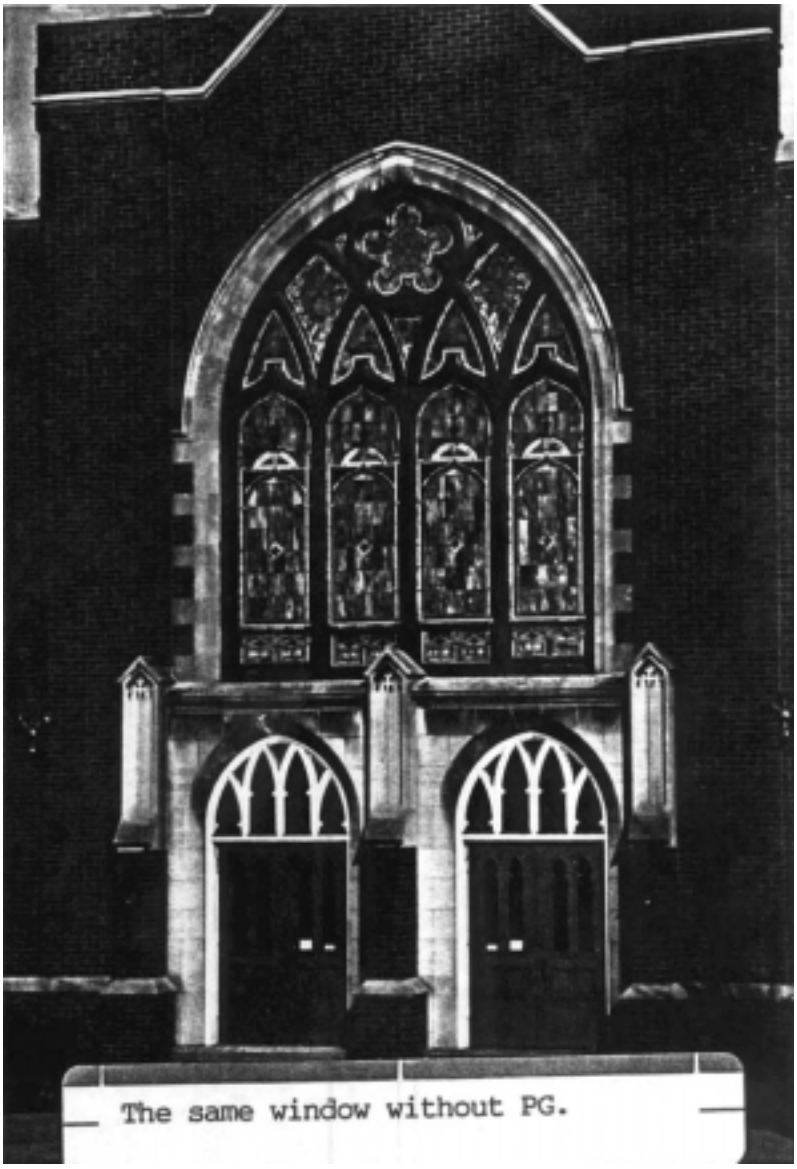
The same window without PG.

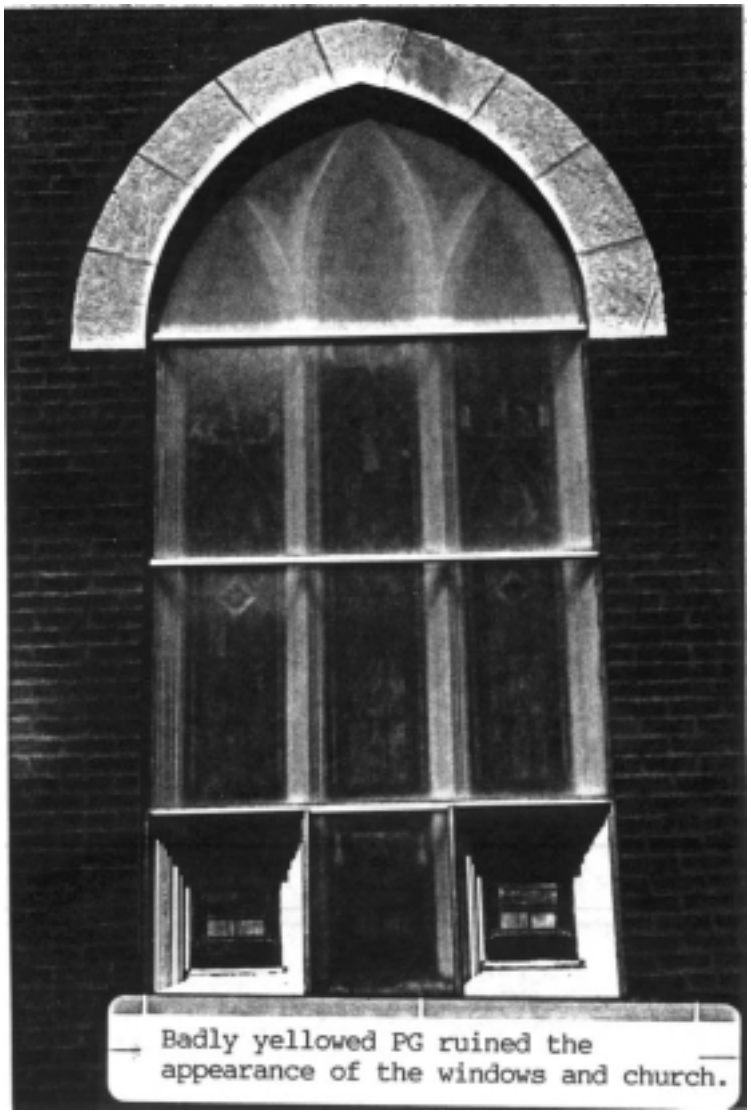
Badly yellowed PG ruined the appearance of the windows and church.

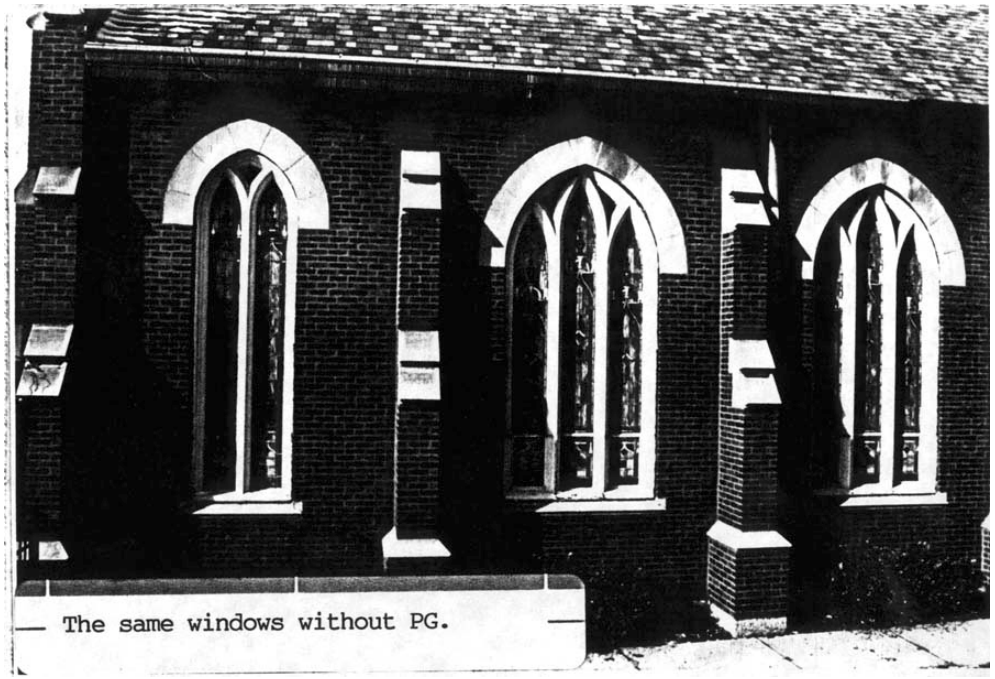
The same windows without PG.

PG typically causes condensation that gets trapped on the sill causing rot.

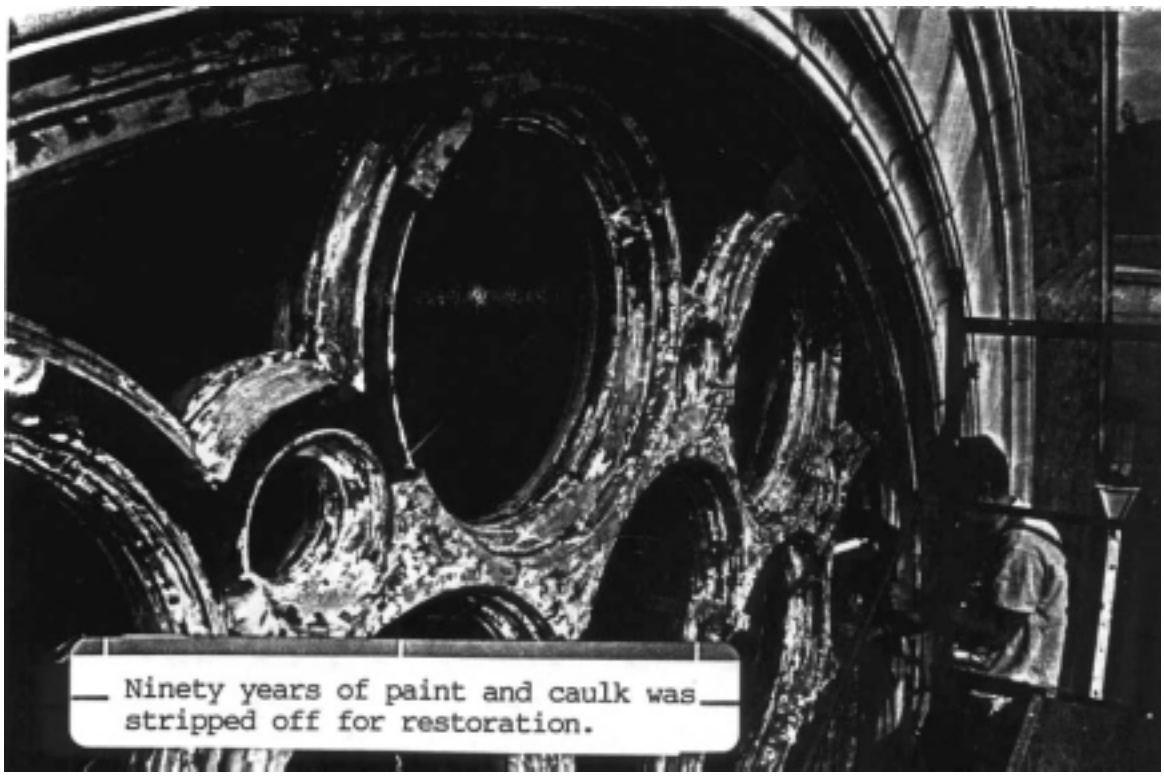
Ninety years of paint and caulk was stripped off for restoration.

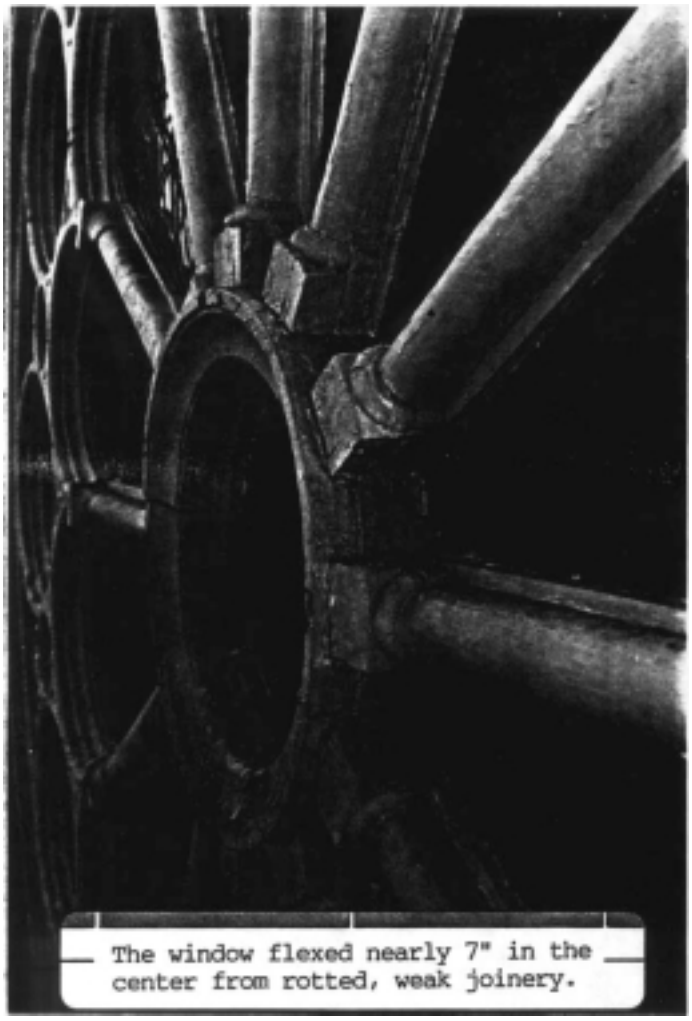
The stained glass has been flattened and braced as recent as the 1980s and was in good condition overall. However, the original 1906 window frame was in seriously deteriorated condition. Upon removal of the PG, it was discovered that the contractor "repaired" the frame with fiberglass cloth, bondo, paint and caulk before installing the PG less than ten years ago. The wood frame laminations were rotting and separating, particularly from six o'clock to 9 o'clock (as typical). The PG was hazed and the framing was weak and buckling badly.

The window flexed nearly 7" in the center from rotted, weak joinery.

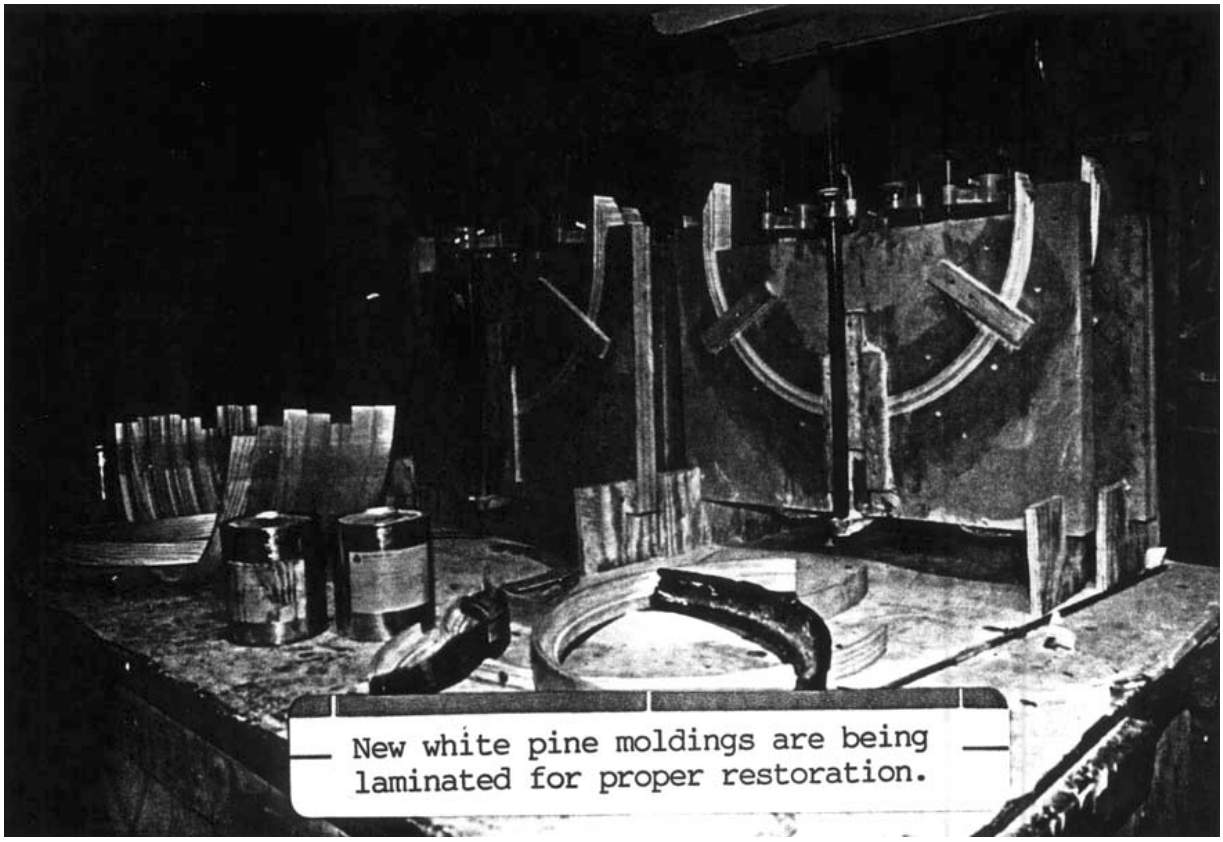
New white pine moldings are being laminated for proper restoration.

[The existing PG was removed and the window will be totally restored.] Test results indicate that the increase in sound transmission is negligible; probably because the rose window is over 30 feet above street level. Daylight only increased about 8% through the relatively dark red, blue, purple and green stained glass. The surface temperature of the glass dropped 11°F within a few minutes after the PG was removed. The frame is partially restored and the stained glass has been reinstalled at the close of this study; the exterior frame will be restored in spring of 1996. The church does not intend to reinstall any PG which will save about $8,000 (if properly installed within the tracery). The total cost of restoration will be approximately $45,000. Hyde Park Union is an excellent example of how PG is too often used to defer badly needed restoration; the rose window was dangerously close to collapse prior to restoration **(see Case Study #6 photos and C4 in Appendix A).**

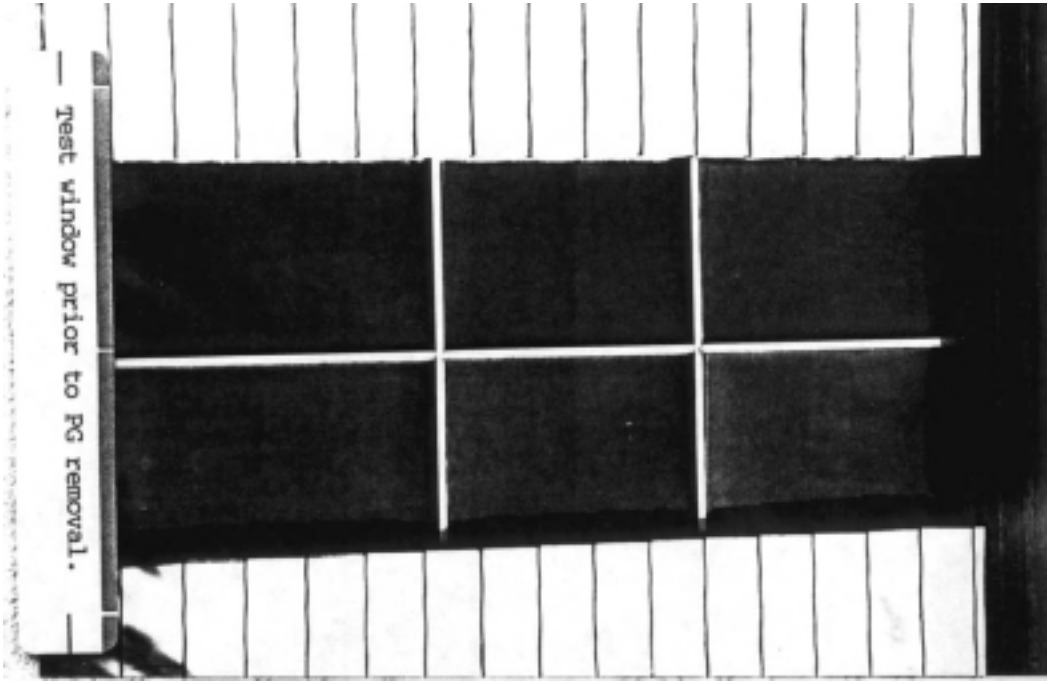
Test window prior to PG removal.

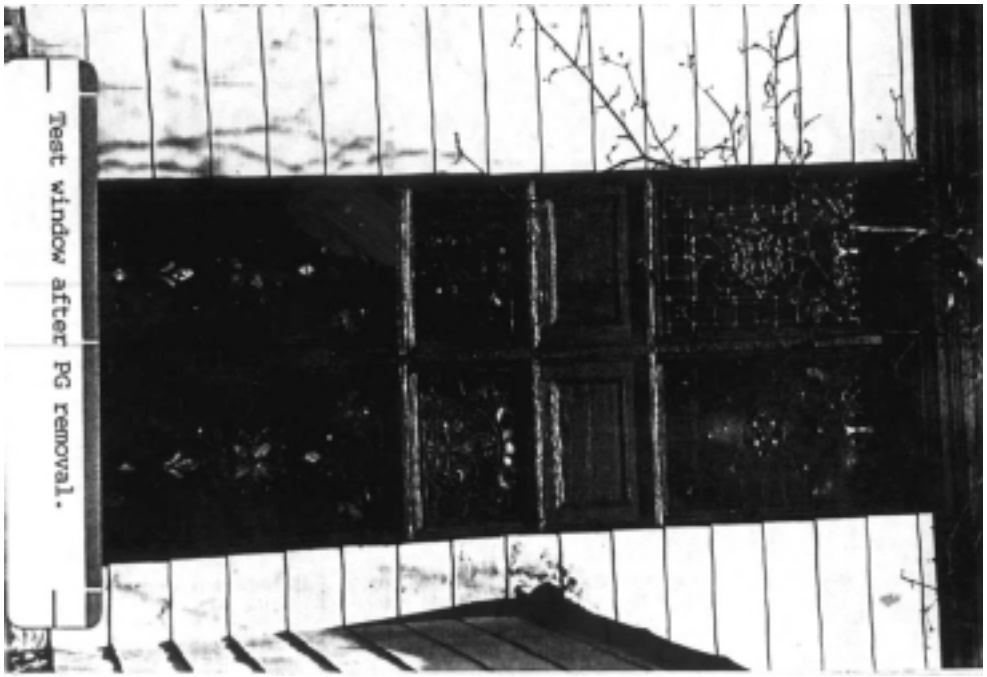
Test window after PG removal.

[The existing PG was removed and the art glass was waterproofed.] Test results indicate that sound transmission only increased two decibels, despite the window's close proximity to a major Chicago thoroughfare with bus traffic. Daylight only increased one footcandle despite the badly hazed PG since the window was so dirty. Cleaning the outer surface of the art glass doubled the daylight through the window, and restored a *"luster and sparkle"* [to the art glass] *"not seen in years"* The surface temperature of the glass dropped 13°F within a few minutes after the PG was removed. The church hopes to continue PG removal soon, and strip off the composite siding in the next few years.
(see Case Study #7 photos and C8 in Appendix A).

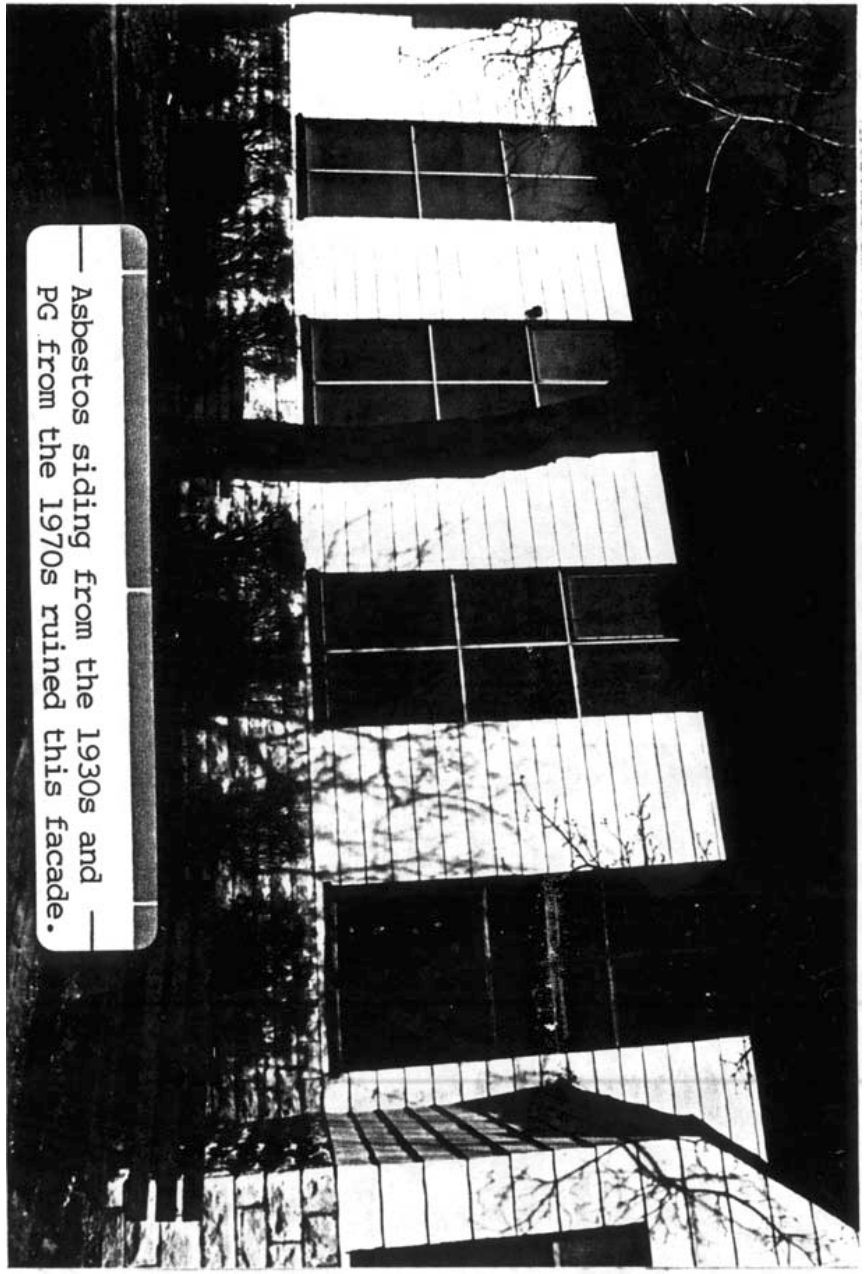
Asbestos siding from the 1930s and PG from the 1970s ruined this facade.

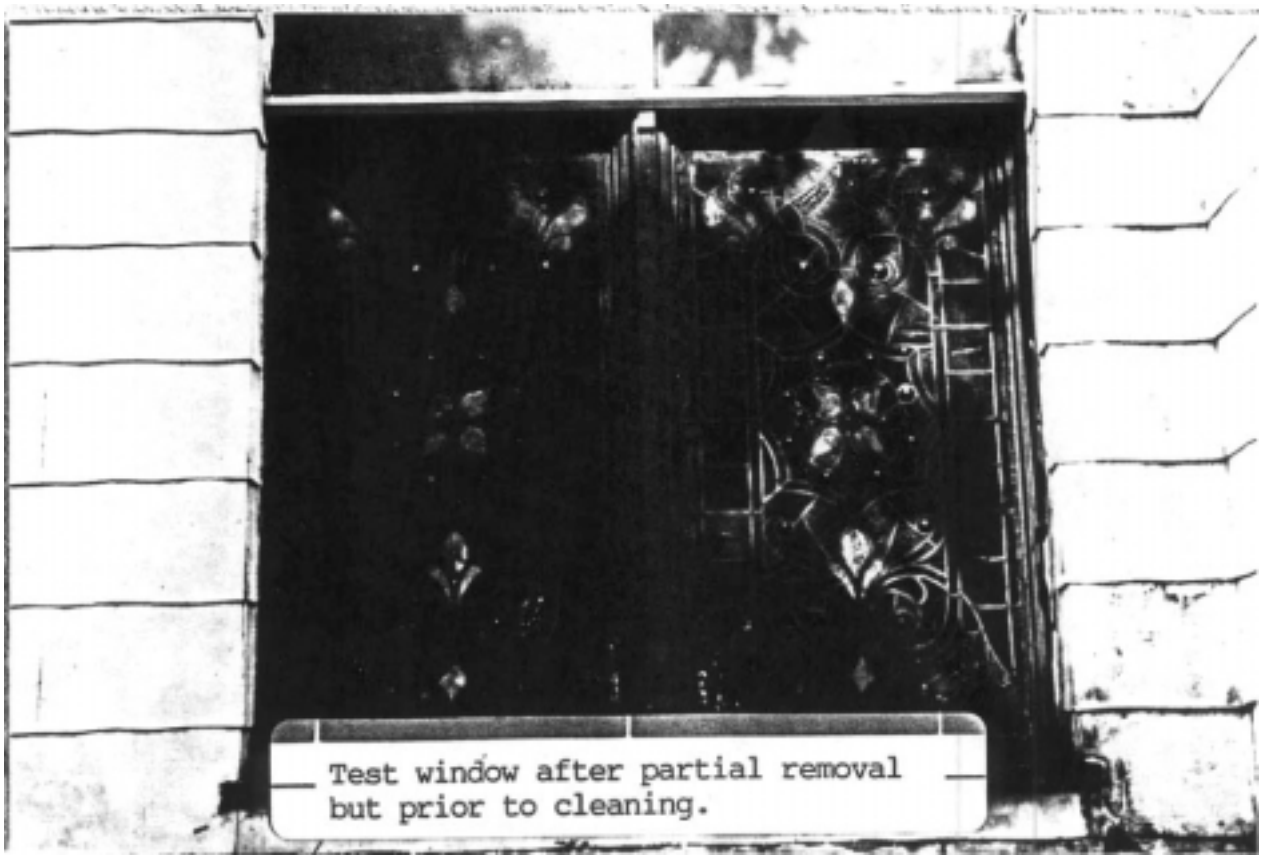
Test window after partial removal but prior to cleaning.

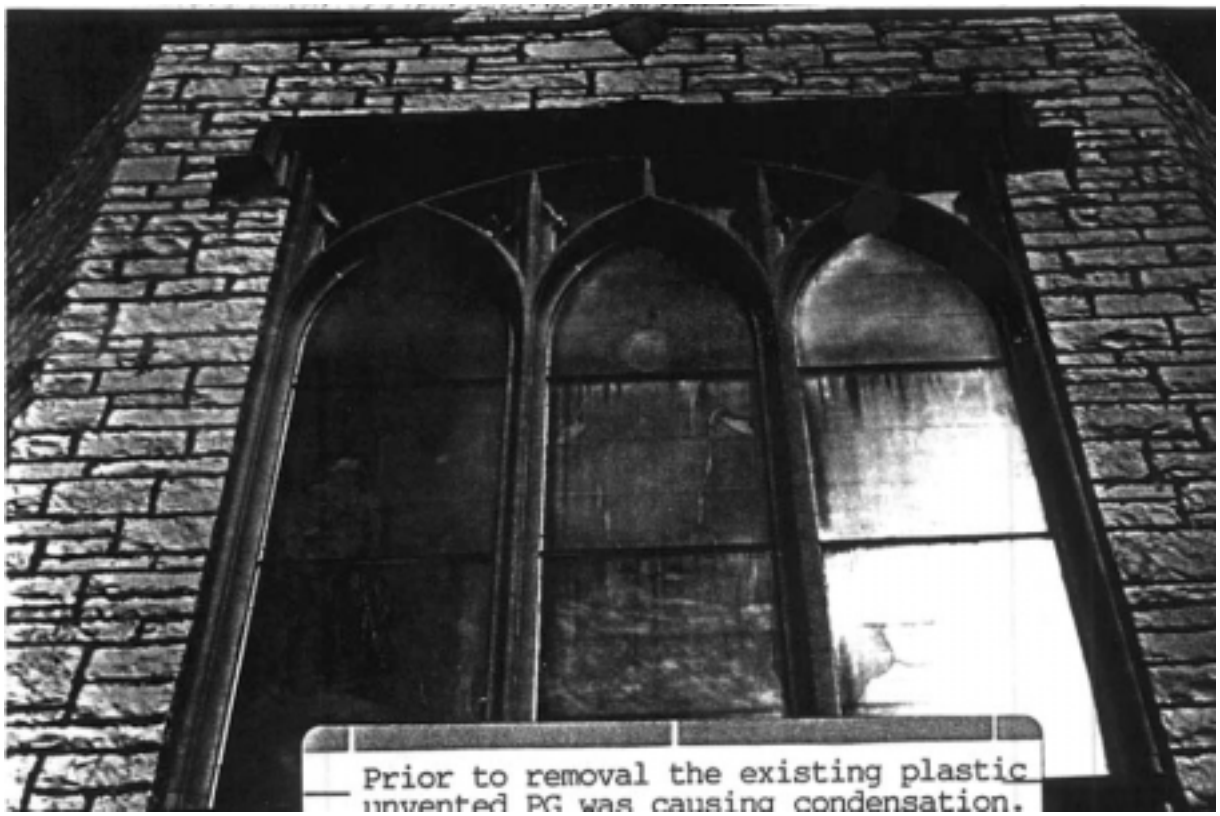
Prior to removal the existing plastic unvented PG was causing condensation.

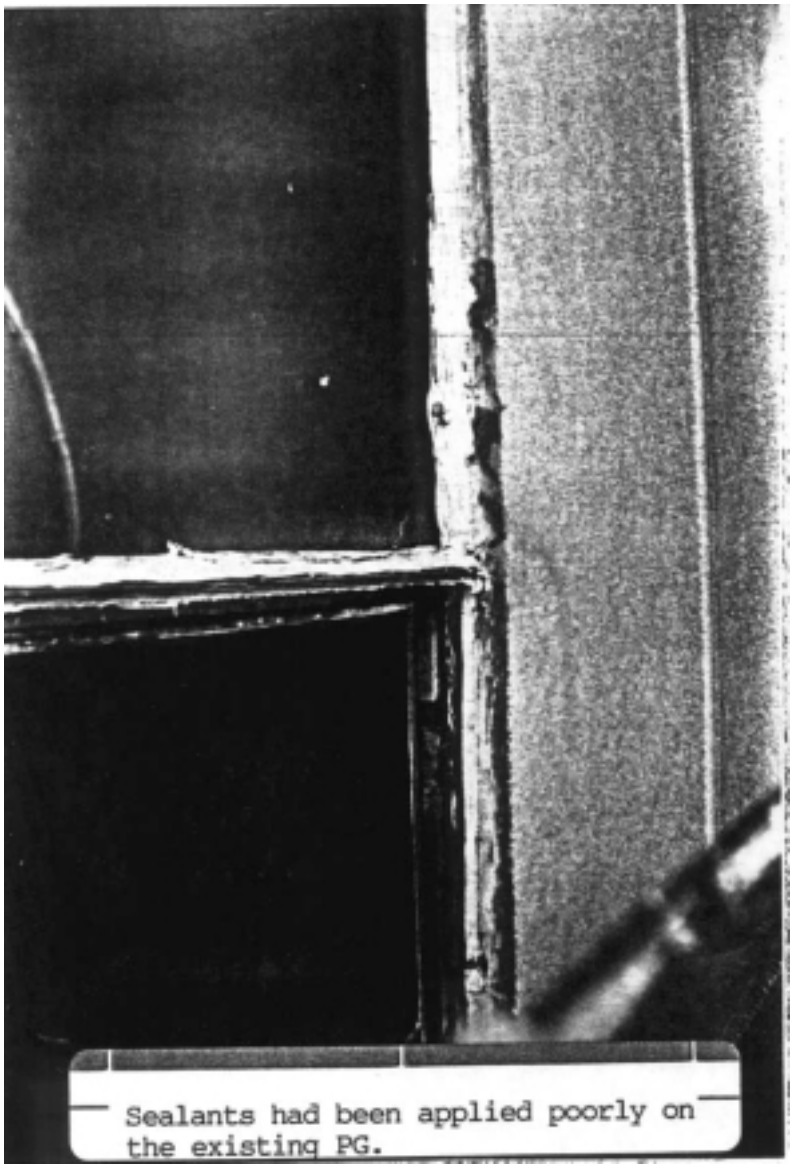
Sealants had been applied poorly on the existing PG.

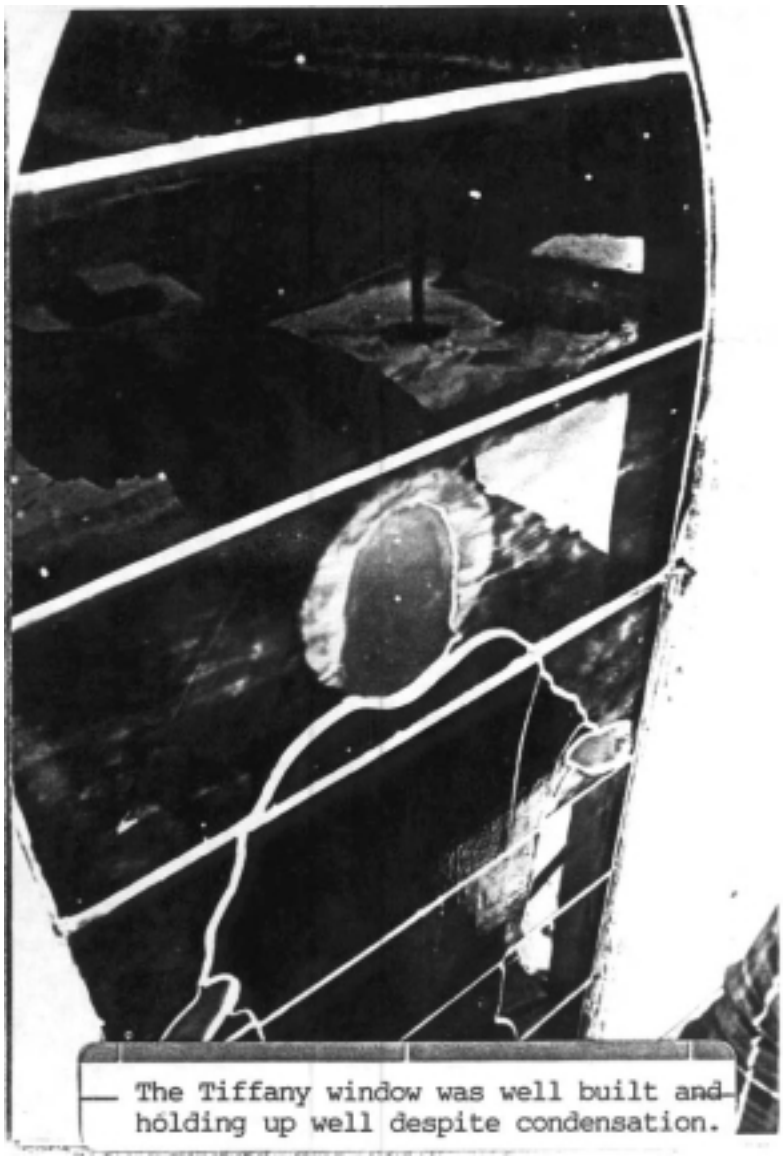
The lexan, as typical, has clouded over, but the window was included in this study due to concerns over extreme condensation problems in the interspace observed on many clear mornings. Even though the window was in excellent condition, the PG has only been in place for a relatively short time and there was a prevailing concern to investigate the condition before any serious problems developed. Levere Temple is located in an upper income neighborhood and adjacent to Northwestern University. Nevertheless, the plated Tiffany window is extremely valuable necessitating protection from any possible vandalism or storm damage. The *Lexan*® was removed in December, 1995 from the center lancet only and replaced with '4" laminated glass that was set further away (1") from the stained glass. The two lower corners and apex of the lancet arch were cropped ¼" to allow for external air flow across the window.

The Tiffany window was well built and holding up well despite condensation.

[The existing PG was replaced with ¼" laminated glass and vented.] Test results indicate that sound transmission was unaffected through the heavily plated window. Daylight only increased one footcandle, also due to the numerous layers of opalescent glass in the plated window. The surface temperature of the glass only dropped a few degrees after the PG was removed. However, the laminated glass allows the window's intense colors to be seen from the outside as well. More importantly, no condensation has been observed since the replacement with ventilated PG **(see Case Study #8 photos and C7 in Appendix A).**

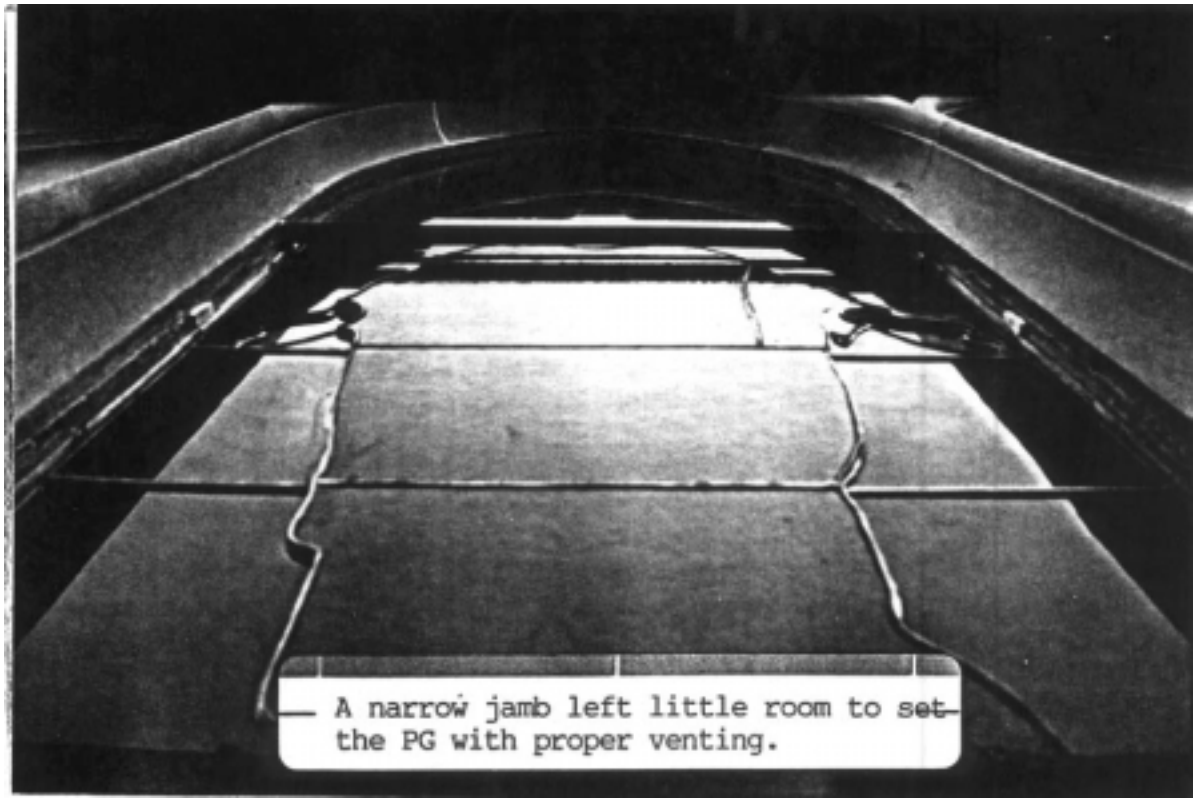
A narrow jamb left little room to set the PG with proper venting.

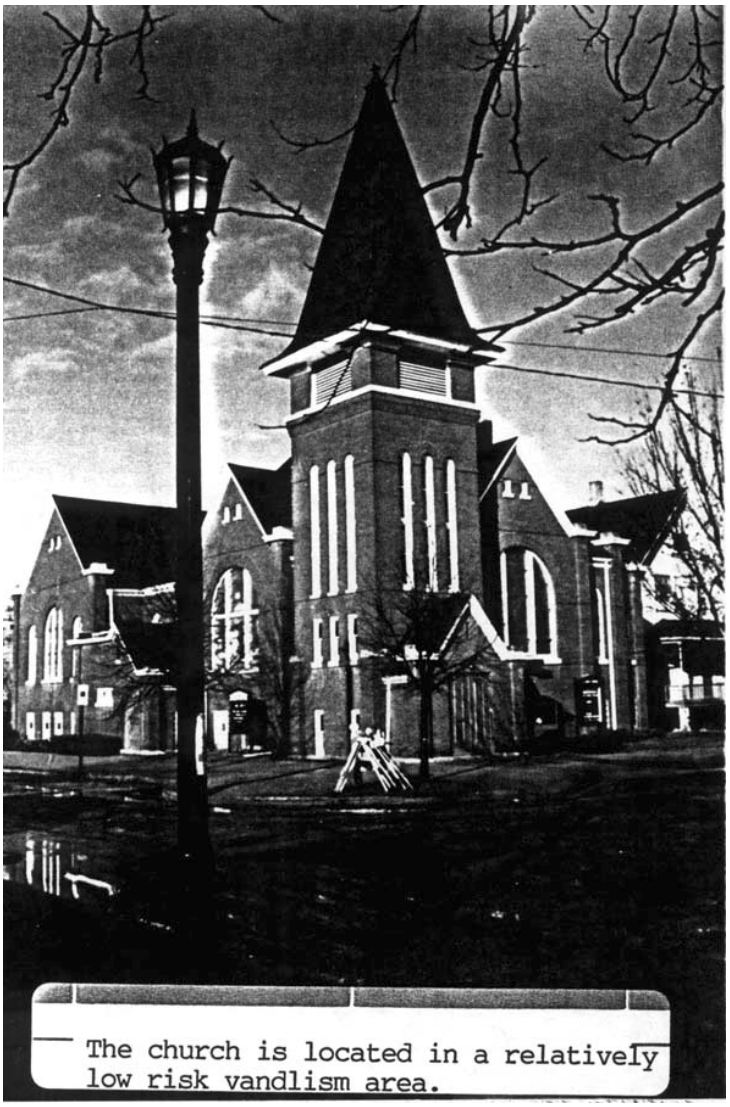
The church is located in a relatively low risk vandlism area.

The PG installed in 1982 had hazed badly.

[The existing PG was removed, the frame repaired, and vented ¼" laminated glass was installed.] Test results indicate that sound transmission was unaffected while daylight doubled! The surface temperature of the glass only dropped a few degrees after the PG was removed. As with many of the other case study windows, removing the PG revealed serious deterioration of the window frame and the need for wood repairs. These rotting conditions would have eventually jeopardized the structural integrity of the frame and caused the window to collapse. Once again this proves that PG is a barrier to maintenance. The new laminated glass allows the window's opalescent colors to be seen from the outside as well **(see Case Study #9 photos and C3 in Appendix A).**

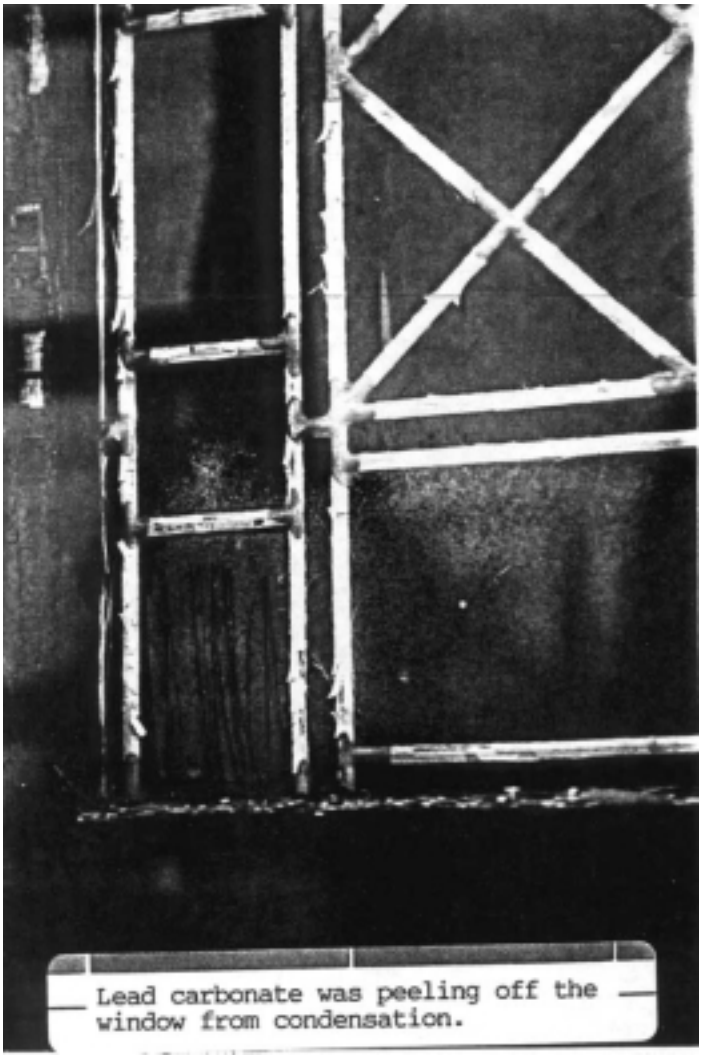
Lead carbonate was peeling off the window from condensation.

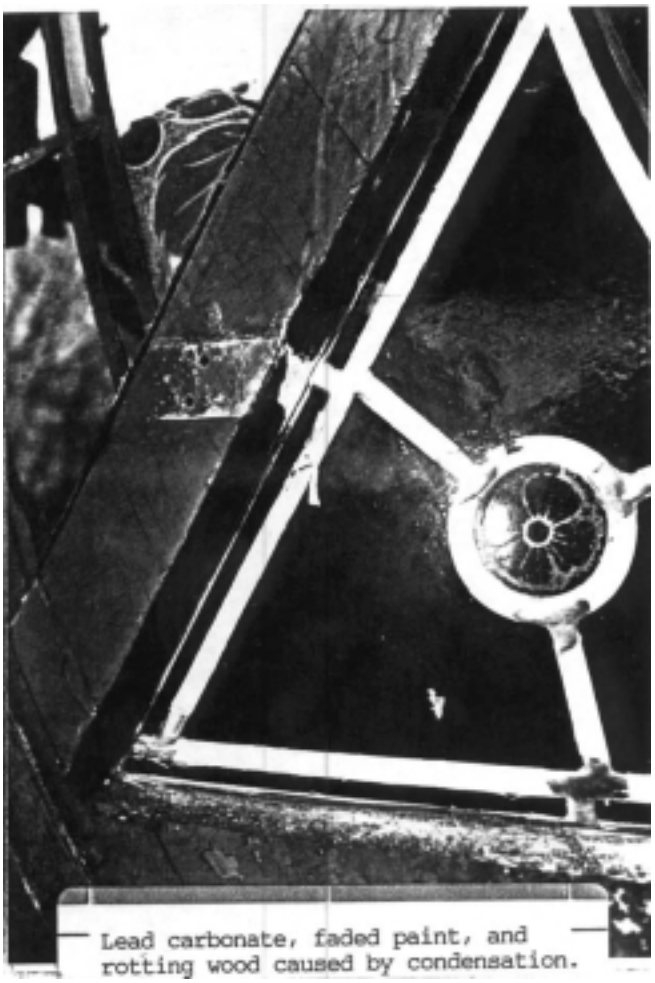
Lead carbonate, faded paint, and rotting wood caused by condensation.

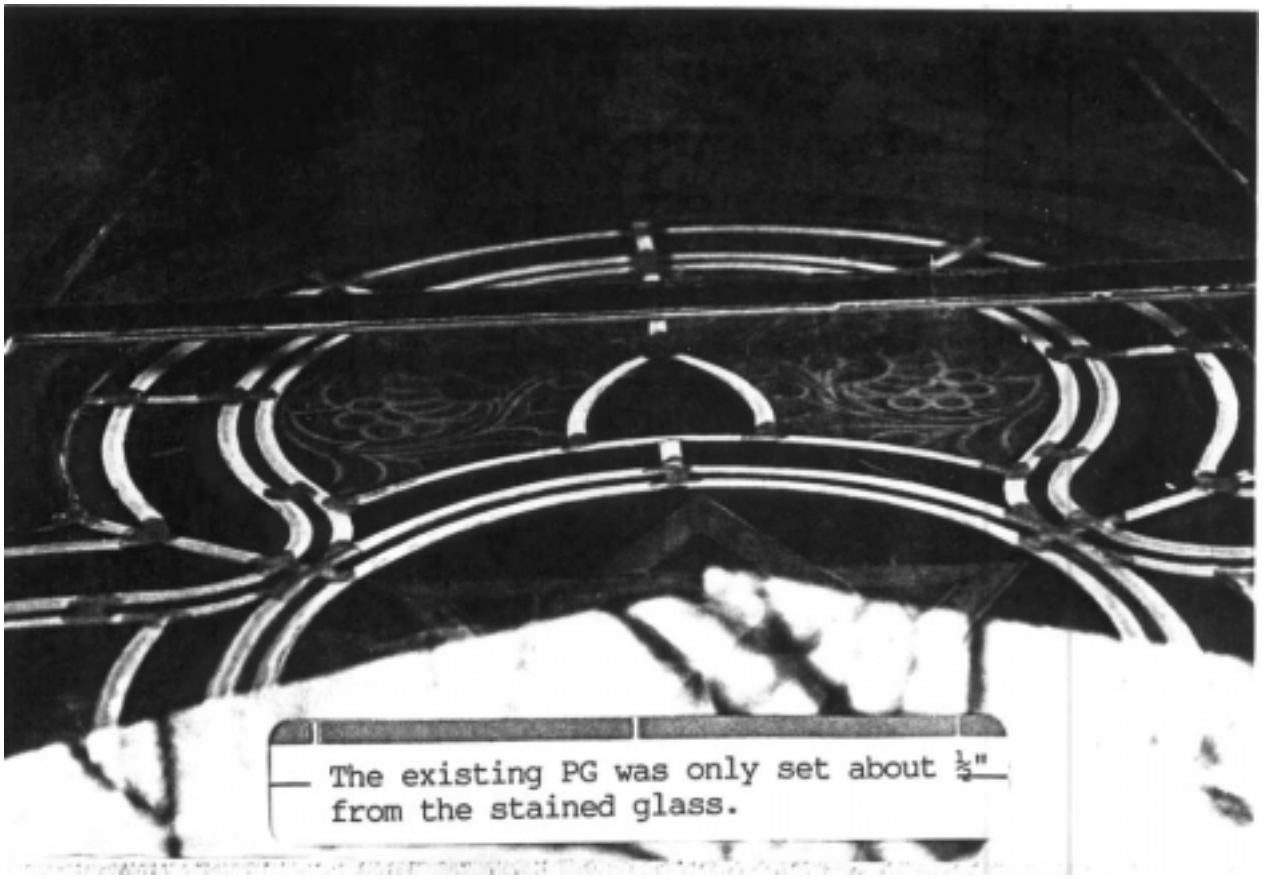
The existing PG was only set about ½" from the stained glass.
