PROTECTIVE GLAZING STUDY

National Preservation Center

Inspired Partnerships, Inc.

March, 1996

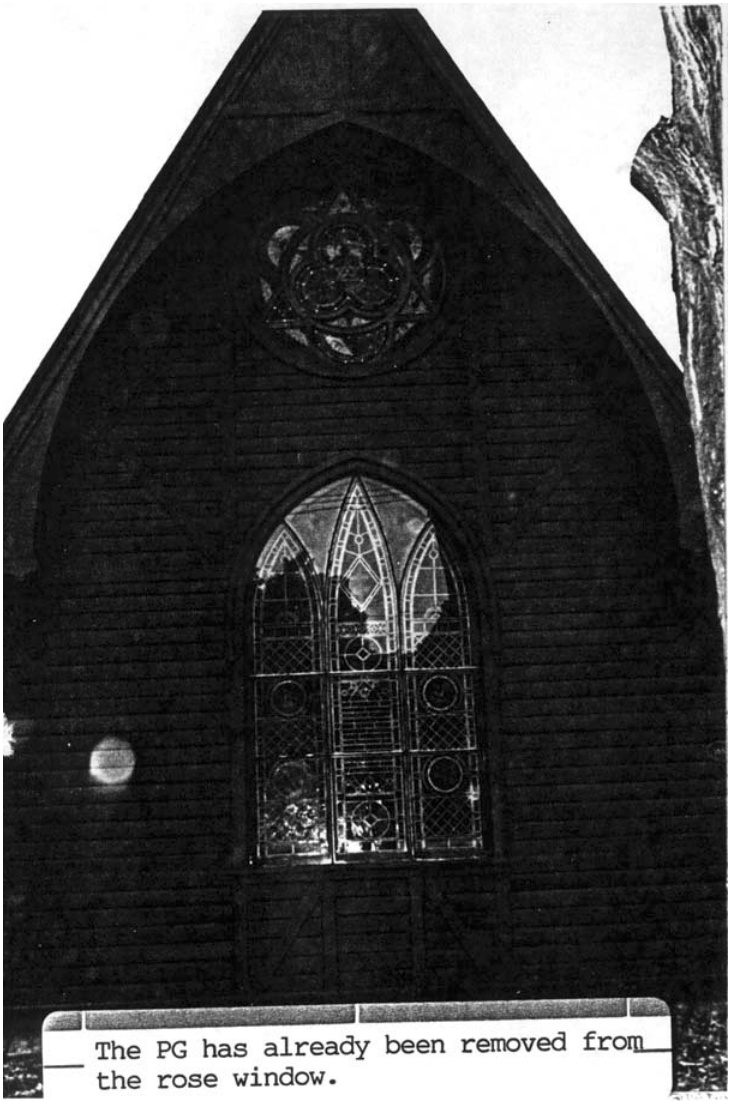
The PG has already been removed from the rose window.

As typical, the PG sealants broke down causing leaks in the interspace.

[The existing PG was **removed from the rose window which will be restored; the existing PG on the lower arched window will be reinstalled with venting].** Test results indicate that sound transmission increased a few decibels while daylight was unaffected by removal of the clear, clean glass. Overcast skies prevented any testing of the surface temperature of the glass. As with many of the other case study windows, removing the PG revealed more deterioration of the window frame then the stained glass. These rotting conditions would have eventually jeopardized the structural integrity of the frame and possibly caused the window to collapse. Once again this proves that PG is a barrier to maintenance **(see Case Study #10 photos and C25 in Appendix A).**
