Testing the Energy Performance of Wood Windows in Cold Climates

A Report to
The State of Vermont Division for Historic Preservation
Agency of Commerce and Community Development

August 30, 1996

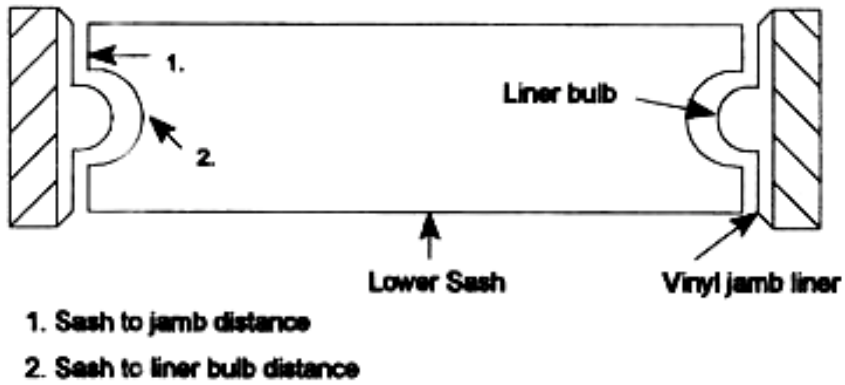
Figure 3: Schematic of lower sash and vinyl jamb liner junction

Separate variance t-tests showed site 12 windows to have significantly larger jamb liner/sash gaps than either site 13 or 7 at a 97% confidence level while having statistically the same $ELA_{s\ x\ 19}$ as site 13. Routing of the sash to accommodate vinyl jamb liners was

done by the same work crew at sites 12 and 13. A different work crew performed the work at site 7. No significant difference in jamb liner/sash gaps was found between sites 7 and 13 at a 98% confidence level while there was a significant difference in $ELA_{s \times 19}$ between the sites. Based on the limited data, it is inconclusive as to whether differing work crews had a significant effect on installation quality. In an earlier study, few significant differences in leakage rates were observed when differing contractors installed the same type windows in new residential housing in Minnesota (Weidt, 1992). It remained unresolved as to why site 7 window upgrades had better sash leakage characteristics than sites 12 and 13.

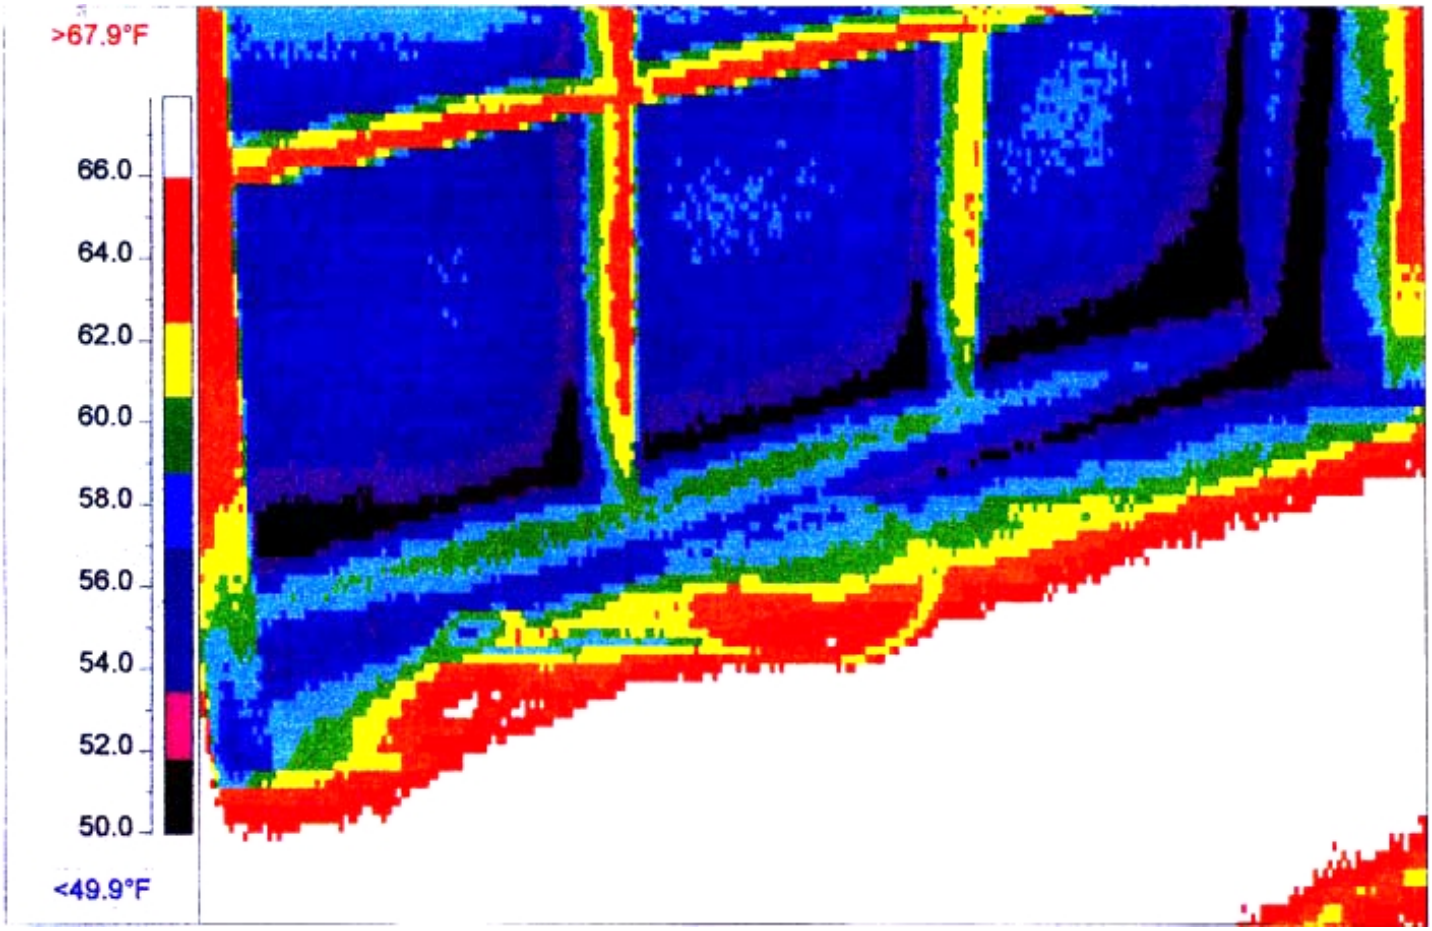
Figure 9: Thermograph of sash infiltration reduction due to rope caulking

Any conclusions based on the Robinson Hall thermographs must consider the effect of unequal space heating. As in most old buildings, hot water radiators were situated beneath the windows. The temperature regimes of the radiators varied considerably from window to window with the coolest radiator being below the coolest window and the hottest radiator being directly beneath the Bi-Glass System upgrade. The radiators likely had a significant effect on the glass surface temperatures, but it is unlikely either of the other two windows would have achieved as high a center of glass temperature as the Bi-Glass window.
