Protective Glazing Study | 1996-06

PROTECTIVE GLAZING STUDY

Inspired Partnerships, Inc.

March, 1996

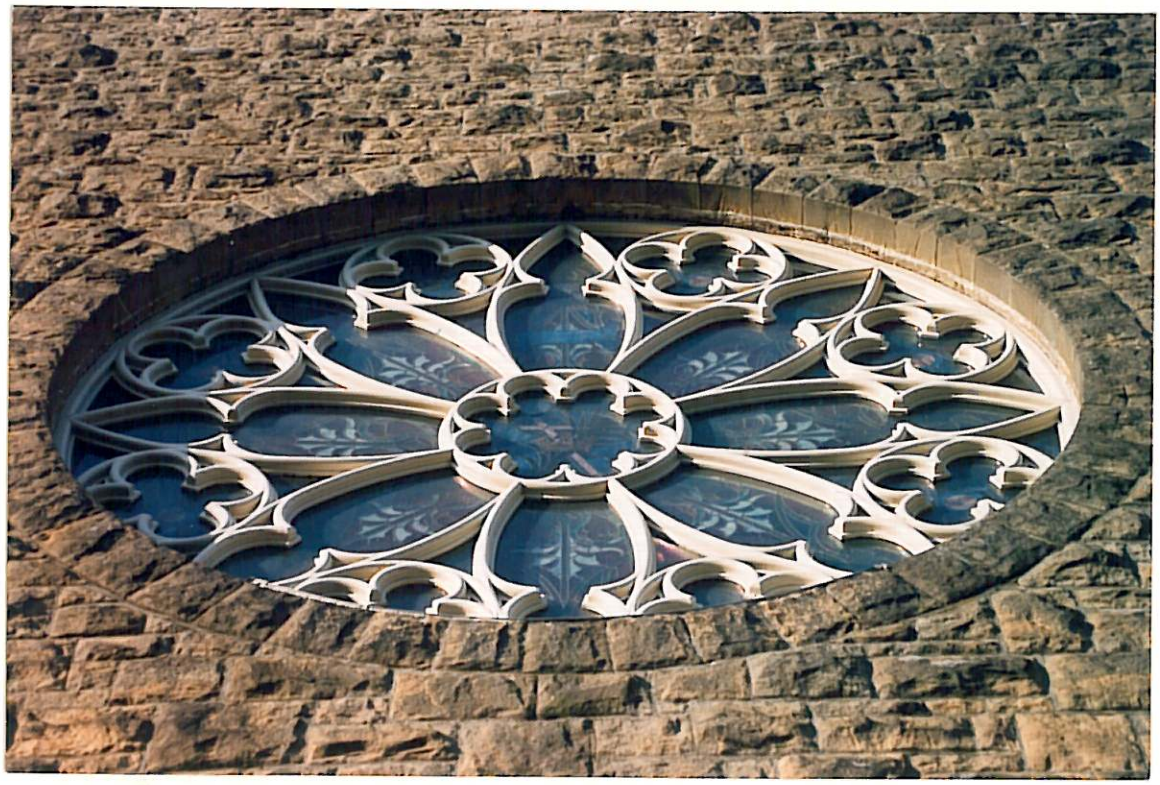
In terms of window orientation, the survey was concentrated on the east (31 %), south (40%) and west (27%) windows, since north windows are not effected by solar gain in the Continental U.S. **[FIG 1.]**. Among the windows surveyed, 40% are a simple rectangular or round-arch window, while 60% are gothic-arch or rose windows with tracery **[FIG 2.]**. Window height from the ground was recorded since improved security is often cited to warrant protective glazing; 22% are within five feet of the ground, 30% are between five and ten feet above ground; and 48% are over ten feet above ground (up to 40 feet) **[FIG 3.]**. The exact type of PG material was recorded when it could be determined, otherwise it was simply grouped into plastics (23%) or glass (27%). The breakdown of PG materials employed is: polycarbonates (31%); acrylics (14%), tempered glass (3%), laminated glass (1%), and fiberglass (1%). Therefore, as a group, plastic products accounted for approximately 70% of the windows surveyed. The age of the installation was also recorded when known.

Fig 1. Most of the windows were tested in direct sunlight.

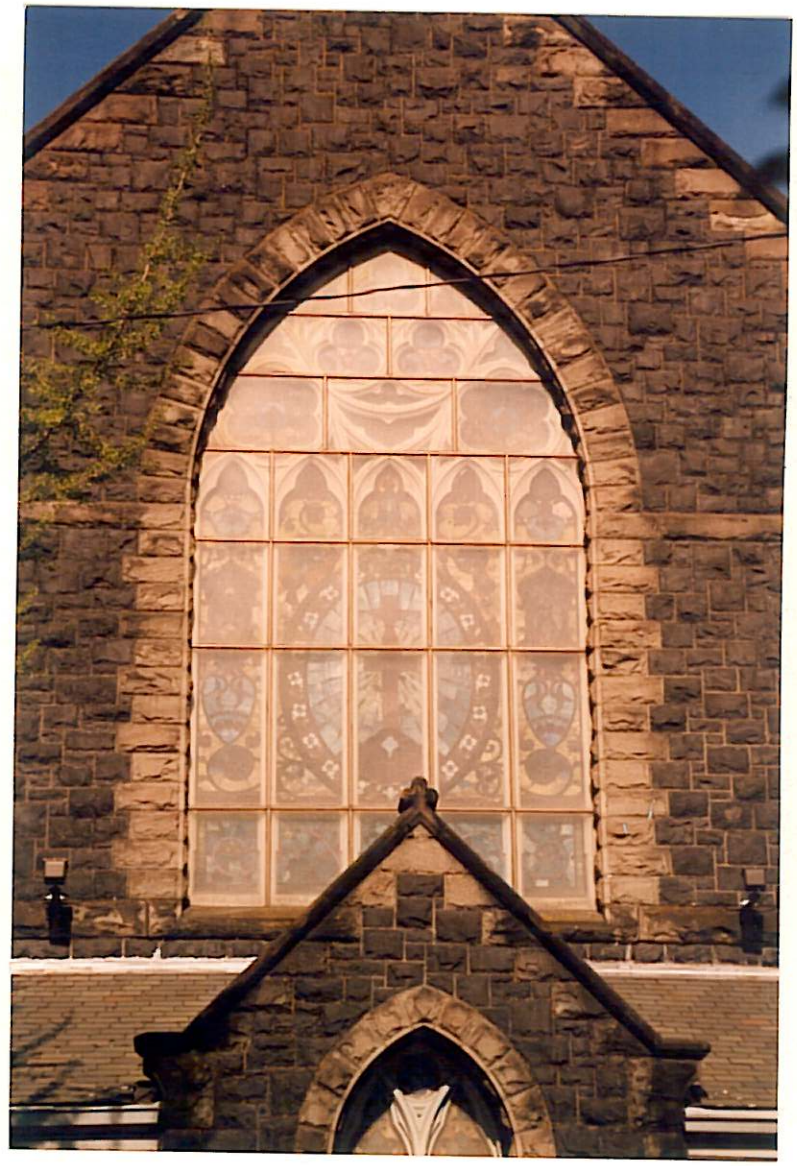
In terms of their condition, over half of the installations (both glass and plastic) appeared "dirty." Usually the dirt was found on the inside surface of the PG. Nearly all of the plastic installations are discolored, scratched or hazed and church members are displeased with their appearance **[FIG 4.]**. About 15% are too discolored to see the stained glass at all. The few (5%) of the plastic installations that are not discolored, scratched or hazed are less than two years old. Approximately half of the installations are set into a sub-frame, typically aluminum, which clashed with the building's historic materials and aesthetics. Another 23% prevent the window ventilators from operating.

Fig 4. Nearly all plastics have badly hazed and yellowed.

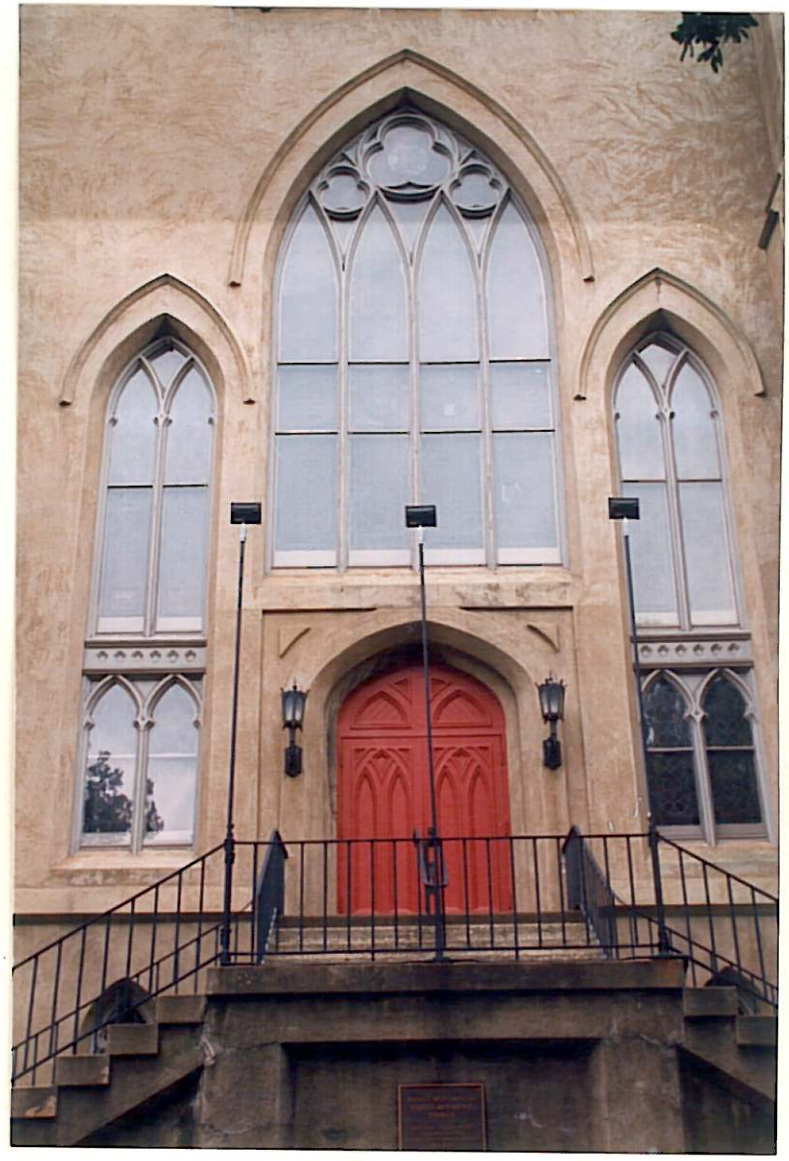
Fig 7. Glazing sealants and frames often deteriorate behind PG.

Nevertheless, the waterproofing (cement) was missing in areas on 40% of the windows and had completely failed on another 22% -- regardless of their quality. Moreover, the perimeter sealants had partially or totally failed on half of the PG installations. The PG definitely prevents proper window maintenance; approximately one-third of the windows surveyed required maintenance to the metal or wood frames, which were not accessible due to the PG **[FIG 7.].**

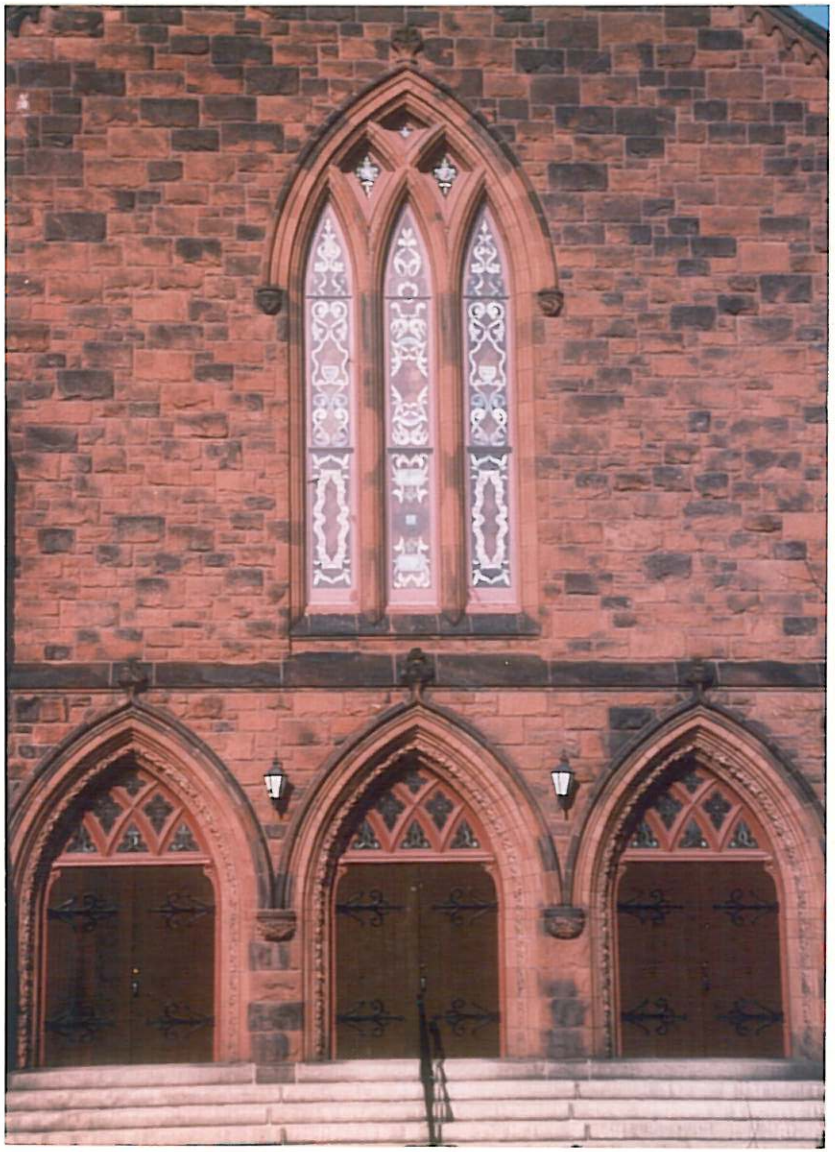
During the field survey, church and temple administrators and clergy were asked how they liked the way protective glazing <u>looked</u> on their building today...73% said they did not like the way it looked. None of those who had purchased plastic PG materials were happy with their appearance today. Although the glazing industry has claimed many advantages for PG, no one claims that it will actually make the stained glass look better. Windows that are not covered with PG look the best **[Fig 19., 20. 21. & 22.].**

Fig 19. The stone and glass harmonize without PG.

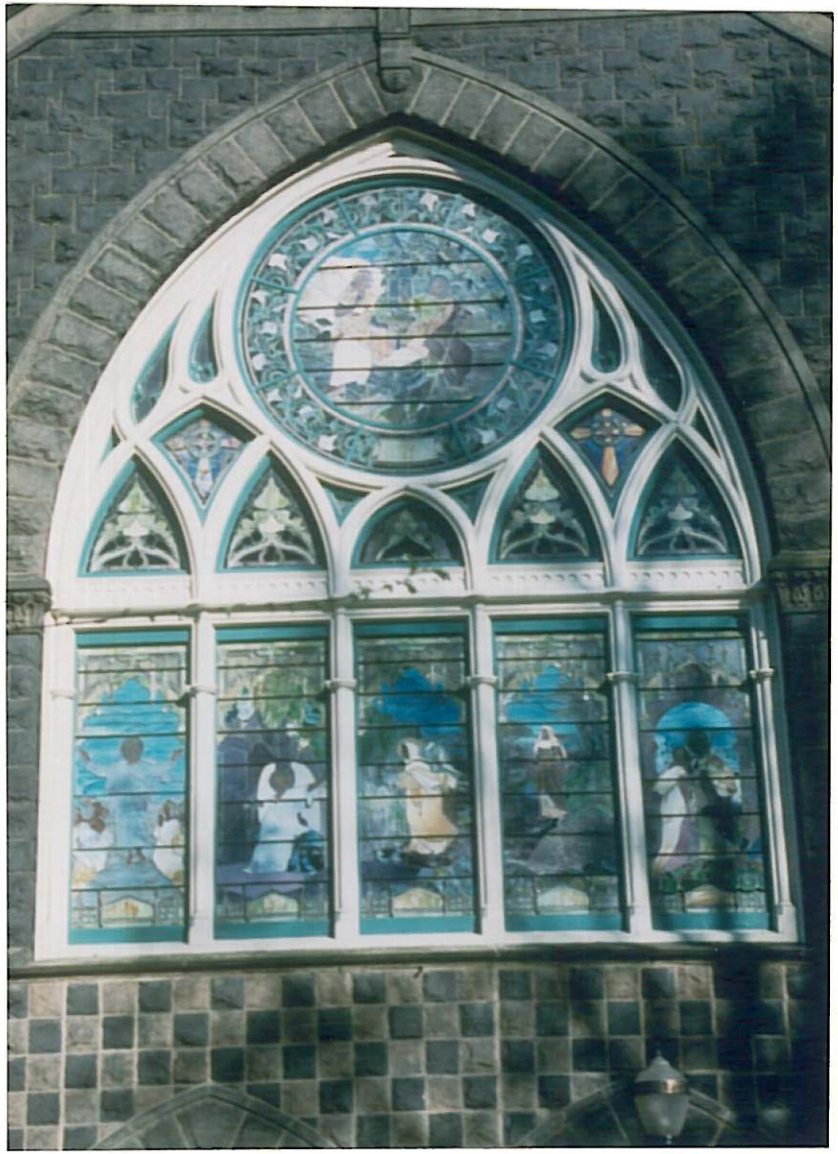
Color & Light: Although the color of stained glass is mostly viewed through transmitted light (from inside), some stained glass -- particularly opalescent glass -- is nearly as beautiful when viewed from the exterior **[see Figs 21. & 22.].** Most glass products today are very stable and will retain excellent clarity over the years. However, it is important to consider how light will play off the glass surface. Reflections and glare can be very disconcerting when PG is viewed from an angle **[Fig 27.].** Some historic and contemporary PG systems have used leading, either figurative or geometric, to break up the broad expanse of glass or sheeting and mitigate the glare. On primary facades, and where leading and texture are of great importance to the perception of the building, this can be a worthwhile approach. Leaded PG is expensive however, typically costing over $100 per square foot.

Fig 21. Opalescent glass adds color to the exterior.

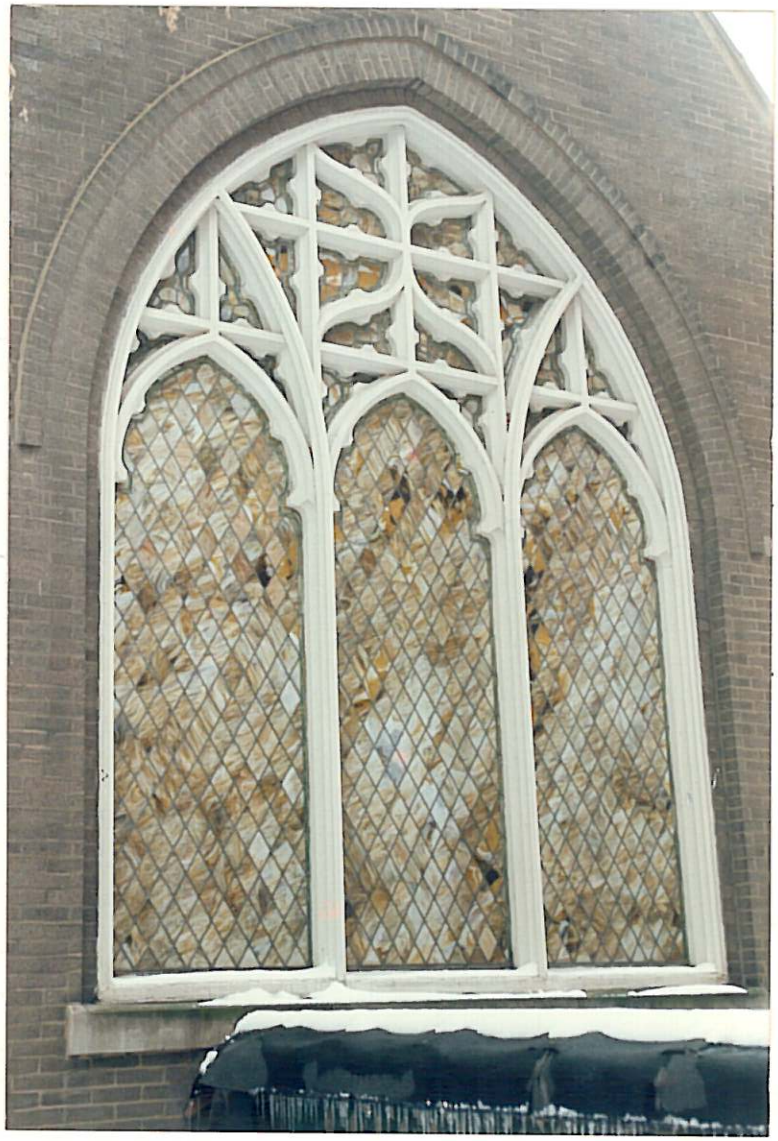
Fig 22. Even simple art glass looks better without PG.

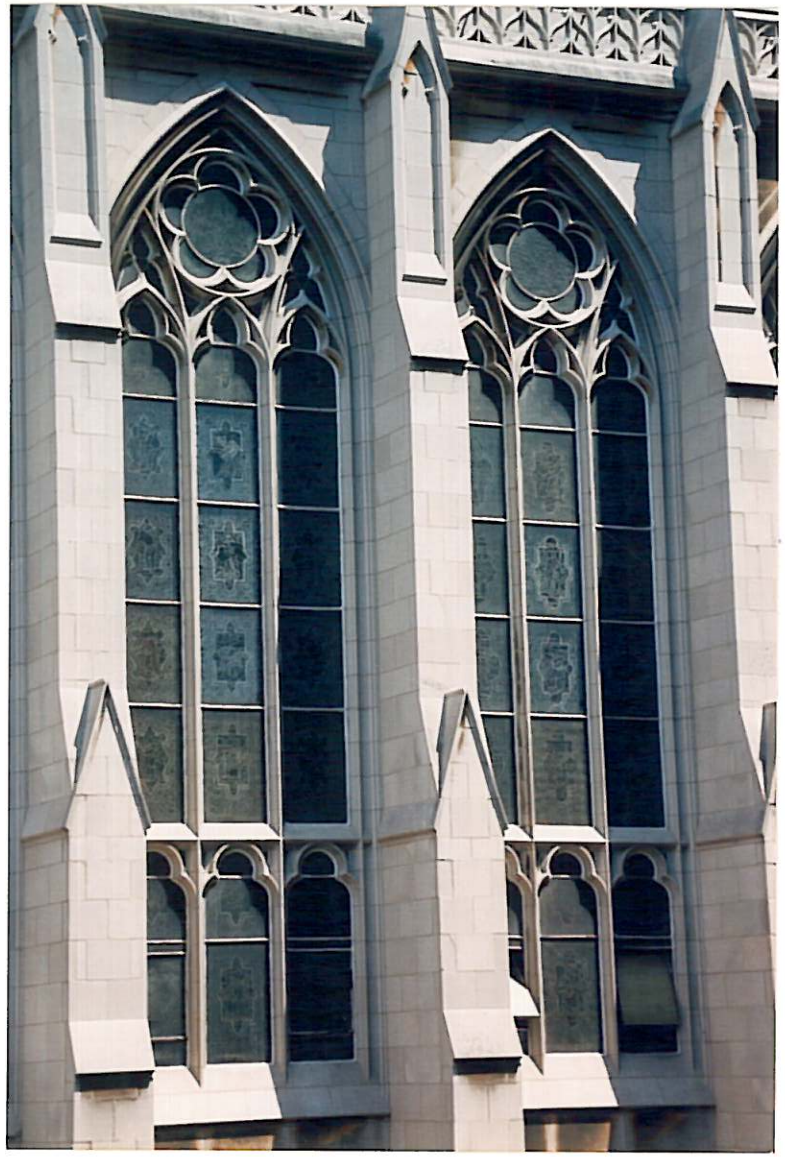
Fig 23. PG over the tracery would alter these windows.

Fig 24. The delicate tracery of this window is completely hidden.

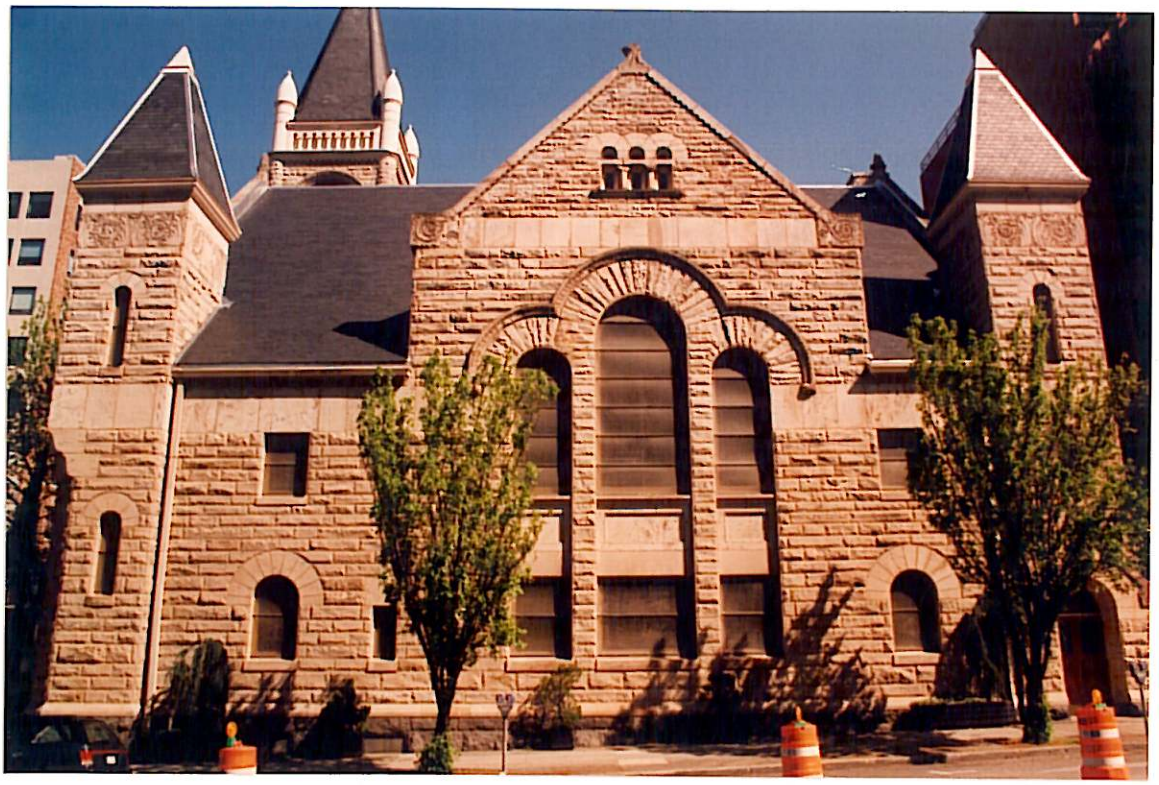
Fig 25. Romanesque Revival churches rely on the shadow effect of deep, recessed windows.

Fig. 26. Due to cloudy PG, these windows no longer read as apertures in the wall.

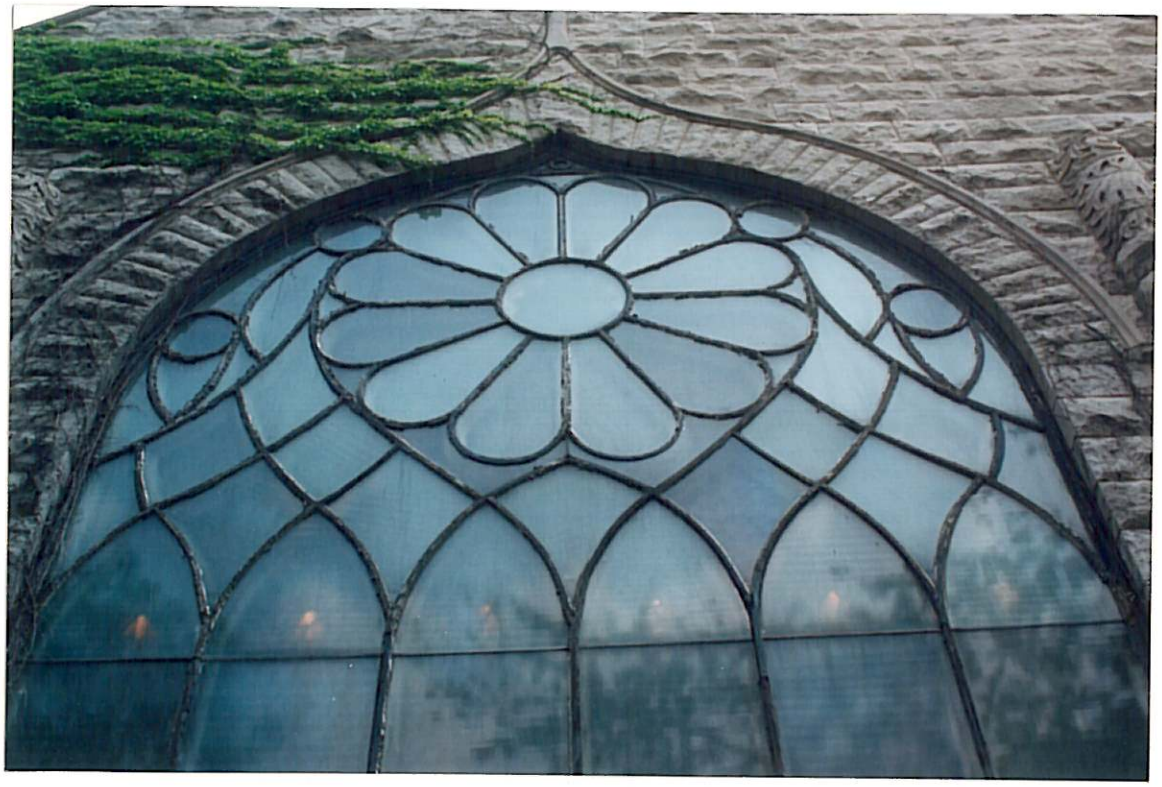
Window Framing: The design of the PG framework should be compatible with the design, materials and color of the original stained glass window frame. Installations in which the glazing is cut to fit within the existing mullions or conform to the tracery are visually most successful **[Figs 28. & 29.]**. Linear frames or grids are faster, easier and cheaper to install than curvilinear frames and have become a popular method of installing PG. Of the 100 installations randomly surveyed, 64% had PG frames which did not conform to the original window frame; most of the remaining 36% had simple shapes without any interior framing. Moreover, the color of the PG frame clashed with that of the stained glass window frame in 42% of these installations. An advantage of wood and steel PG frames is that they can be painted to match or compliment the original frame and surrounding trim. Aluminum frames do not hold paint well but are available in anodized colors, typically ranging from silver to bronze to black **(see Appendix B)**. Materials should be selected carefully to enhance rather than detract from the windows and architecture; aluminum or silver metallic colors should generally be avoided.

Fig 28. This PG needs maintenance, but the muntins conform to the tracery.

Fig 29. Another PG installation on the same building disregards the tracery.

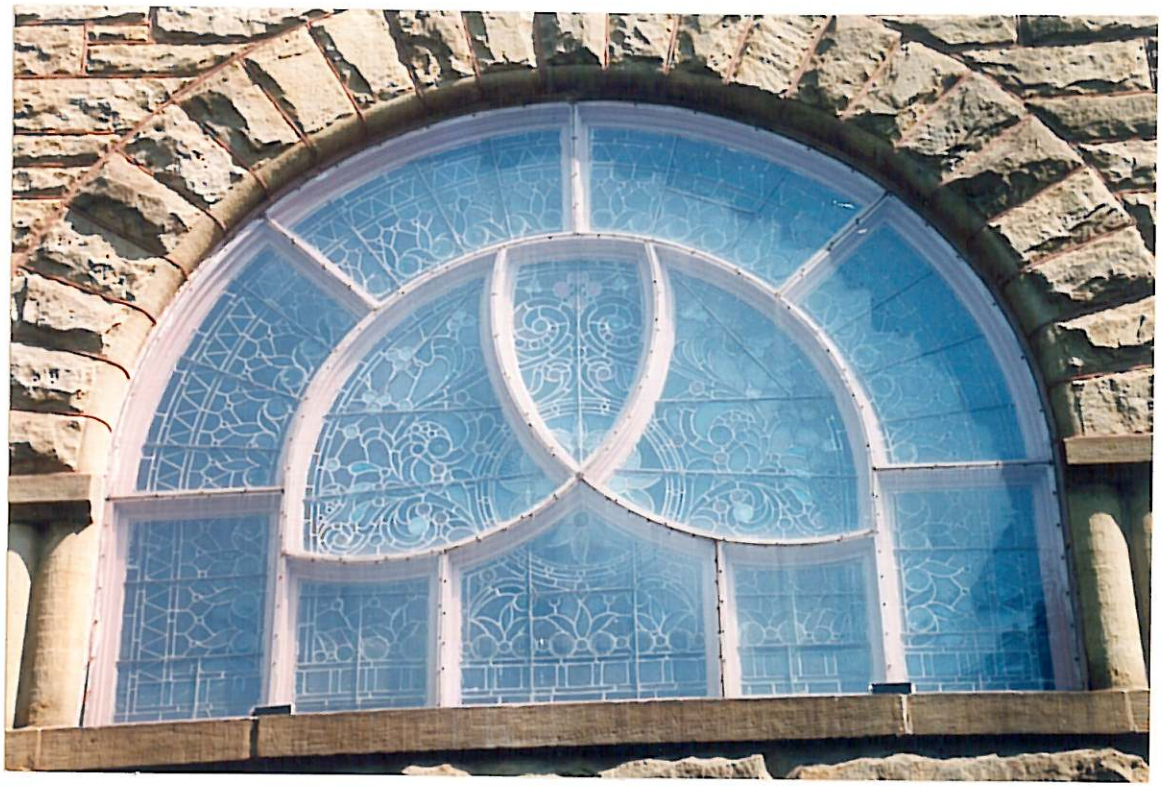
Fig 30. Only a few years old, this PG will haze and obscure the window reveal.
