Vibration characteristics of vaulted masonry monuments undergoing differential support settlement

Sezer Atamturktur [a,*], Luke Bornn [b,1], François Hemez [c,2]

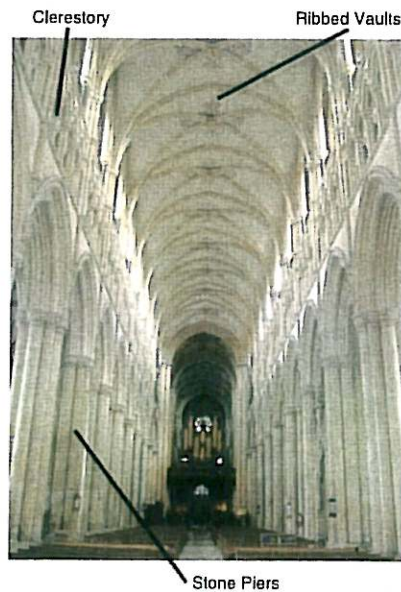
Fig. 1. The interior view of the nave of the Beverley Minster displays the limestone piers that support the stone vaulting. The leaning of the columns outwards is visually observable on site.

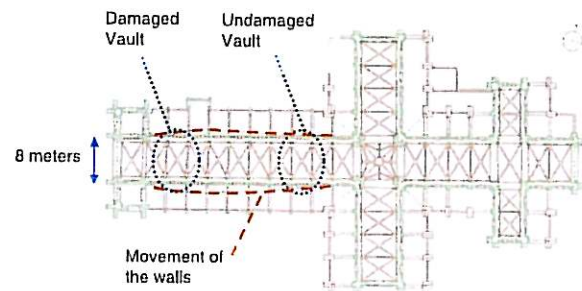
Fig. 2. A schematic of Sabouret Cracks, by Heyman [2] (with permission).

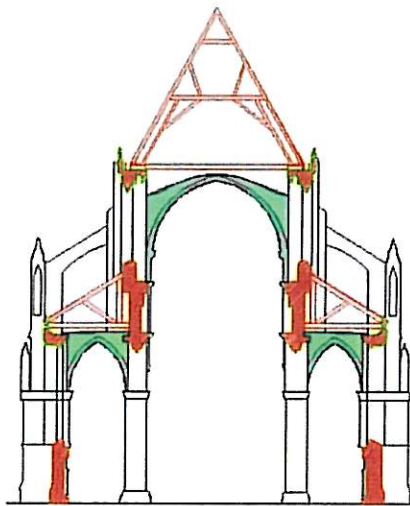
Fig. 4. The cross section of the vault displays how the stone walls and buttresses horizontally support the nave vaults. The settlement of the buttresses pulls the walls outward, causing separation between the walls and vaults.

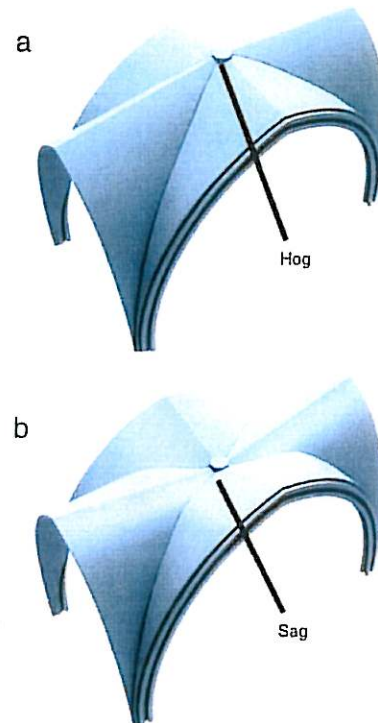
Fig. 6. The originally concave down curvature of the vaults is flattened: (top) undamaged and (bottom) damaged vault. The formation of the 6 "wide Sabouret cracks results in an 8" sagging of the crown of the vaults.

The two prototype vaults investigated in this study have two significant differences due to damage: the Sabouret cracks and consequent geometric distortion (Figs. 2 and 6). Aside from these two aspects, the two prototype vaults are expected to exhibit minor variations in their geometric and material properties. The present study relies on the important premise that these minor differences between the two prototype vaults have negligible effect on the vibration response. This premise will later be verified through FE simulations in Section 5. In the present section, however, we discuss two campaigns implemented to quantify

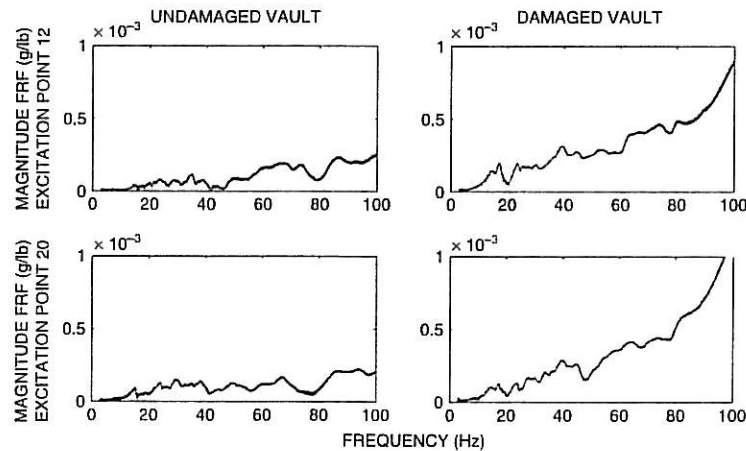
Fig. 16. The frequency response function of the damaged vault tends to have higher amplitudes compared to the undamaged vault, especially at higher frequencies.

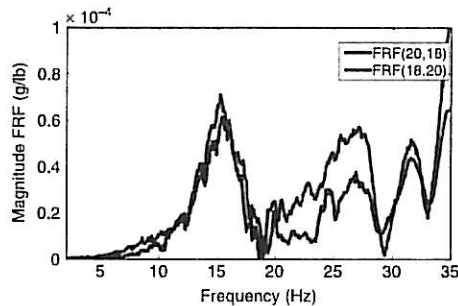
Fig. 17. The reciprocity check completed between measurement point 18 and 20 for the damaged vault.

Reynolds and Pavic [32] provide a discussion of quality assurance of test data obtained from civil engineering systems. As part of the quality assurance procedure, reciprocity checks are completed to confirm the linear behavior of the vaults under the excitation forces (Fig. 17). However, the judgment of the analyst is necessary for determining the acceptability of the deviations in the reciprocity check. Once again, considering the inherent variations in both the testing procedure and the tested structure, the correlation obtained between FRF(18, 20) and FRF(20,18) of Fig. 17 is deemed acceptable. Also, because the peaks of these two FRFs remain nearly unchanged, the identification of modal parameters is minimally affected by the presence of the deviations.

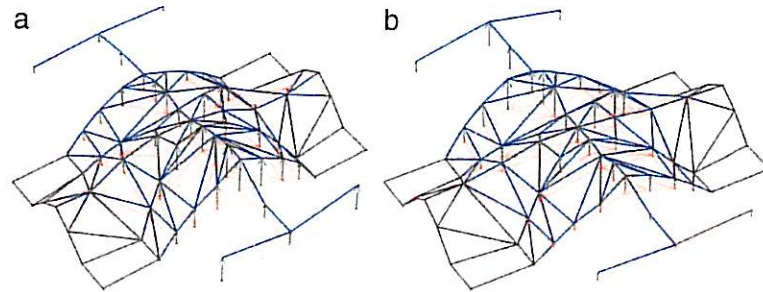
Fig. 18. The first mode shape of (a) undamaged vault, (b) damaged vault.

Assurance Criterion (MAC) is used to obtain a lower-dimensional metric to compare the mode shapes obtained from the damaged and undamaged vaults. A MAC value of 1.0 represents a perfect correlation between two mode shape vectors, while 0.0 indicates two orthogonal mode shape vectors, i.e. uncorrelated mode shapes. Due to the complexity of *in situ* experiments, MAC values of 80% or higher are considered satisfactory for the purposes of this study. Fig. 18 provides a visual comparison of the first modes of the two prototype vaults, which yield a MAC of higher than 90%. In Table 3, mode shape vectors are shown to yield good correlation for the first three modes, while higher-order modes exhibit less correlation. This observation is in agreement with an earlier study by Ramos [10], which demonstrated the insensitivity of mode shapes to structural damage. However, the higher-order, uncorrelated mode shapes are possible indicators of differences between two structural conditions, i.e. wall–vault separations. This statement assumes that the system identification is completed with sufficient accuracy.

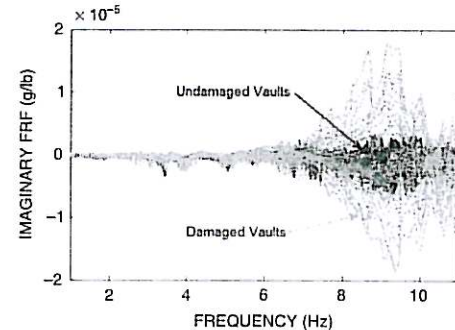
Fig. 19. The imaginary component of the FRF conveys the relative deformations of the measurement points, which are observed to be comparable for the damaged (red dashed) and undamaged (blue solid) vault for frequencies below 7 Hz. Frequencies higher than 7 Hz have significantly higher amplitudes for the damaged vaults.

Overlaying FRFs obtained from the damaged and undamaged vaults gives a visual indication of change between the structures. As Fig. 19 shows, the FRFs obtained from the two vaults agree relatively well up to 7 Hz. For higher frequencies, the FRF obtained from the undamaged vault has significantly lower amplitudes than the FRF obtained from damaged vault. The same trend is observed consistently in all FRFs (Fig. 19) and is in agreement with the simulated response of the vaults as given in Fig. 10. Through this visual assessment, the FRFs yield a clear indication that a change between the two structural systems has occurred. This observation is consistent with the FRFs simulated by the FE model (see Section 4), as indicated in Fig. 10. If the onset of damage introduces nonlinearity to a predominantly linear system, then coherence functions can be used as damage indicators. A typical coherence function, corresponding to the driving point measurement at the crown of the undamaged vault, can be seen in Fig. 20. The coherence functions of the damaged vaults are observed to be lower than those of the undamaged vaults, possibly due to system damage amplifying the nonlinearity of the vibration response.

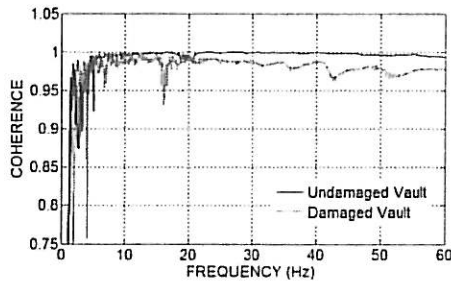
Fig. 20. The coherence plot indicates the linear relationship between the input force and output response. The damaged vault coherence plot shows a reduction in this linear relationship.

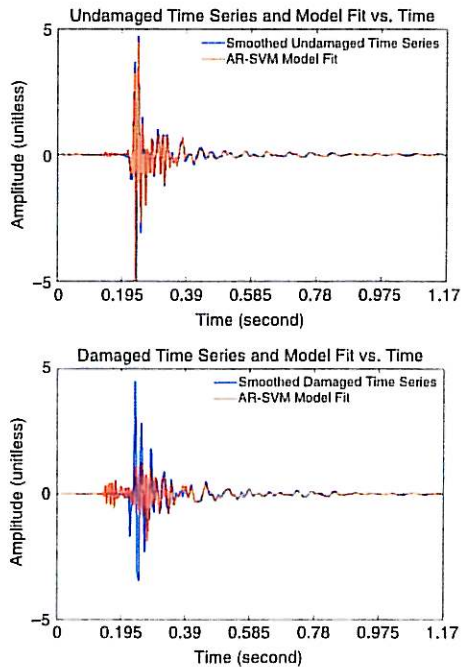
Fig. 21. Comparison of AR-SVM fit to normalized transient impact data in (top) undamaged and (bottom) damaged cases. Average absolute residuals for this sensor in the undamaged and damaged cases are 0.0412 and 0.1308 respectively, indicating significantly improved model fit to the undamaged case.

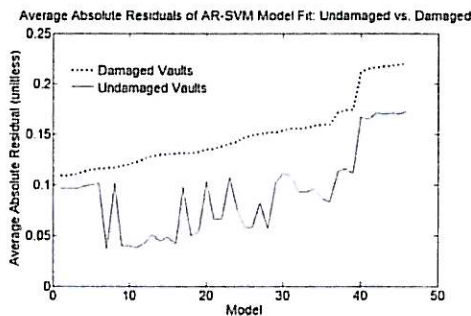
Fig. 22. Average absolute values of lack-of-fit residuals of AR-SVM predictions at 46 sensor locations for the undamaged and damaged cases.
