WOMEN'S OLD GYMNASIUM
HISTORIC STRUCTURE REPORT

Northwestern State University
Natchitoches, Louisiana

Regina T. Binder
With Joan Berkowitz and David Bitterman

1993

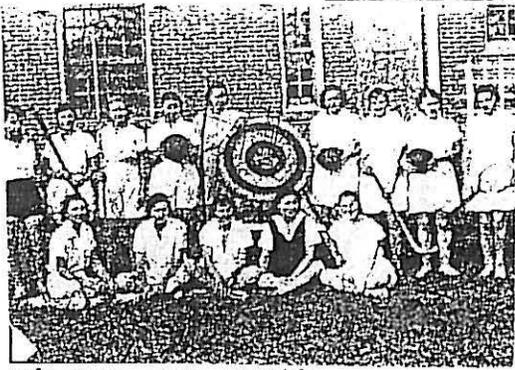
Figure 13: South
Elevation bay 1, 1932,
note window

Windows. A single window containing 12-over-12, double-hung sashes is centered on the west wall. A window in the south wall has been fitted with a large fan. See figure 160. The historic photographs of the exterior suggest that the fan was probably installed between 1942 and 1943. See figure 13.

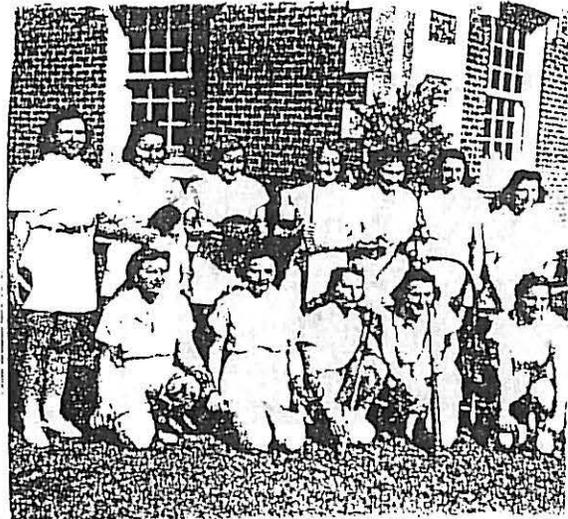
Figure 14: Southwest Corner,
1942, note paint

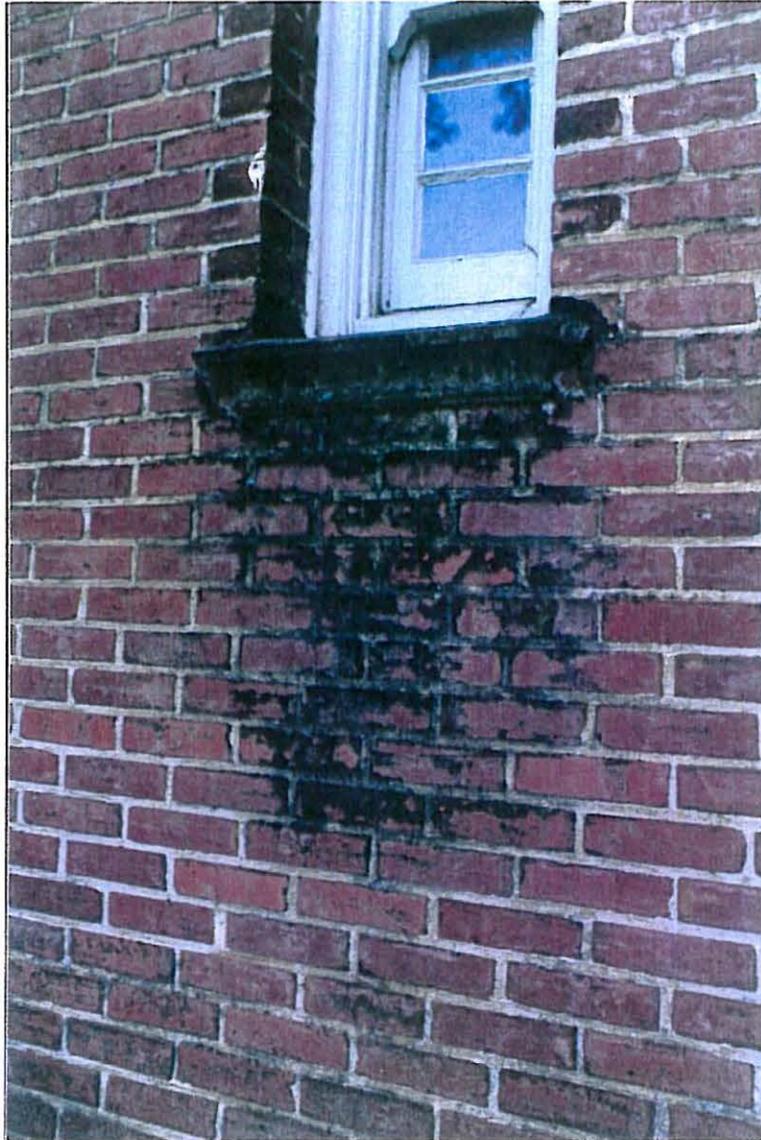
surface deposits of fine particulate matter, generally dark in color and modifying the original appearance of the substrate. The majority of soiling on the Women's Old Gymnasium is dark particulate matter and appears to have been generated by biological activity, most likely mold. This condition may be a product or remnant of biological activity no longer active (see figure 42)

Figure 42. Typical soiling as seen on brick and cast stone. Soiling is most likely moisture related given location under damaged cast stone window sill.

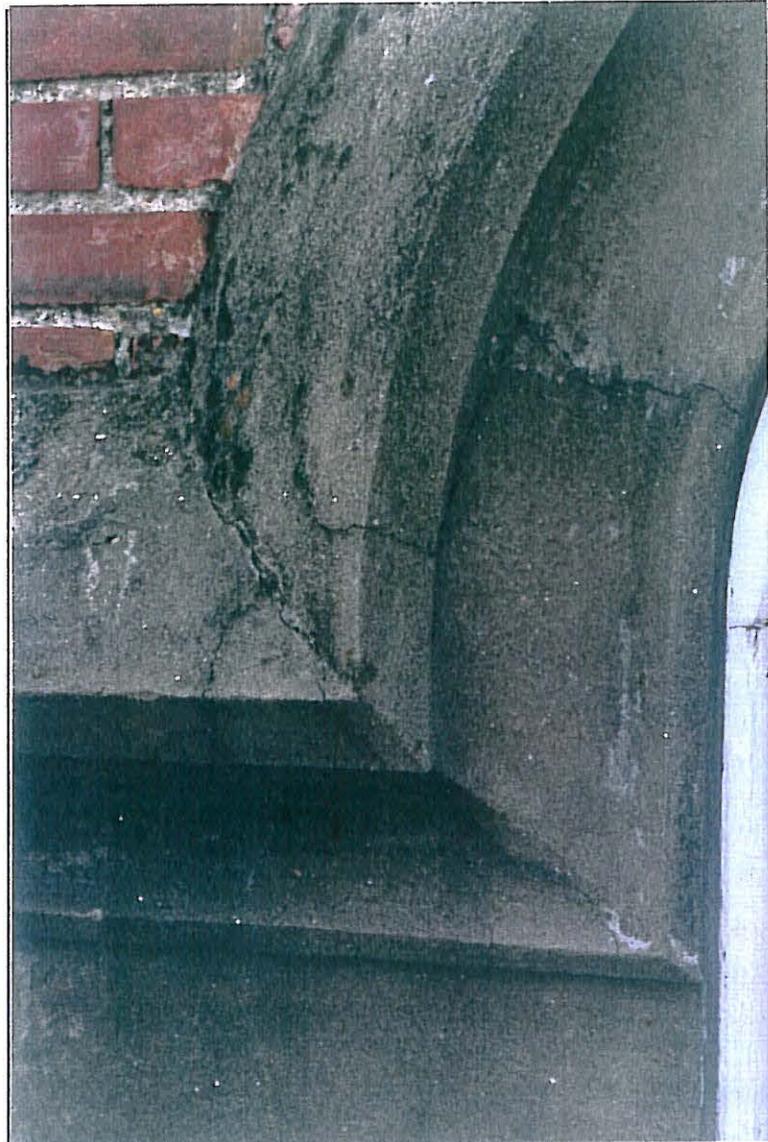
The cast stone on the Women's Old Gymnasium has weathered poorly compared to other materials found on the building. Conditions observed on the cast stone include widespread cracking and unit deterioration, loss of unit cohesion and integrity, and leaching of component materials at cracks (which is seen as lightly colored surface accretions). Many elements have failed and fallen from the building. Almost all cast stone on the building appears soiled, because it is covered with various forms of biological growth including mold, lichens, and mosses (see figure 45).

Figure 45. Typical view of cracking cast stone window hood. Note many cracks present at the ear's corner.

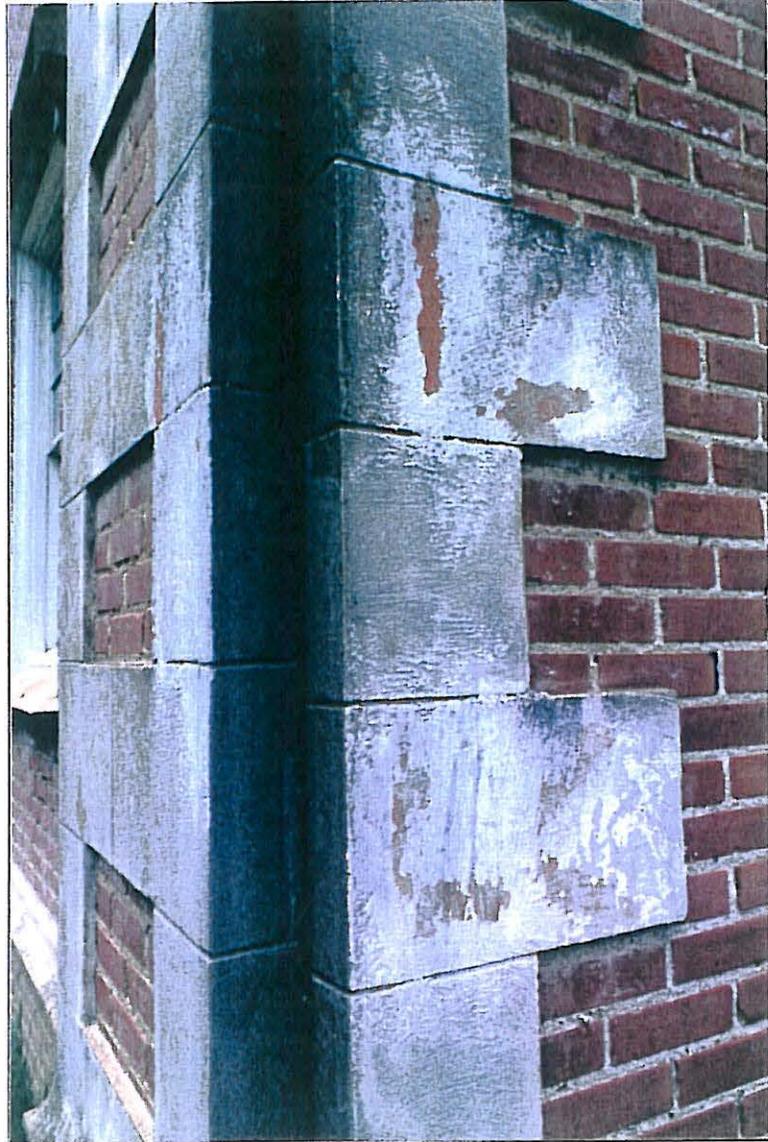
Conditions that are aesthetic in nature, rather than relating to nonperformance of materials, include a few areas where cast-stone quoins have been painted white. On close inspection, it seems that this white paint has been applied to cover disfiguring graffiti, which appears to be orange paint. This attempt at remedial treatment is itself visually disruptive (see figure 47). A curious swirling pattern, lighter in color than the body of the cast stone itself, can be seen on many of the cast-stone quoins (see figures 48-49). There are at least

Figure 47. White paint applied to cover orange graffiti on cast stone quoins.

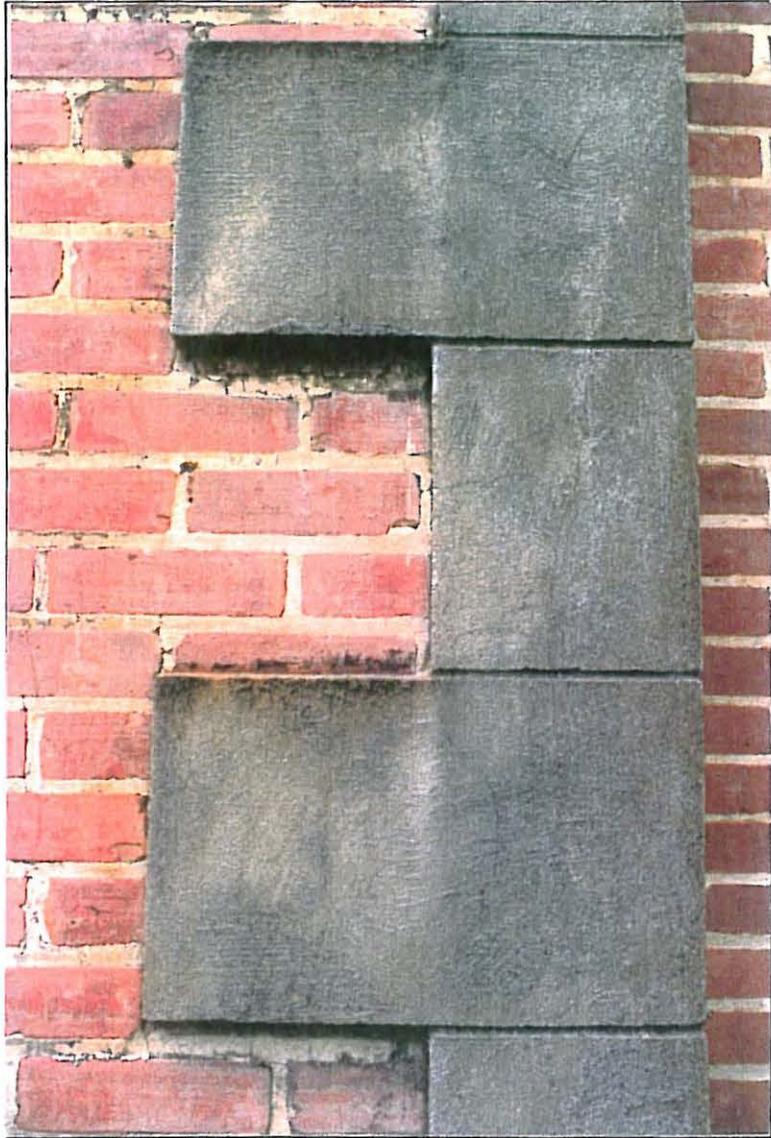
Figure 48. Note curious swirling pattern on cast stone, possibly an applied finish on quoins.

three possible explanations for this effect. One, it may be a pattern created by differential surface weathering. Two, it may have been an intentional design feature of the original cast stone, perhaps to have it more closely imitate the swirling surface texture seen on a particular type of actual stone. Three, it may have been a deteriorating surface coating, possibly a thin cementitious paint, applied at the time of fabrication or at a latter date. However, no records were found of subsequently applied surface coatings of any type.

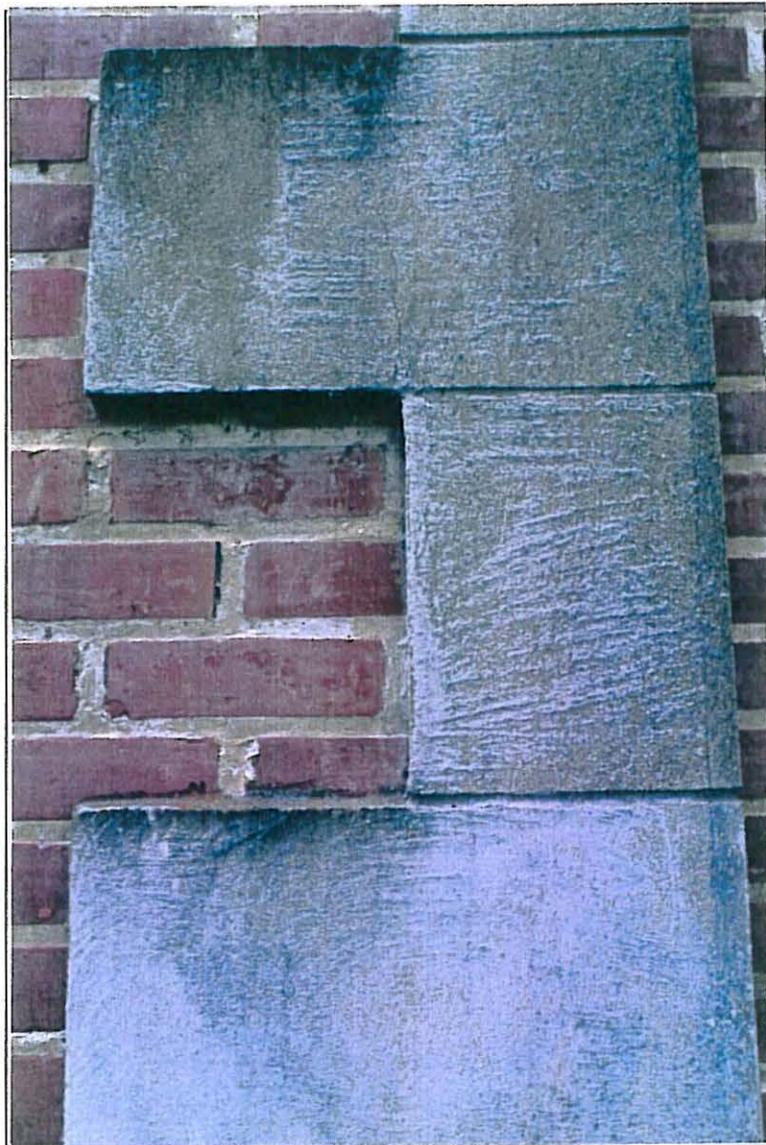
Figure 49. Note swirling pattern on cast stone in a typical weathered location. This finish weathers back revealing a surface finish on cast stone of a more golden tone.

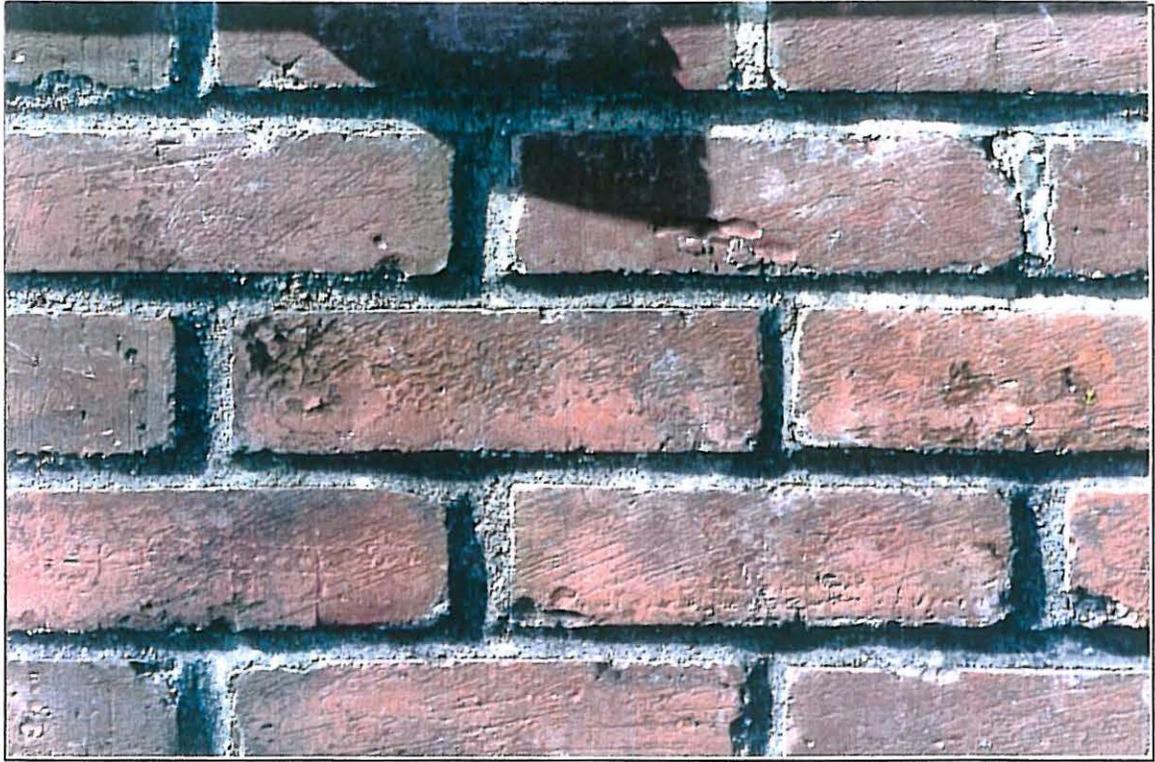
The surface abrasion, or scarification, of the brickwork can only be explained as the result of an earlier abrasive cleaning effort (see figure 50). Although no record of this maintenance effort was found, the marks closely resemble those that would have been made by running wire brushes over brick surfaces. If there was in fact such a cleaning effort, it was most likely to remove some form of biological growth: the area of Natchitoches does not have sufficiently high levels of atmospheric pollutants to soil the building in that manner. The scarification may be exacerbating surface deterioration, for three reasons:

- it interferes with the ability of the bricks to shed moisture;
- it provides a greater-than-normal exposed surface area (or weathering face); and
- it has removed the "fire skin," or denser crust, of the bricks, which tends to greatly reduce the service life of the bricks.

Figure 50. Typical view of scarified and abraded brick. Note scratches and slight flaking of brick.

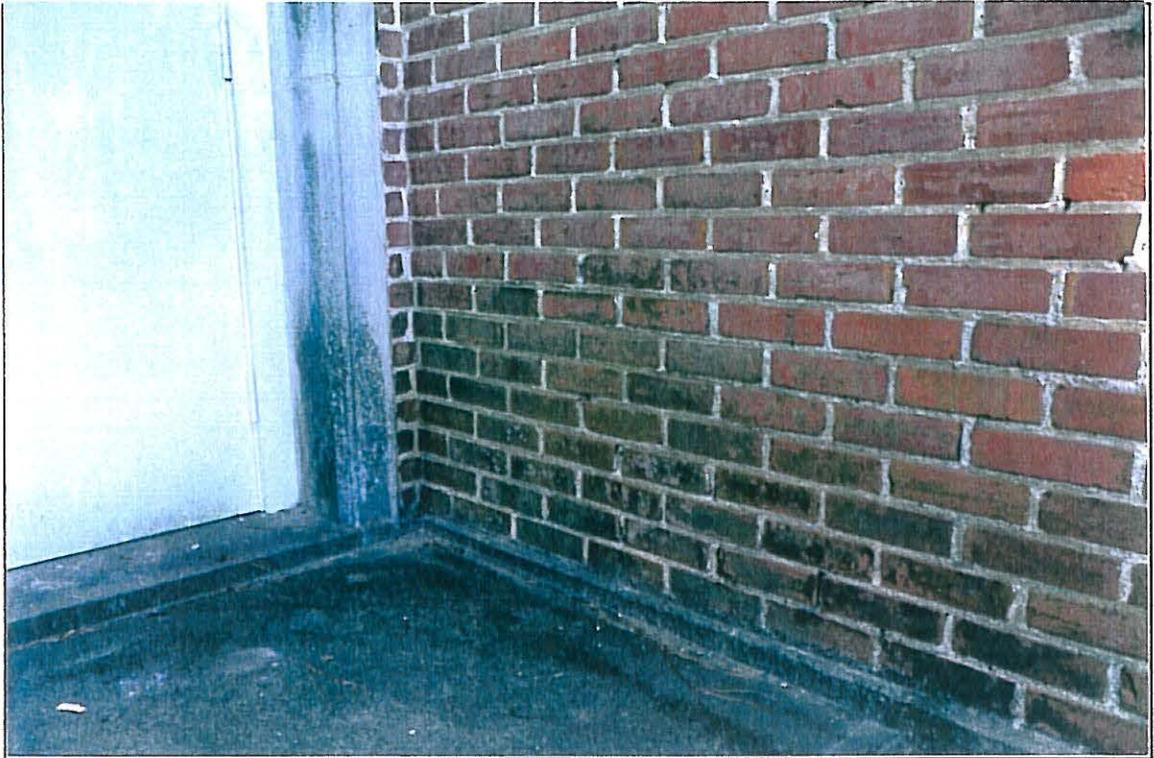
Areas of brick in protected corners, shaded zones, below open joints and leaking window openings, and adjacent to damaged elements are most susceptible to biological activity (see figure 52). As is always the case with this condition, the phenomenon is both a symptom of excessive moisture, a cause of additional moisture, and itself a physical and chemical agent of decay.

Figure 52. Typical condition of biological activity in the form of green algal growth on brick and cast stone. Note location in shaded corner of north elevation, on area near water table and susceptible to splashing.

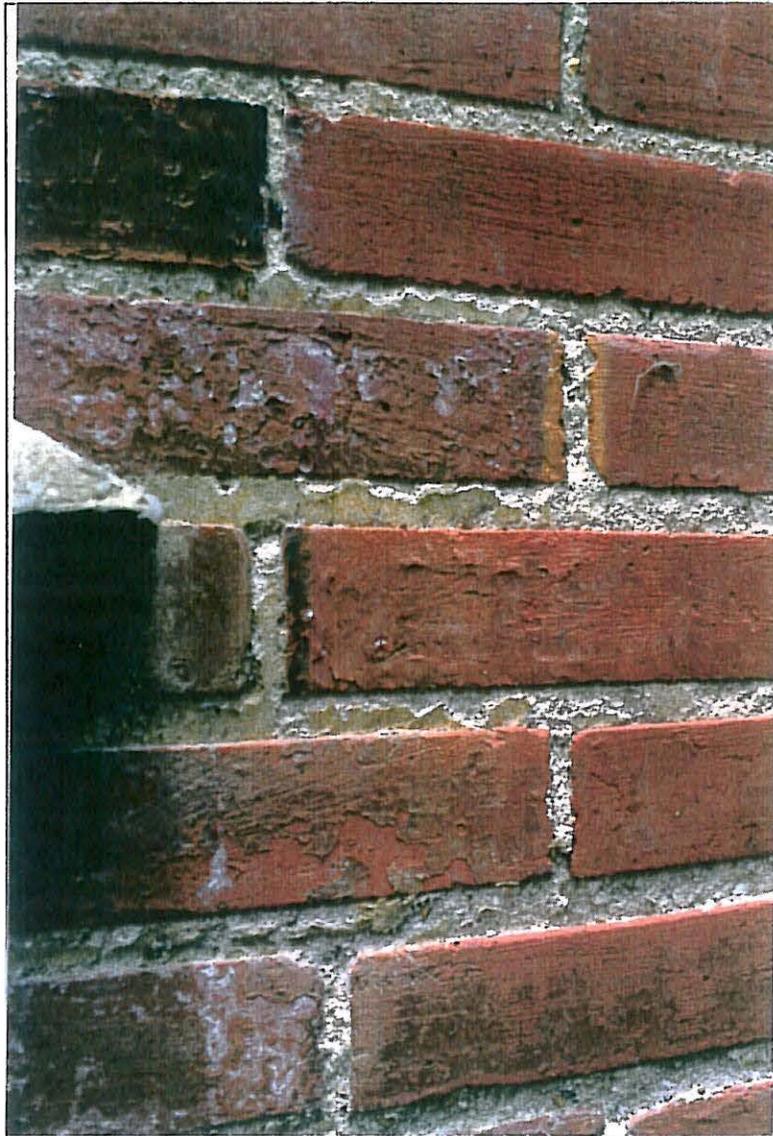
Figure 53. Note typical condition of deteriorating mortar, with yellow smooth finish eroding back to whiter more friable material. Minor efflorescence also visible on brick.

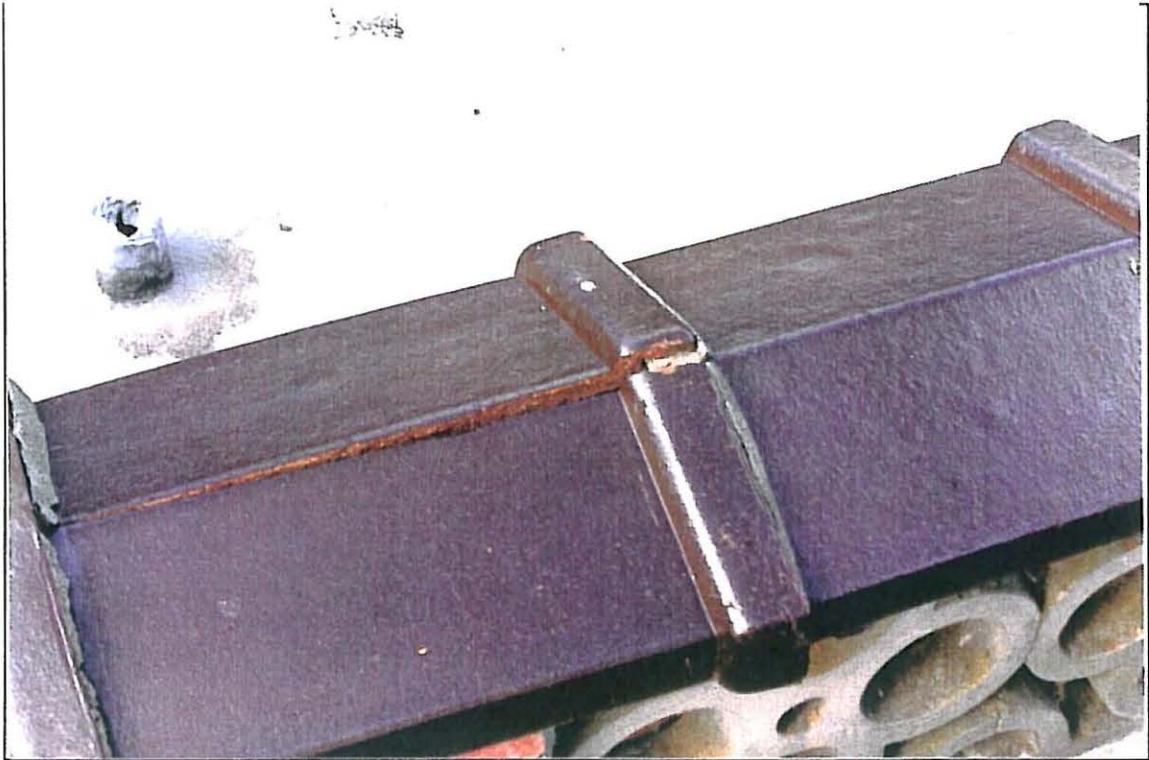
Terra cotta is also found on the building, although it is used for only one detail—the coping tiles of the building's parapet. The terra-cotta tiles are generally in good condition, with only a few split or fractured units (see figure 54). The root of this failure may be physical stresses caused by the differential coefficients of expansion and contraction of the tiles, and the dense cementitious mortar which fills the joints

Figure 54. Note split in terra cotta coping tile. Also visible is cementitious joint filler.

between the overlapping units. Regardless of the reasons for failure, fractured units along the tops of parapet walls serve as ports for excessive water entry directly into walls. Coping tiles are part of the building's first line of defense against moisture infiltration. Once they have been compromised, deterioration of elements below will be accelerated. It is interesting to note that two types of terra-cotta tiles are seen on the parapet. Darker brown tiles are located on the central portion of the roof, while reddish brown tiles are seen on the sloping and flat sections of the parapet. It is possible that the reddish tiles are replacements, since they are in place over the rebuilt (formerly scrolled) sections of the parapet walls (see figure 55). Another indication that tile replacement may have occurred tiles is the fact that existing tile units do not always appear to fit correctly in their installed locations.

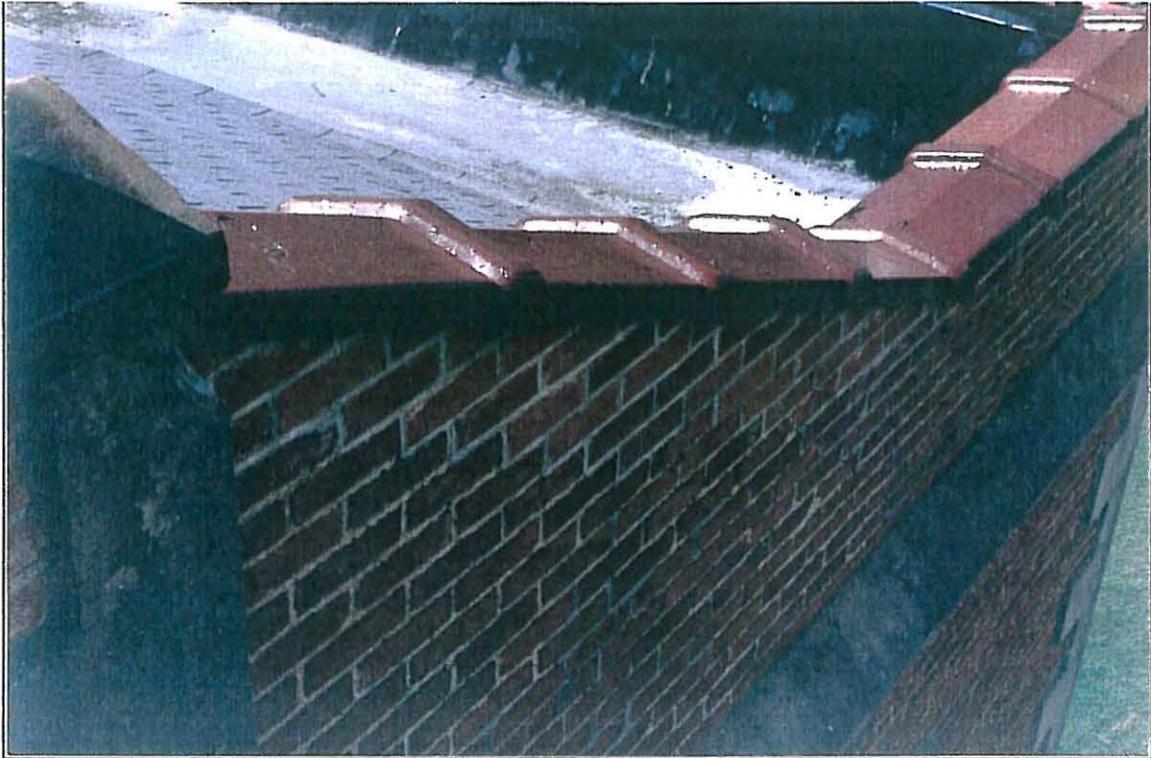
Figure 55. Typical view of modified section of parapet walls. This condition noted on east and west elevations in two areas on each elevation.

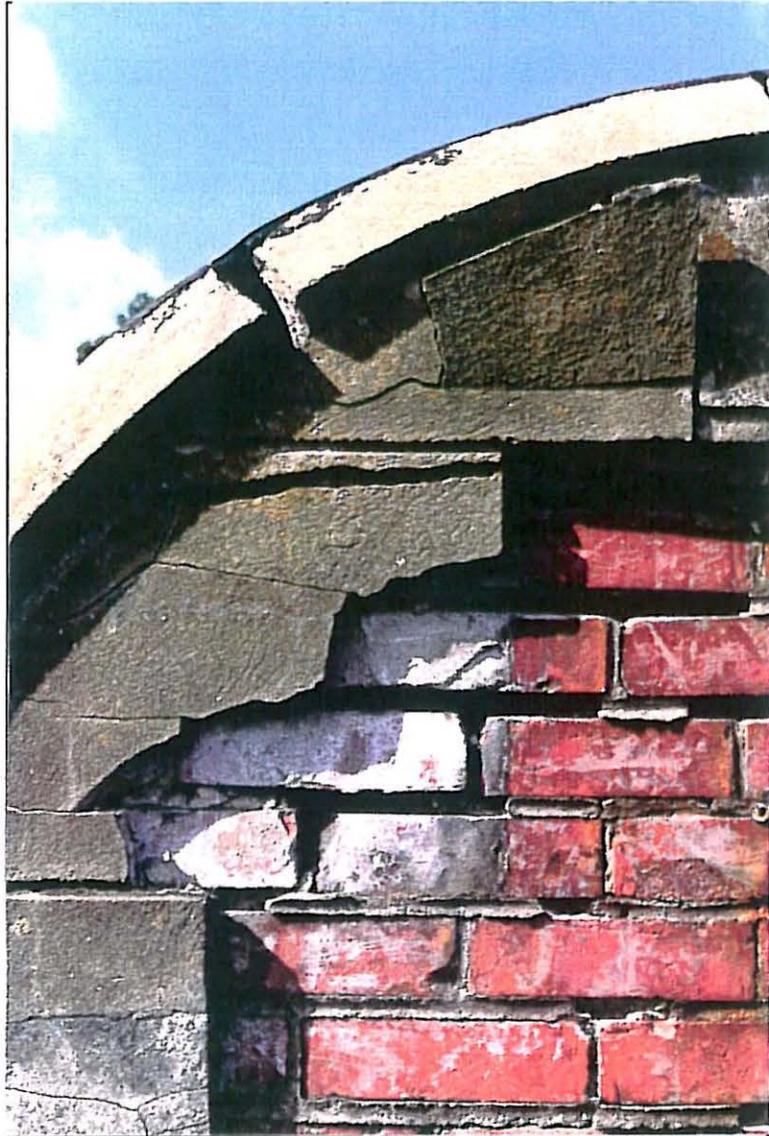
Figure 56. Deteriorating applied cast stone quoins on central gable, north elevation. Note unit failure with pieces of cast stone failing and lost. Note open joints in gable and in areas where cast stone is missing.

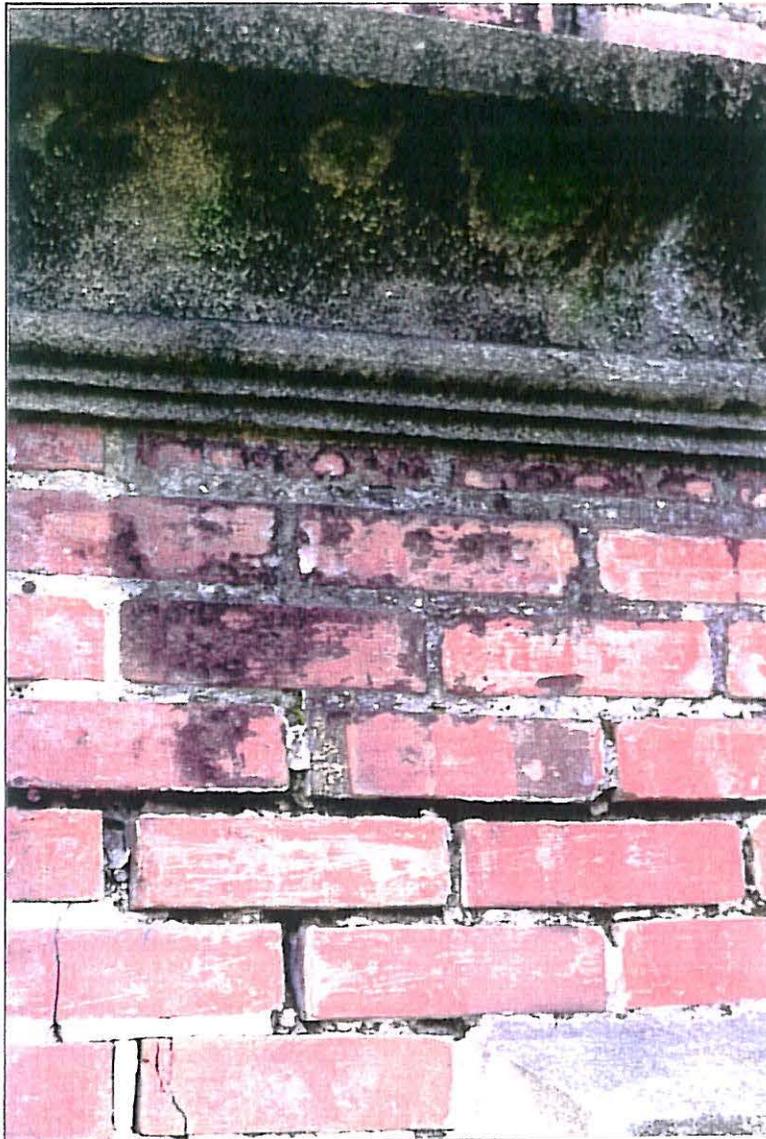
Figure 57. Typical view of biological activity, active growth as often seen in conjunction with dark soiling on a cast stone stringcourse. Also note zone of open joints as typically seen.

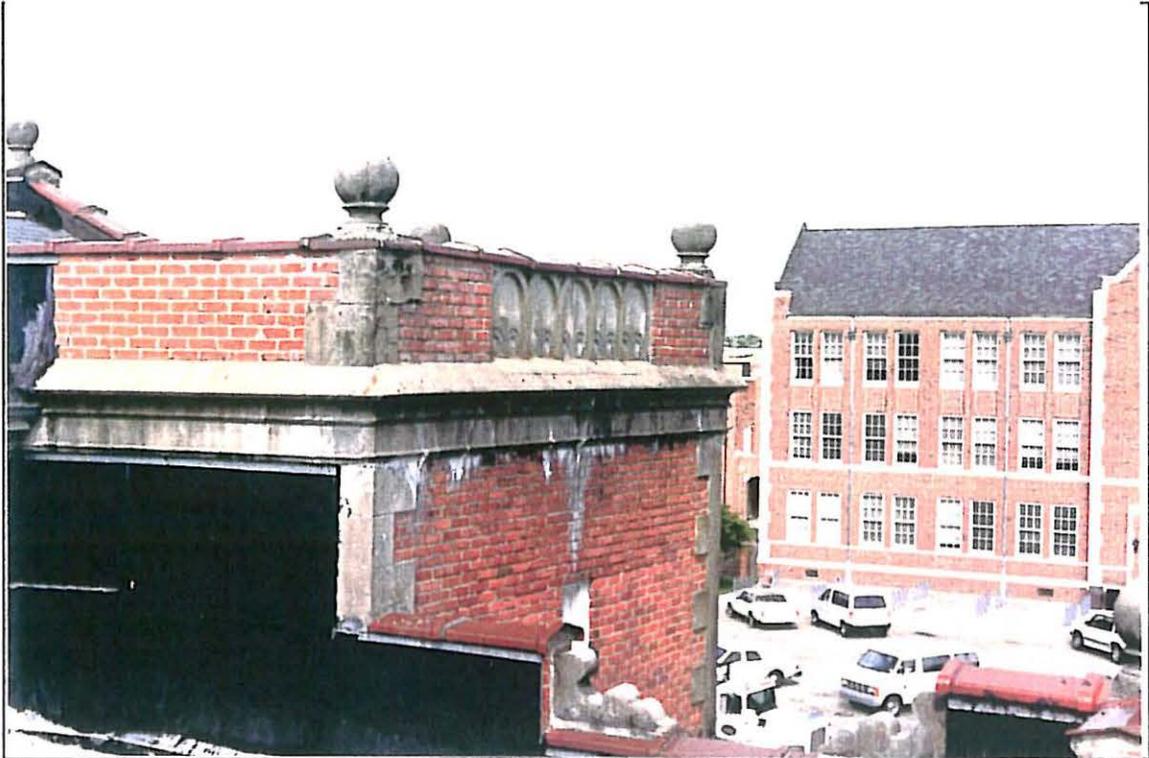
Surface accretions on the north elevation are always associated with open joints. Accretions are concentrated at the parapet and below the upper stringcourse of the central bay. The outer bays each have particularly thick accretions below the

vertical crack running through the cast-stone fleur-de-lis panel
(see figure 58).

Figure 58. Note thick white surface accretion forming below crack in cast stone panel and belt course. Also note large area of open joints below this section of the north elevation.

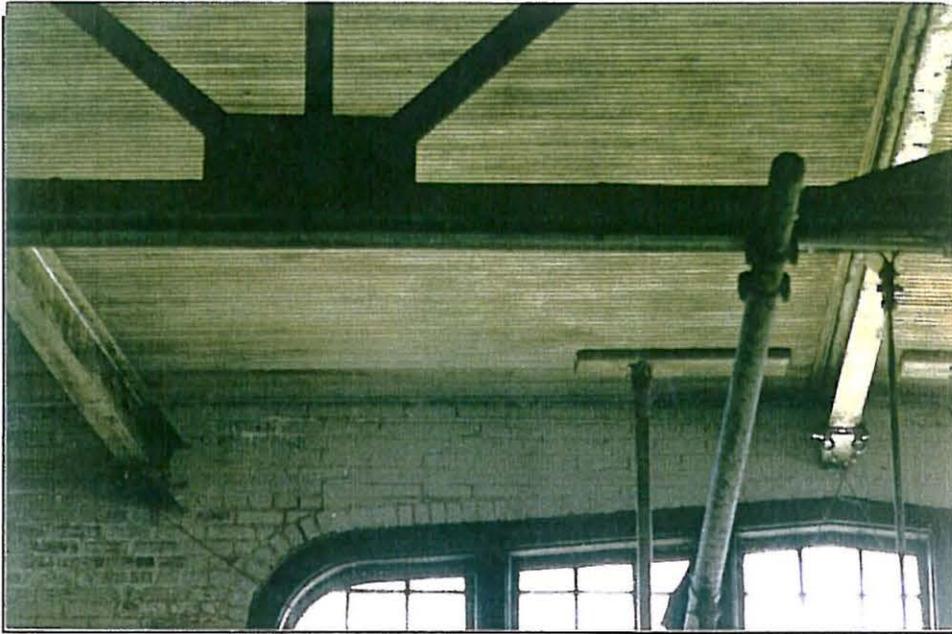
An even greater challenge to concealed lintel design is presented by the broad pointed-arch motifs over the center-bay windows on the east and west elevations of the gymnasium block. Since it is nearly certain that the masonry arches in each case are nonstructural, the use of steel lintels is strongly indicated. However, a straight member placed high enough to clear the apex of the arch would leave unsupported triangular areas of wall masonry below the lintel, near the springing points of the arch. It may be that some custom stepped or curved steel member exists at each end, which can directly support all the masonry without otherwise affecting the surface rhythm of the joint (see figure 59). If not, the unsupported corners of masonry bear on the wood frame of the window.

Figure 59: Window head in east wall of Room 201. The pointed arch configuration suggests a steel lintel location above the springing points, rendering difficult support conditions for masonry situated above the window head but below the lintel.

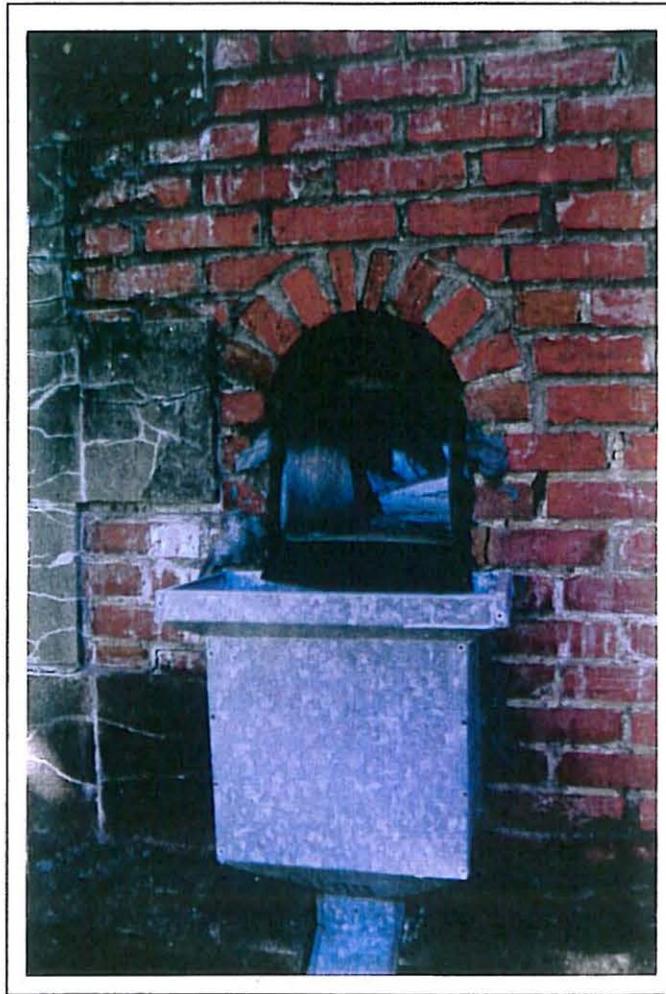
All of these devices notwithstanding, there are four uses of true structural masonry arches on the building, all occurring along north parapet of the office/classroom block. Here, the outer two brick wythes are laid in a semicircular arch to form a scupper, allowing drainage through the parapet into a conductor head (see figure 60). The innermost wythe at these locations consists of 4-inch nominal structural clay tile, which spans the opening on a steel lintel.

Figure 60: Arched scupper and conductor head on north elevation parapet

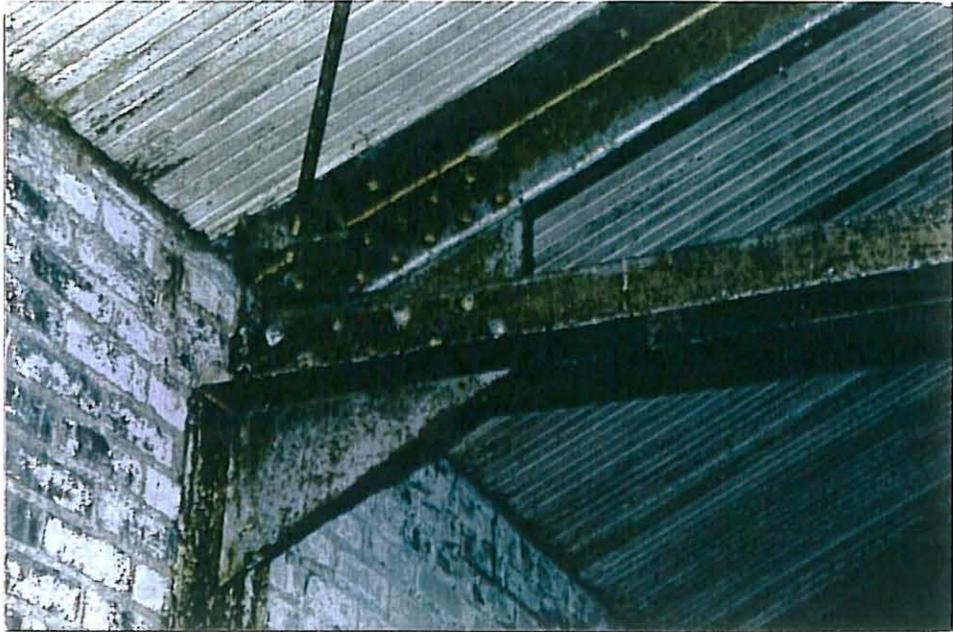
Four steel roof trusses span the gymnasium block, running from the tops of the columns in the common wall to the pilasters on the south wall (see figure 61). The trusses are made of built-up angle sections, joined by gussets with both bolted and riveted connections. The top chords of the trusses consist of four sections joined to form a gambrel-shape. The trusses are tied to each other at six locations, three at the top chords and three at the bottom chords. The points of attachment on the top chords are the intersections of the four sections; the attachment points on the lower chord are directly below those on the top chord. In the center three bays, the top-chord ties are comprised of back-to-back angles; the bottom-chord ties are "I" sections; and upper and lower ties are reinforced with cross bracing. In the two ends bays, upper and lower ties are "I" sections. The outer sets of these ties angle inward, so that they can intersect the east and west walls at the locations of the exterior pilasters on those walls. In addition to the horizontal ties, the trusses in the center three bays are cross-braced by steel tension rods running from the top chords of the trusses to the bottom chords of adjacent trusses (see figure 62).

Figure 61: Steel roof truss of gymnasium block bearing on steel column in north wall.

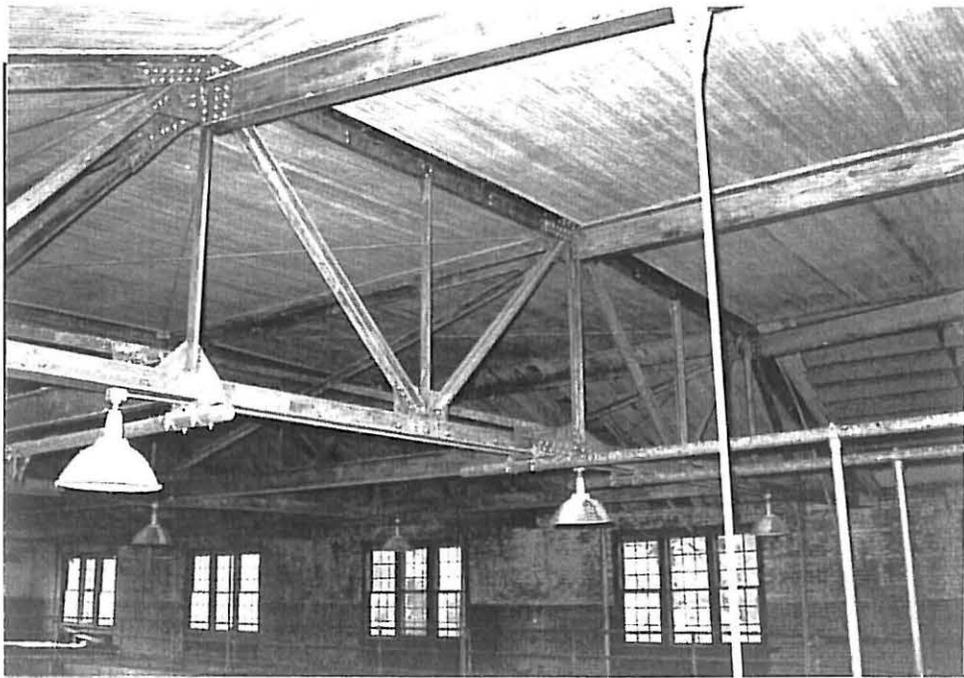
Figure 62: Steel roof trusses of gymnasium block, with upper and lower lateral ties, and horizontal and vertical cross bracing.

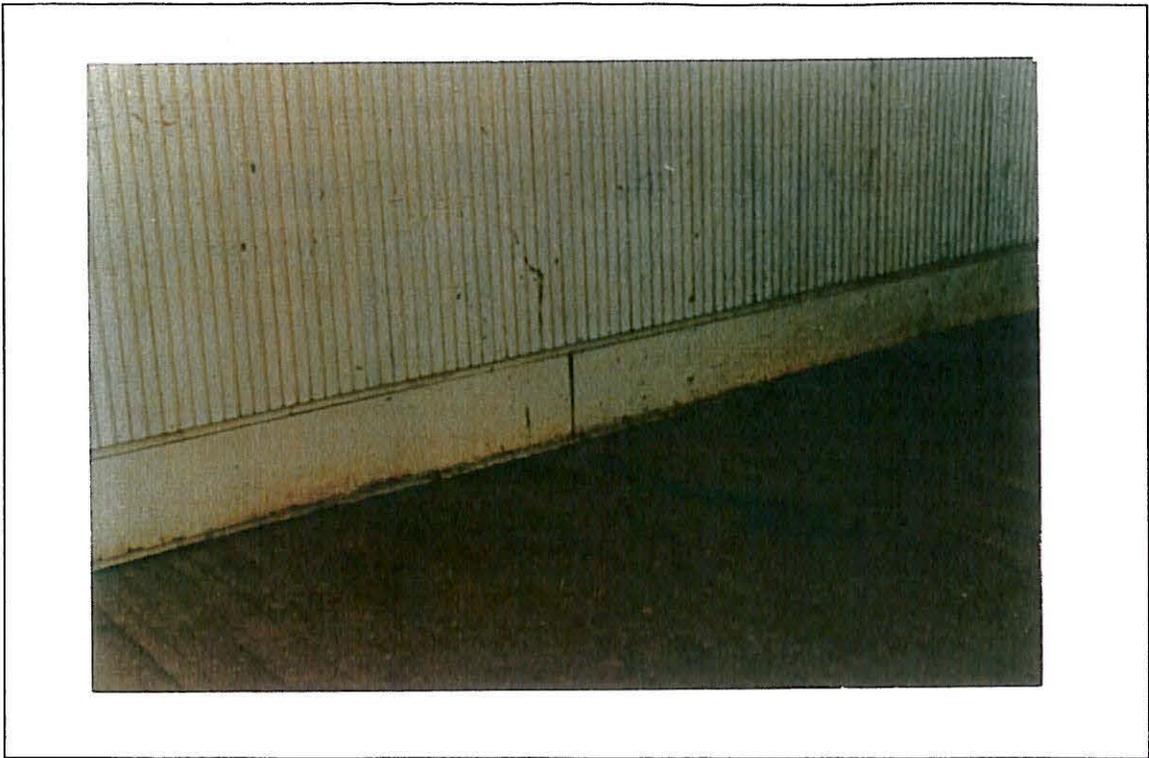
Figure 63: Typical Floor

Floors are typically 2-inch-wide boards running east-west. The floors are unpainted. They may have been varnished originally, but this finish is worn off. See figure 63.

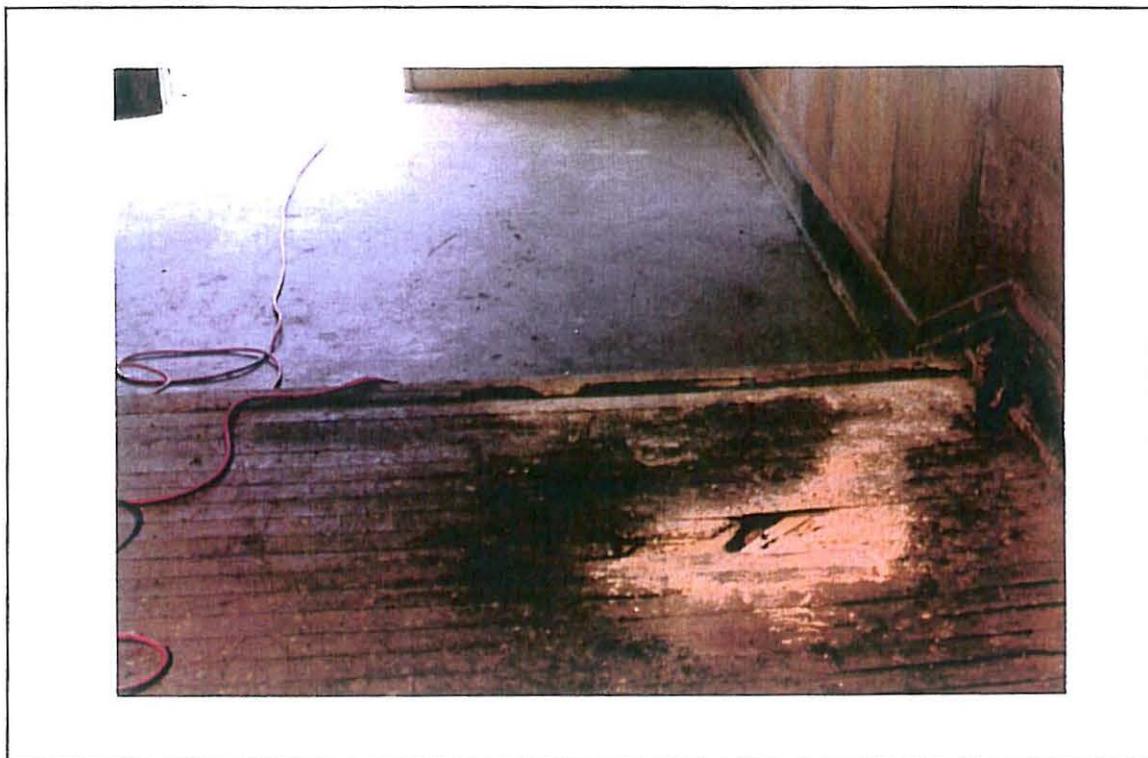
Figure 79: Room 100, Concrete lip at entry door & Floor Failure

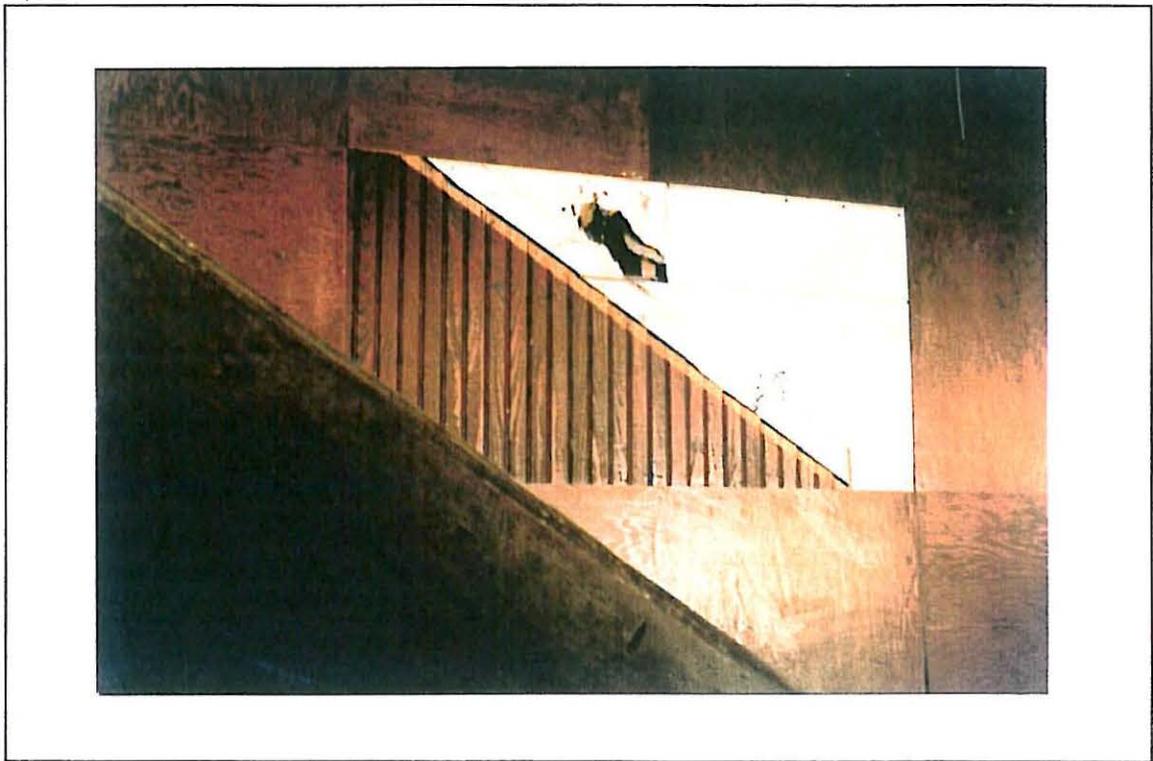
Walls. A section of the plywood paneling has been removed from the east wall, revealing the beaded-board and fiberboard beneath. See figure 81. A section of the plywood paneling is missing at the corner of the east stairway, also revealing beaded-board beneath. See figure 84.

Figure 81: Room 100, Exposed fiberboard, and Beaded-Board behind plywood panels.

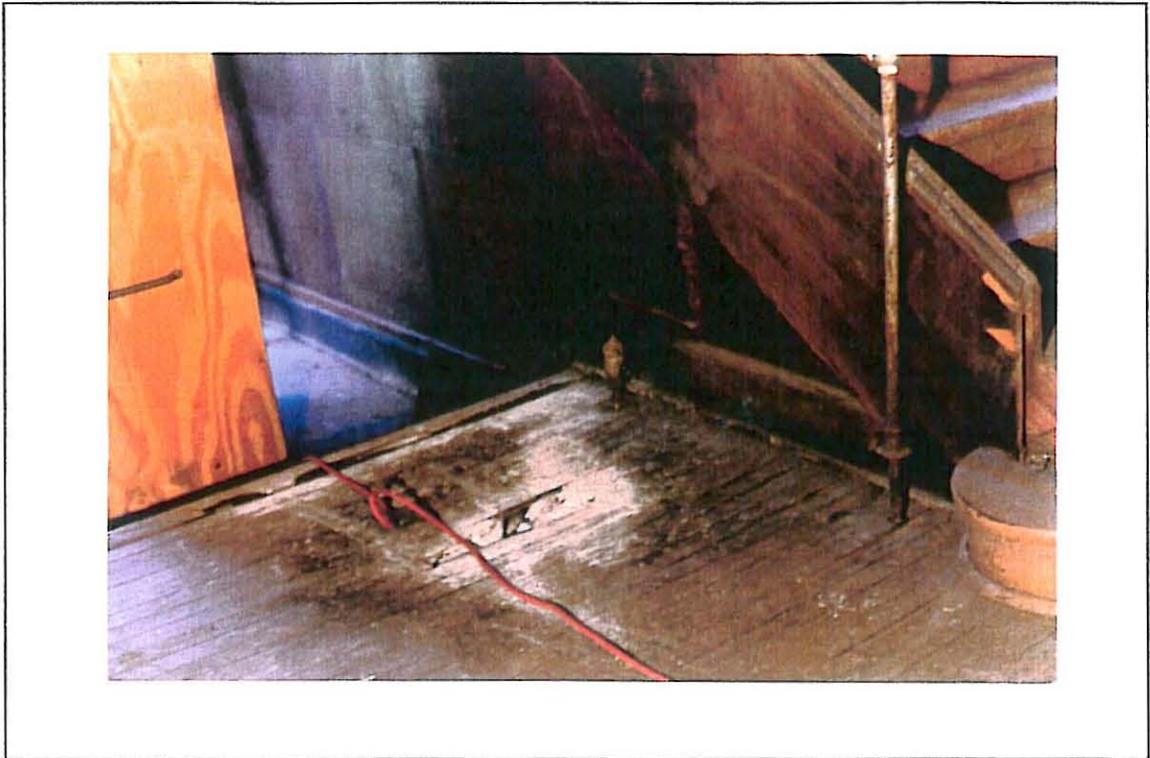
Floor. A large portion of the northeastern section of the floor at the top of the two entry stairs has failed. See figure 84. Some weakness in the flooring also exists at the south wall, near the doorway to room 101.

Figure 84: Room 100, NE Section of Floor showing typical rot of floor boards. Also note exposed beaded board at stair corner.

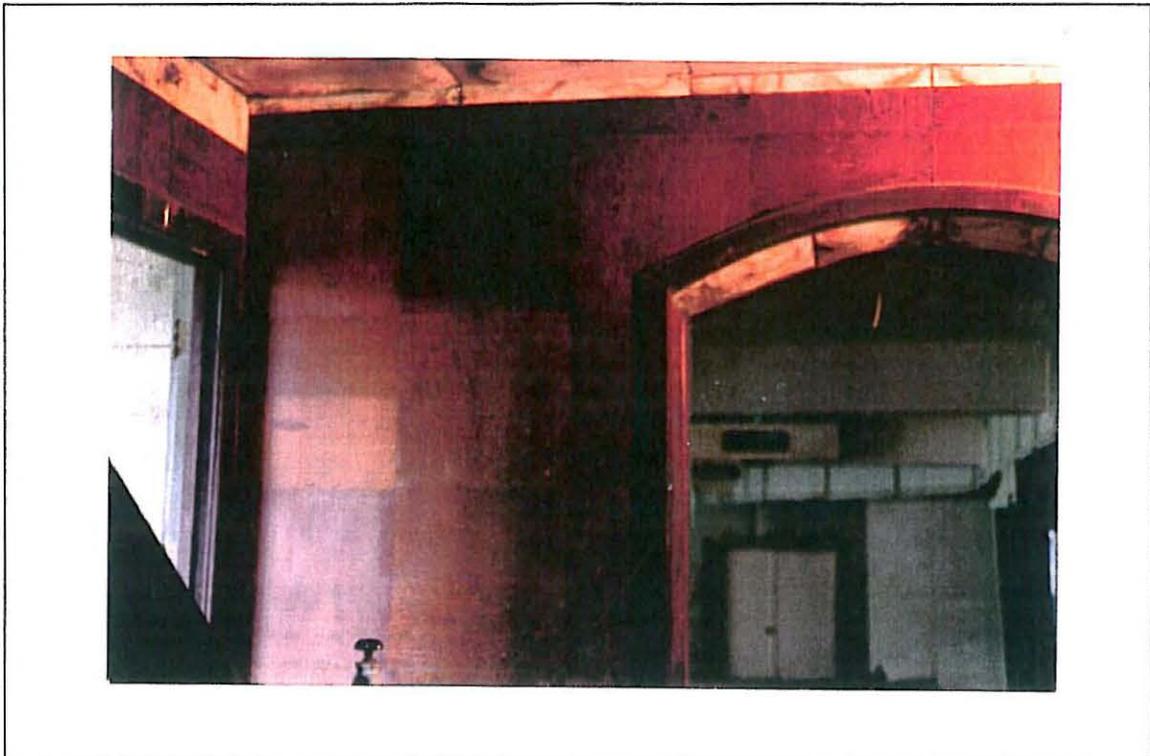
Cornice. The cornice strip is missing all along the south wall, except at the southwest corner. It is also missing along the east wall to the boxed beam. See figure 85.

Ceiling. Water damage exists along the southern end of the ceiling and is especially severe at the southeast corner. See figure 85. Underneath the stairways leading to the landing, the fiberboard has fallen off or buckled. Water stains are present. See figure 86. The remaining sections of ceiling are in adequate or average condition.

Figure 85: Room 100, SE Corner Ceiling showing buckled fiberboard tile and water damage

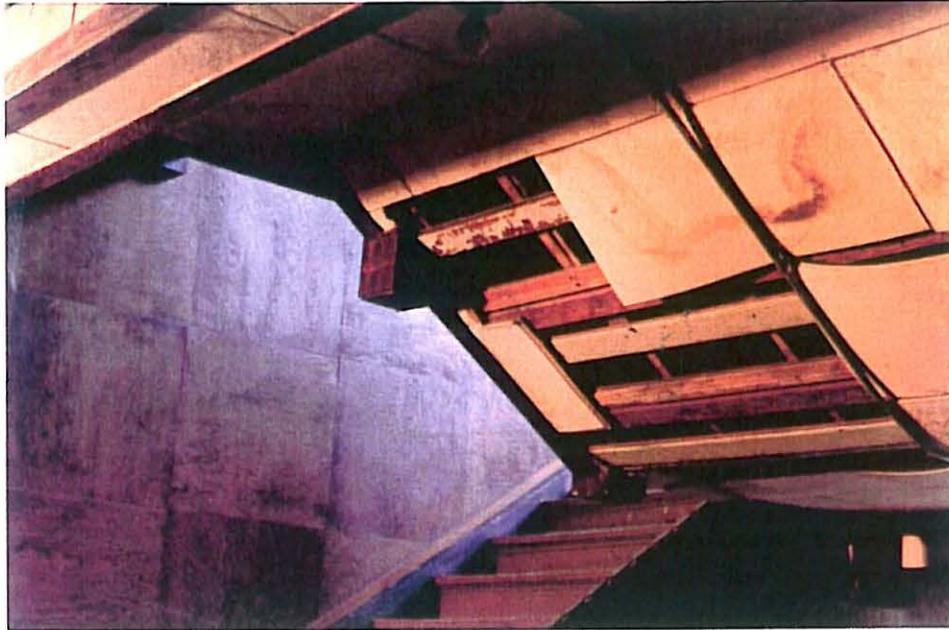
Figure 86: Room 100, Nailers exposed under stairs. Water damage and buckled tile present here.
