WOMEN'S OLD GYMNASIUM
HISTORIC STRUCTURE REPORT

Northwestern State University
Natchitoches, Louisiana

Regina T. Binder
With Joan Berkowitz and David Bitterman

1993

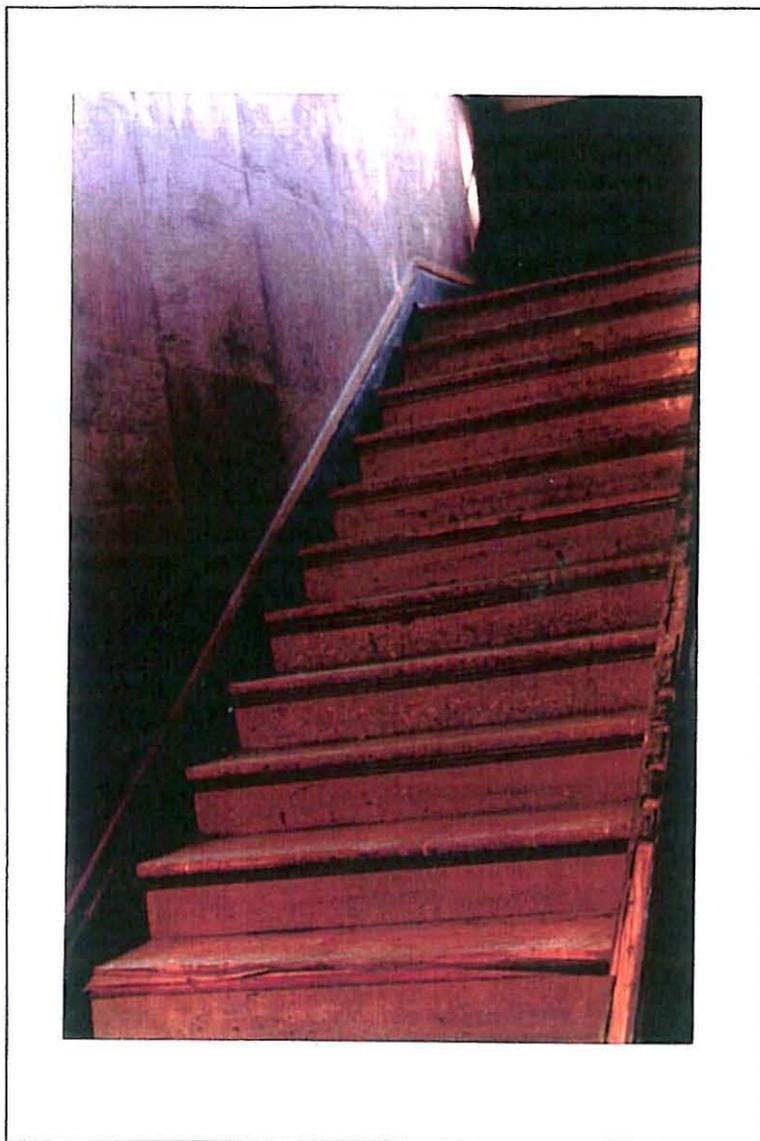
Stairway. The handrails and balusters are missing from both the east and west stairways. See figure 87.

Figure 87: Missing Balusters

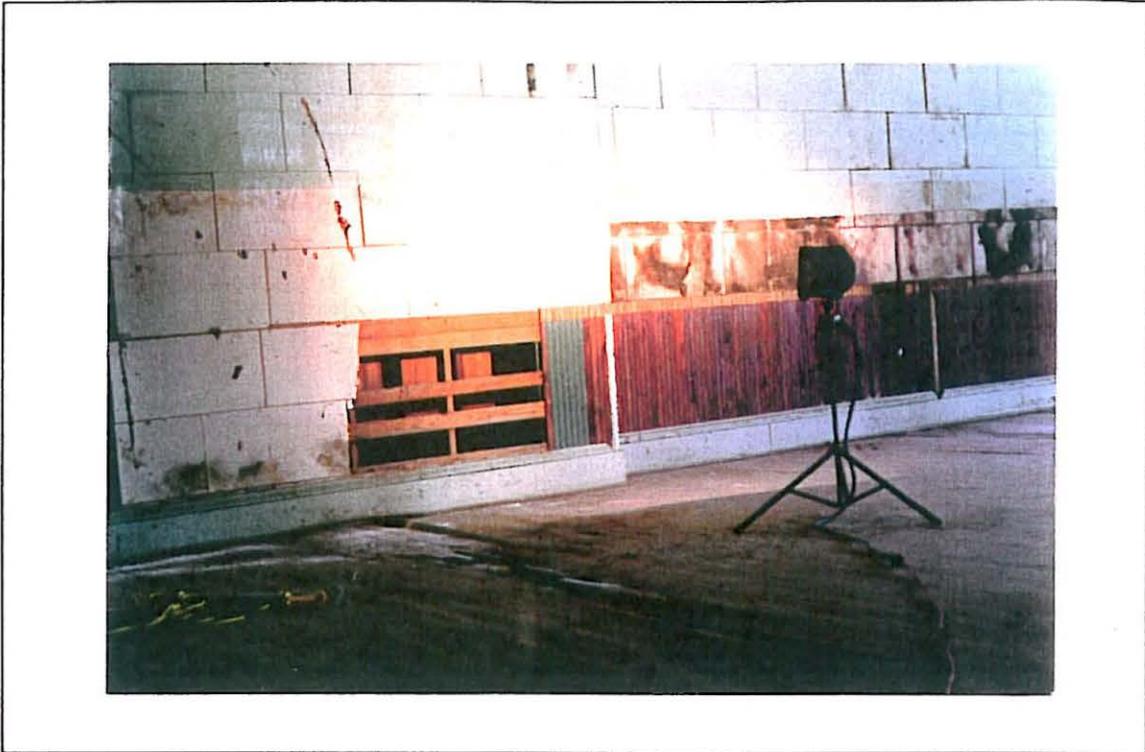
Figure 92: Room 101, North Wall

The wainscot is missing from the west portion of the north wall. Fiberboard covers the part of the gap closest to the main entry, but the rest of the gap is open, exposing the missing wainscot's nailing elements. See figure 92. The midsection of the wall retains its wainscot, but not its cap molding. Wainscot with cap remains only at the east end and corner of the north wall closest to the doorway to room 111. See figure 93.

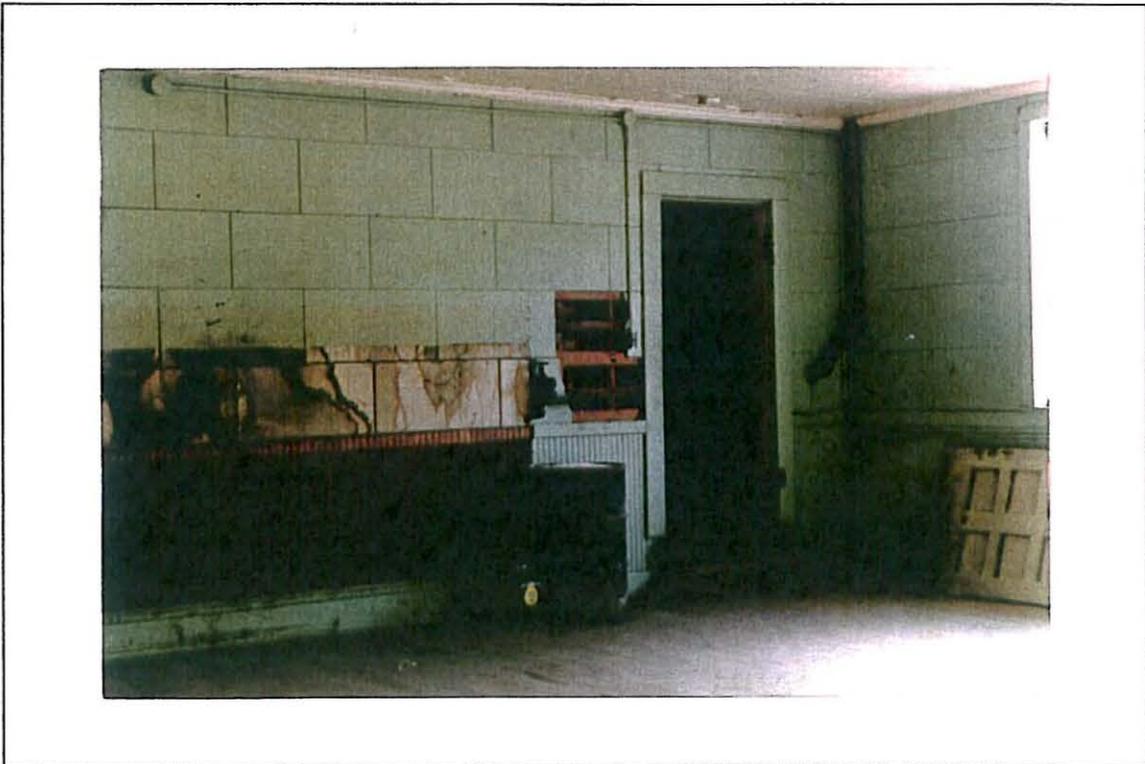
Figure 93: Room 101, NE Corner

The east wall worsens from north to south. Beaded boards are missing under the center set of five windows. This condition dominates at the southern end, where a piece of the wainscot cap is missing. Water damage exists on the fiberboard panels, and the wainscot is buckling. See figure 93.

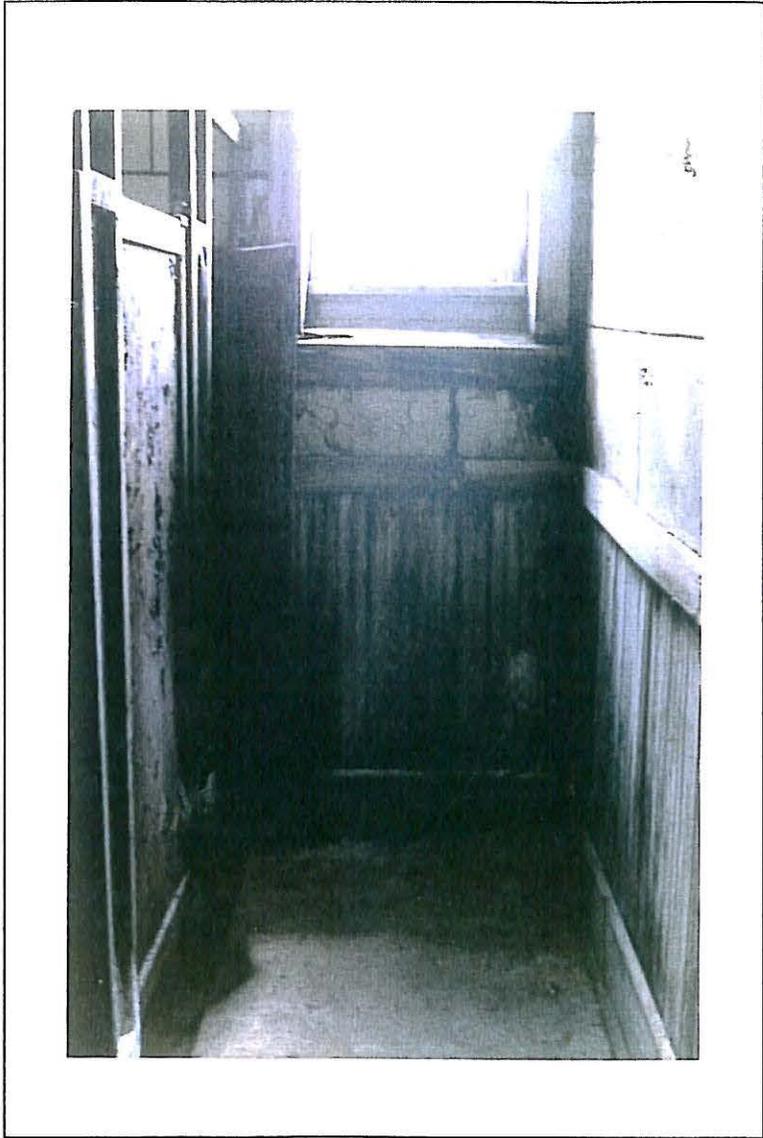
Figure 118: Room 102, General Wall Condition

Walls. The wainscot on the west wall is buckling. On the south wall, water staining and paint alligatoring are seen throughout. See figure 118. This condition is most likely due to some type of water leak as evidenced by the ceiling holes above.

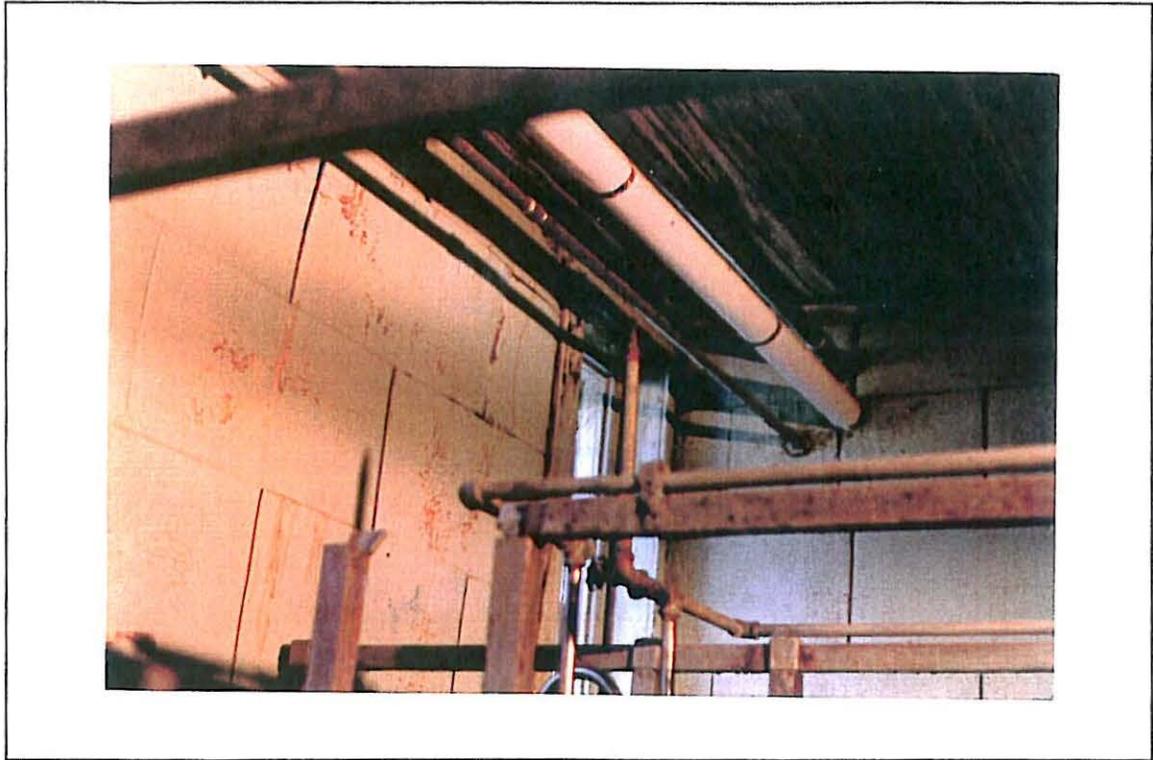
Figure 119: Room 102, Ceiling Condition

Ceiling. The beaded boards at the east end and the entire southern half of the ceiling are in bad condition, with some missing. See figure 119. All of this area is darkly stained and alligatored. Minor buckling is also noted in this area.

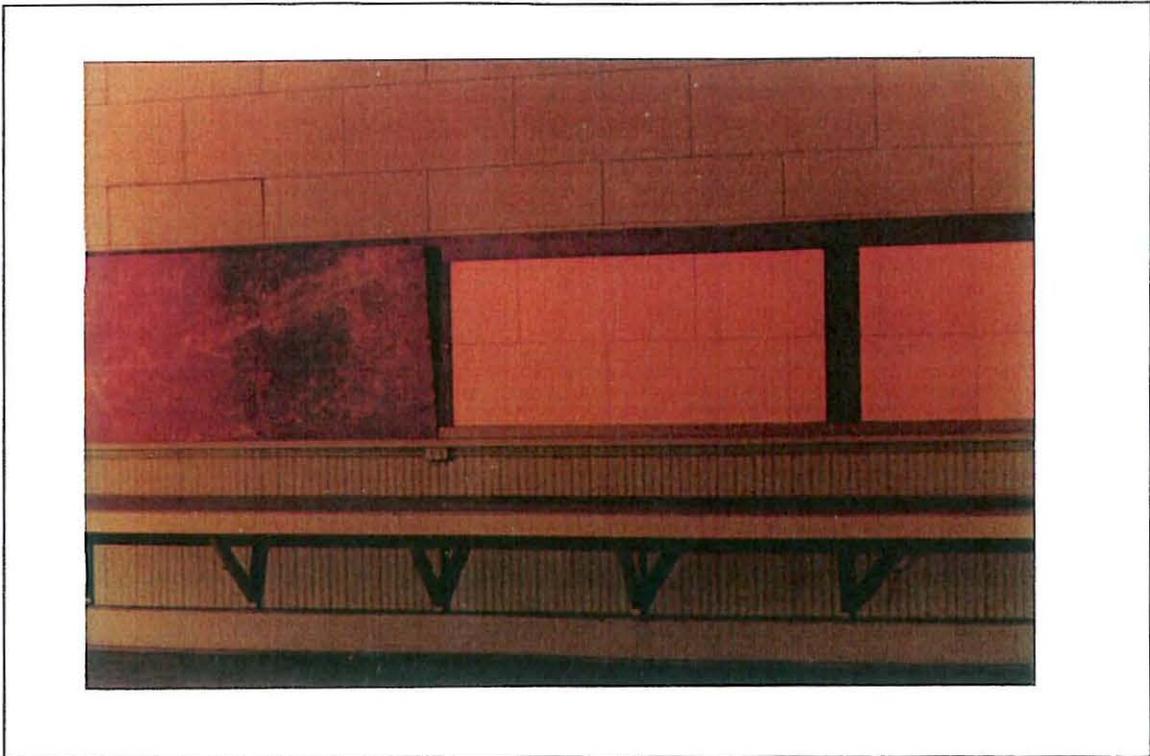
Figure 130: Room 103, West Wall

Baseboards. The baseboards along the east and west walls are in very good condition, presumably because they were sheltered by the vanity tables above them. See figure 130. The baseboard on the north wall is deteriorated, with dark staining and rot seen. See figure 127. The cap molding is broken off under the doorway and at the northeast corner, a piece of the baseboard is broken and detached from the wall. The baseboard on the south wall is in fair condition.

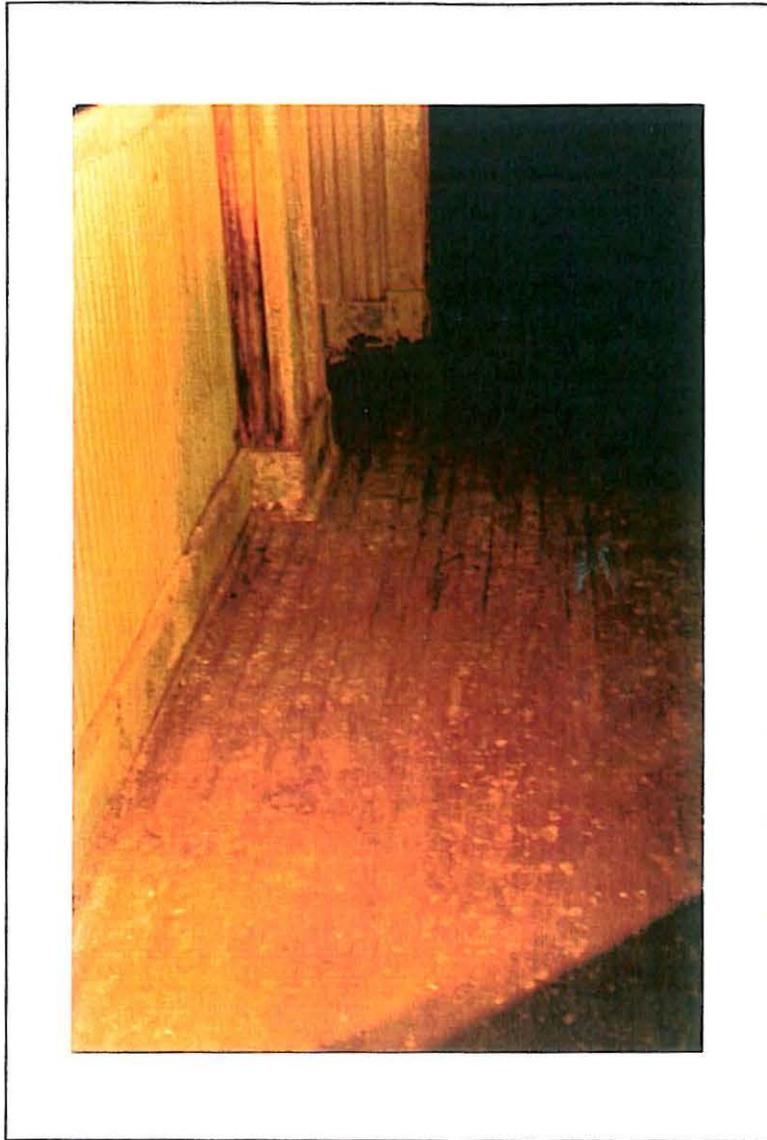
Figure 133: Room 104, Floor & Baseboard

Baseboards. Paint is failing as evidenced by chipping and alligating throughout. See figure 133.

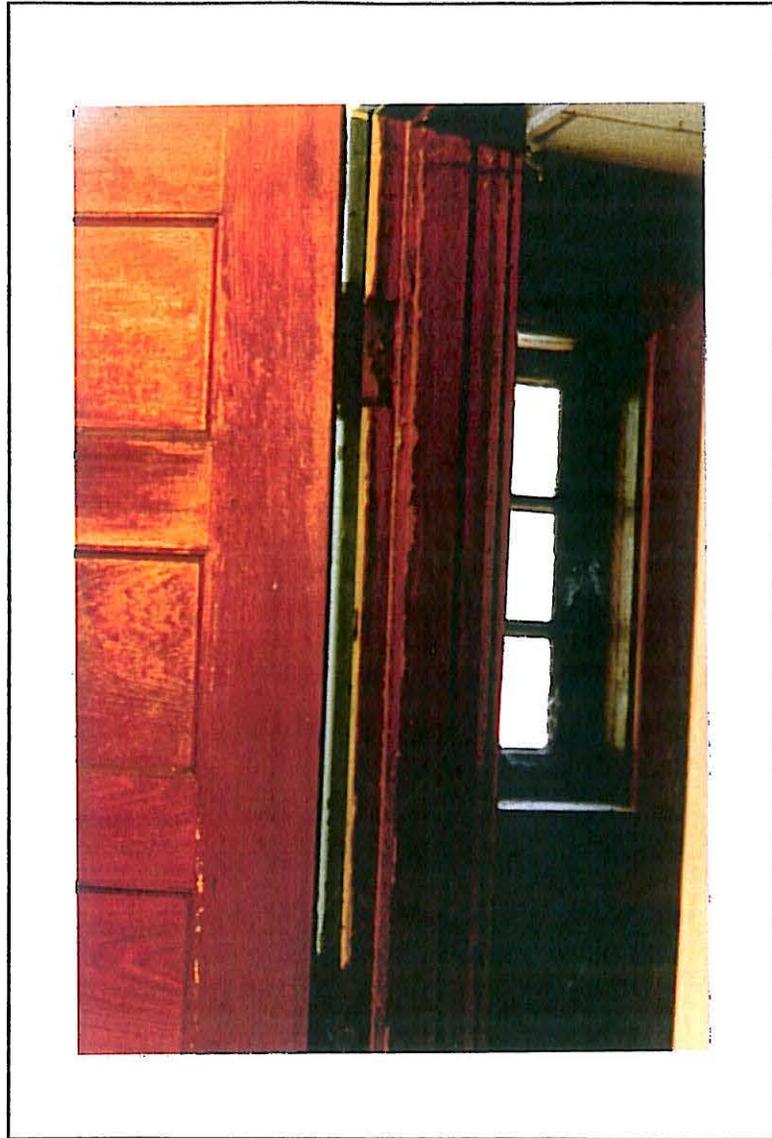
Figure 135: Room 105, Water Closet

The water closet has one window on the north wall, with a fixed three-light sash in a masonry opening measuring 1 foot 4 inches by 2 feet 9 inches. See figure 135.

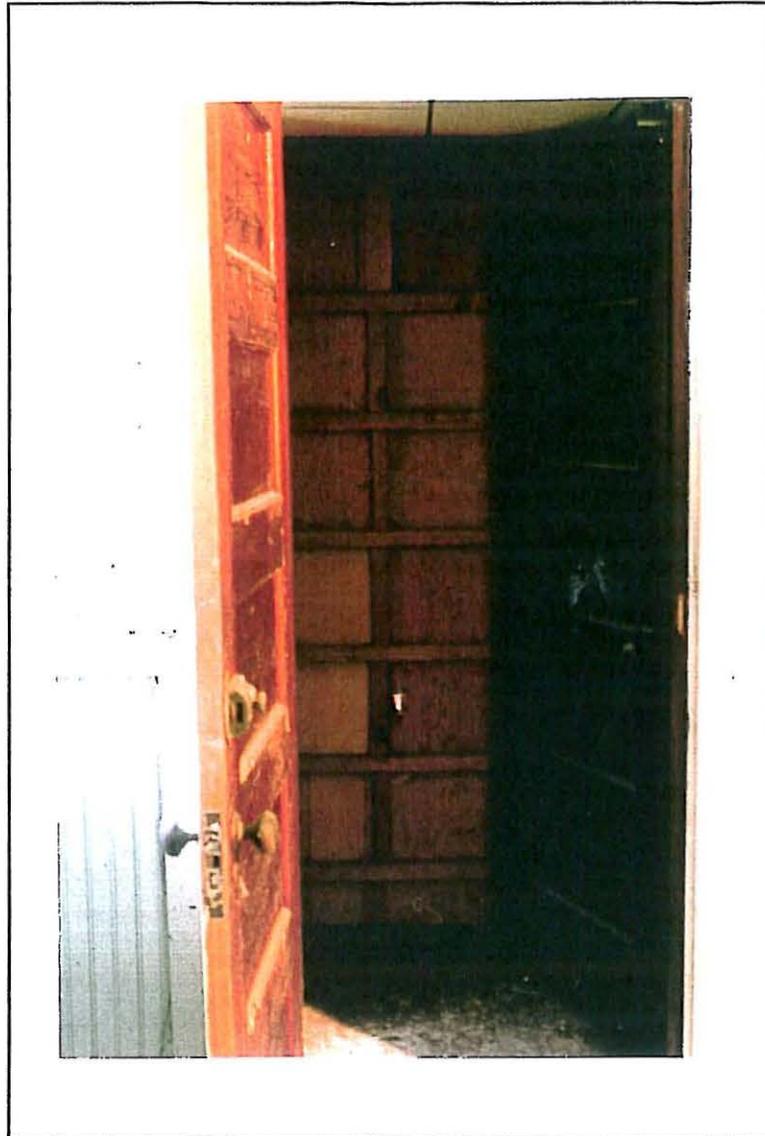
Figure 136: Room 105, Inside Water Closet.

At the north end of the east wall is a water closet, located in the space under one of the two main stairways. There is a doorway on the east wall. Its opening has been covered from the other side. One can now see the nailers and other wooden members to which the plywood panels have been attached. This door is not noted on the 1939 plan; however, it does appear from paint analysis to be original. Samples taken show only two layers of varnish. See figure 136.

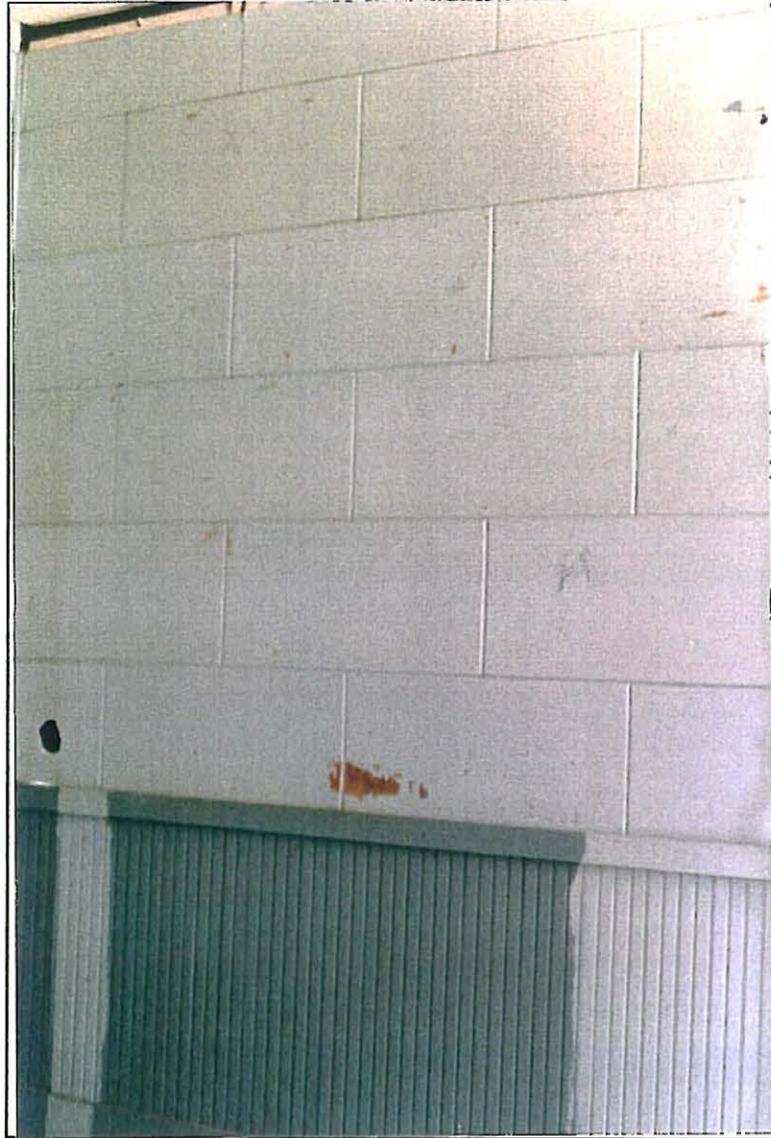
Figure 139: Room 105, West Wall

Walls. The walls are covered in the manner described in the general section. All walls except the west are painted a light shade of green. A section of the beaded-board wainscot on the west wall is painted a darker shade of green. A paint ghost, unpainted wainscot, and missing baseboard exist on the south wall. The paint ghost—a horizontal band with vertical stripes beneath—continues onto the east wall. The shape of this paint ghost may indicate that some element was attached there once. See figure 137. To the west of the entry door on the south wall, the wainscot is painted in a shade of green darker than typical. See figure 138. This darker shade continues onto the west wall and then is interrupted by a vertical stripe of the lighter, more typical green. The darker shade then resumes and continues toward the north wall, stopping about midway. Brush strokes are seen where the darker color is discontinued. See figure 139. In many samples examined, the darker shade of green is the layer beneath the current light-

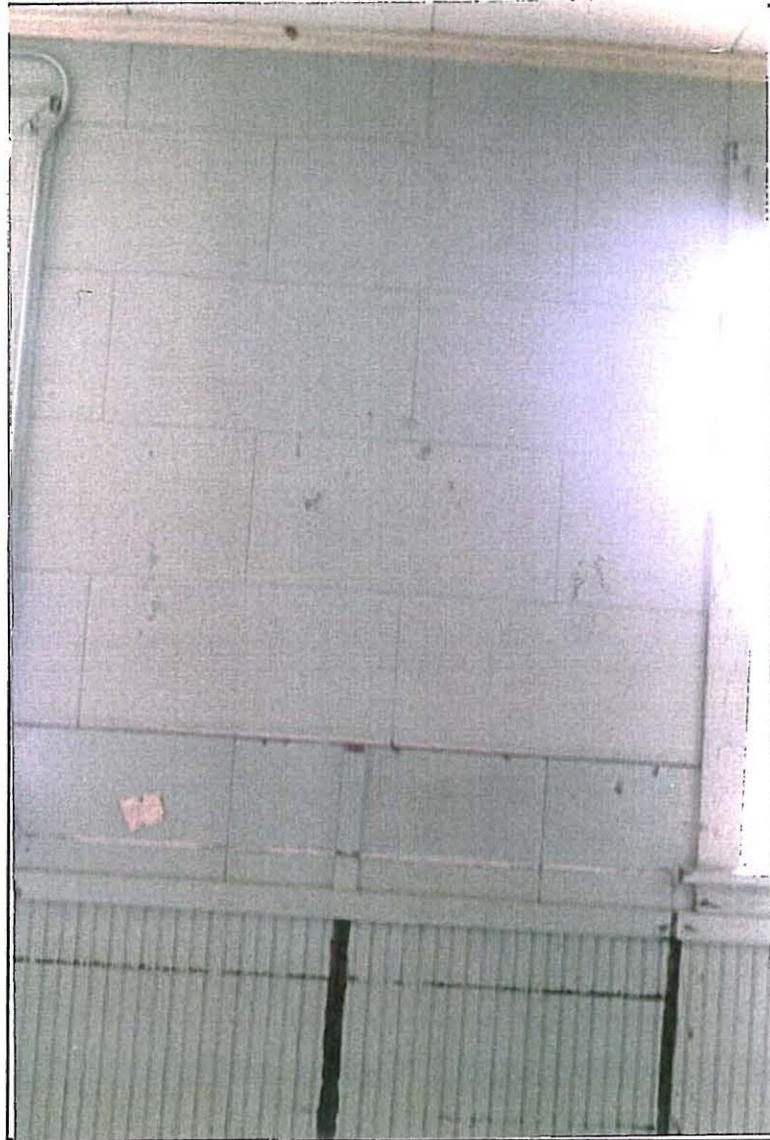
Figure 141: Room 105, North Wall

Cornice. The cornice molding is the same as that seen throughout the building. On the north, south, and east it is painted off-white, like the ceiling. See figure 141. It is missing along the majority of the west wall.

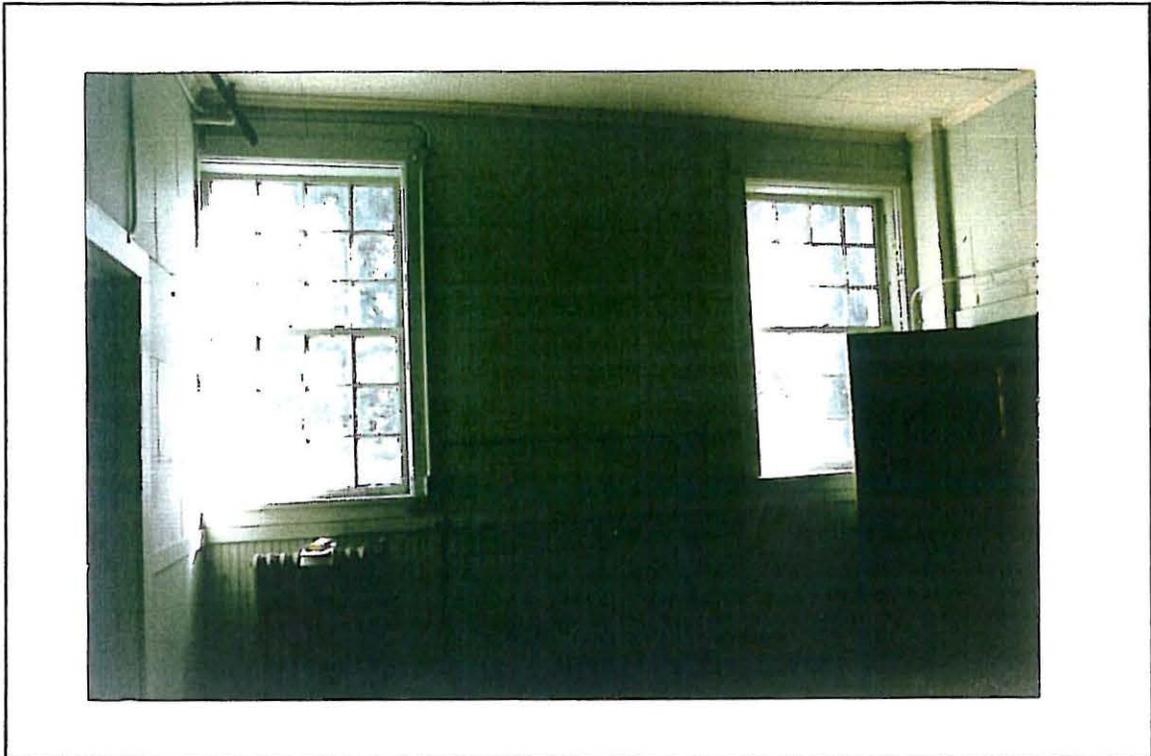
Figure 142: Room 105, North Wall Window Configuration

The window at the east end of the north wall is typical of those found throughout the building. It has a plain architrave measuring 4 1/2 inches wide, and 12-over-12, double-hung sash with original hardware. The only other window in the room is the one described in the water closet at the northeast corner of the room. See figures 142-143.

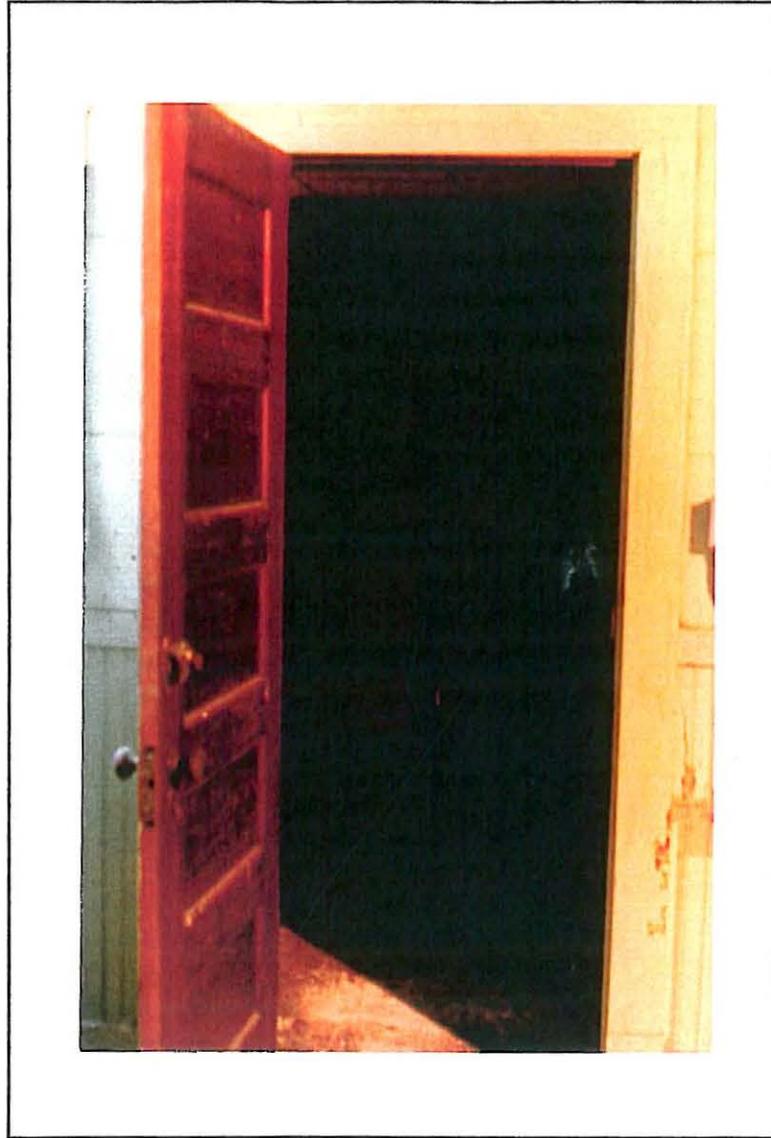
Figure 144: Room 105, Doors in Toilet

Doorways and Doors. There are three doorways in the room, and an additional door in the water closet. A doorway in the south wall leads to room 104 (hallway). It no longer has a door. A doorway at the north end of the east wall leads to the water closet, while a doorway at the north end of the west wall leads to room 106 (office/examination room). The east and west doorways have five-paneled doors. The outside of the door to the water closet is painted green, while the inside is unpainted. The door on the west wall is painted green; the door inside the water closet is unpainted. See figure 144.

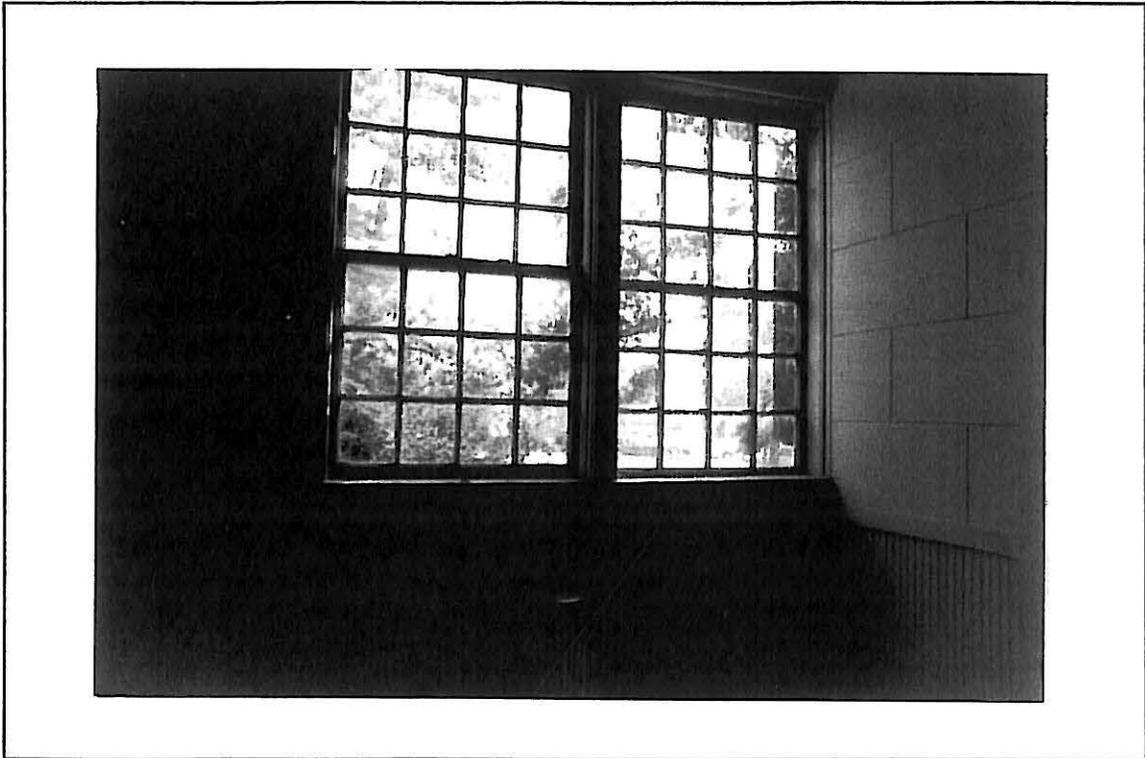
Figure 145: Room 106, NE Corner

Configuration. The configuration of room 106 does not appear to have changed since the 1939 plan was drawn. As stated in connection with the adjacent room 105, aspects of the windows in the north wall may indicate that the west wall was added after construction but before 1939. See figure 145. The dimensions of the room are 10 feet 4 inches by 16 feet 3 inches.

does not have the same outer elements as the window on the west wall. See figure 145.

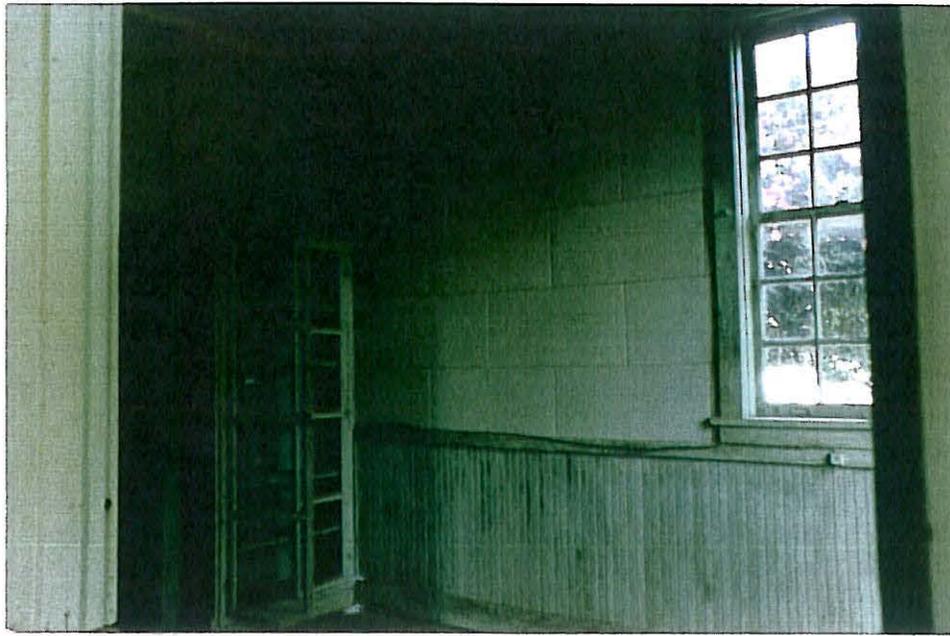
Figure 147: Room 106, SW Corner, Typical Configuration

Walls. The surface treatment of the walls matches that found throughout the building. The only wall feature of special significance in this room is on the south wall, where glass cabinets flank the doorway from room 104. They have glass doors that open from the center with latches. There are four glass panels on each door. Shelves sit behind the doors and are attached directly to the walls behind. These cabinets have no backs, perhaps necessitating that the wall behind them be painted. See figure 146. No varnish layers were found on samples taken from the cabinets. This may indicate that they were installed later than 1939. These cabinets and all walls have been painted the same shade of green that predominates throughout the building. See figure 147.

Cornice. A cornice molding matching that described in room 105 is found around the entire room. See figure 147.

Ceiling. The ceiling is covered with white fiberboard tile as described for room 105. See figure 147.

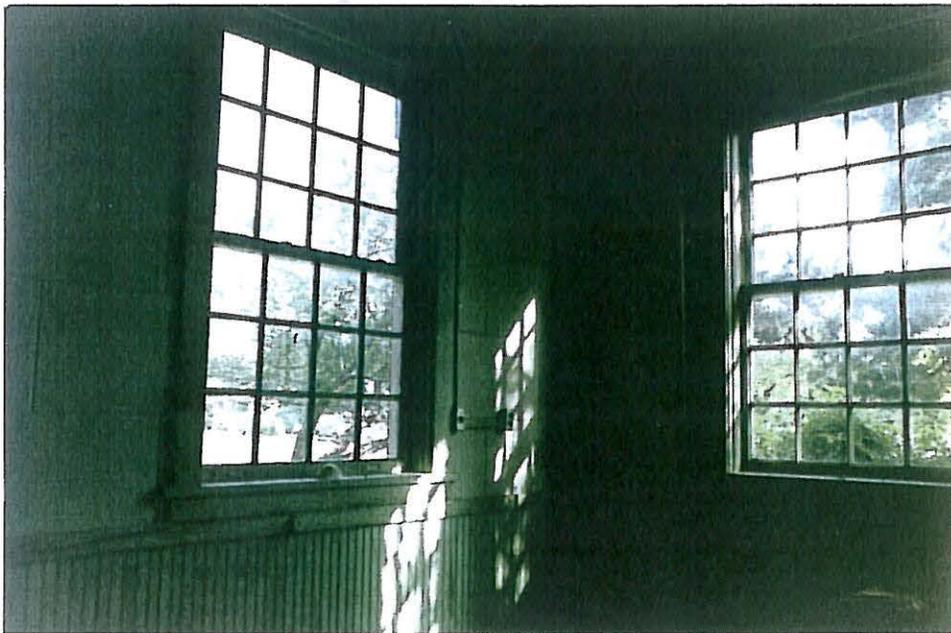
Figure 148: Room 106, Window NW Corner

There is another window at the north end of the west wall. It has 12-over-12, double-hung sashes and retains its original hardware. See figure 148.

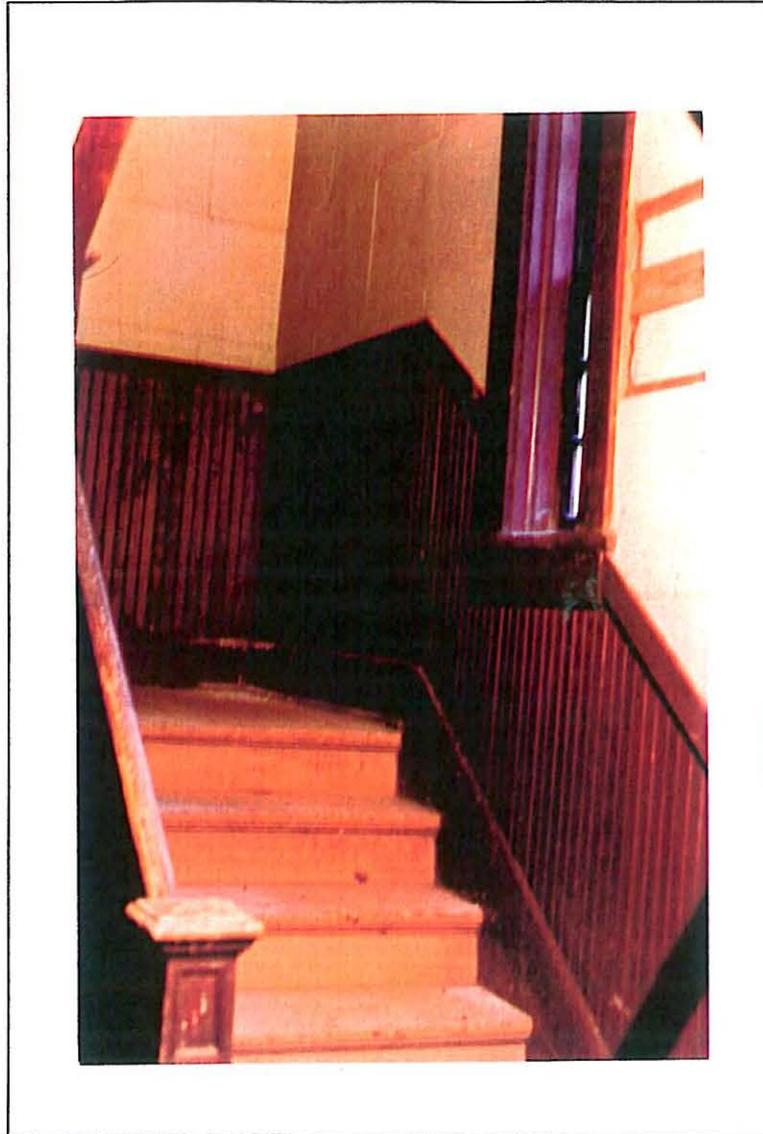
Figure 149: Room 107, General Wall Configuration

Walls. The walls are covered with the same surface treatments as those found throughout the building. The woodwork is unpainted. Samples taken from this area show only varnish. Varnish appears as the earliest stratigraphies on most woodwork samples taken throughout the building. This may indicate that this room contains some of the few remaining original finishes. The fiberboard on the upper walls has been painted the same green shade seen in other rooms. See figure 149.

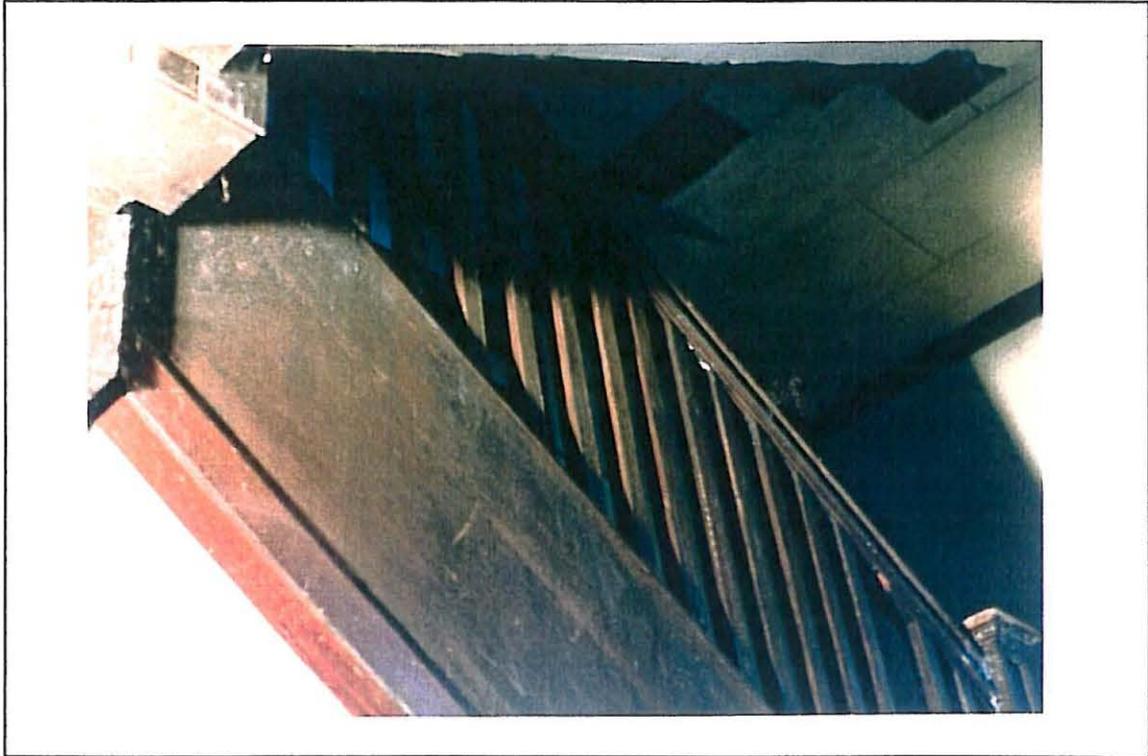
Figure 150: Room 107, Ceiling

Ceiling. White fiberboard panels have been attached to the ceiling and the undersides of the two stair flights leading to the second story. See figure 150.

Generally, this area is in fair condition. The floor, baseboards, beaded-board wainscot, and wainscot caps show no signs of significant deterioration. See figure 153. Some of the fiberboard panels are missing from the north wall, exposing the nailing members and plaster beneath. A hole is seen through the plaster near the top of the exterior doorway's frame. See figure 154. Other fiberboard panels have become detached on the ceiling and the undersides of the stair flights. See figure 150. The fiberboard panels also have nicks, scrapes, and scars, especially along the stairway walls.

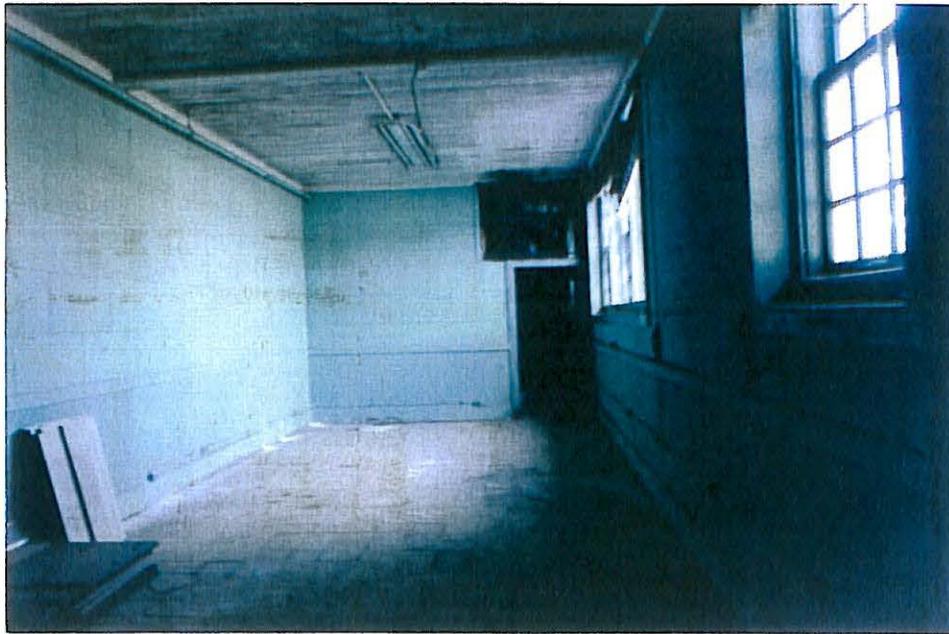
Figure 155: Room 108, General View

Walls. The wall treatment is also the same as that found throughout the rest of the building. The only exception is on the south wall, where a large section above the doorway appears to have been cut out, possibly for some type of ventilation equipment. See figure 155.

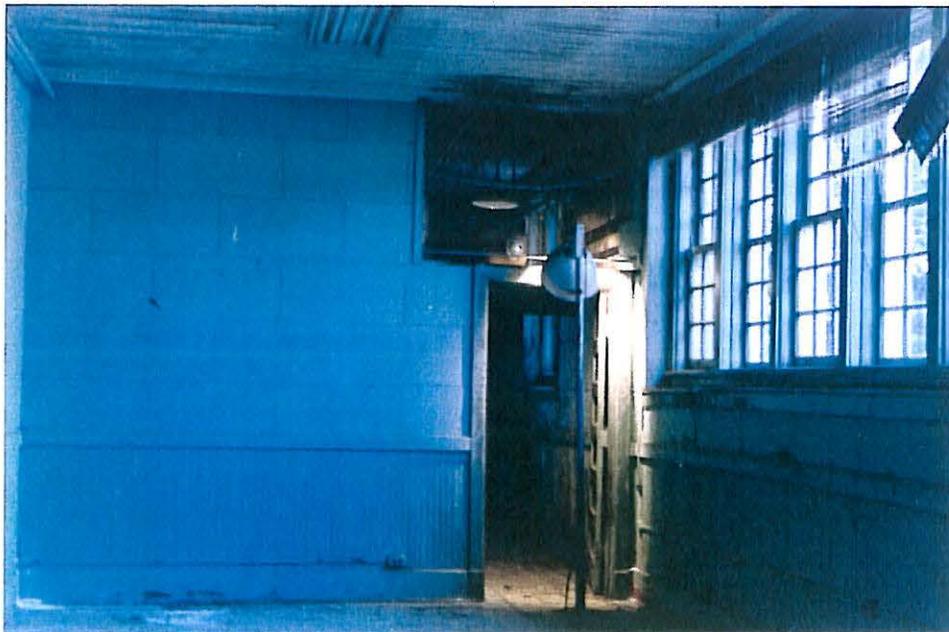
Figure 156: Room 108, SW Corner Windows & Vent

Windows. A set of five windows is at the south end of the west wall. (It would have been centered when rooms 108 and 109 were one space.) All five windows have nine-over-nine sashes. The center and two outer windows have double-hung sashes, while those of the two inner windows are fixed. See figure 156. This window configuration is mirrored on the opposite side of the building (east wall of room 101). A single window with 12-over-12, double-hung sashes is at the north end of the west wall.

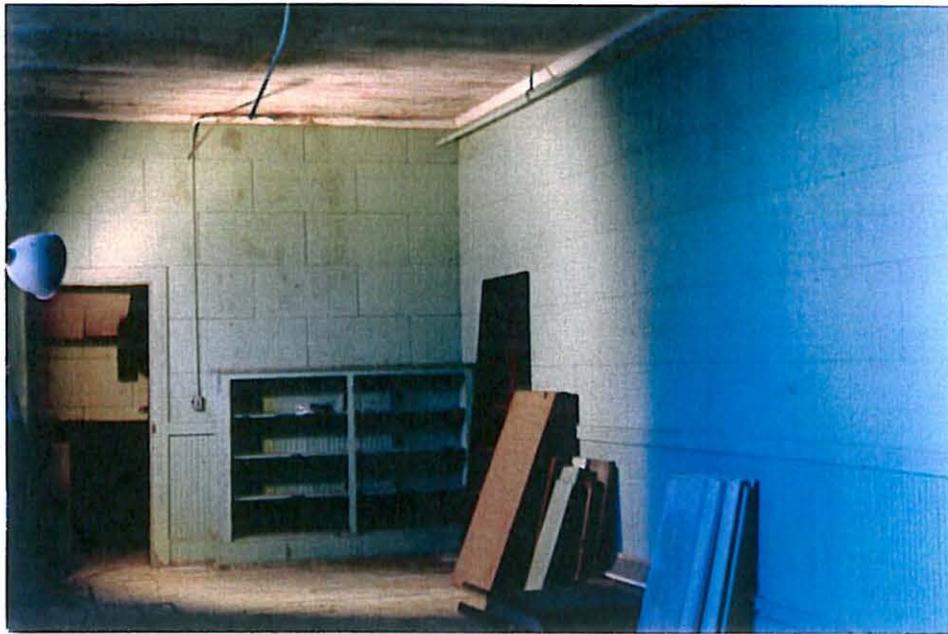
Figure 157: Room 108, South Wall Condition

Fixtures. Of particular note in this room is the shelving cabinet on the north wall. Its size and height are similar to the paint pattern left in room 105, where it was clear that some type of element had been removed. Disassembled shelf parts are lying near the doorway. A boxed fluorescent light remains attached to the ceiling. See figure 157.

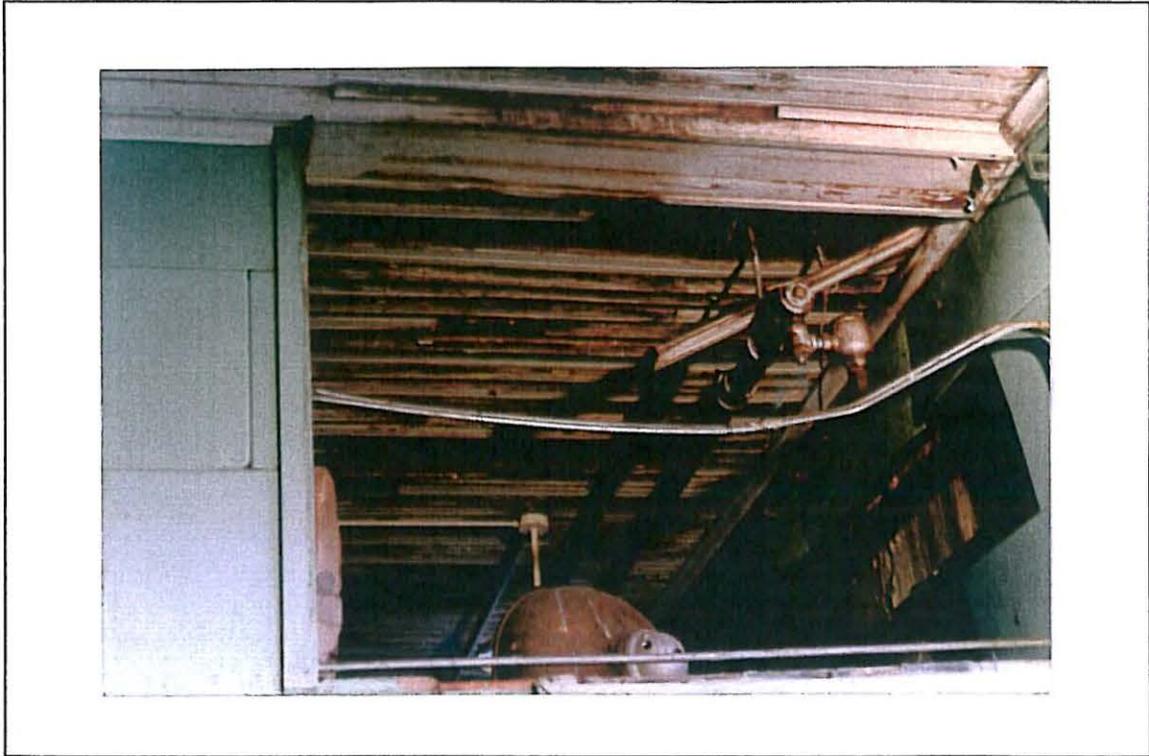
Figure 159: Room 108, Ceiling SW corner .

Ceiling. The worst conditions can be found at the southwest corner, where dark water-staining and buckling can be seen. Rotted beaded boards are detaching from the ceiling; they are completely detached and failing just south of the doorway to room 109. See figure 159. The condition becomes less severe to the north. Dark staining is also seen along the northeastern section of the ceiling, but to a lesser extent than in the southern section.

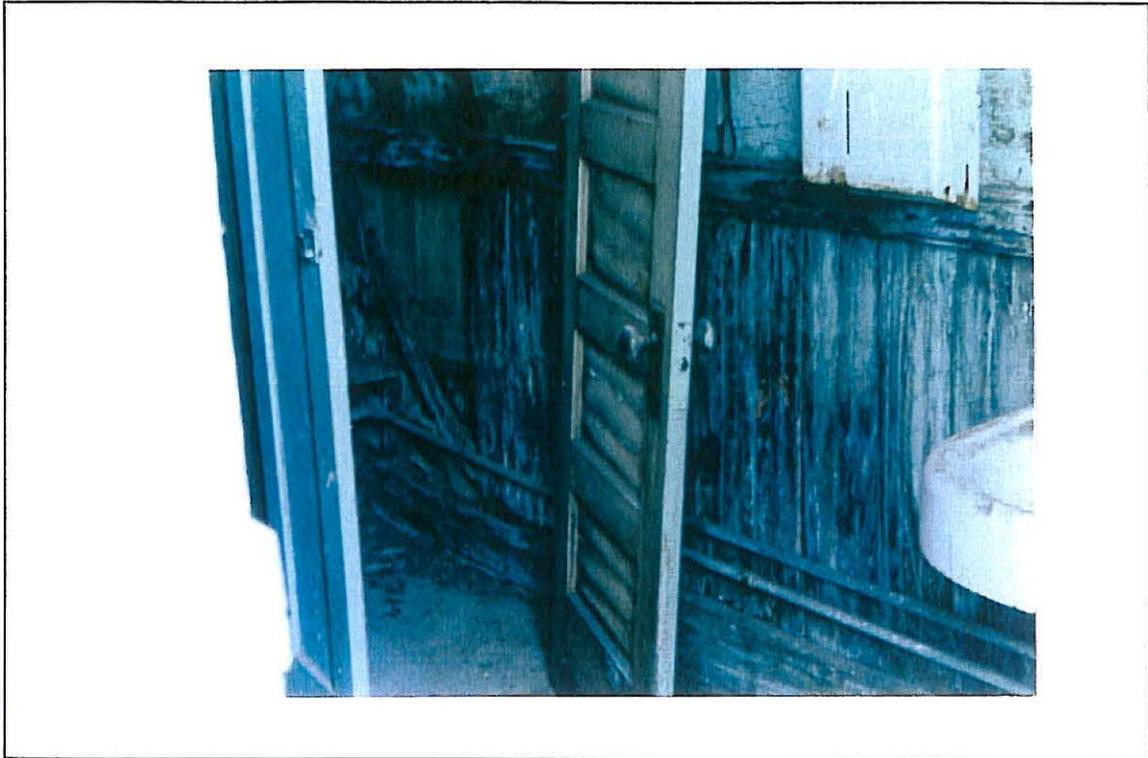
Figure 161: Room 109, General Condition

As stated above, the condition of this room is very poor. See figure 161. The southwest corner of the ceiling has caved in, and the resultant damage beneath includes extreme buckling of fiberboard, complete detachment of beaded boards and fiberboard, dark water-staining, and rot. Brick and plaster on the south wall are completely exposed. See figure 162. Conditions improve minimally at the northern section of the room, especially near the interior walls. However, water damage and partial ceiling failure are also noted near the entry doorway from room 108. The bathroom area is in relatively better condition.

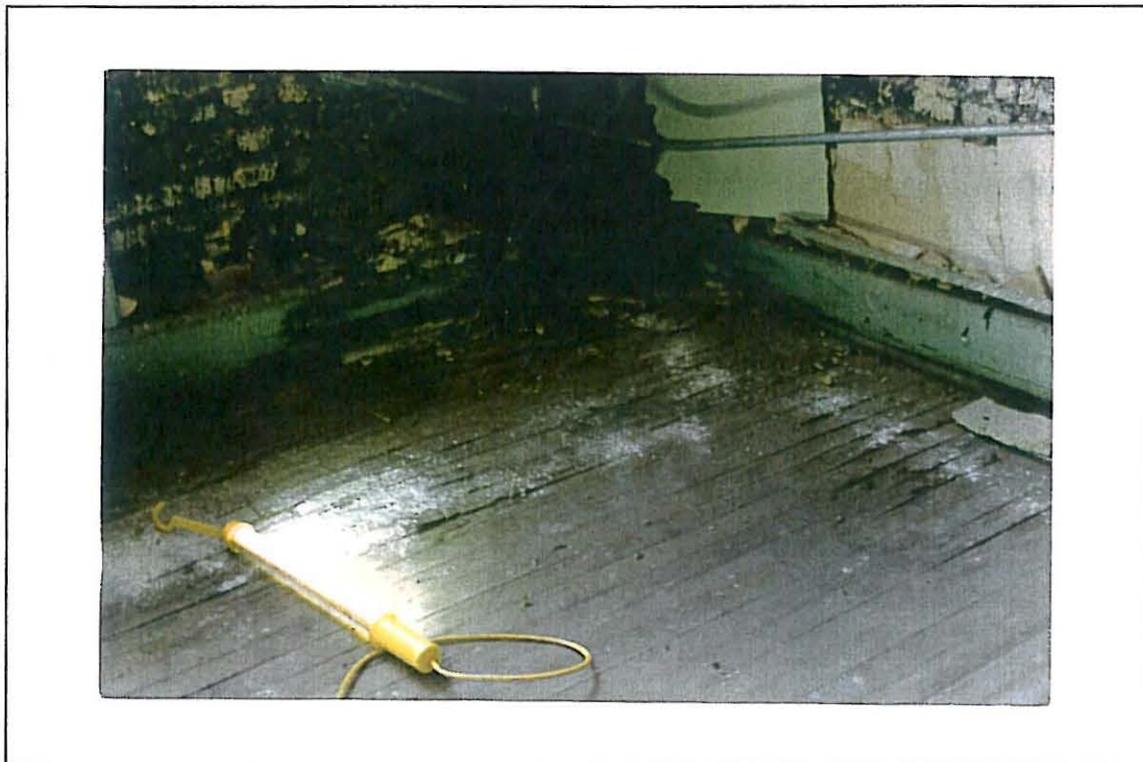
Figure 167: Room 110, NE Corner

Floor. The floor at the northeast end of the room is badly deteriorated. See figure 167. The northeast corner has almost completely failed. Boards are beginning to buckle along the west wall as well. A hole is seen at the north center of the room, just west of the radiator. As is the case in all of the rooms, guano covers the majority of the floor. Lime has been applied to keep fungus and mold growth to a minimum.

Baseboards. The baseboard at the northeast corner has become detached from the wall. The quarter-round toe molding and rounded cap have separated from the center panel. The north-wall baseboard has rotted. See figure 167. An accumulation of broken plaster exists behind it. Dark water-staining is seen at the southeast corner. The baseboard is detached on the boxed post at the east end of the south wall. The baseboard at the northwest corner is badly stained, presumably from water or moisture damage.
