WOMEN'S OLD GYMNASIUM
HISTORIC STRUCTURE REPORT

Northwestern State University
Natchitoches, Louisiana

Regina T. Binder
With Joan Berkowitz and David Bitterman

1993

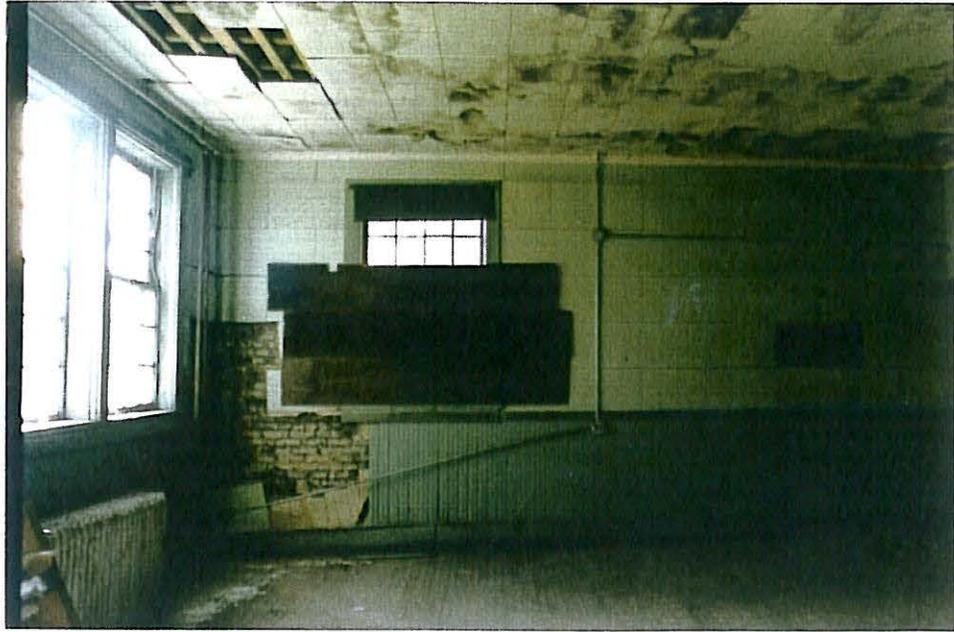
Figure 168: Room 110, SE, East Wall

Walls. Complete failure of the wall surface at the northeast corner has occurred, on both the north and east walls. The brick beneath the residual plaster is exposed. See figure 168. A large and long vertical crack runs from the corner of the easternmost window in the north wall down to the floor. Dark and light water-staining dominates the south wall. See figure 165. A section of beaded-board wainscot is missing from the south wall near the west-wall entrance. A panel of fiberboard is missing from the east wall. Alligating and chipping paint dominate all four walls, with the worst of these conditions seen on the south wall and the south end of the east wall. See figure 169. Heavy moisture staining is also noted at the west-wall entrance. Dark water stains dominate the southwest corner and along the upper portion of the west wall.

Ceiling. Dark staining, presumably from moisture damage, can be seen over 50 percent of the ceiling surface. Several fiberboard tiles are missing near the set of windows at the east end of the north wall. See figure 168.

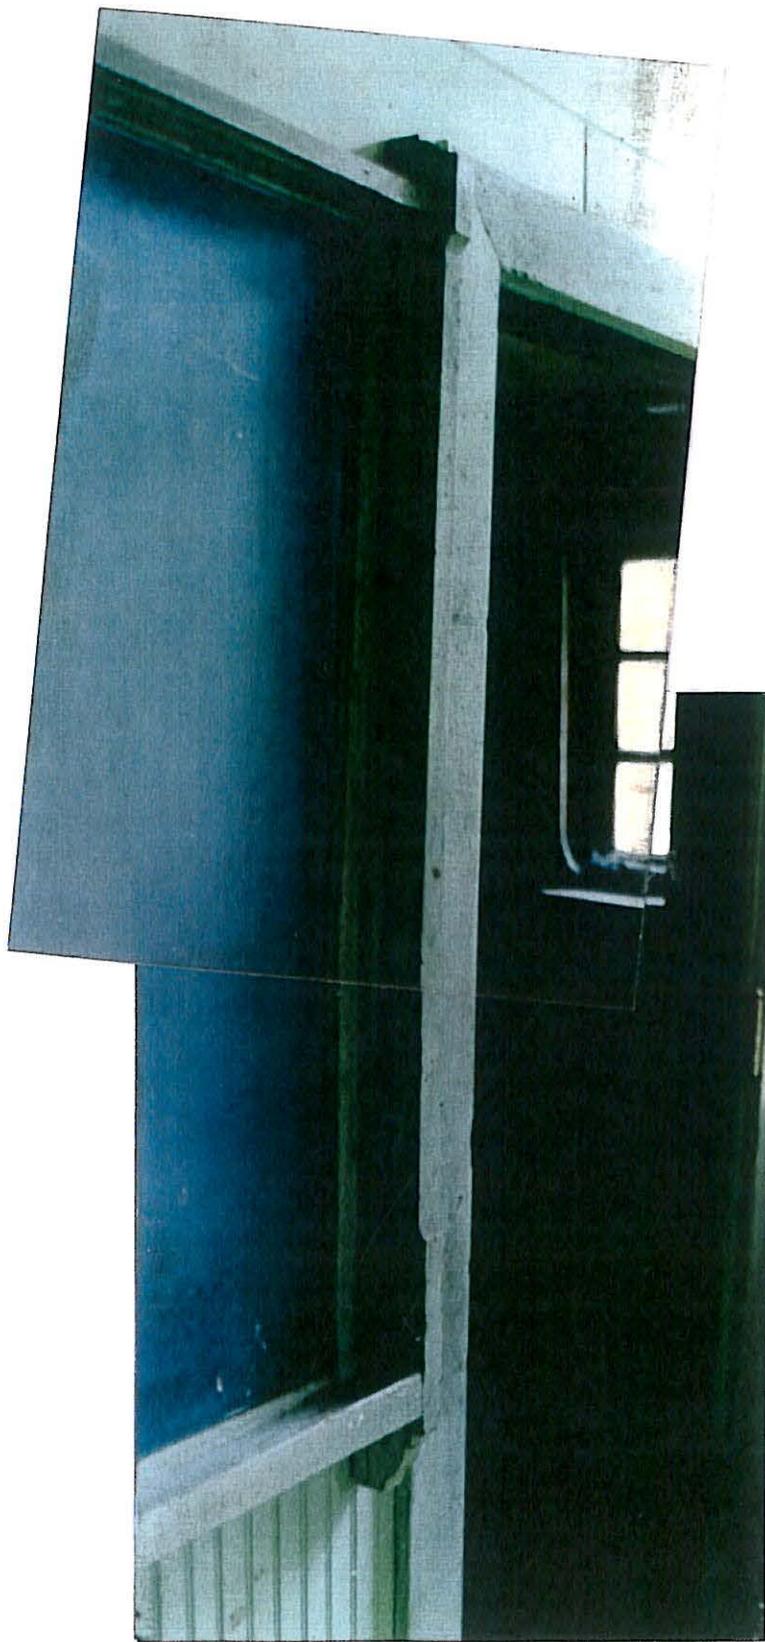
Figure 170: Room 110, Blackboard
Trim

Character-Defining Features. The room retains the character of its original use as a classroom. The blackboard emphasizes the educational aspects of its use, while the trim around it helps define the original style. See figure 170. This trim is worthy of retention, since it matches the Jacobean detail on the windows' exterior meeting-rail stops.

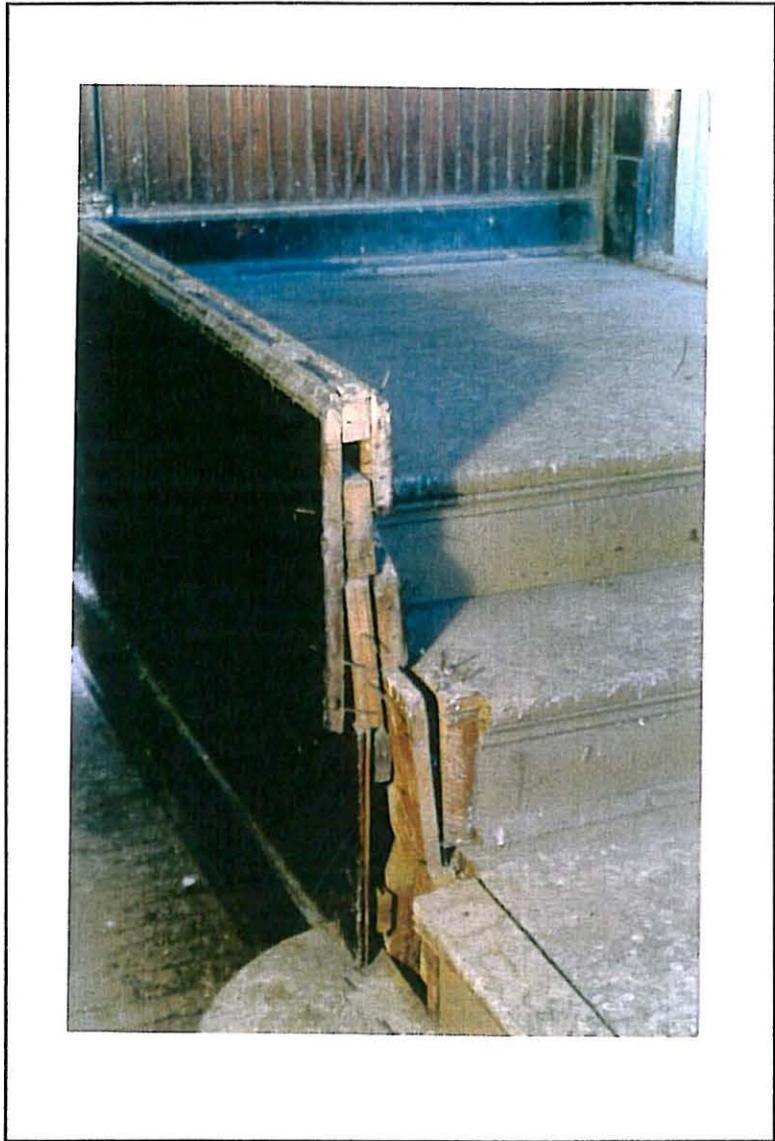
Figure 178: Room 200, East Rail

Fixtures. The handrails and the newel post on the east portion of the access to the classrooms are missing. See figure 178. Several of the balusters are also missing from the balustrade along the east side of the landing.

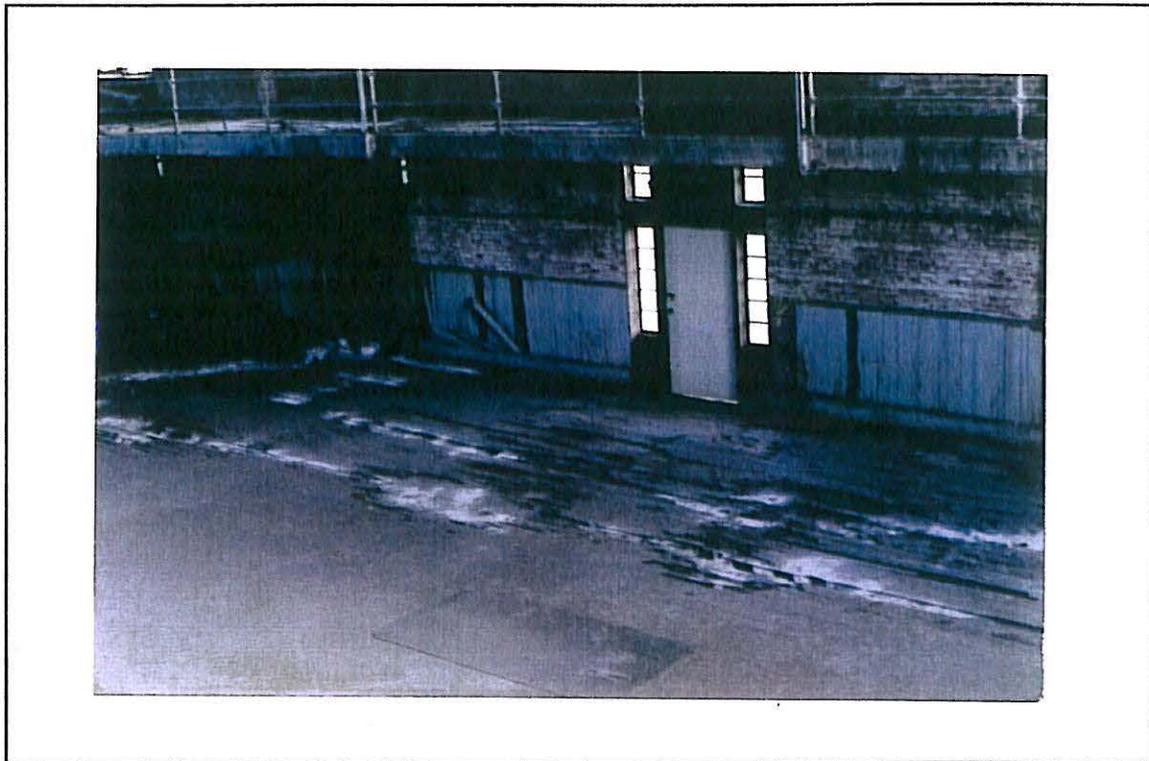
Figure 179: Room 201, Floor, Looking South

Floors. The floor matches that typically found. Remnants of painted boundary lines remain from the use of this room as a basketball court. See figure 179.

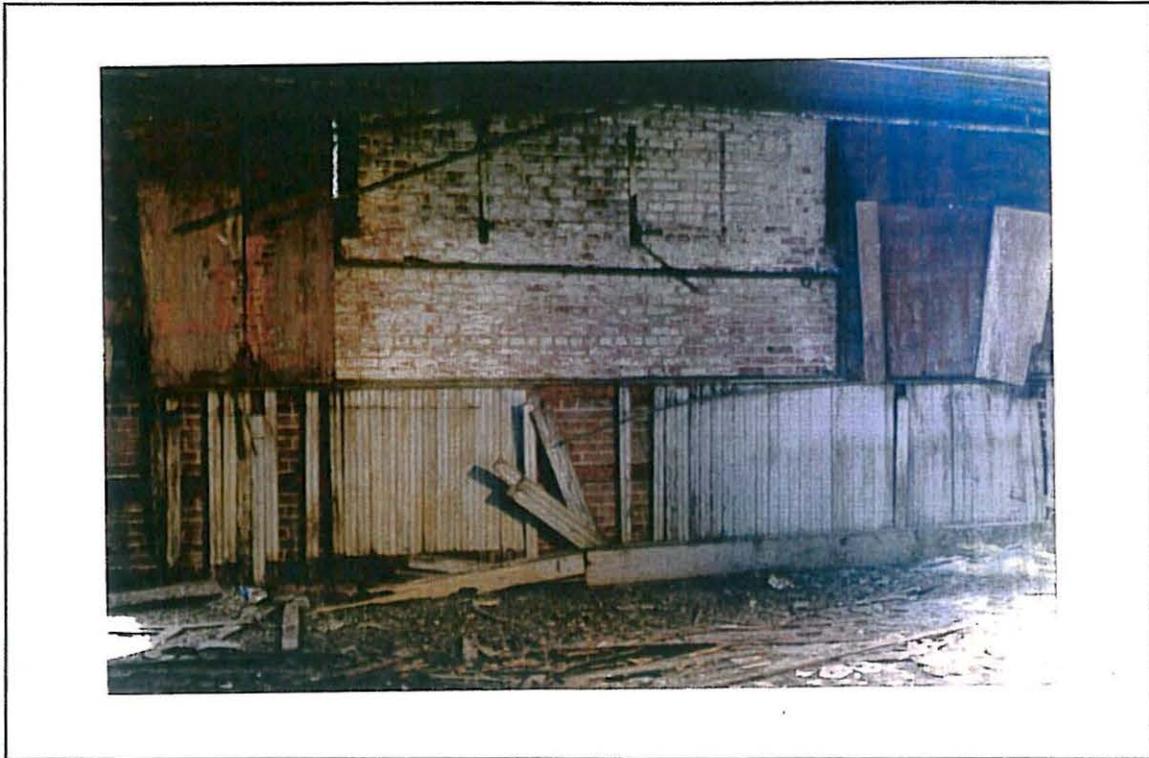
Figure 192: Room 201, SE Corner Condition

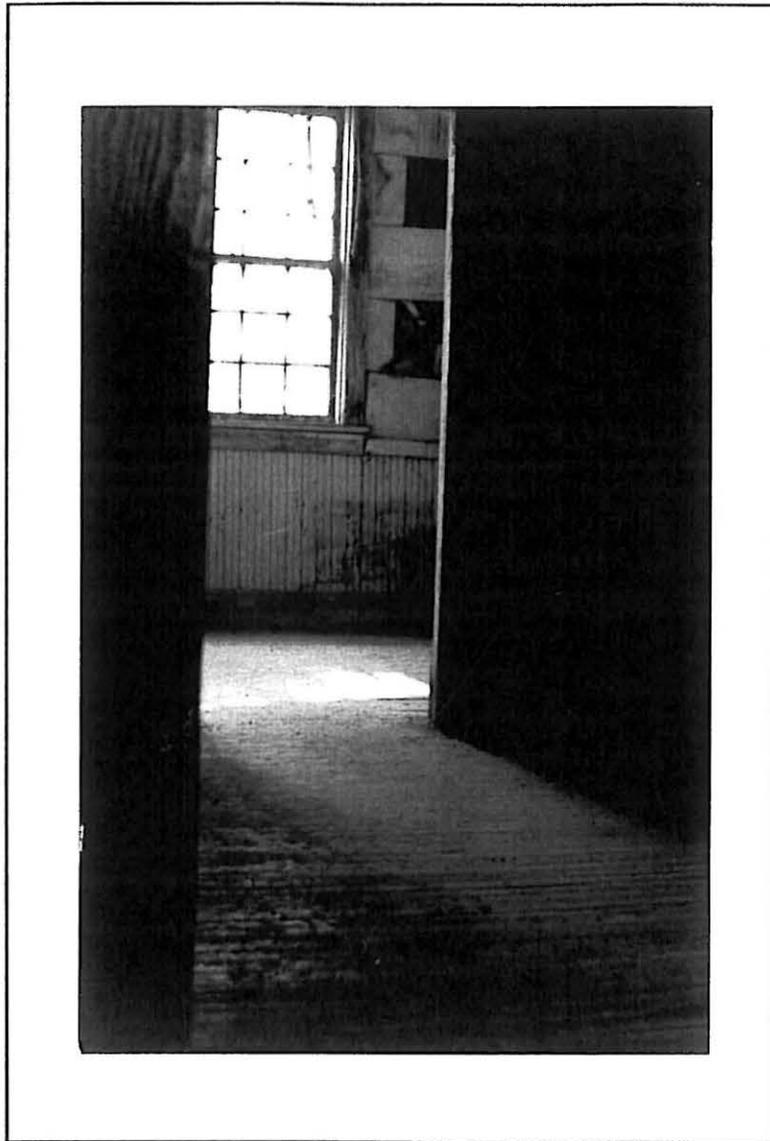
Walls. The north wall has pieces of fiberboard that have become detached, exposing the brick exterior wall and its nailing strips. Water-staining is prevalent on the wainscot near the east wall. The sill and framing of the window unit also show severe signs of rot and water damage. See figure 196.

**Figure 196: Room 203, NE Corner
Configuration & Condition**

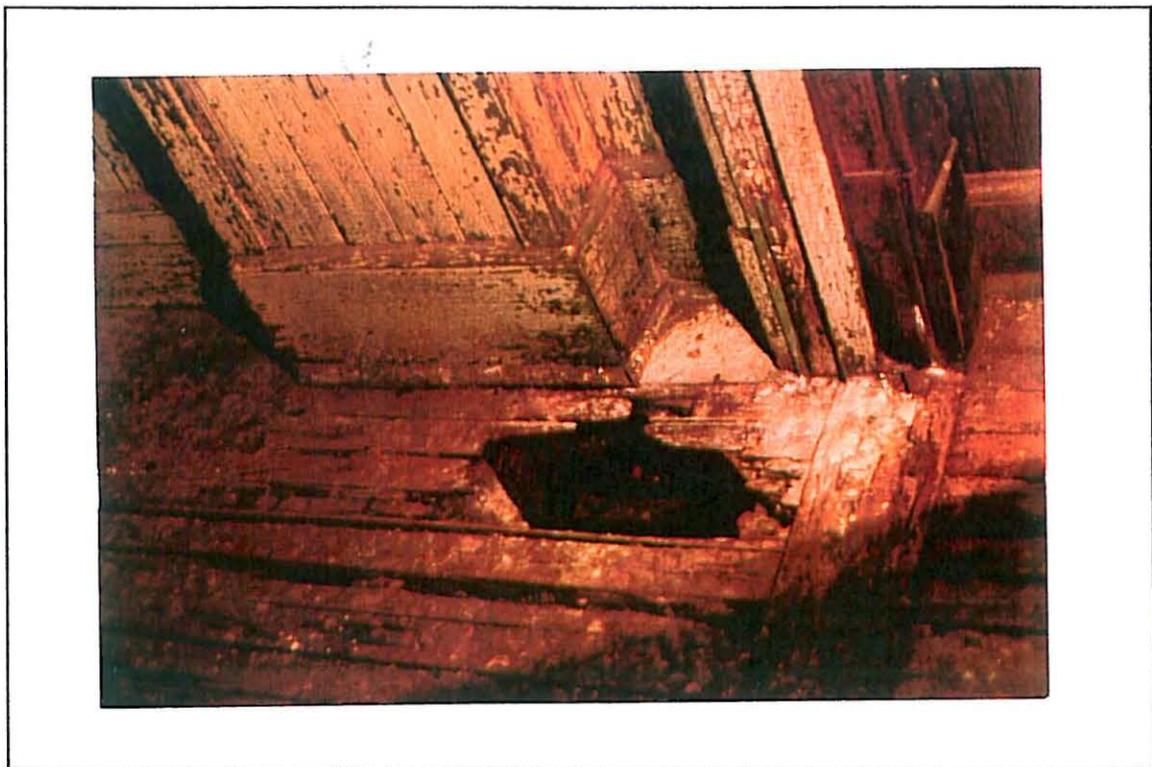
Floor. The floor at the southwest corner of the room has totally failed. A large hole is present, making entry into the room dangerous. See figure 199. Signs of rot are evident all along the southwest section of the room. There are also severely deteriorated sections in the northeast section of the room.

Figure 199: Room 204, Boxed Post

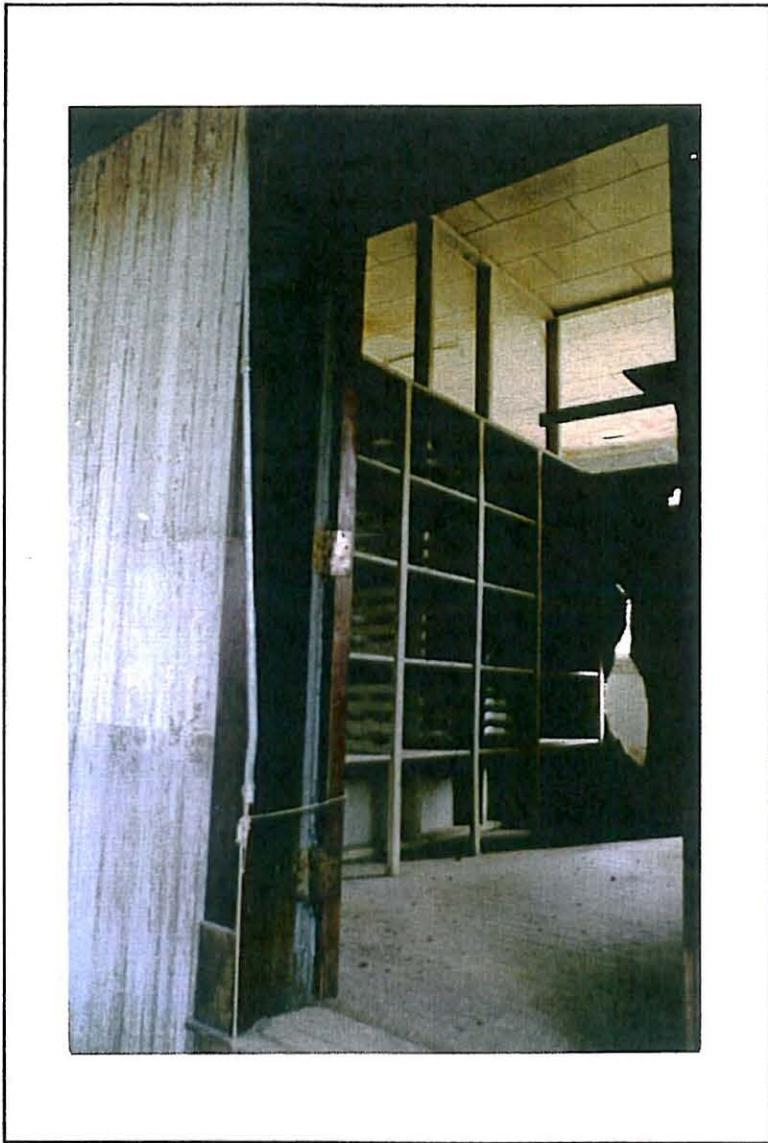
Walls. Damage from moisture and staining is most prevalent at the northeast and southwest corners. Severe paint alligatoring, paint chipping, and paint cracking can be seen on the boxed post near the doorway to room 200. These same problems exist to a lesser extent on the north wall, to the east of the window. A large hole is seen in the partition wall. See figure 203.

Figure 203: Room 204, Storage Area

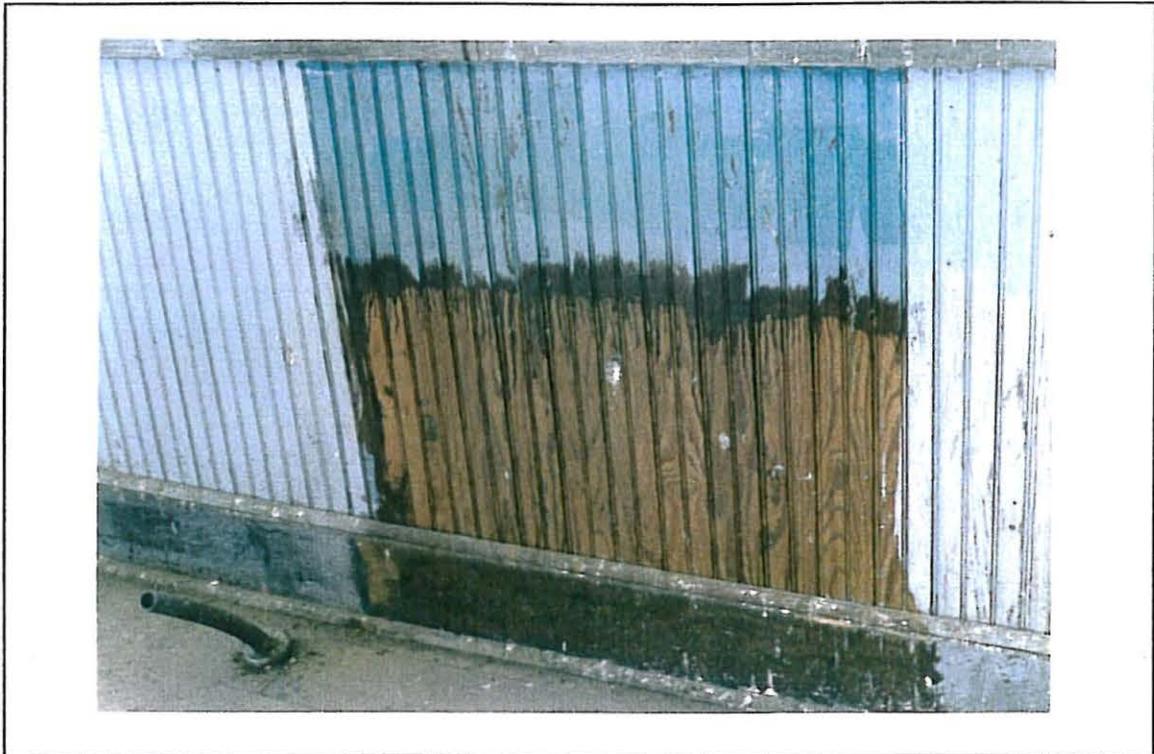
Figure 208: Room 205, North Wall, Paint Changes

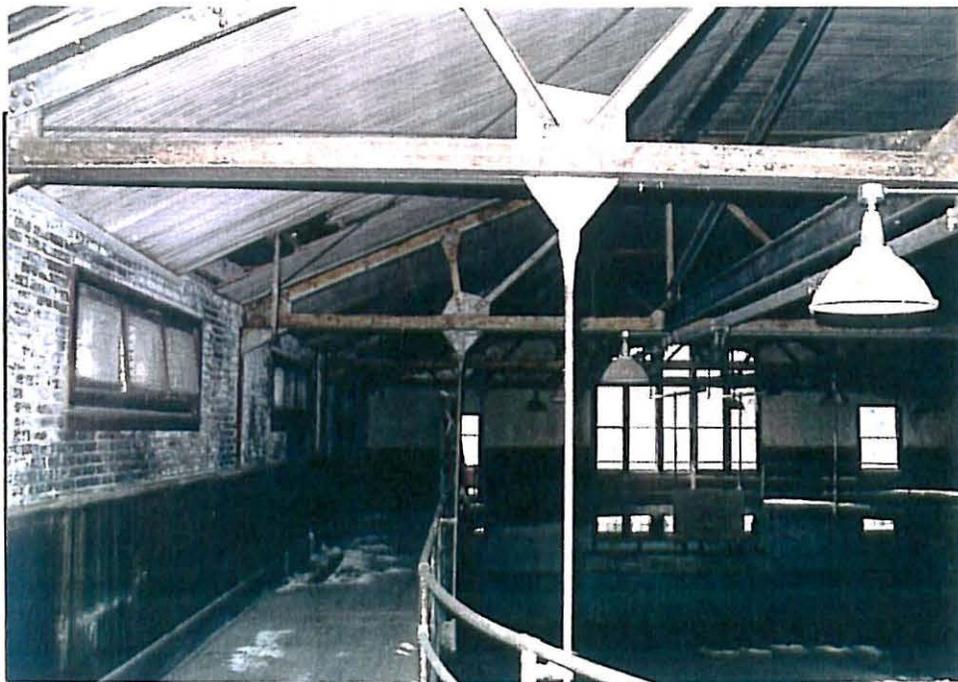
The beaded-board wainscot on the lower portion of the north wall is detached in areas near the east end. Staining is also seen in this area from the wainscot cap down toward the sections of floor that are now missing. The brick above this surface treatment is in fair or average condition. See figure 211.

Figure 211: Room 300, North & East View

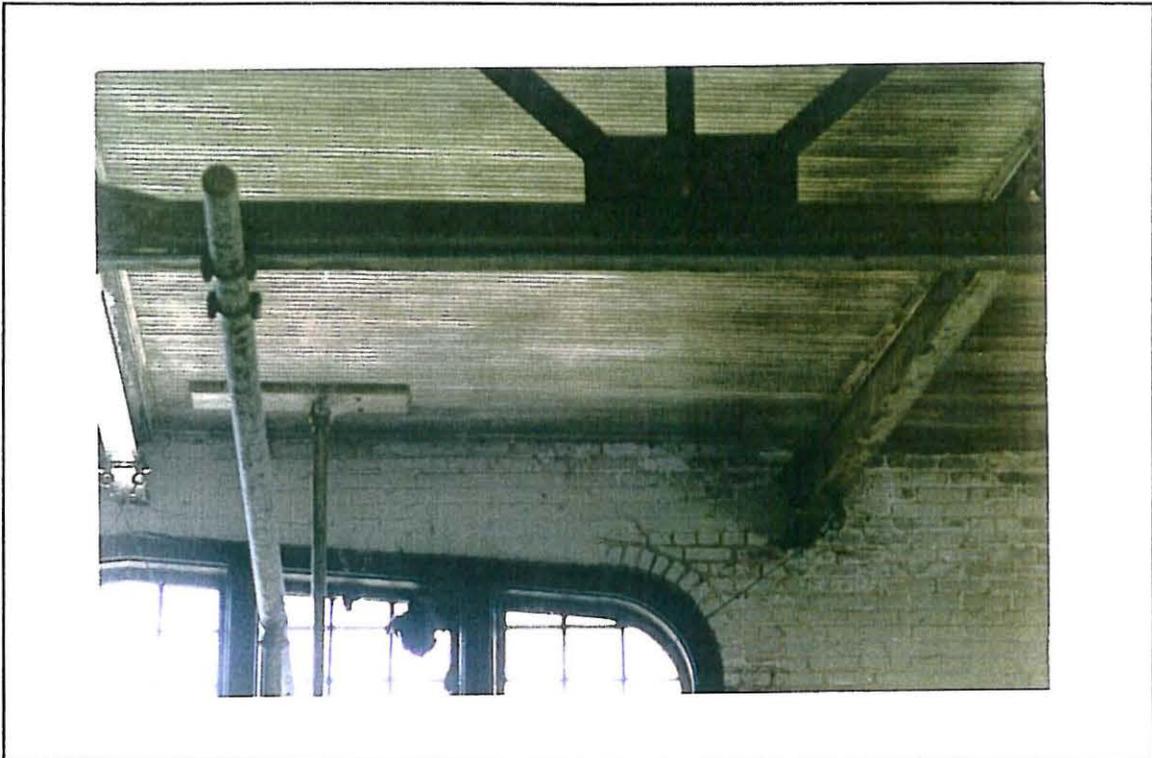
Figure 219: Room 300, Ceiling Condition

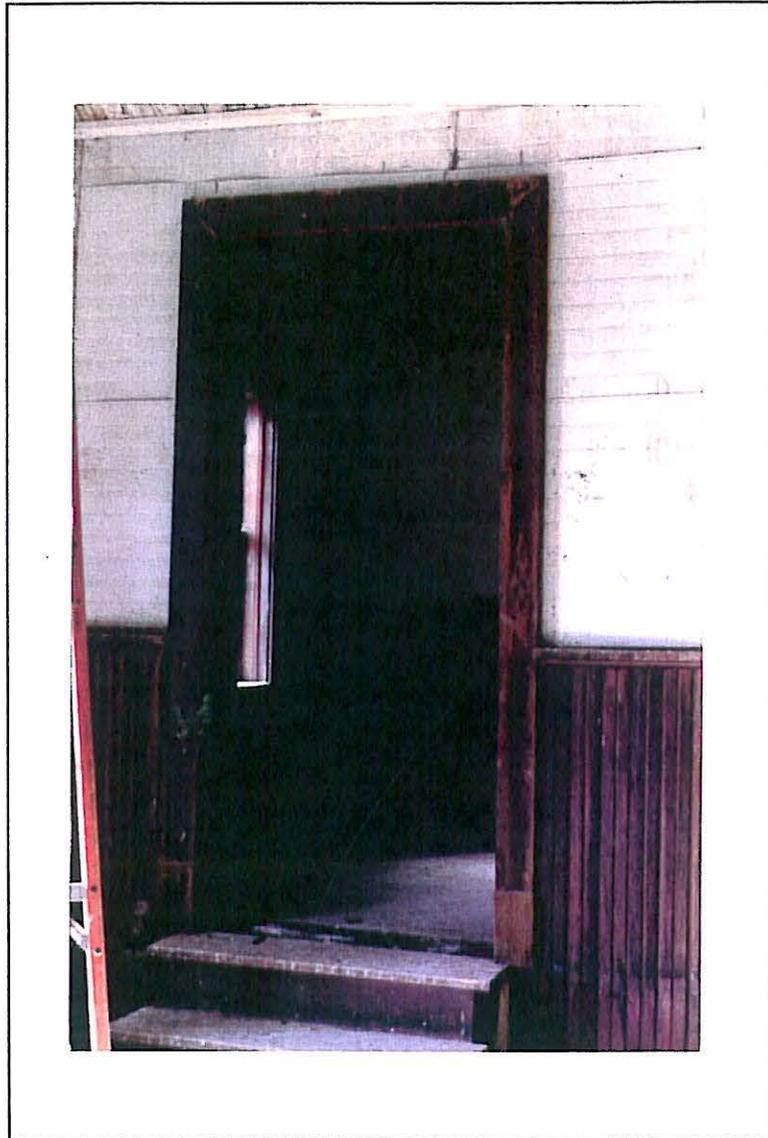
The appearance of the room is the same as provided for rooms 107 and 206. Ascending from the second floor, interior evidence of the change in the thickness of the wall from three wythes to four are seen. The north and west walls each have one window typical of those in the stair pavilions, i.e., with three-over-three, double-hung sashes. The ceiling contains a trap door that leads to the roof. The condition of the room is fair. The woodwork is intact, but alligating and paint cracking are seen. See figures 221-222. The stairway was described in connection with room 107.

Figure 221: Room 301, Stair Hall

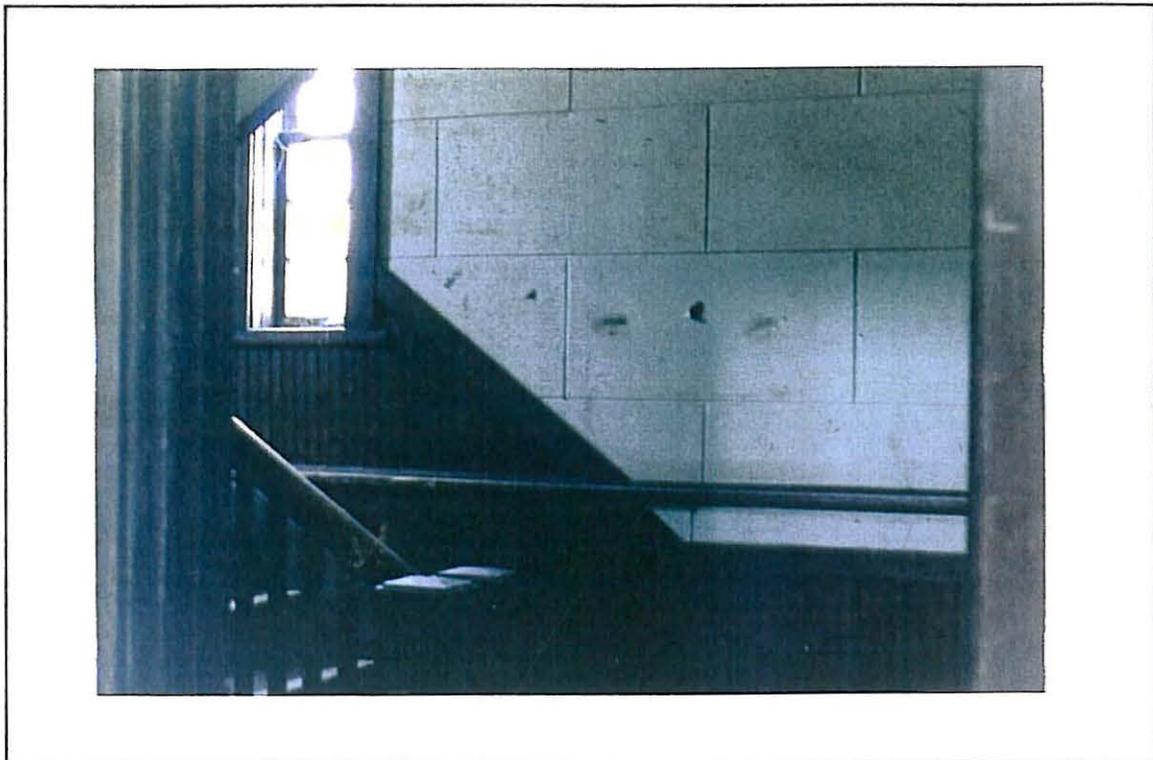
Figure 222: Room 301, Wall Configuration

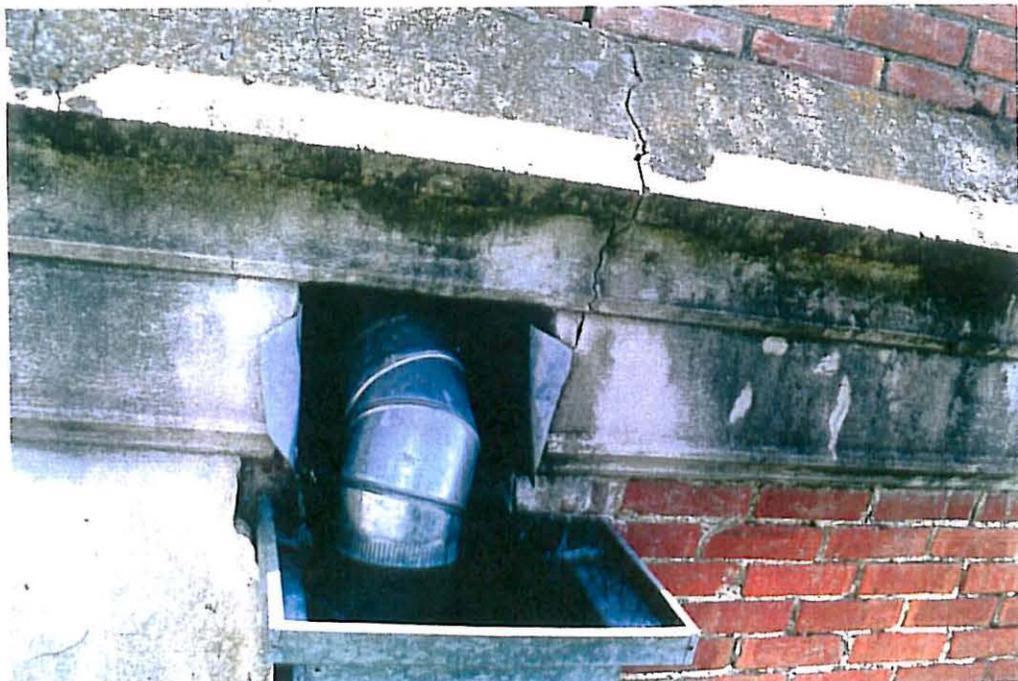
Figure 224: South parapet of gymnasium block, with sheet metal elbow installed in former scupper.

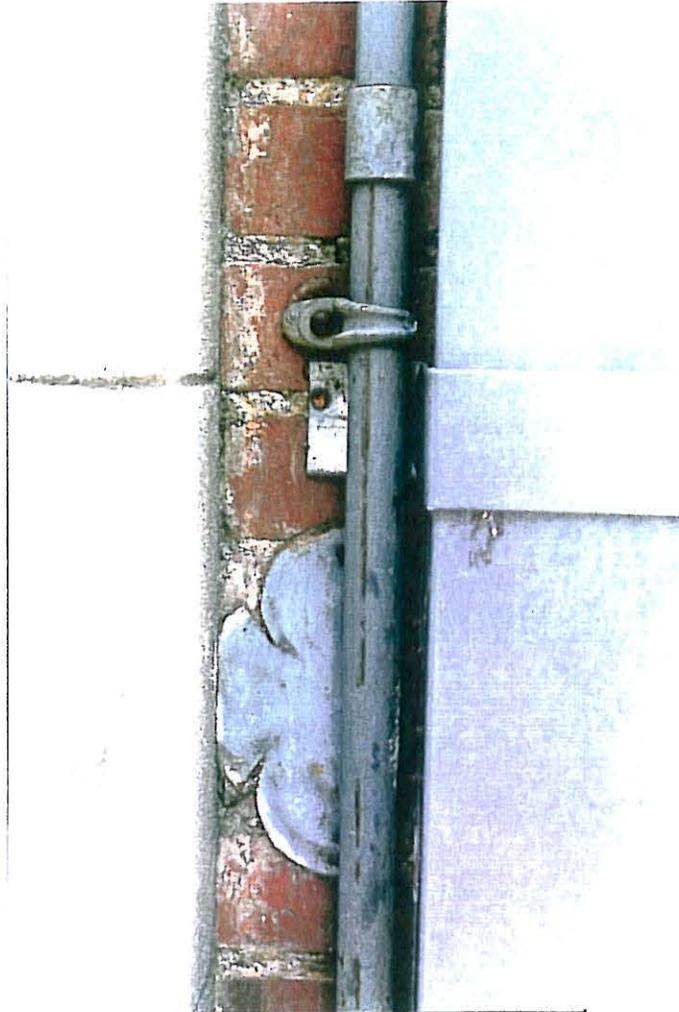
All eight main conductors are also fabricated of galvanized-steel sheet metal. All appear to date to the last reroofing of the building, replacing earlier conductors at the same locations. See figure 226. The conductors themselves are of 4-by-5-inch rectangular section, installed with offsets around interrupting cast-stone belt courses; they each have a single 45-degree discharge elbow at their lower ends. Conductors are secured to the masonry surface with unornamented galvanized-steel sheet metal straps.

Figure 226: South wall of gymnasium block. Note new galvanized sheet metal conductor and strap installed over remnant of earlier cloved strap.

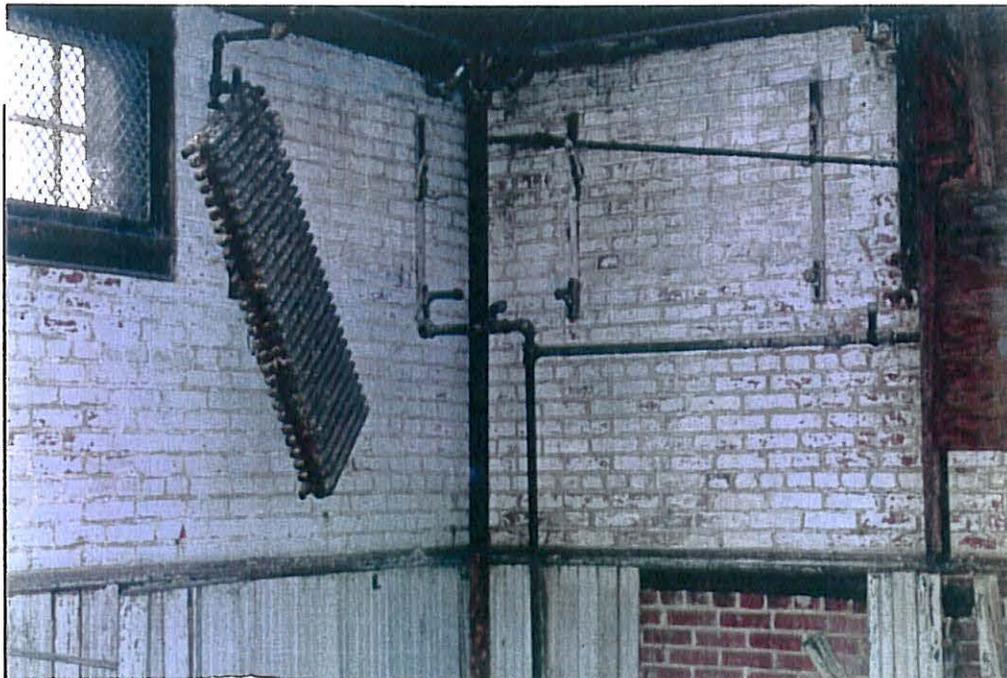
Figure 231: Wall-hung steam radiator (single unit), room 201, slipped from bracket. Note empty radiator brackets on adjacent wall.

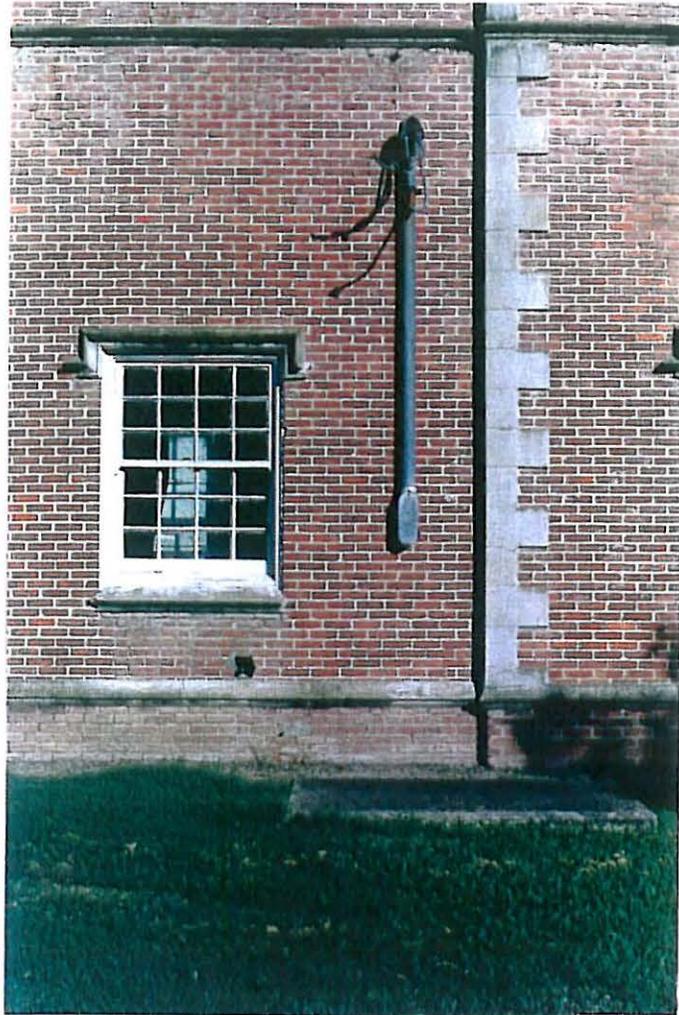
Figure 235: Concrete equipment pad off east wall of gymnasium block. Masonry opening beneath window suggests possible routing of electrical and coolant lines. Note also the abandoned service entry conduit of the second generation electrical system.

Service for the new system was again brought overhead to the exterior of the building, although apparently from a different pole location. The new overhead secondary reached the east wall of the building on its southern bay, immediately south of the projecting center bay. See figure 235. A line anchor assembly, since removed, was situated immediately below the cast-stone stringcourse separating the first and second stories. This location is confirmed by a surviving array of anchor-bolt holes in the masonry. Service conductors entered the surface-mounted metal weather-head and metal service-entry conduit approximately 2 feet below, and were fed through the masonry wall via a pulling elbow situated approximately 6 feet above grade. The conduit feeds directly into the back of the main panel in room 101. The size and number of conductors suggests a three-phase, four-wire, 120/208-volt system.

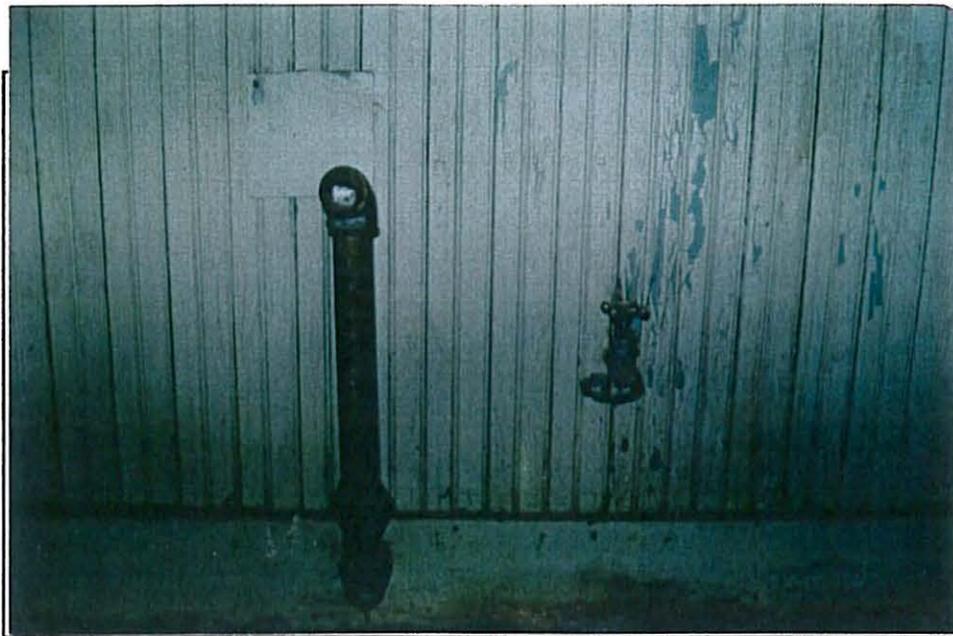
Drinking fountains were located in rooms 101 and 201. In the former, a single fountain was situated at the west end of the north wall. Although the fixture is no longer extant, the drain and cold-water supply remain. Room 201 contained two fountains, at the east and west ends of the north wall. Again, drain and supply rough-ins are the only surviving components. See figure 243.

Figure 243: Remnants of drinking fountain drain and supply in room 101

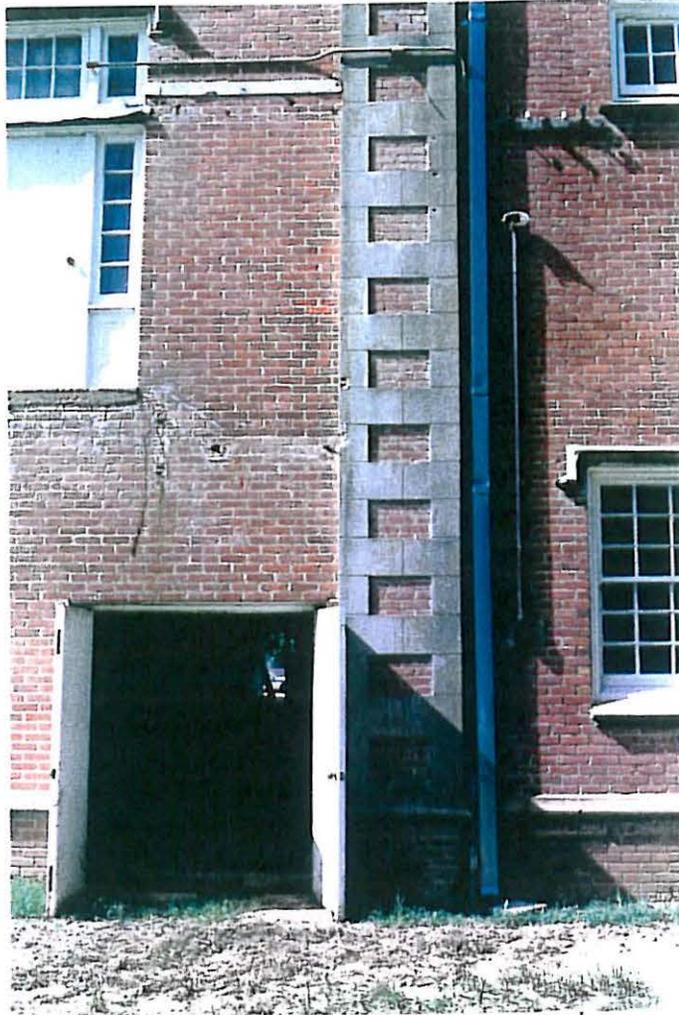
The overhead secondary reached the building immediately east of the fire escape formerly centered on the south exterior wall of the gymnasium block. See figure 245. A line anchor assembly (with most of its insulators intact) survives on the exterior of the south wall, adjacent to the pilaster on the east side of the center bay, mounted just below the level of the second-story window sills. Below this, a surface-mounted metal weather-head and service-entry conduit also survive intact. The conduit feeds into the masonry wall through a pulling elbow at approximately 7 feet above grade, then sweeps into the top of the main panel in room 101. A grounding conductor is clamped to the conduit immediately above the elbow. The masonry wall penetration at the elbow is trimmed with a projecting cast-stone block. See figure 246.

Figure 245: Abandoned service entry conduit of the first generation electrical system. Note the line anchor assembly with intact insulators above, and weather-head and service-entry conduit below

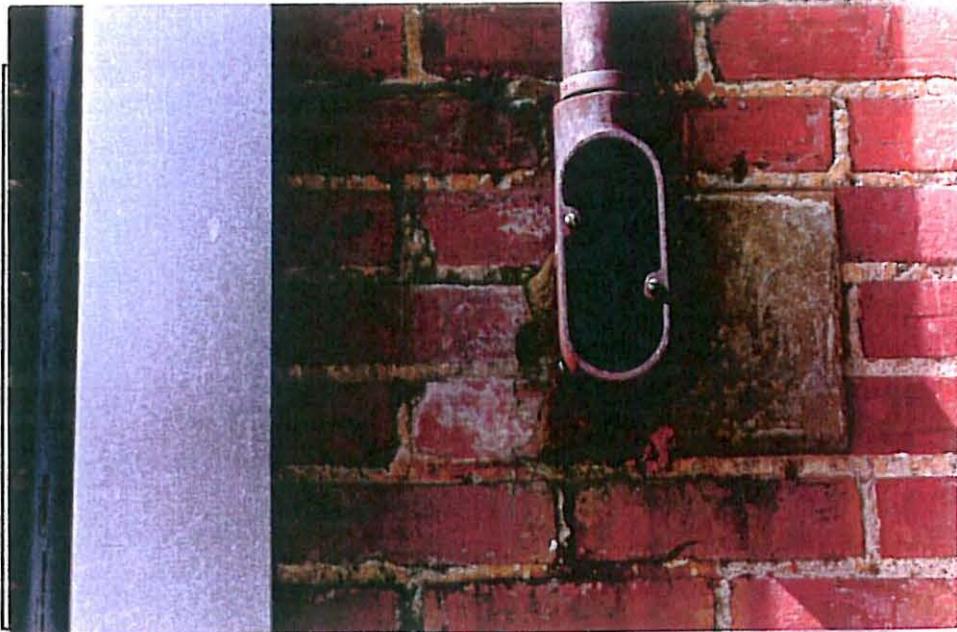
Figure 246: Partially intact cast stone trim at pulling elbow of the first generation electrical system service entry

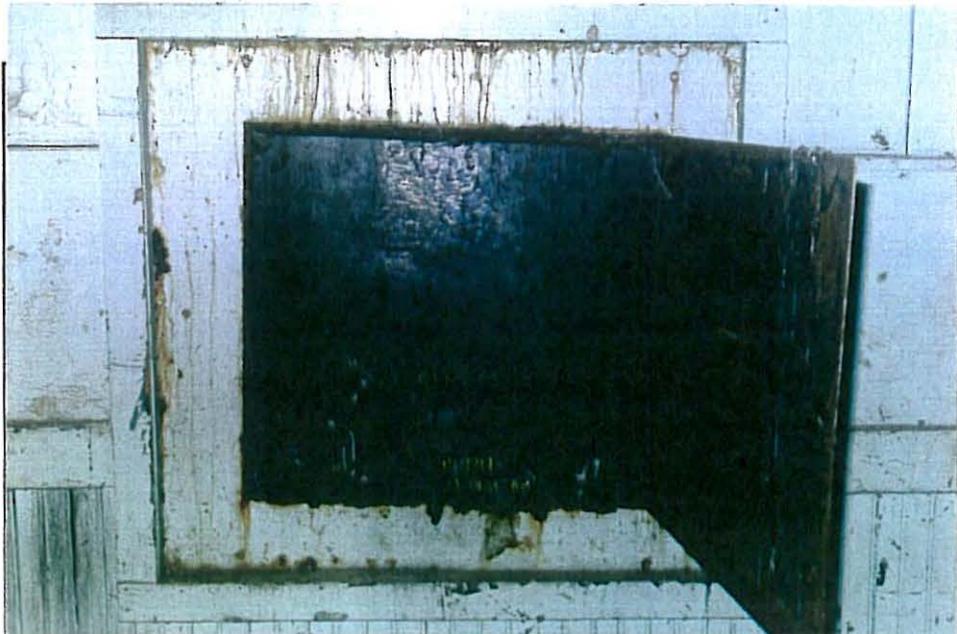
The main panel consists of a steel flush-mounted cabinet, with face frame and single side-hinged door. See figure 247. From this location, feeders in conduit were distributed to subpanels located on the first, second, and third stories. The first-story subpanel is located on the north wall of room 101, immediately east of the doorway to room 100. See figure 248. A corresponding subpanel for the second story is located directly above, on the north wall of room 201. See figure 249. The third-story subpanel is situated

Figure 247: Abandoned first generation main panel on south wall of room 101

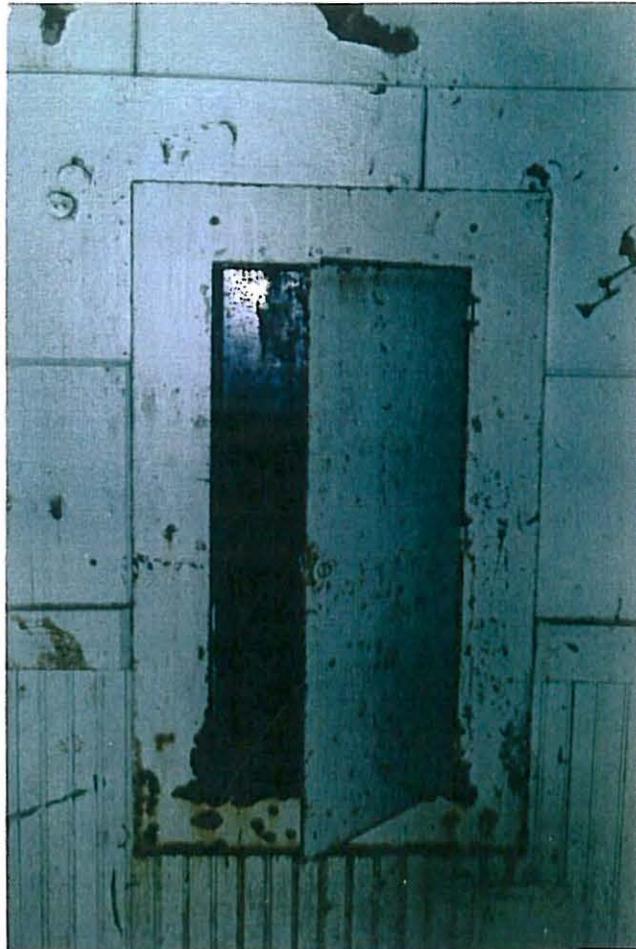
Figure 248: Abandoned first generation subpanel on north wall of room 101

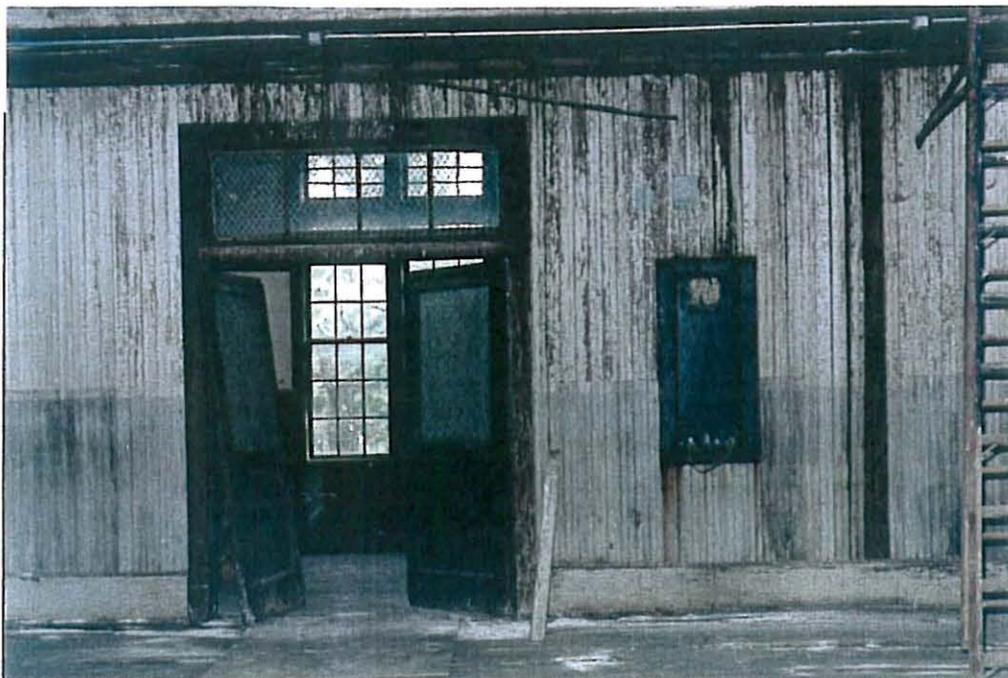
Figure 249: Abandoned first generation subpanel adjacent to north main doorway of room 201

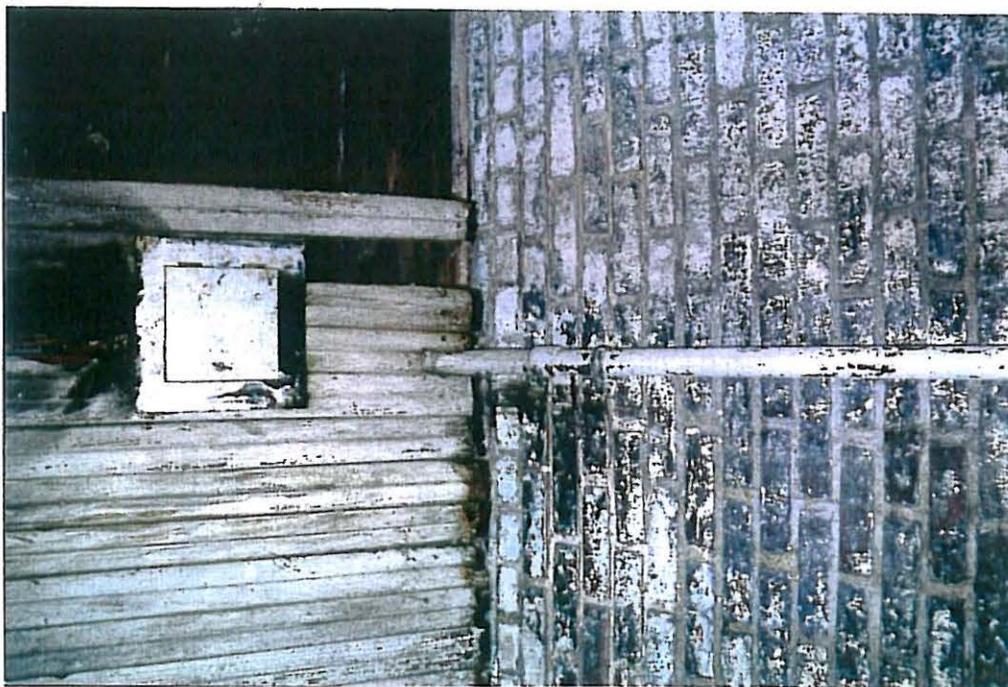
directly above that, and is installed in the sloped ceiling at a point roughly 9 feet above the floor of the track. See figure 250. All subpanels are of the same generic type and configuration as the main panel, but they vary in size in accordance with the number of branches served. No evidence of overload protection devices or switch gear has survived in any of the first-generation main or subpanels.

Figure 250: Abandoned first generation subpanel in north ceiling of room 201

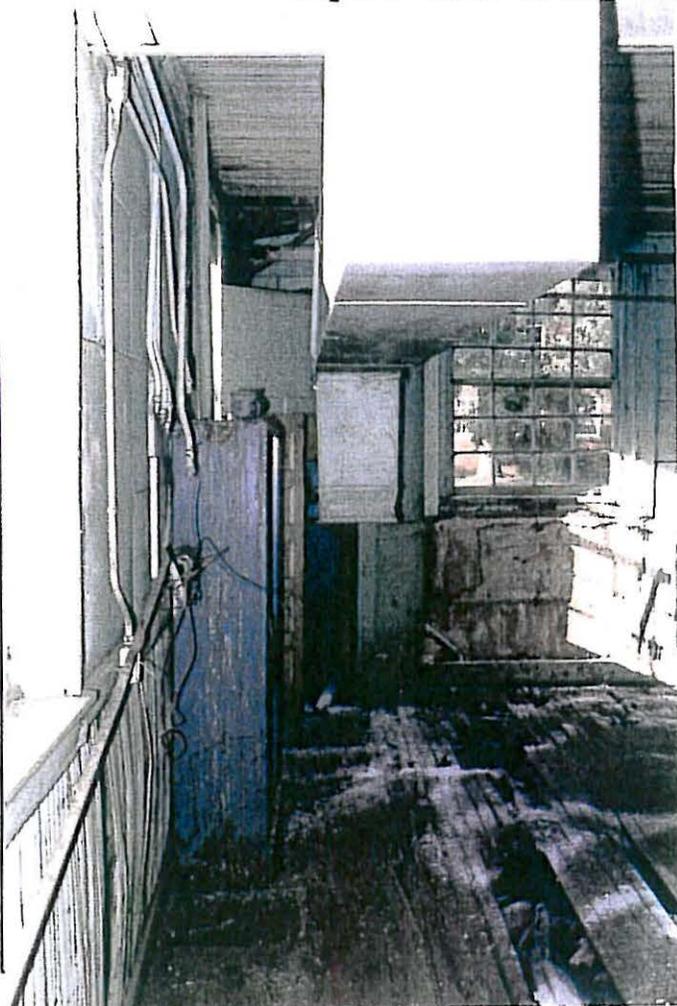
The main panel is a floor-standing single-door steel cabinet situated against the east wall of room 101. A single conduit exits the top, and rises to the second story. An EMT branch conduit exiting the right side of the panel appears to have fed an outside compressor/condenser unit no longer extant. A short nipple exits the left side, and fed an adjacent surface-mounted subpanel, also no longer extant. Five EMT conduits exiting from the missing subpanel fed various power and lighting branch circuits on the first story of the building. See figure 252.

Figure 252: Abandoned 2nd generation main panel room 101. Missing subpanel.

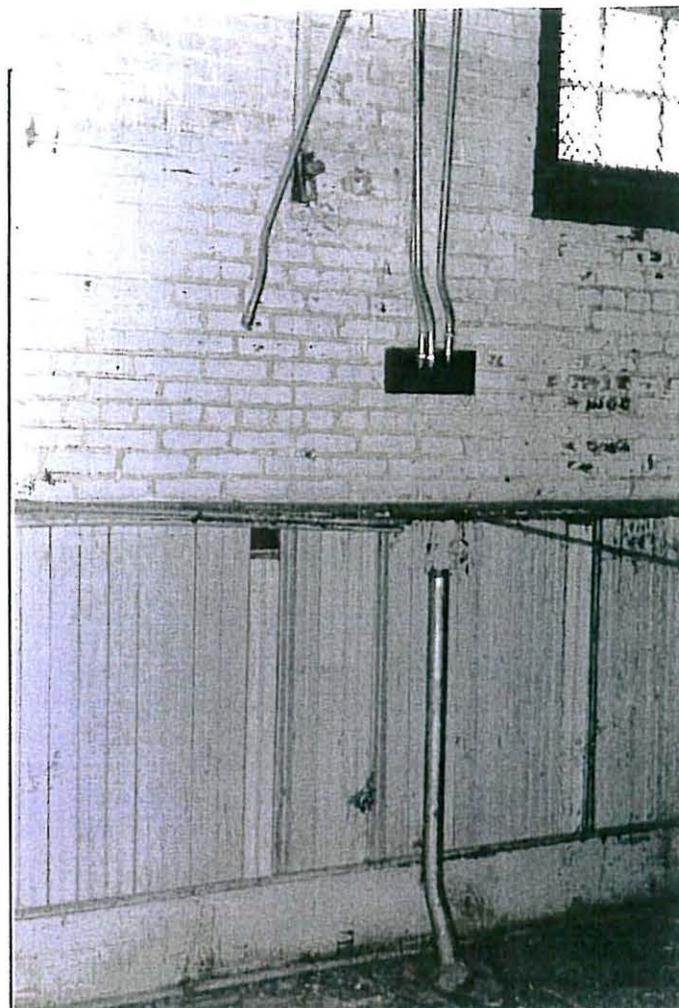
The second and third stories were together served by a single additional subpanel, surface-mounted on the east wall of room 201 directly above the main panel on the first story. This subpanel, also no longer extant, was fed by the riser from the top of the main panel, and in turn supplied both power and lighting branch circuits that exited the subpanel in five EMT conduits. See figure 253.

Figure 253: Site of second generation subpanel on east wall of room 201. Note disengaged main feeder conduit below and branch circuit conduit above
