WOMEN'S OLD GYMNASIUM
HISTORIC STRUCTURE REPORT

Northwestern State University
Natchitoches, Louisiana

Regina T. Binder
With Joan Berkowitz and David Bitterman

1993

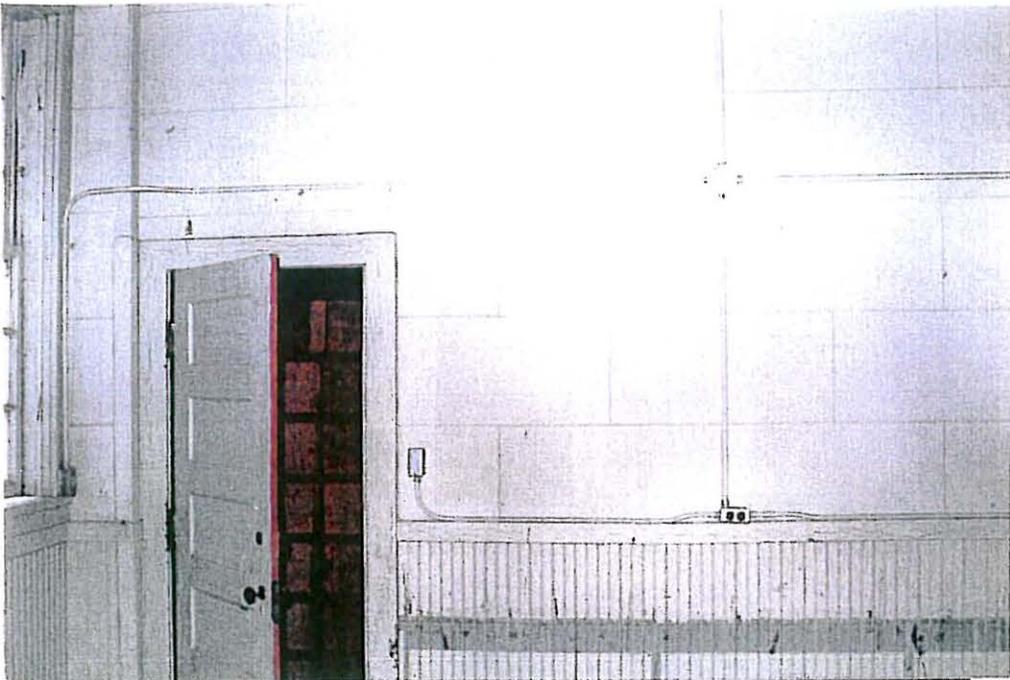
Virtually all second-generation branch wiring was run in surface-mounted conduit, with the exception of limited uses of armored cable to connect with fixed equipment. Expediency appeared to be the rule in dictating conduit locations and mounting methods, as conduits are run in all directions over virtually every type of wall and ceiling surface without discretion. See figure 254. The system utilized a variety of octagonal and square junction and

Figure 254: Typical interior surface mounted conduit configuration

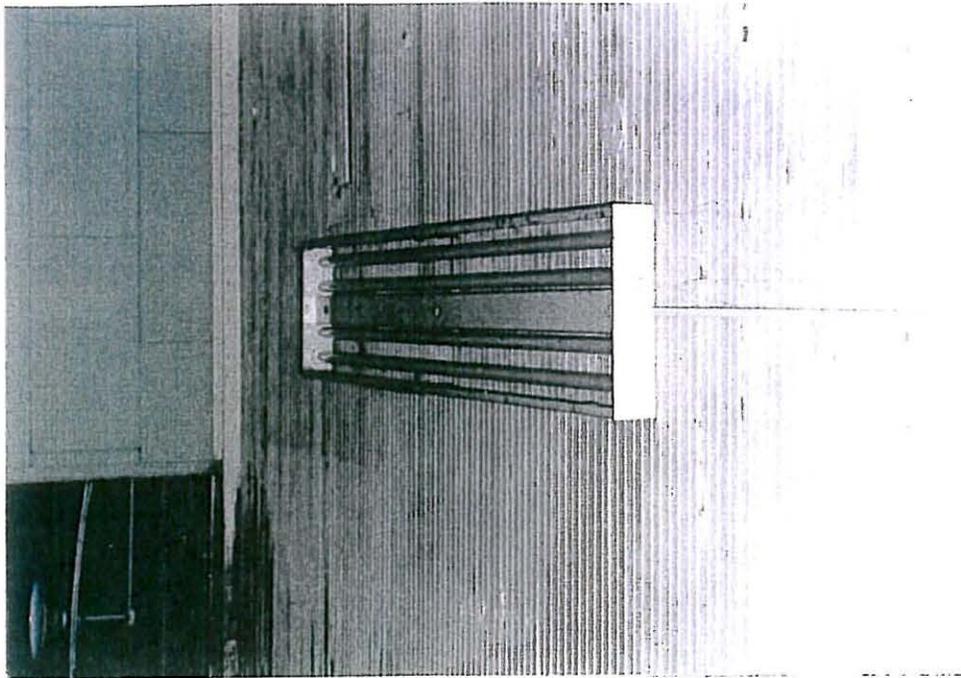
Figure 256: Typical second generation fluorescent surface mounted fixture, room 108

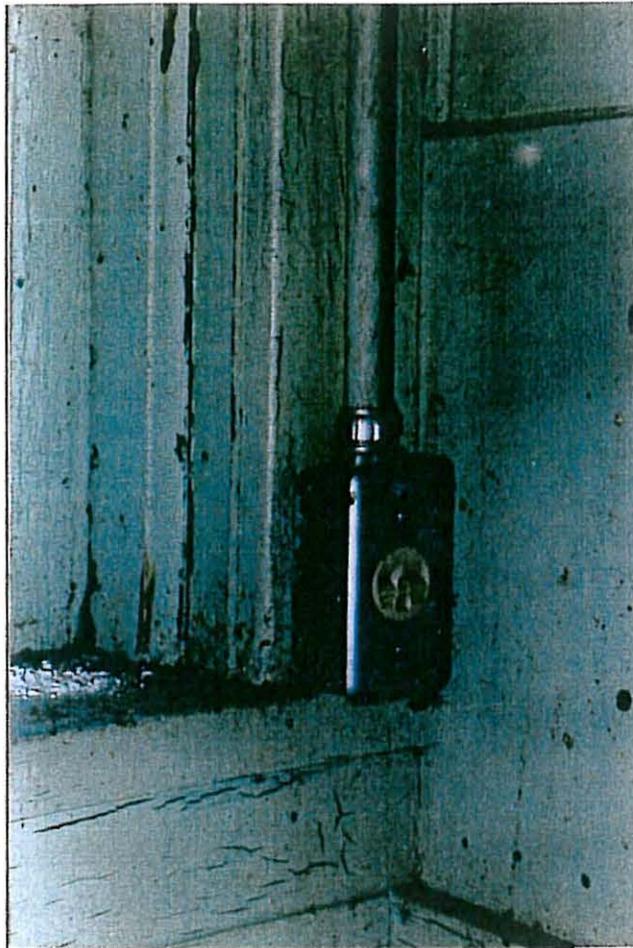
Several rooms of the office/classroom block and room 108 have additional receptacles located adjacent to windows. Although fed from conduits otherwise containing 110-volt branches, the configuration of these particular receptacles appears to be for 208-220 volt circuits. Their specific locations suggest they were installed to provide power to window air-conditioning units. See figure 258.

Figure 258: Second generation surface mounted receptacle, possibly intended for use by a window air conditioner

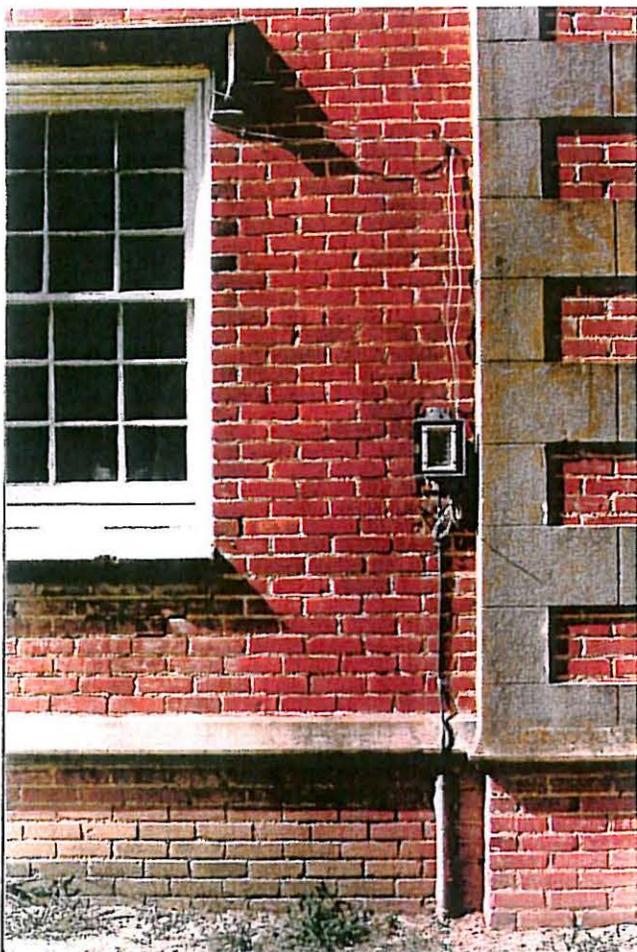
Figure 259: Abandoned telephone service entry on south wall of gymnasium block.

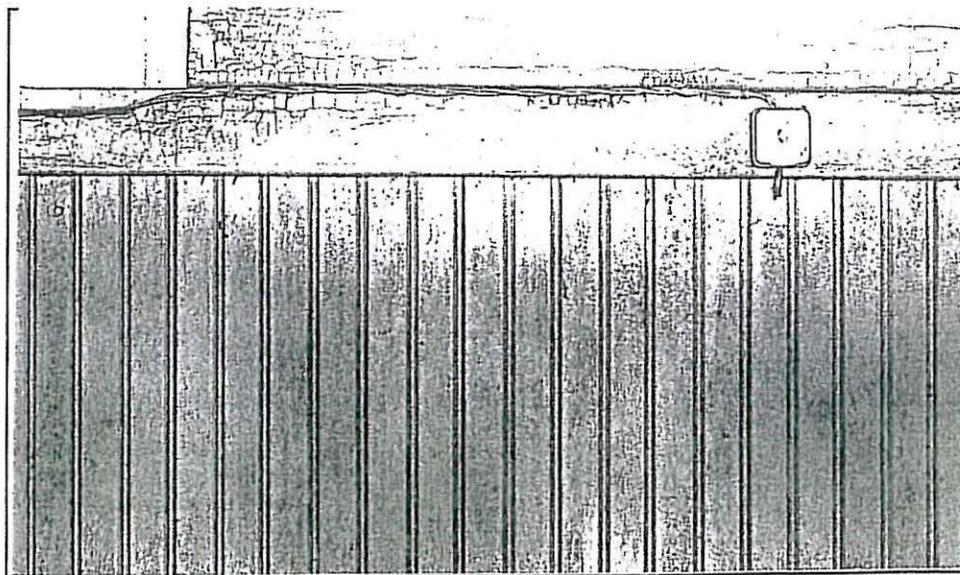
Inside the building, cables are primarily run on surfaces, along discontinuities of finish planes were possible (e.g., along baseboards, wainscot caps, doorway casings, etc.). Depending on installation date, interior cables are either of single-pair twisted configuration, or two-pair within an outer sheathing. No conduit is employed for any of these conductors. Telephone service was extended to relatively few rooms, and was principally confined to the office/classroom portion of the building. Handsets appeared to be hardwired directly into standard four-pin terminal blocks without benefit of user-removable plugs or connectors. See figure 260.

Figure 260: Surface mounted interior telephone branch and handset terminal block

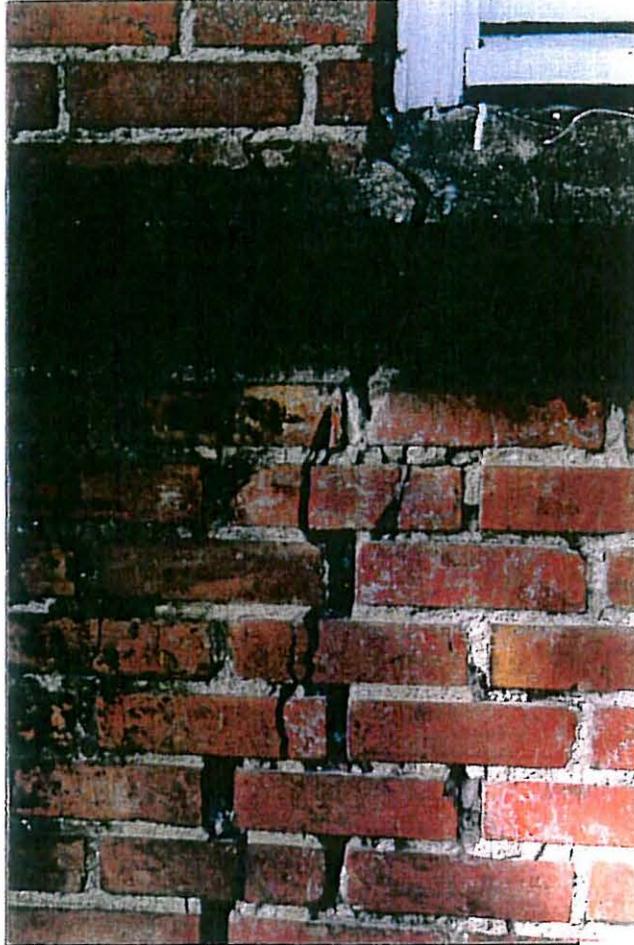
Additional study is required to determine the pathology of the significant network of cracking systems noted in previous sections of this report, and to evaluate whether structural remediation is required. See figure 261. Study should focus on a broad range of possible factors, including the following issues.

Design-Induced Factors. Placement of large window openings in load-bearing masonry walls is always problematic. Cracking may frequently occur along lines of differential stress between adjacent sections of masonry wall. These conditions are typically found at the jambs of windows, particularly those having broad openings, since aggregate compressive stresses in window-bay masonry can be far less than in the adjoining unarticulated areas. Other types of cracking patterns can be induced by inconsistent vertical alignment and/or configuration of masonry openings, which occur in this building as well. Systems initiated by these conditions are often perpetuated by other forces.

Settlement-Induced Factors. Configurations and conditions of foundations and soils are currently unknown. Footing failures can occur as either continuing conditions, or as conditions of limited duration. In the latter case, previous but currently arrested settlements may have enabled a cracking cycle to begin, which was subsequently perpetuated by other forces.

Figure 261: Example of north elevation masonry cracking system, below east jamb of second floor east window, office/classroom block.

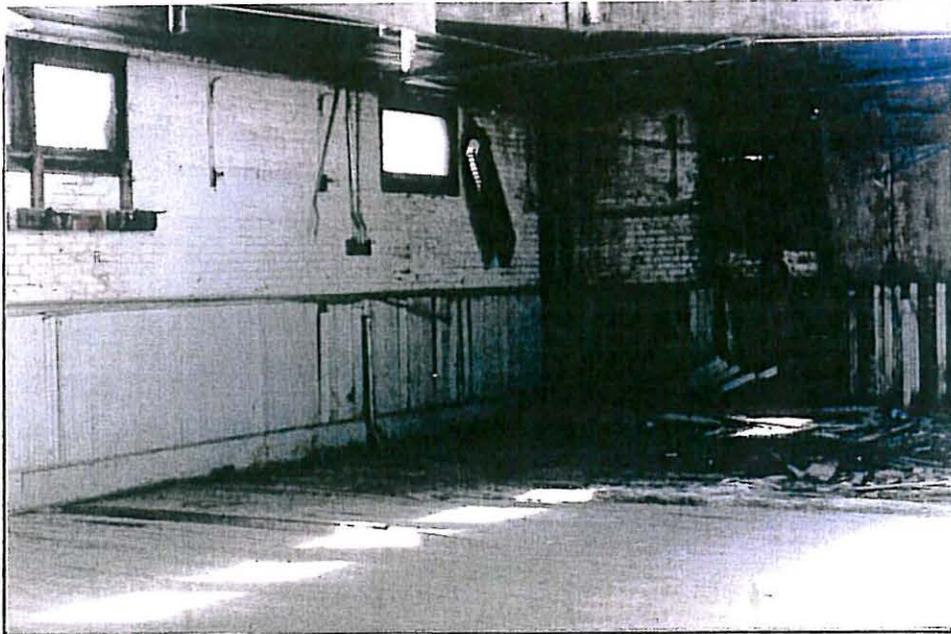
Although most interior deterioration can be ascribed to former problems with the integrity of roofs and windows, extensive areas of finishes and wood structure have been damaged as a result. The principal zones of damage fall along the north and south main walls of the gymnasium block, impacting—from top to bottom—roof framing (some of which has received recent stabilization) and ceiling finishes, wall framing and finishes, and floor framing and finishes. See figures 262-264. Along the north wall, collateral damage has affected the adjoining portion of the office/classroom block, as well. More localized damage to the structure and finishes occurs in the northeast corner of the office/classroom block, on both floors, and in room 201 of the gymnasium block, adjacent to the windows in the center bays of the east and west walls.

The sum total of moisture-related damage throughout the building suggests that very extensive areas of finish will require removal for repair or replacement, as well as for thorough inspection and repair of underlying structure. It therefore appears that the prospects for economic in-situ preservation of historic finishes (other than brick masonry) are slight. This is somewhat disconcerting in light of the fact that many of these finish materials may be character-defining features of the building. The most likely means for preservation of these may be as reinstalled salvaged materials, supplemented by extensive use of reproduction elements.

Figure 262: Moisture induced damages to ceiling, wall, and floor finishes and structure, southeast corner room 201

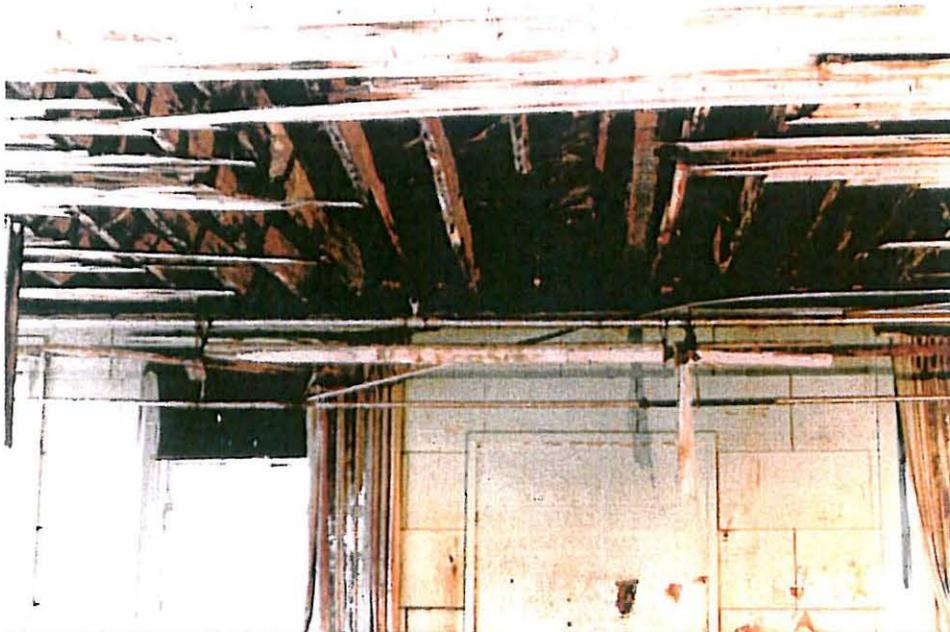
Figure 263: Moisture induced damages to ceiling finishes and structure, southeast corner room 101.

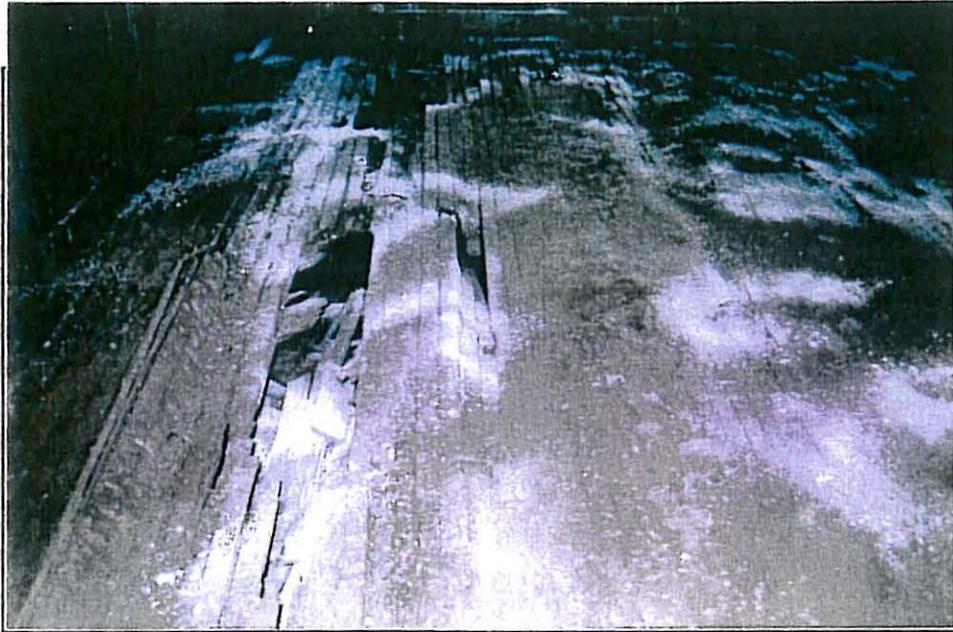
Figure 264: Moisture induced damages to floor finishes and structure, southeast corner room 101.
