HISTORIC AMERICAN TIMBER-FRAMED STEEPLES

II. Restoration Strategies

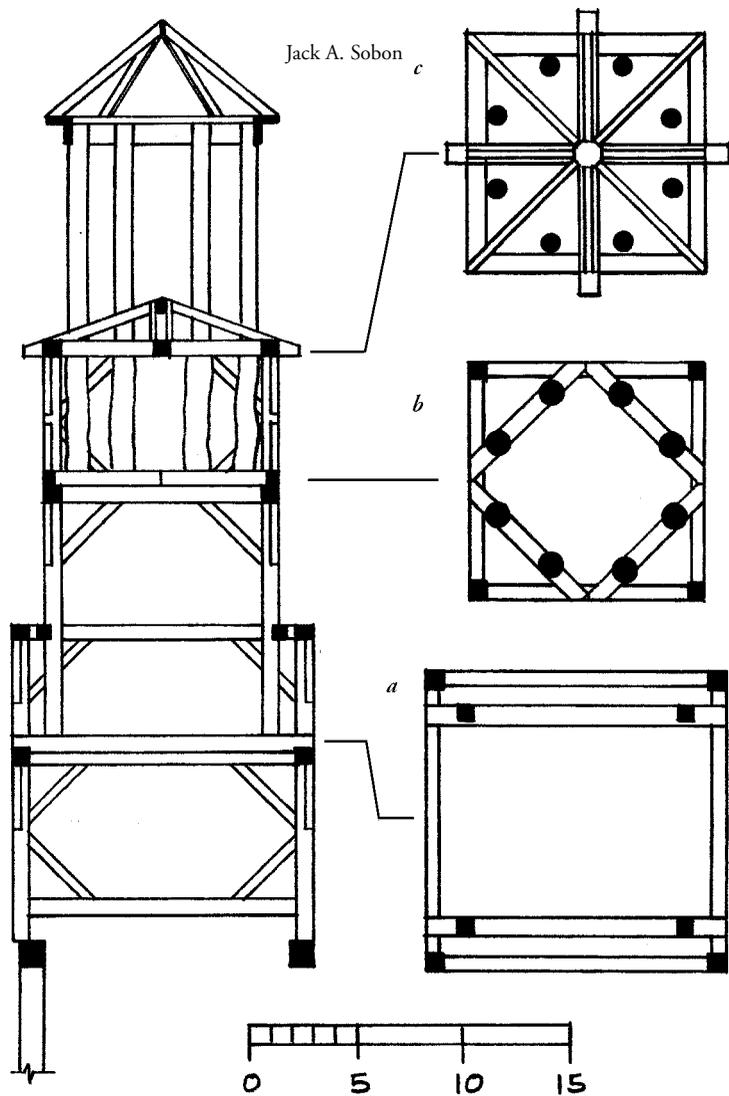
The second square stage of the steeple rises from sleepers resting on girts 6 ft. down within the first tower (Fig. 1c) and carries the heavily framed bell deck 18 ft. above (Fig. 1a). The bell deck is in the form of a low-angle kingpost truss, the kingpost a short octagonal block of hemlock, 14 in. across the flats and with eight small mortises to accept the hip and principal rafters, the latter acting as four main braces for the truss (Fig. 2).

Some 8 ft. below the plates of the bell deck, four sleepers lodge diagonally across wall girts and carry eight butternut columns that surround the bell and support the short conical spire over the belfry (Fig. 1b). The 18-ft. butternut columns are notable for having been turned between centers to a tapering cylinder for their visible upper 10 ft. but left as debarked logs for their concealed lower 8 ft. The columns, thus rough and irregular for about half their length, nevertheless tenon into the sleepers in a regular layout governed by the central axis of their upper visible portion and the octagonal form implicit in the diagonal sleepers.

Fig. 1. South Woodstock steeple frame section seen from inside looking toward eaves of church. To form first stage, tower posts rise from tie beam in front wall of church (at left in drawing) and tie beam in first roof truss. To form second stage, posts rise from sleepers resting on girts 6 ft. down within first tower (plan view a) and reach bell deck (plan view c) 18 ft. above, intersected about halfway by horizontal framing (plan view b) to support feet of eight columns surrounding bell. Original columns were lathe-turned where they could be seen in belfry, left in the rough where concealed. Compare Fig. 14 on page 11.

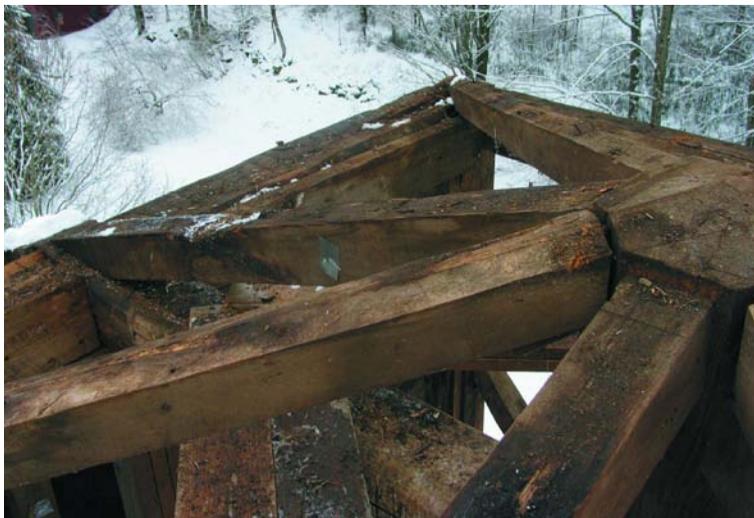
Fig. 2. Original South Woodstock bell deck. Since belfry is open to weather on four sides, deck must be framed and sheathed to shed water. Rafters measure $4 \times 4\frac{1}{2}$, hips $3\frac{1}{2} \times 5$. Short kingpost is 14 in. across flats.

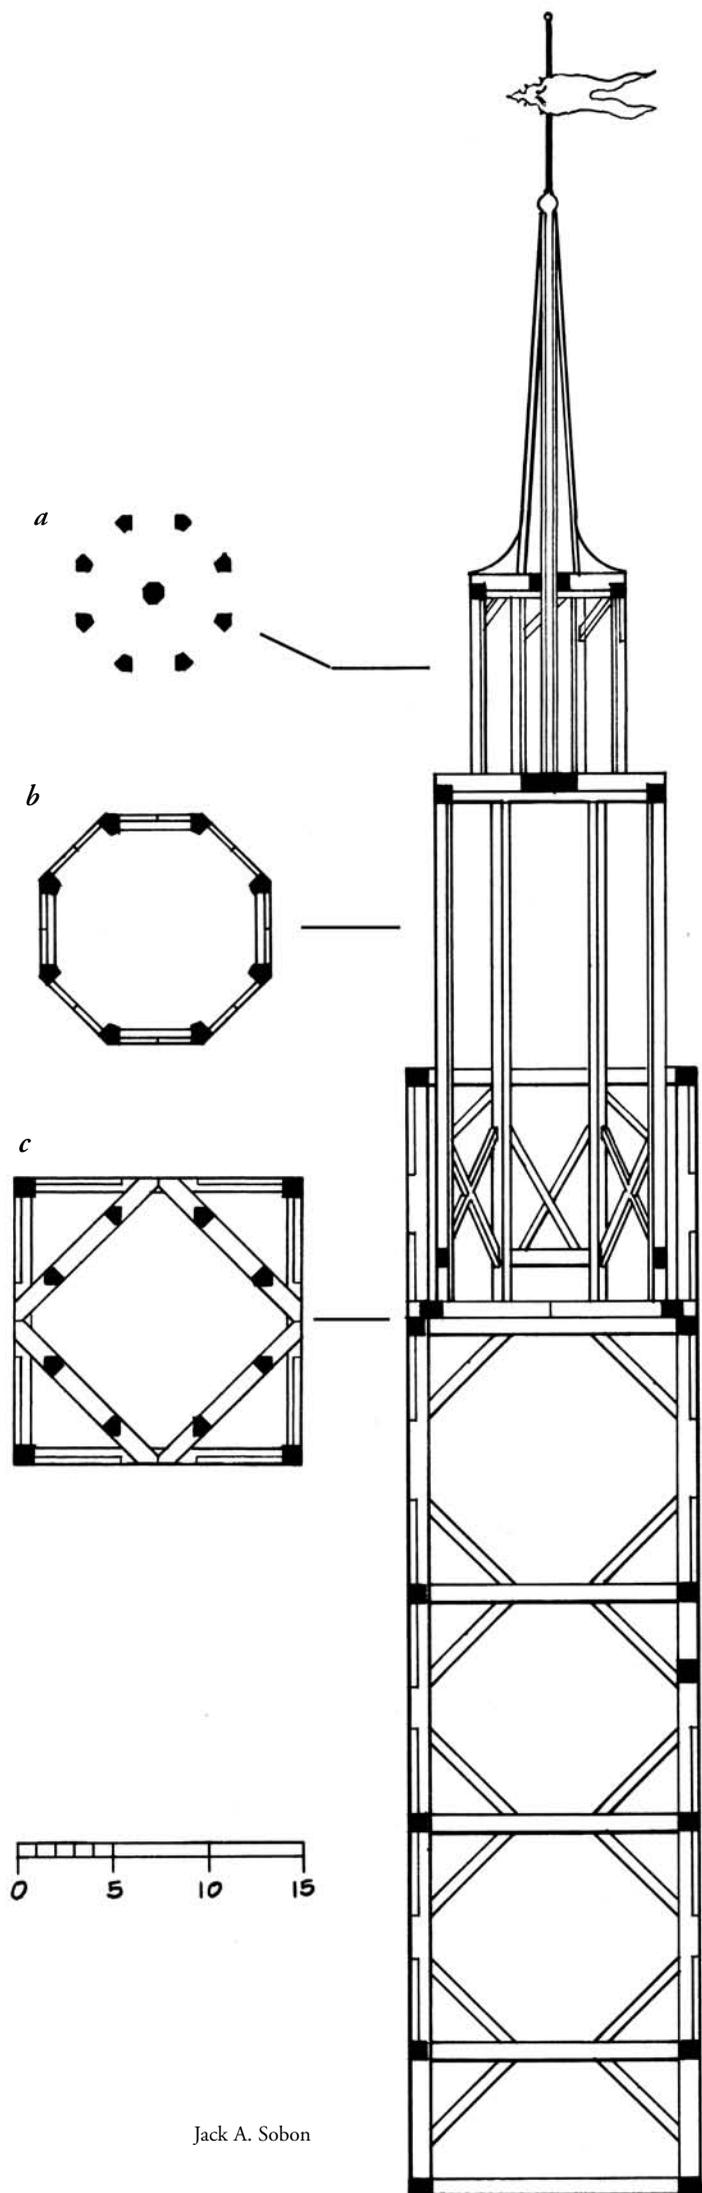
The framing of the tower telescopes where exterior design allows. Belfry posts rise from diagonal sleepers 14 ft. below the roof of the tower (Fig. 16c). That tower roof is the bell deck as well, so that the weight and dynamic loads of the bell are borne first by cambered bell girts that cross the tower plates and then by the heavily braced framing of the tower below (Fig. 16). A horizontal timber crab (a frame with eight radiating legs) sits on top of the belfry posts, providing a base for the eight wall posts of the lantern and footing for the mast (Fig. 17). The mast, a 12x12x30 timber, rises through the lantern and offers a center for the spire and anchorage at the top for the weathervane (Fig. 16).

Fig. 16. Strafford steeple section seen from inside looking toward back of meetinghouse. First stage (tower) begins at grade and rises to bell deck, identical with tower roof. Second stage (octagonal belfry) begins on sleepers 14 ft. down in tower (section c) and rises to belfry roof (identical with base of octagonal lantern). Third stage (octagonal lantern) rises to base of spire. Spire mast is footed in belfry roof.

One level of tower girts carries the four belfry sleepers, 10x9 pine timbers, set diagonally across the corners of the tower, each with mortises for two belfry posts with lower through tenons, unpinned (Fig. 16). These belfry sleepers lodge on the tower girts, as is typical, neither lapped in nor affixed in any way. Today's engineers, architects and contractors are usually shocked by this lack of a mechanical tiedown between telescoped stages, but my examination of 100 and more steeples indicates that uplift is not a problem at this location. Stages are better left only lodged, the intent of their historic engineering.

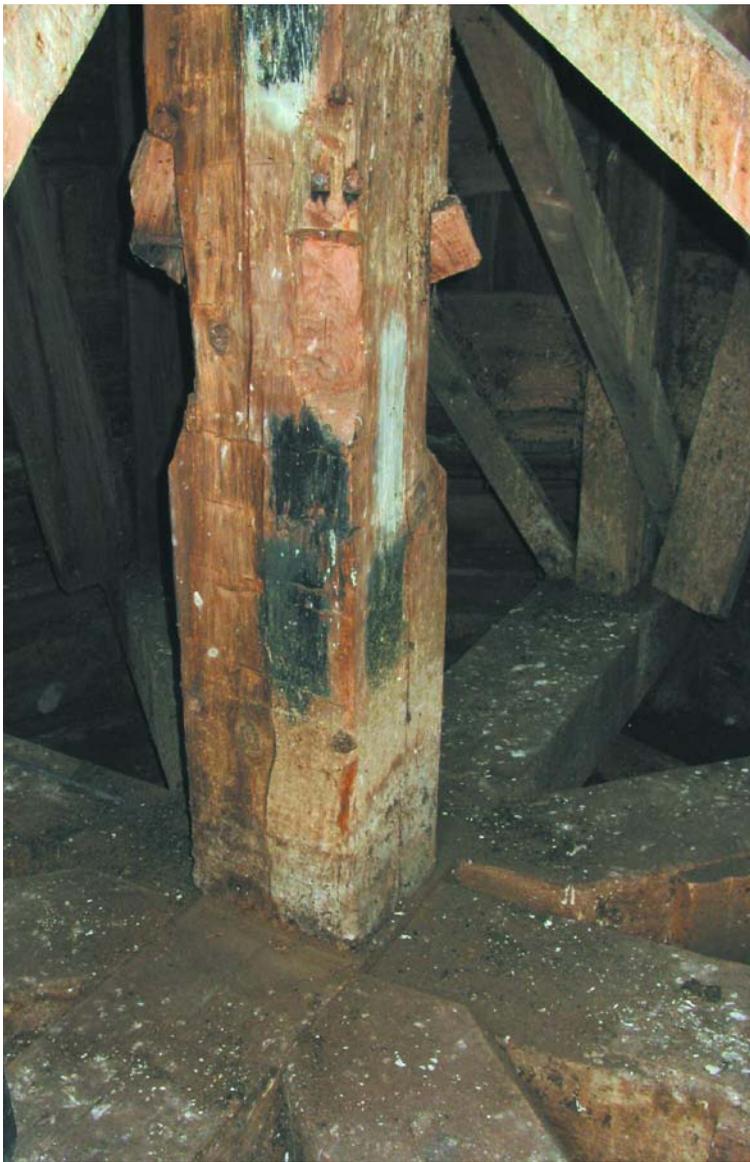
Fig. 17. Mast for Strafford spire is footed in eight-legged crab in belfry roof, which also forms base of octagonal lantern.
