ENERGY CONSERVATION IN HISTORIC BUILDINGS

TASK 1 - INVESTIGATIONS FOR INSULATION STRATEGIES

August 2012

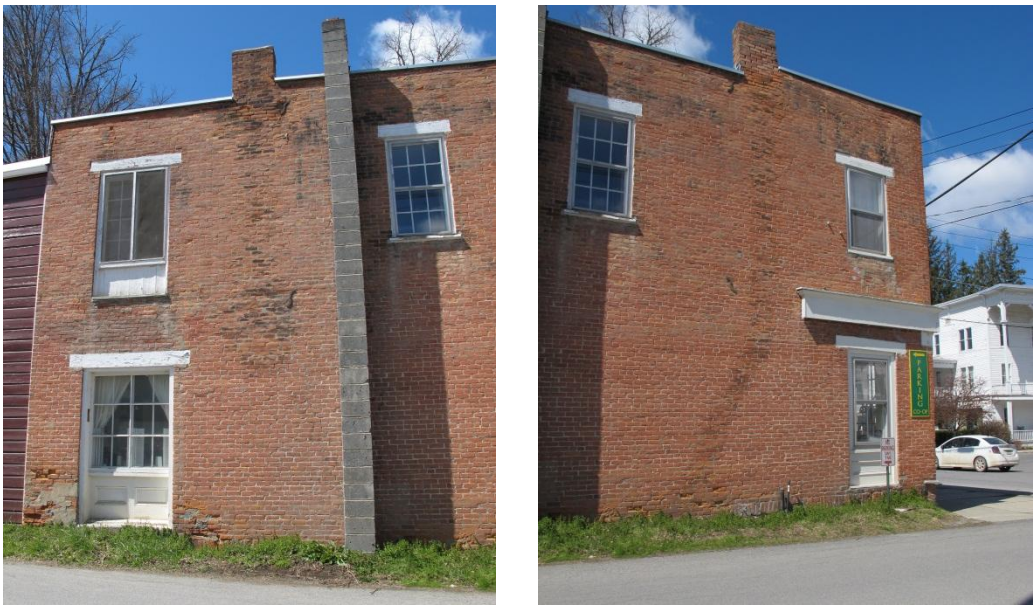
Figure 01. Brick masonry deterioration at the Cambridge Food Co-op primarily occurs in areas affected by moisture, manifesting itself on the surface of the walls in brick spalling or efflorescence, or both. This is caused either by moisture infiltration such as rising damp or condensation emanating from inside chimney flues.

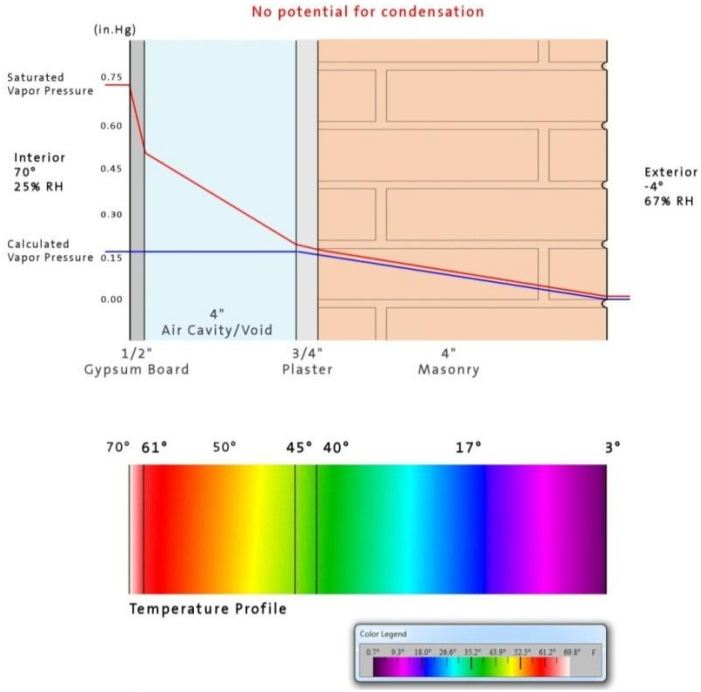
The existing envelope conditions at the Co-op were modeled, evaluated, and found to show no signs of potential interior condensation. The analysis and actual field conditions do, however, show moisture accumulation within the exterior masonry, as exhibited by deterioration and actual wet surfaces, primarily due to rising damp. The confirmation of modeled results with actual field conditions is important because it provides yet another parameter to verify risk and potential for infiltration, condensation, and other damaging factors.

Figure 13: Cambridge Food Co-Op
Existing conditions @ Typical Exterior Wall
Hygrothermal Analysis

It was noted that currently the existing masonry wall is, in effect, being heated and warmed from the interior space as heat escapes through the un-insulated wall. This is increasing the heating load on the building and perhaps creating undesirable interior conditions on colder days. The same heat loss is most likely also helping the masonry undergo an important drying cycle and avoid even greater damage from freezing internal moisture during the winter months.

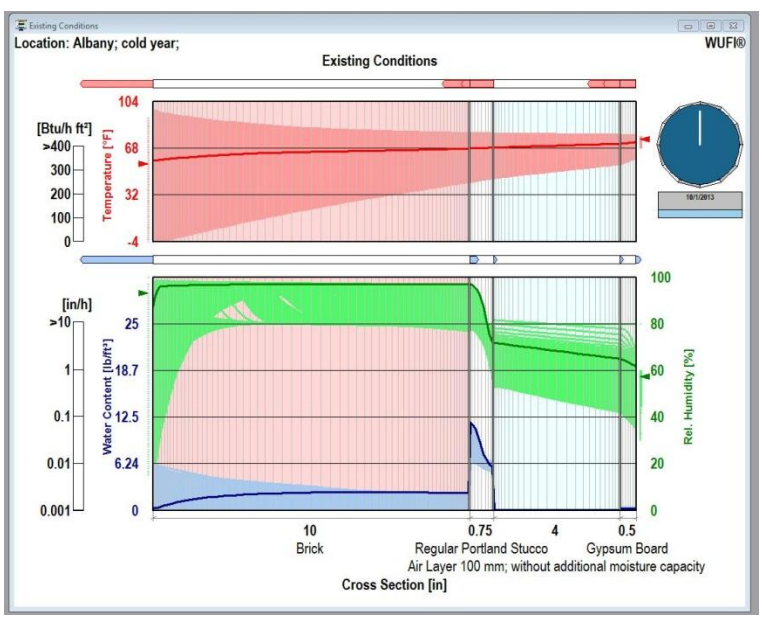
Figure 14: Cambridge Food Co-Op
Existing Conditions at Typical Exterior Masonry Wall - Yearly Cycle – WUFI Hygrothermal Analysis shows that the existing condition of the wall allows for excess moisture accumulation within masonry, but that the masonry is being warmed from the interior. While the presence of moisture itself is not desirable, heating of the masonry assembly reduces the potential for damage from freeze/thaw cycling.

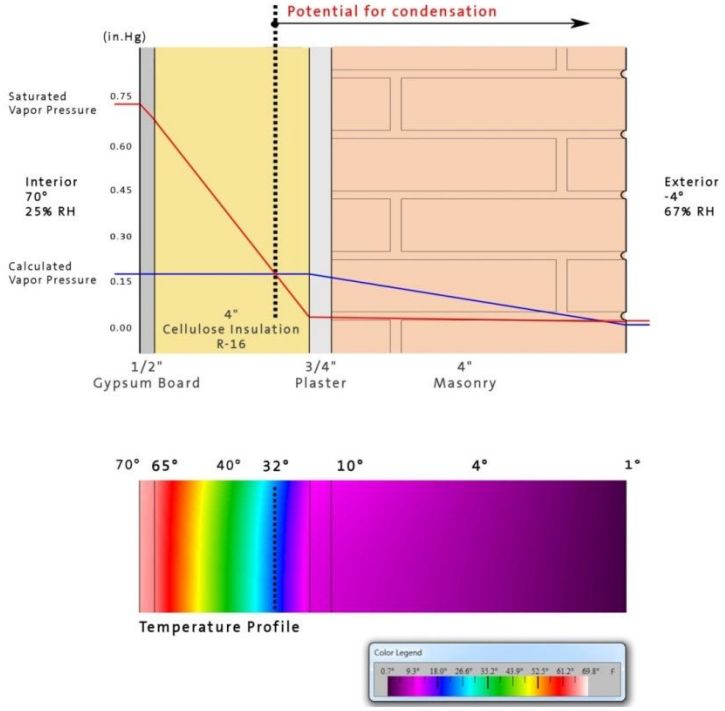
The wall assembly was next evaluated with insulation added to the interior framed cavity. The existing framed cavity was assumed to be insulated to full depth with an insulation of approximately R-4 per inch. The analysis of the proposed insulated wall shows potential for condensation within the insulated cavity if moisture is not controlled. If left uncontrolled, vapor drive would occur outward, resulting in moisture condensation on the first coldest surface, in this case the interior face of plaster.

Figure 15: Cambridge Food Co-Op
Insulated Conditions @ Typical Exterior Wall
Hygrothermal Analysis

This moisture drive should be controlled through the installation of a vapor retarder on the "warm side" of the insulation, as will be discussed below. It is important to note that since the exterior wall at the Co-op is insulated, the thermal profile shifts significantly, subsequently keeping the masonry colder for longer periods of time. This resulting condition should be carefully considered, since retaining internal moisture for longer periods of time, potentially during freezing conditions, will dramatically increase the risk of masonry damage in freeze/thaw cycling.

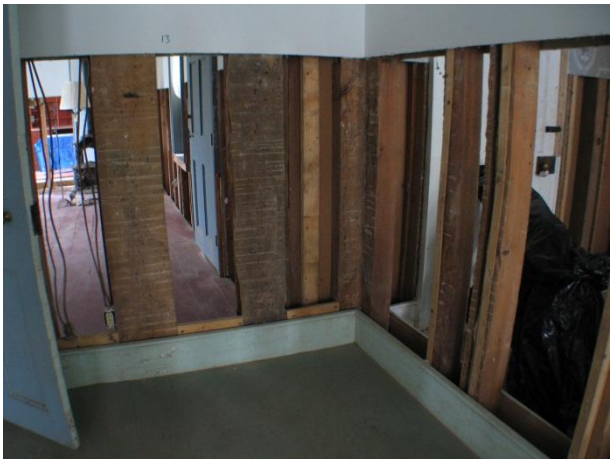
In August of 2011, Hurricane Irene caused significant flooding in the Prattsville area, including the Zadock Pratt museum. The subsequent cleanup has left the walls partially exposed as the interior of the walls are left to dry. Observations suggest that pre-flood method of wall construction may have provided a very viable solution to insulation and moisture control issues. The following analysis was performed assuming walls had no insulation (as originally constructed) in comparison to level of added insulation (closer to recent modifications).

Figure 16. Image on the left shows an exposed section of the exterior plank wall construction in the bank window. Image on the right shows the intersection of a more common interior stud wall framing condition in the original footprint with a modified version of the plank framing used in the bank wing.

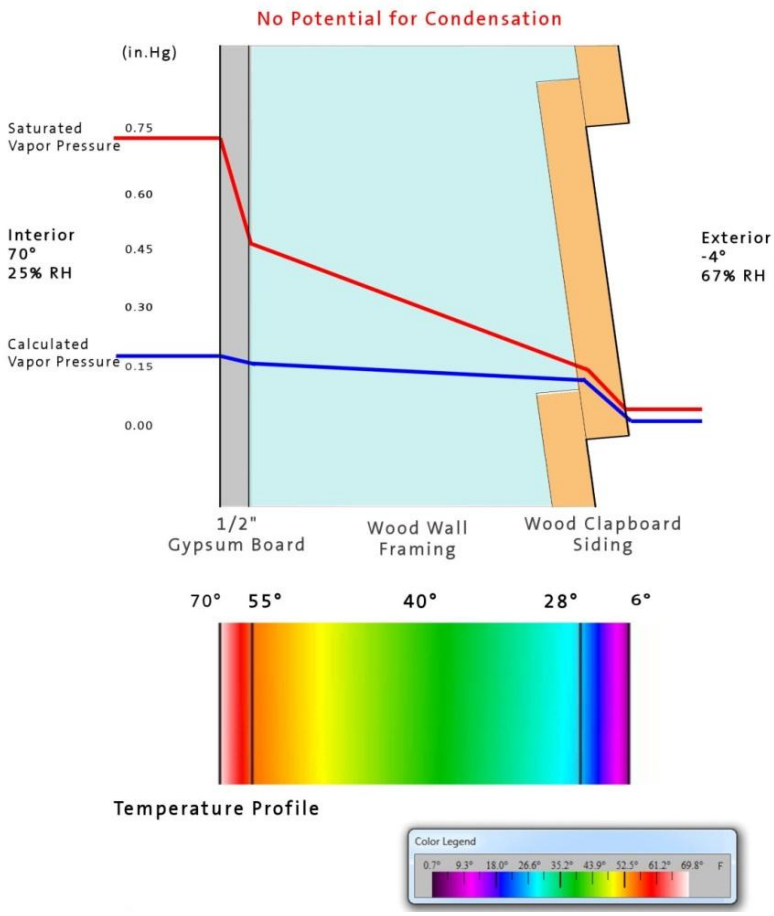
Figure 17: Zadock Pratt Museum
Insulated Conditions @ Typical Exterior Wall
Hygrothermal Analysis

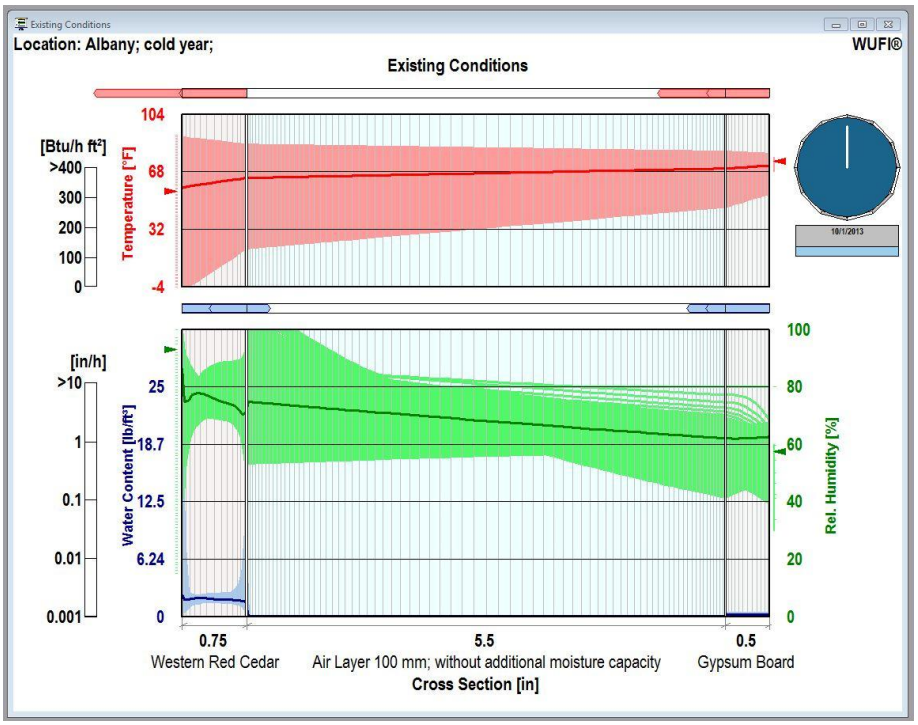
The existing envelope conditions at the Museum were modeled, evaluated, and found to show no signs of potential interior condensation. The walls as originally constructed would have allowed for significant air infiltration and heat loss.

Figure 18: Zadock Pratt Museum
Existing Conditions at Typical Exterior Wall- Yearly Cycle
WUFI Hygrothermal Analysis

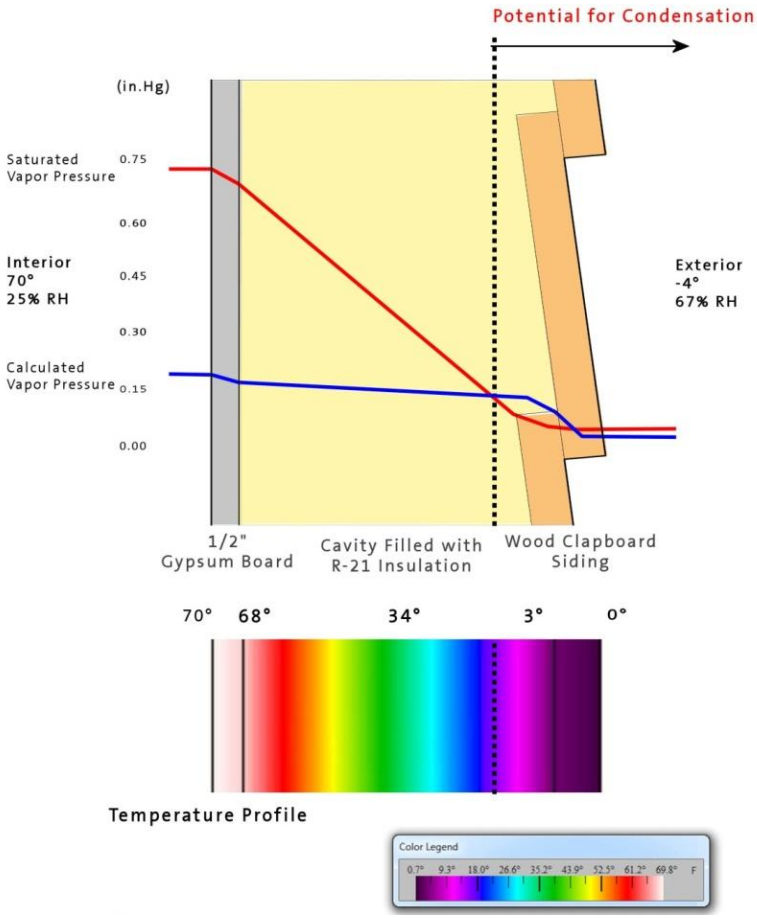
The wall assembly was next evaluated with insulation added to the interior frame cavity (similar to modifications prior to flooding). The frame cavity was assumed to be insulated to full depth with an insulation of approximately R-4 per inch. The analysis of the proposed insulated wall shows potential for condensation within the insulated cavity if moisture is not controlled. If left uncontrolled, vapor drive would occur outward, resulting in moisture condensation on the first coldest surface, in this case the interior face of clapboard.
This moisture drive should be controlled through the installation of a vapor retarder on the "warm side" of the insulation.

Although not specifically a focus of this report, air infiltration should be addressed at the Museum. The current exterior wall will allow significant exterior air infiltration bringing in moisture-laden air and changing the thermal profile of the wall considerably, adversely affecting the dew point location. These items are addressed in the recommendations below.

Figure 19: Zadock Pratt Museum
Insulated Conditions @ Typical Exterior Wall
Hygrothermal Analysis

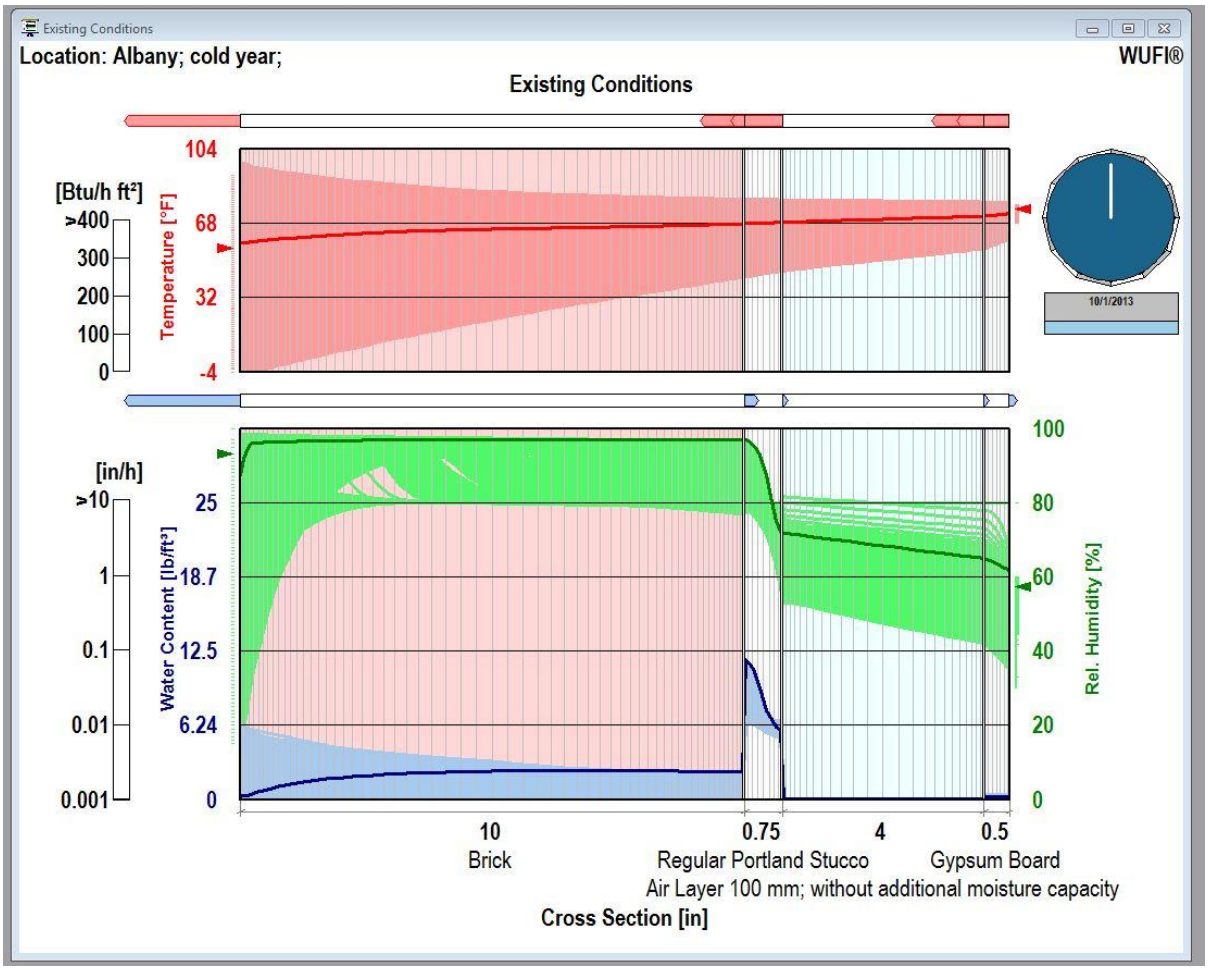
Appendix Figure A-12:
Cambridge Food Co-Op
Existing Conditions at Typical Exterior Masonry Wall - Yearly Cycle

WUFI Hygrothermal Analysis shows that the existing condition of the wall allows for excess moisture accumulation within masonry, but that the masonry is being warmed from the interior. While the presence of moisture itself is not desirable, heating of the masonry assembly reduces the potential for damage from freeze/thaw cycling.

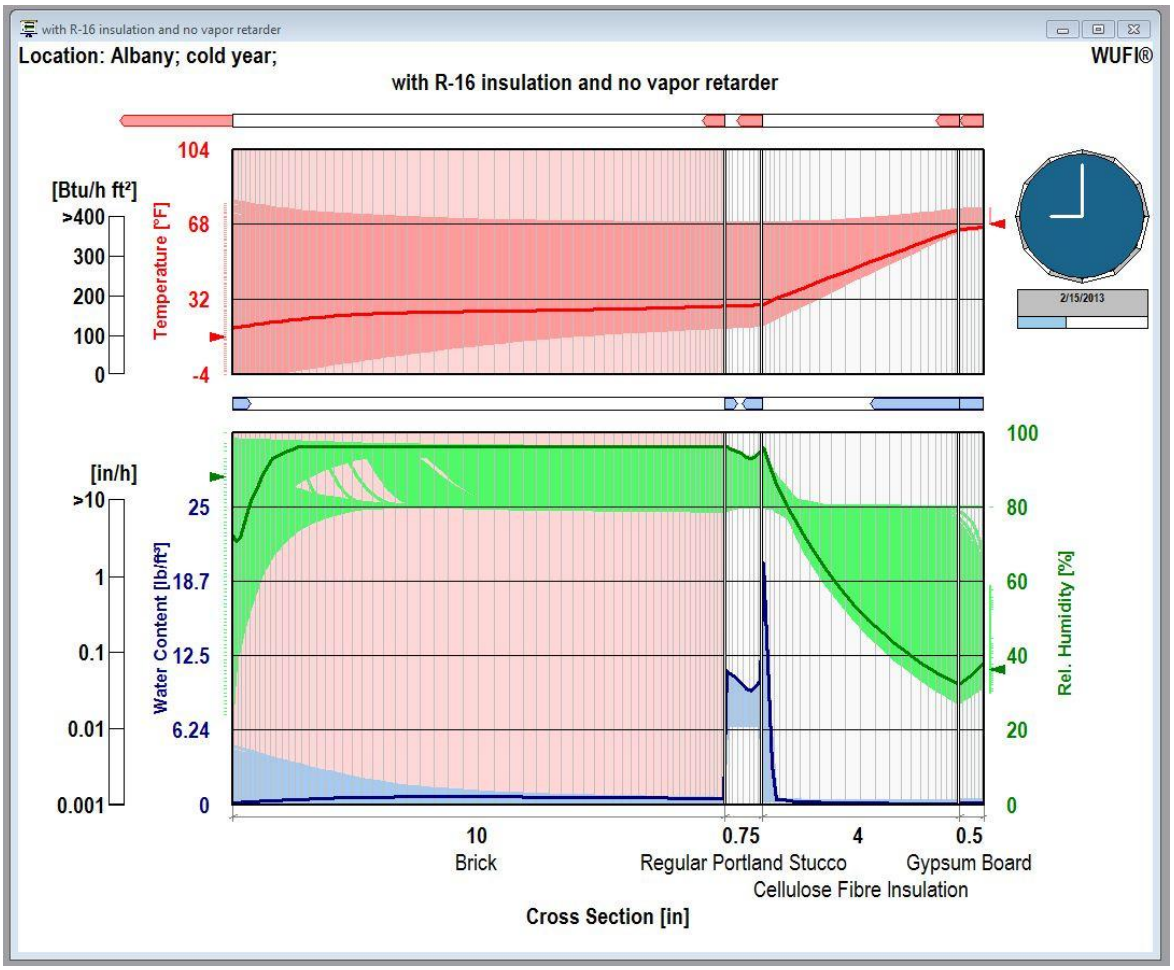
Appendix Figure A-13:
Cambridge Food Co-Op
Insulated Wall - No Vapor Retarder - Mid-Winter Condition
WUFI Hygrothermal Analysis shows that when insulation is added (for instance, blown-in cellulose fiber), it affects the temperature gradient of the wall; the excess moisture accumulation within masonry has not decreased, and the masonry has become moderately colder than it was in the existing condition. In addition, it shows the moisture accumulation spikes at the surface of the plaster.

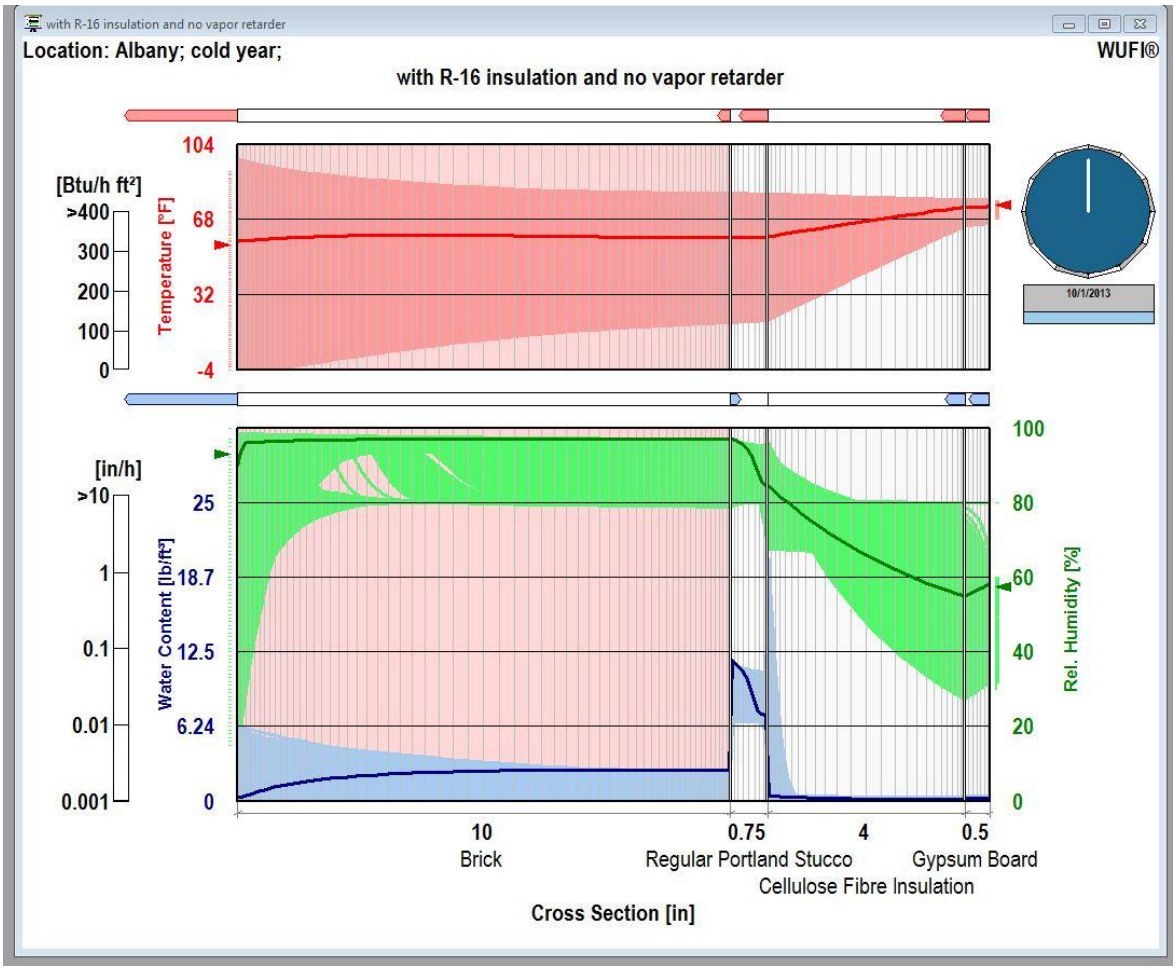
Appendix Figure A-14:
Cambridge Food Co-Op
Insulated Wall – No Vapor Retarder - Yearly Cycle
WUFI Hygrothermal Analysis

- excess moisture accumulation within masonry
- masonry is moderately "colder" than existing
- moisture accumulation on interior face of plaster and within plaster

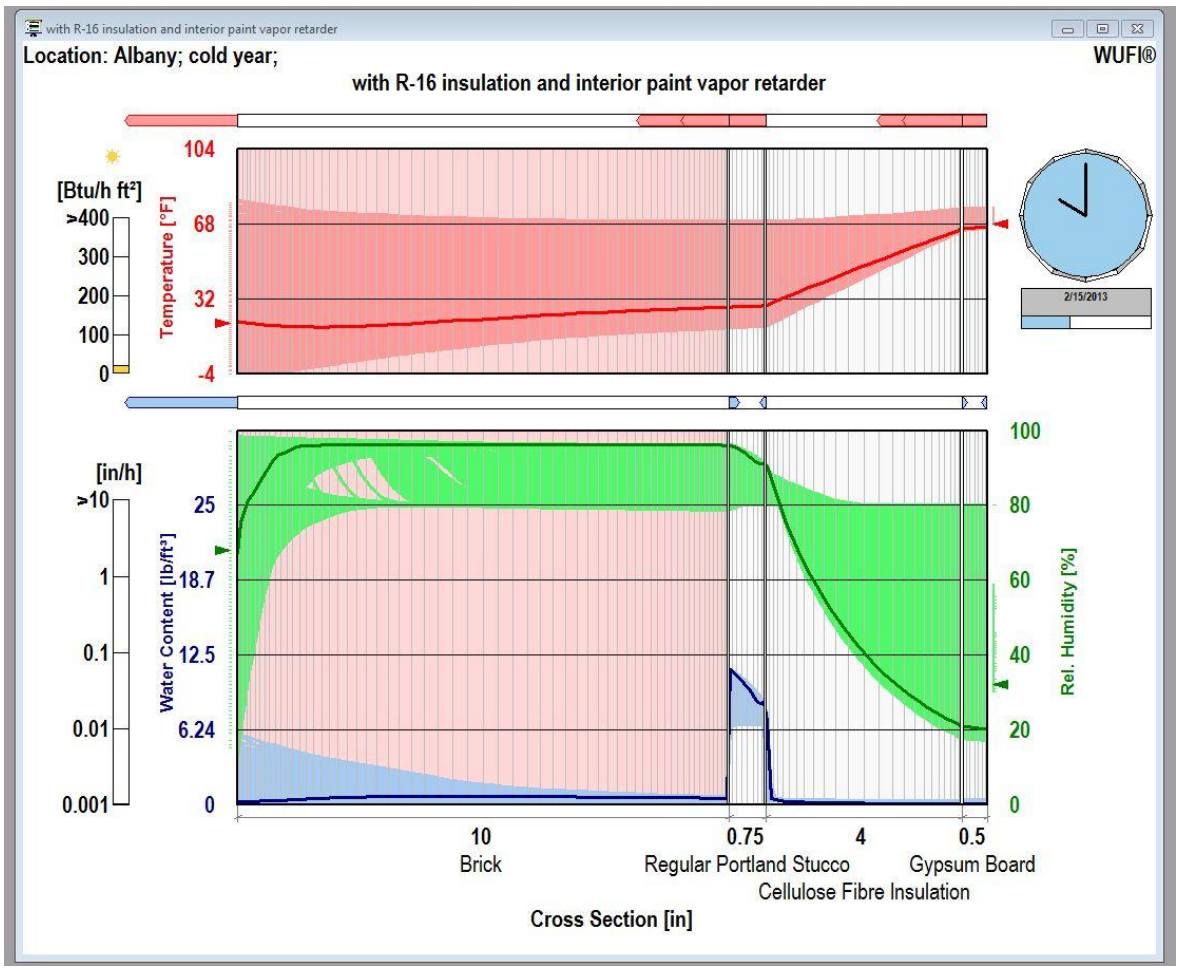
Appendix Figure A-15:
Cambridge Food Co-Op
Insulated Wall – Vapor Retarder Paint on Interior – Mid-Winter Condition
WUFI Hygrothermal Analysis

- *excess moisture accumulation within masonry*
- *masonry is moderately "colder" than existing*
- *moisture accumulation is reduced from w/o vapor retarder*
- *RH is not reaching saturation point of 100%*

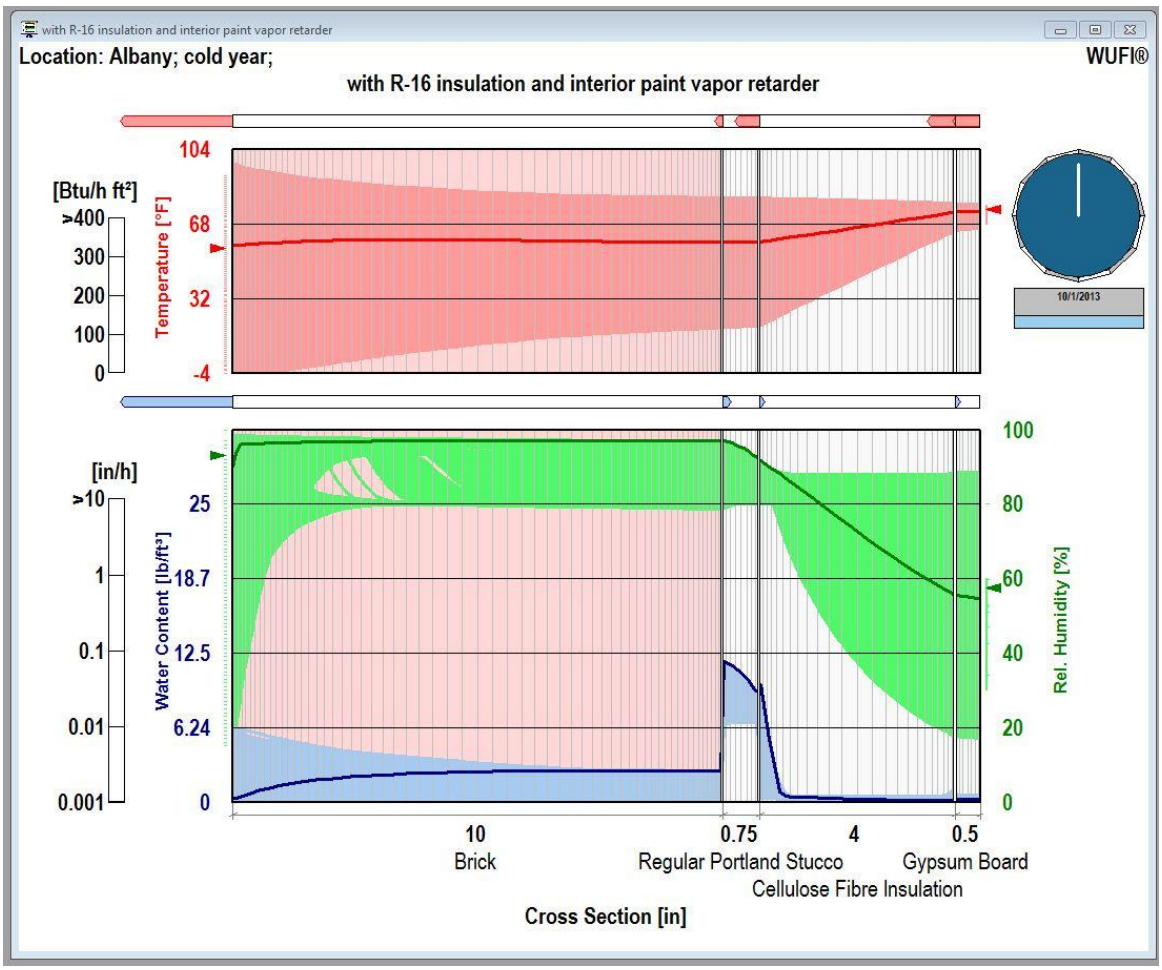
Appendix Figure A-16:
Cambridge Food Co-Op
Insulated Wall – Vapor Retarder Paint on Interior – yearly Cycle
WUFI Hygrothermal Analysis

- *excess moisture accumulation within masonry*
- *masonry is moderately "colder" than existing*
- *moisture accumulation is reduced from w/o vapor retarder*
- *RH is not reaching saturation point of 100%*

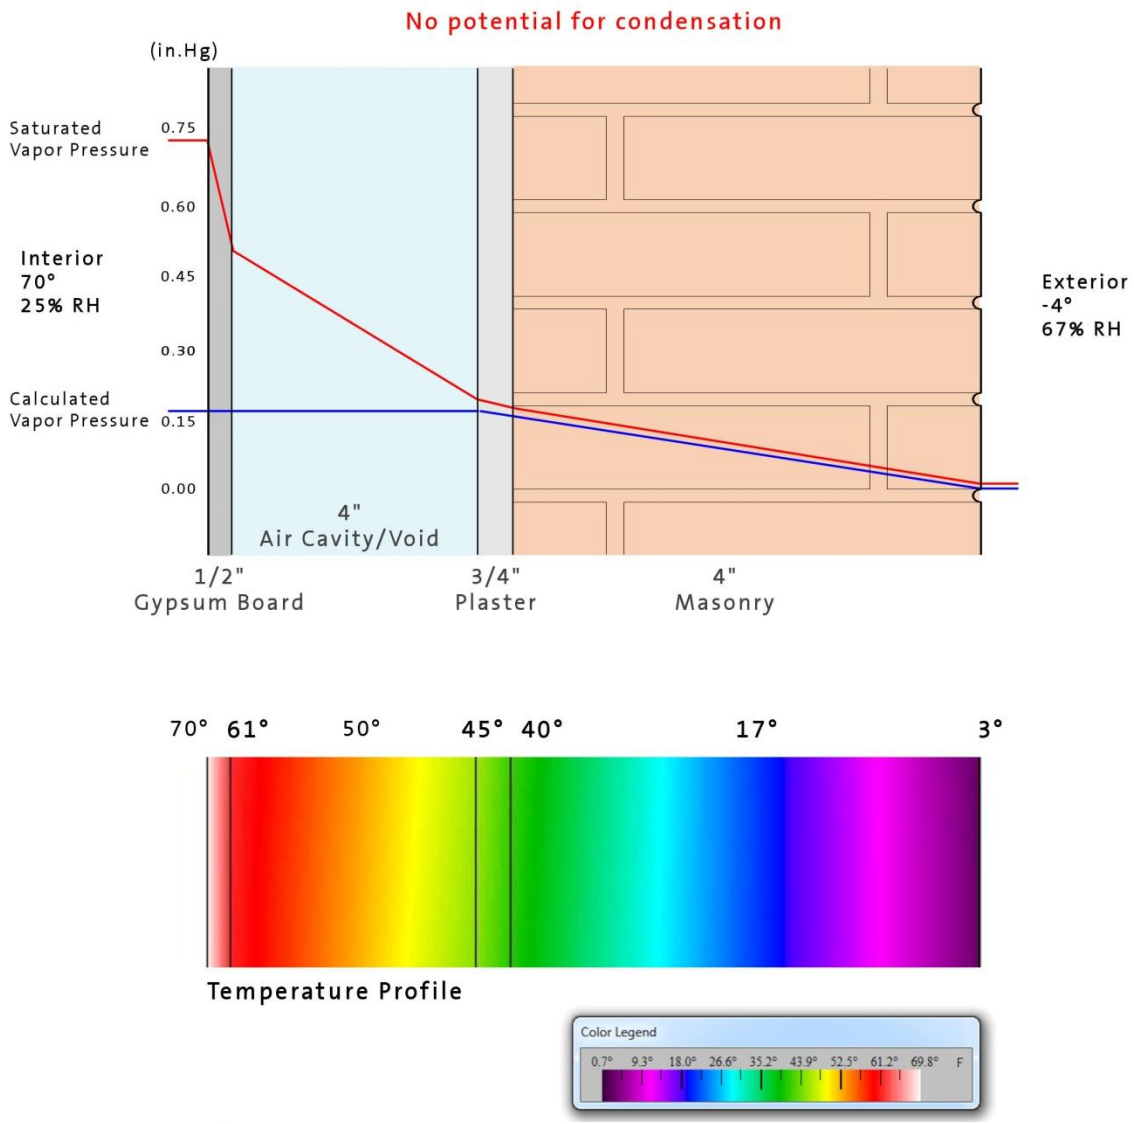
Appendix Figure A-17:
Cambridge Food Co-Op
Existing conditions @ Typical Exterior Wall
Hygrothermal Analysis

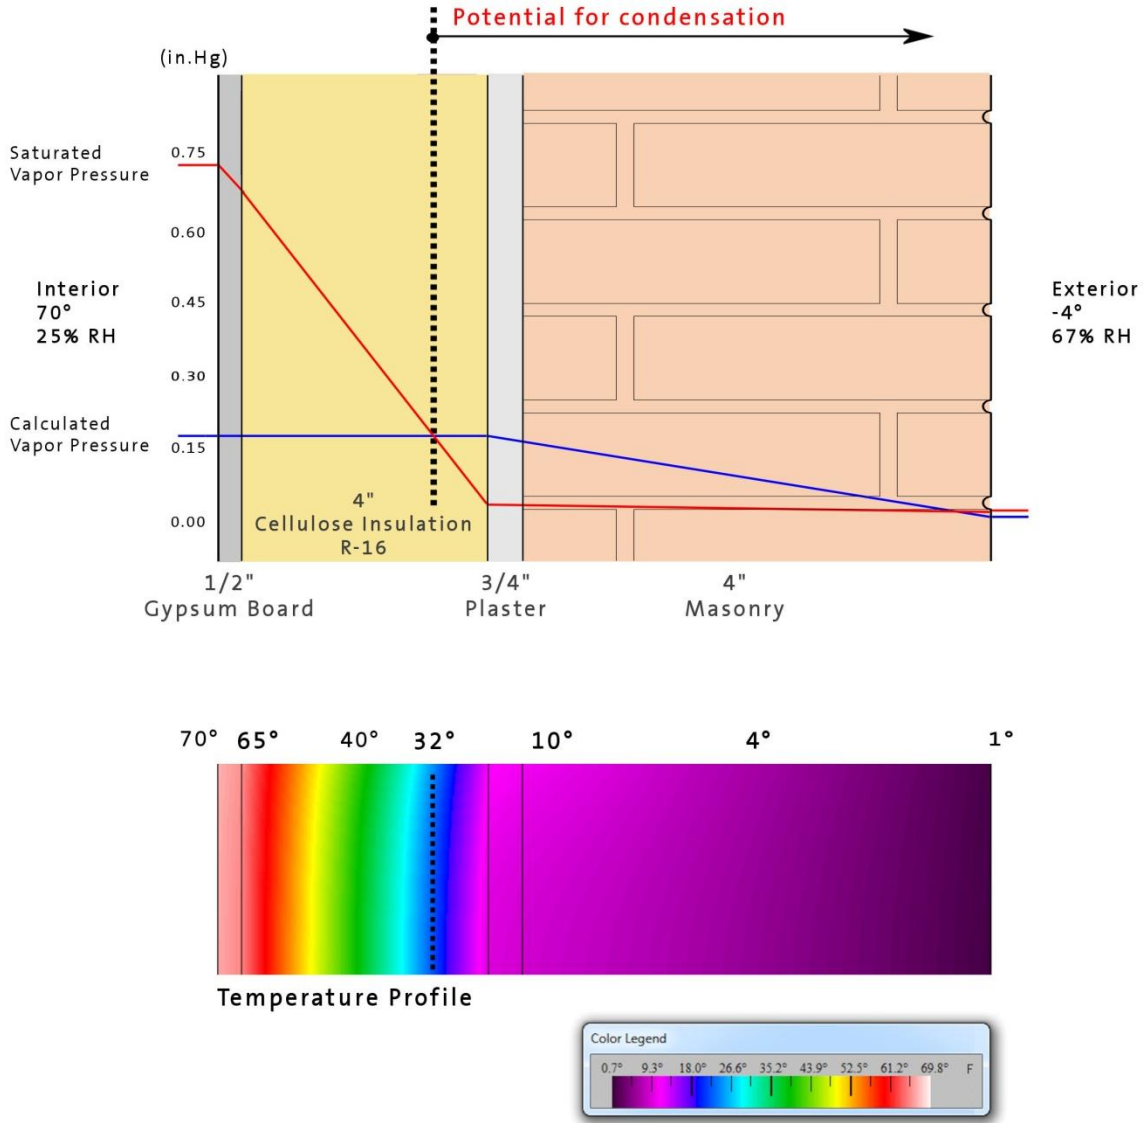
Appendix Figure A-18:
Cambridge Food Co-Op
Insulated Conditions @ Typical Exterior Wall
Hygrothermal Analysis

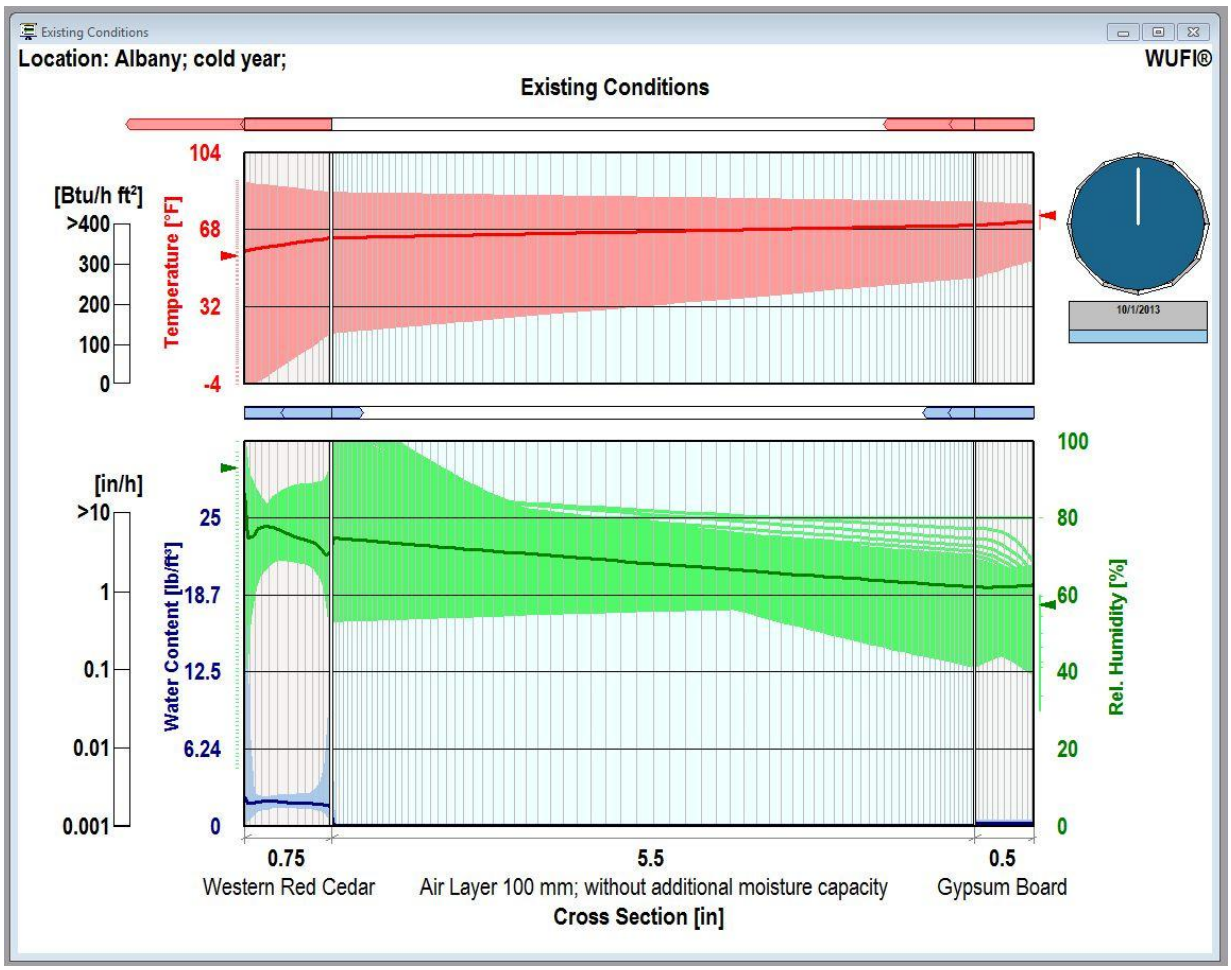
Appendix Figure A-25:
Zadock Pratt Museum
Existing conditions @ Typical Exterior Wall- Yearly Cycle
WUFI Hygrothermal Analysis

- *excess moisture accumulation*
- *constant heat flow through wall*

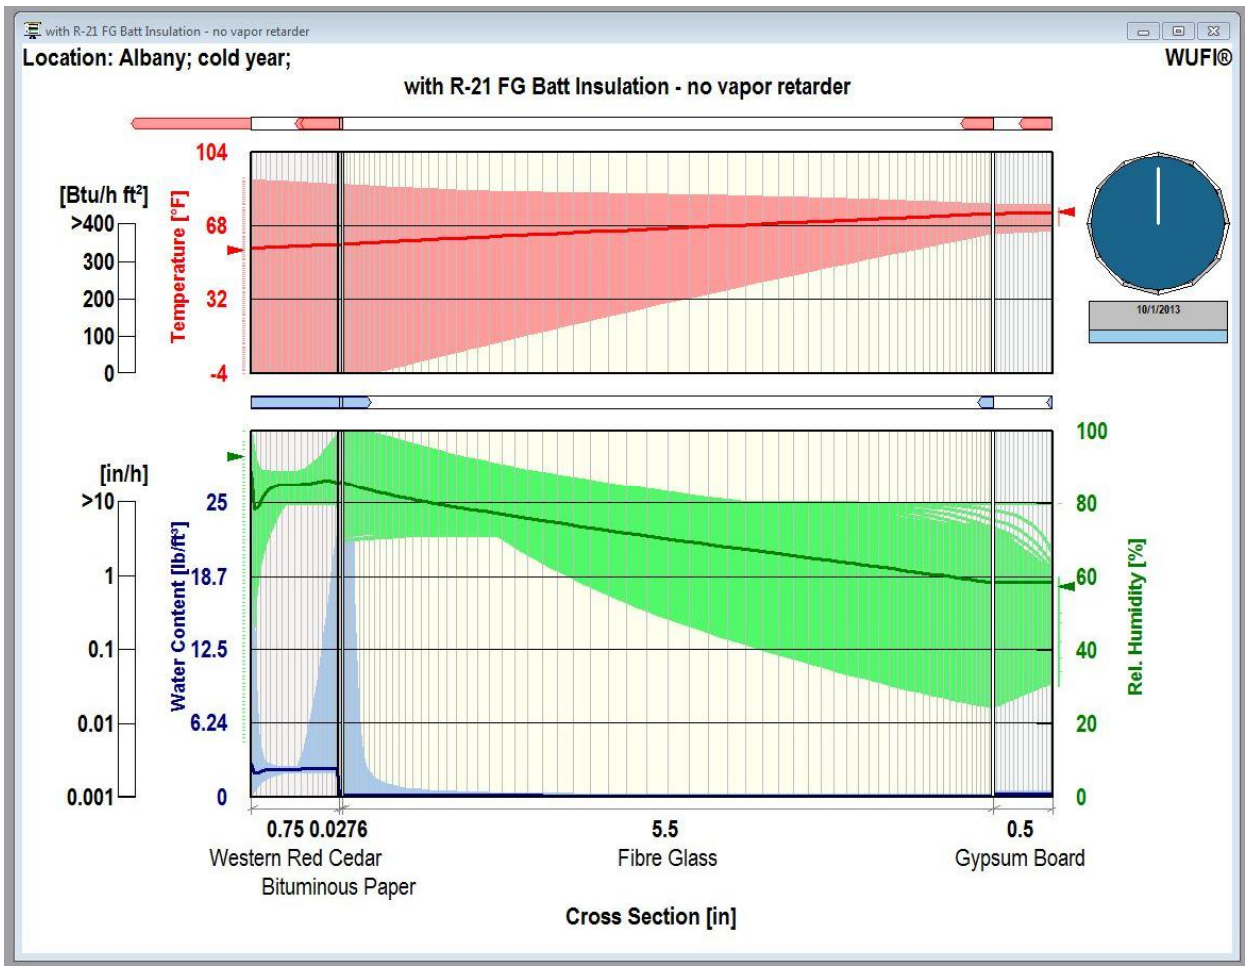
Appendix Figure A-26:
Zadock Pratt Museum
Insulated Wall - No Vapor Retarder – Yearly Cycle
WUFI Hygrothermal Analysis

- *excess moisture accumulation on interior face of siding*

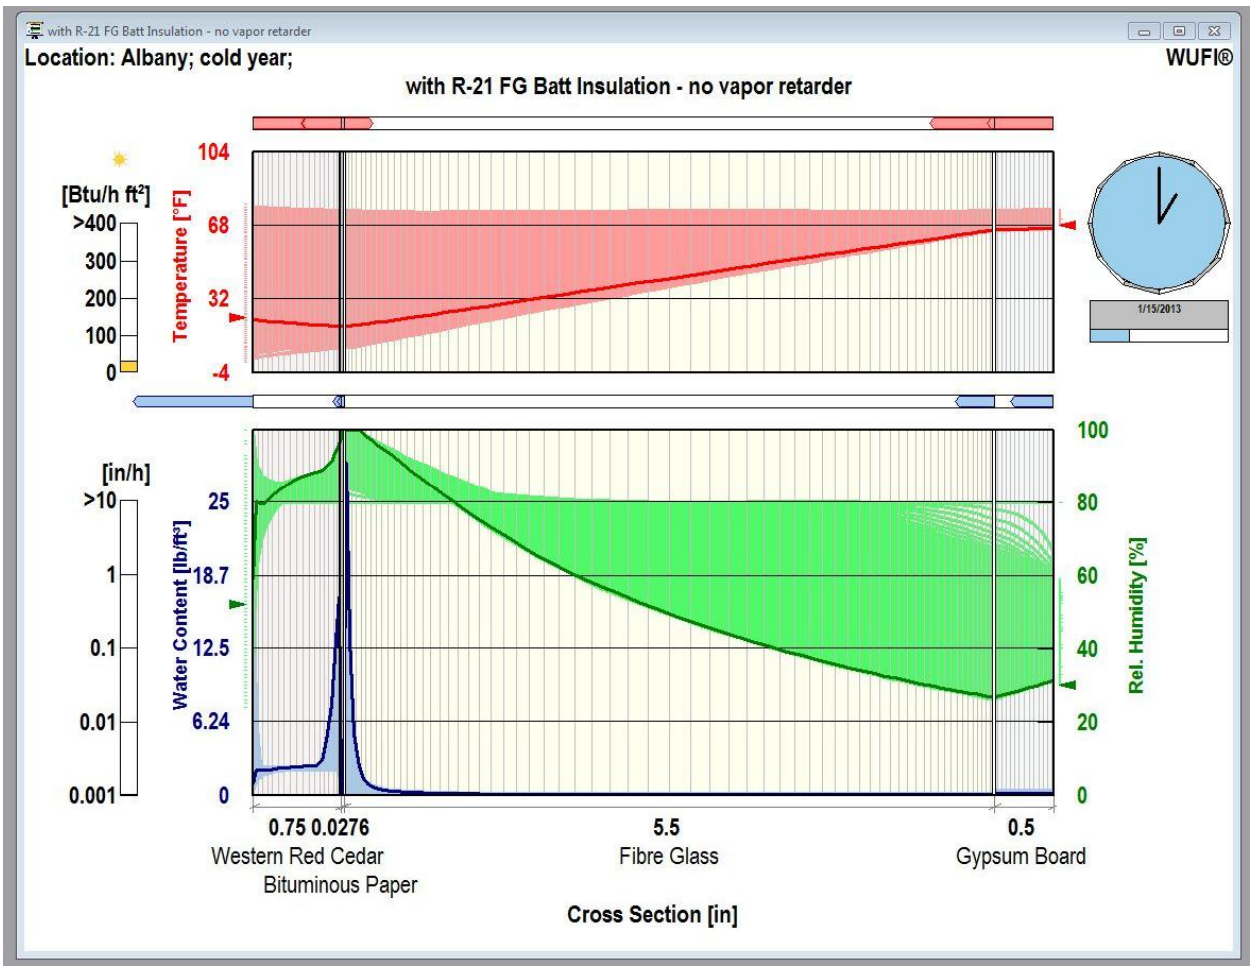
Appendix Figure A-27:
Zadock Pratt Museum
Insulated Wall - No Vapor Retarder – Mid-Winter Condition
WUFI Hygrothermal Analysis

- *excess moisture accumulation on interior face of siding*
- *Relative Humidity (RH) reaches saturation point (100%)*

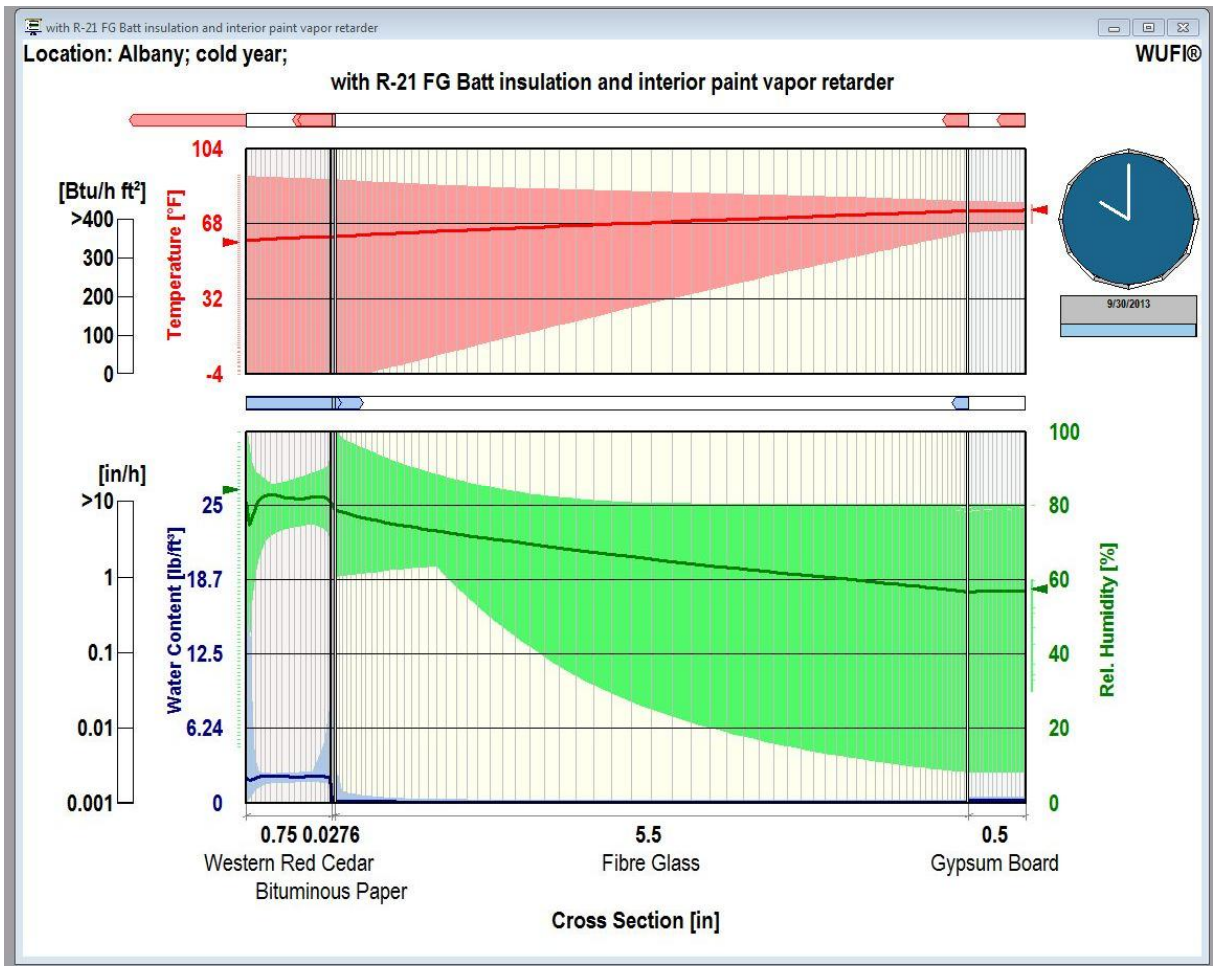
Appendix Figure A-28:
Zadock Pratt Museum
Insulated Wall – Vapor Retarder Paint on Interior – Yearly Cycle
WUFI Hygrothermal Analysis

- *Moisture is not accumulating within wall*
- *drying cycle is surpassing wetting periods*

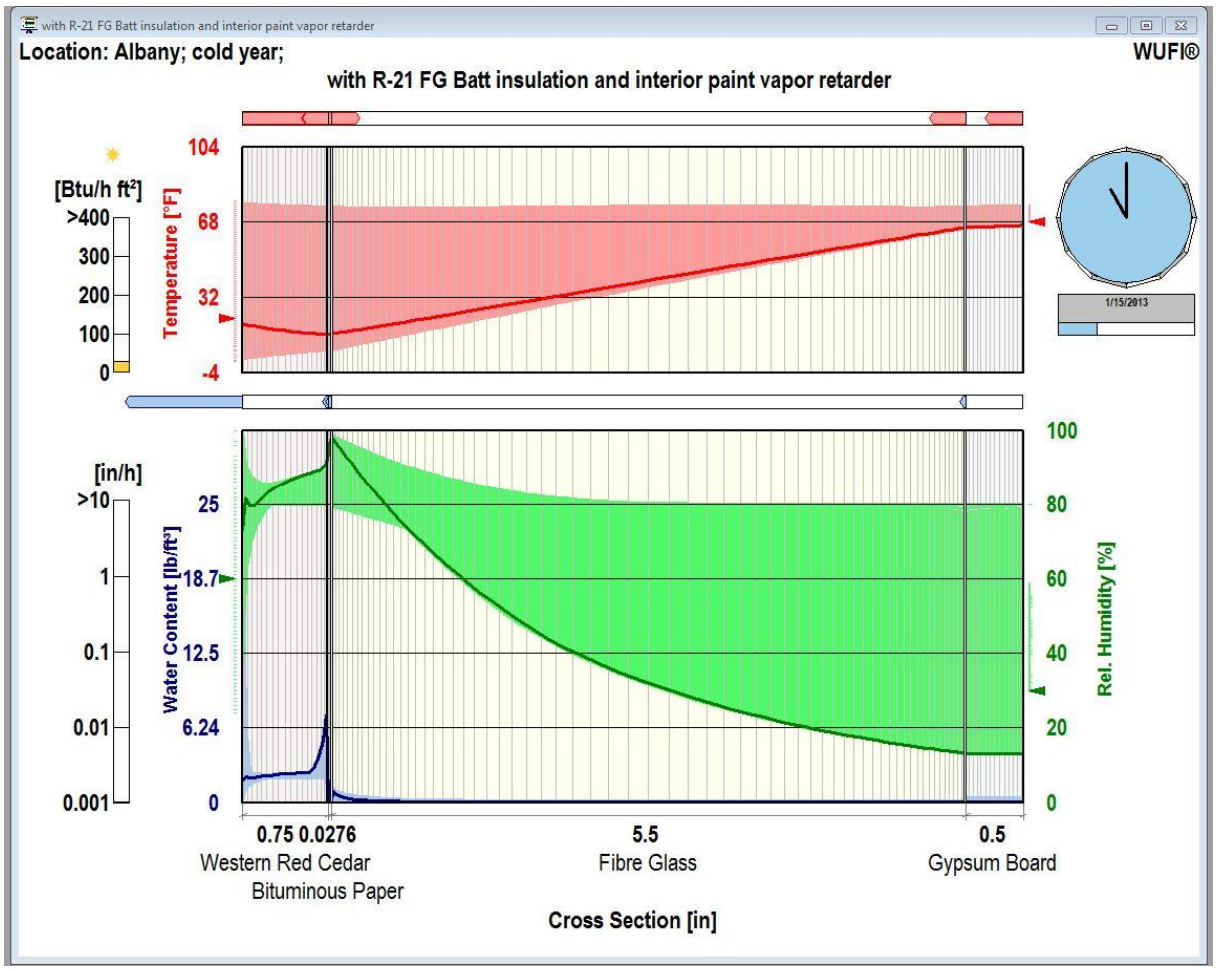
Appendix Figure A-29:
Zadock Pratt Museum
Insulated Wall – Vapor Retarder Paint on Interior – Mid-Winter Condition
WUFI Hygrothermal Analysis

- *relative humidity (RH) reaches saturation point for short periods of time*
- *Moisture is not accumulating within wall*
- *drying cycle is surpassing wetting periods*

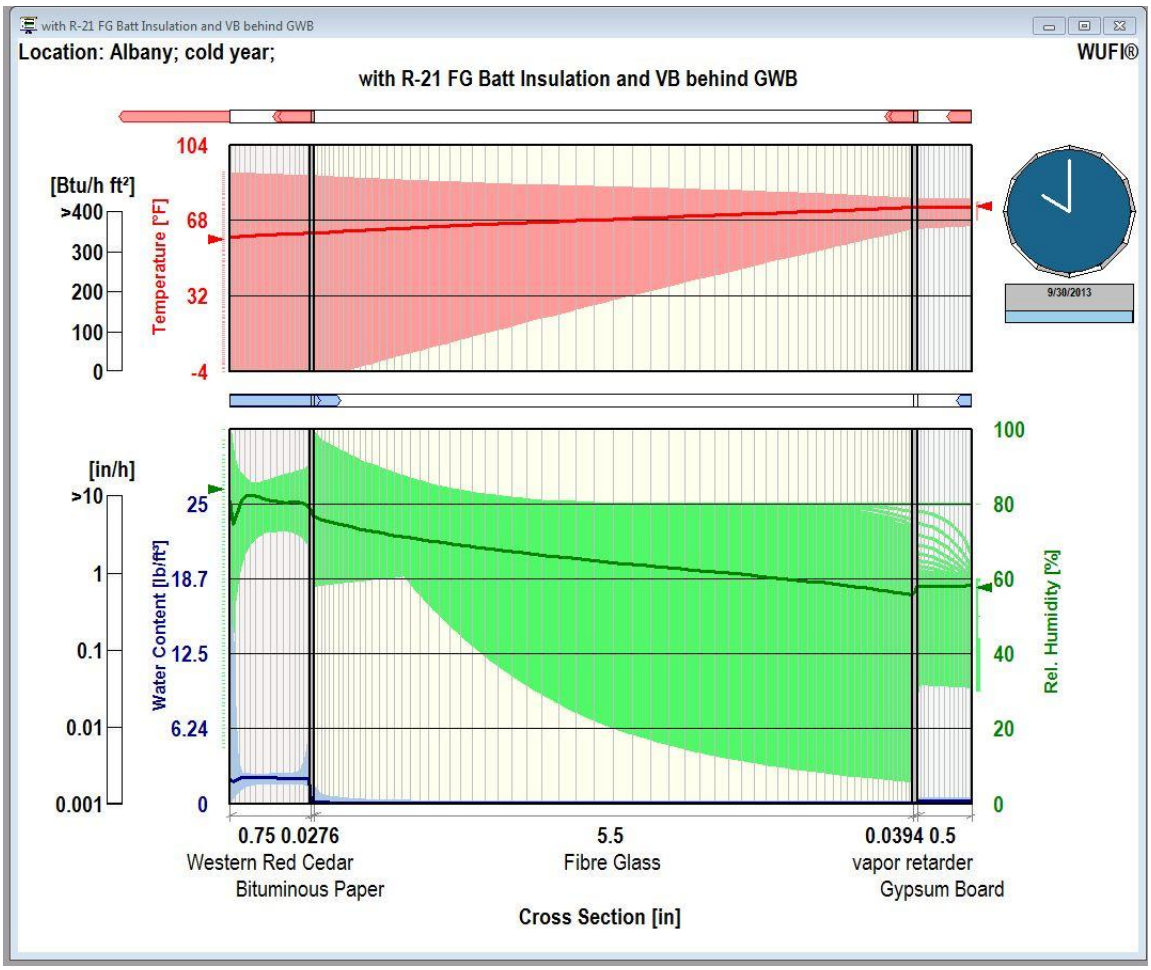
Appendix Figure A-30:
Zadock Pratt Museum
Insulated Wall – Vapor Retarder Sheet on Interior – Yearly Cycle
WUFI Hygrothermal Analysis

- *Moisture is not accumulating within wall*
- *drying cycle is surpassing wetting periods*
