ENERGY CONSERVATION IN HISTORIC BUILDINGS

TASK 1 - INVESTIGATIONS FOR INSULATION STRATEGIES

August 2012

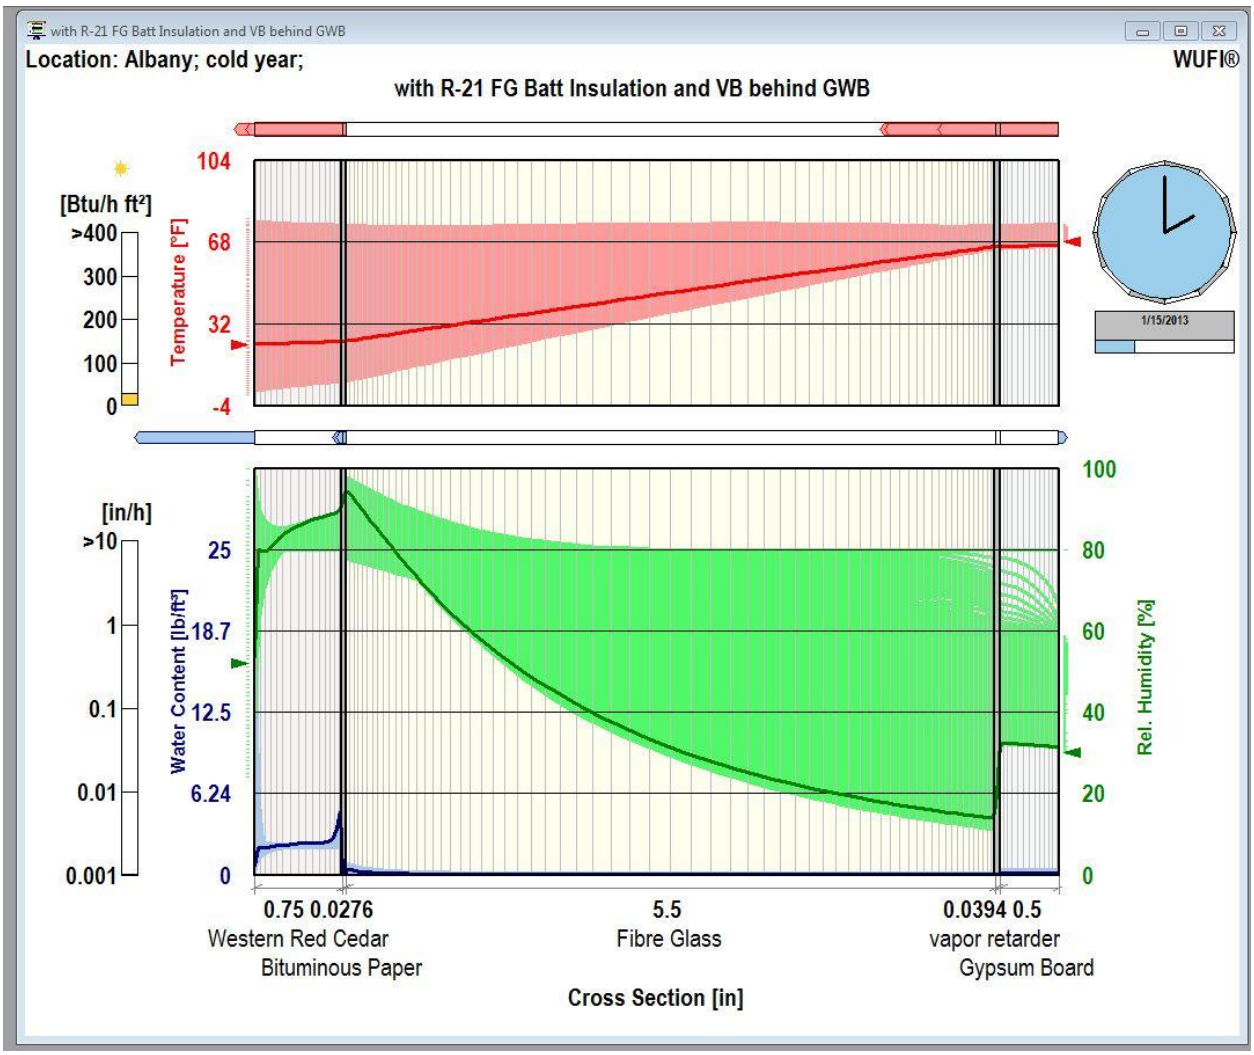
Appendix Figure A-31:
Zadock Pratt Museum
Insulated Wall – Vapor Retarder Sheet on Interior – Mid-Winter Condition
WUFI Hygrothermal Analysis

- *relative humidity (RH) reaches saturation point for short periods of time*
- *Moisture is not accumulating within wall*
- *drying cycle is surpassing wetting periods*
