# THE CONSERVATION AND PRESERVATION OF TABBY

## A SYMPOSIUM ON HISTORIC BUILDING MATERIAL IN THE COASTAL SOUTHEAST

February 25–27, 1998  
Jekyll Island, Georgia

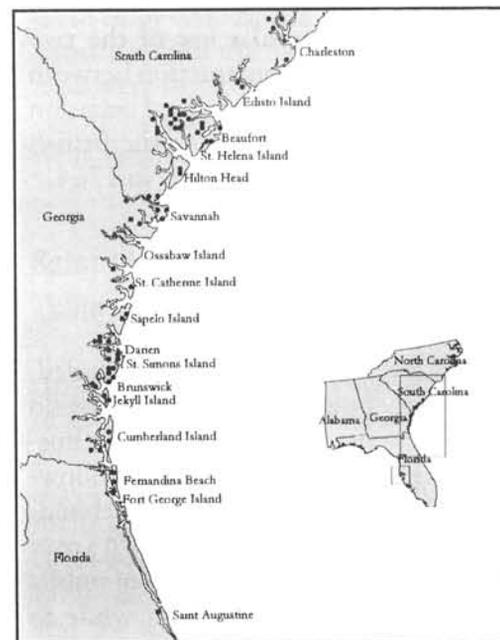
*Selected extant tabby structures in the Southeastern United States*

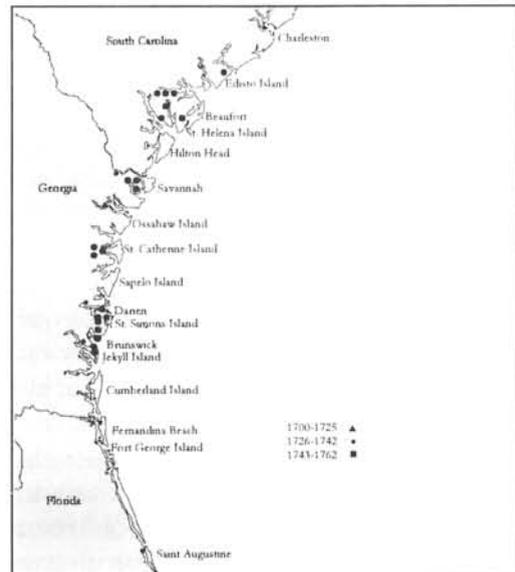
*Tabby of British origin from 1700 to 1762.*

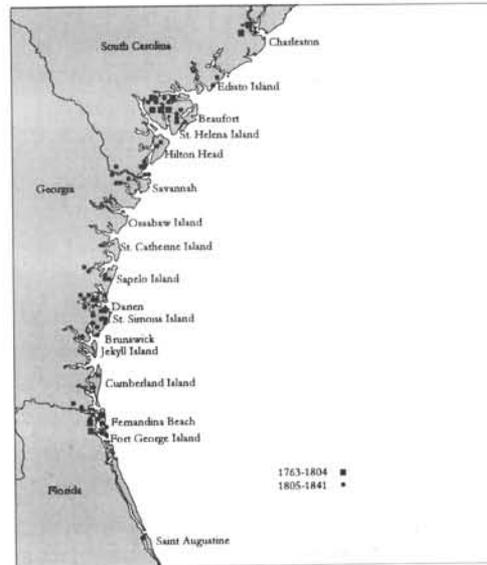
*Tabby of British and American origin from 1763 to 1841.*

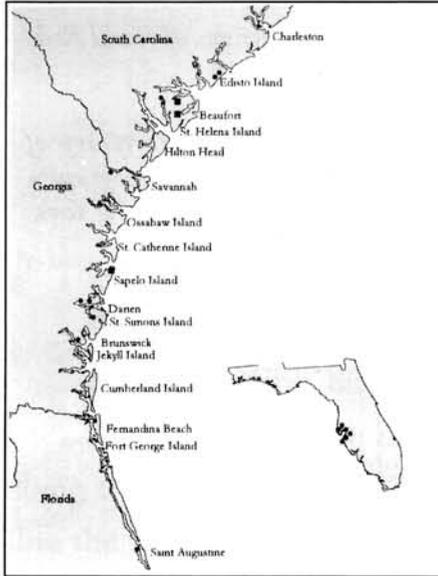
*Tabby of American origin from 1842 to 1920.*

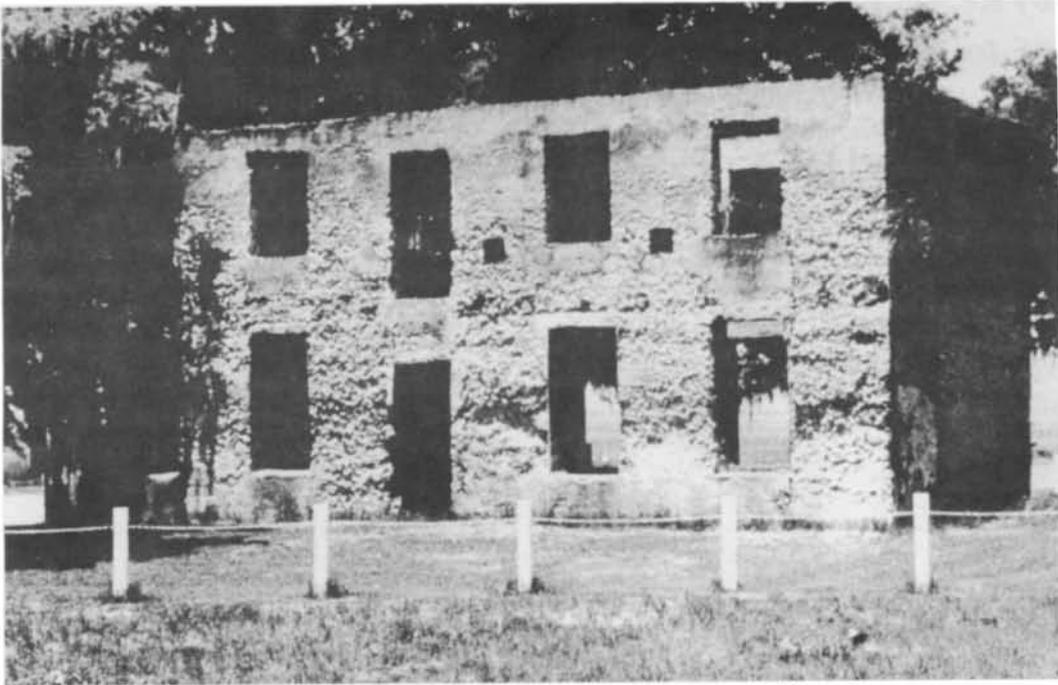
*The Horton-DuBignon House on Jekyll Island (circa 1738) is one of the oldest intact tabby structures in Georgia.*

The structure that remains today is a two-story tabby ruin, forty-one feet long, eighteen feet wide, and eighteen feet high.

There is one standing chimney on the west facade. The existing ruin is made up of three separate tabby constructions. Portions of tabby and the existing stucco date from the 1899 "restoration" of the structure by the Jekyll Island Club. It may have been during this period that steel rods were added for bracing. The second tabby pour, the age of which has not been determined, is evident along portions of the second-floor windows. The remaining portion, which is the majority of historic tabby, is identical in texture and consistency to that of the nearby ruins of the Horton Brewery, which date to the 1730s. A conjectural drawing done in a 1960s restoration plan depicts what the house may have looked like.

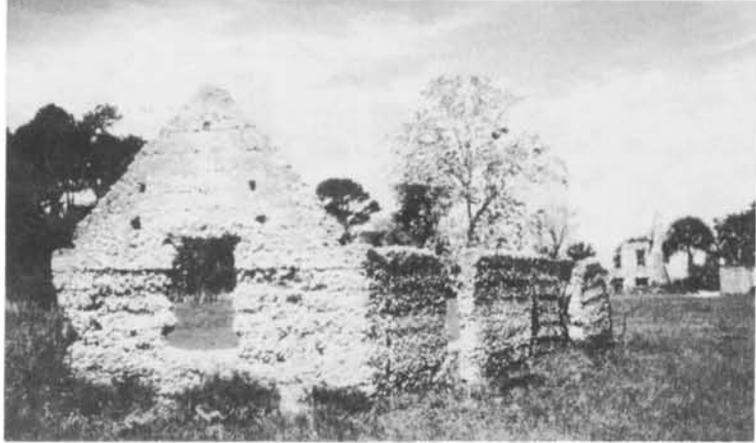
*Chocolate Plantation on Sapelo Island in McIntosh County is believed to have been built sometime between 1812 and 1820. The site consists of over fifteen tabby structures, including the main house, individual slave cabins (above), storage buildings, an infirmary, and stables.*

tures. Immediate structural stabilization of many of the walls is needed before much of this site is lost.

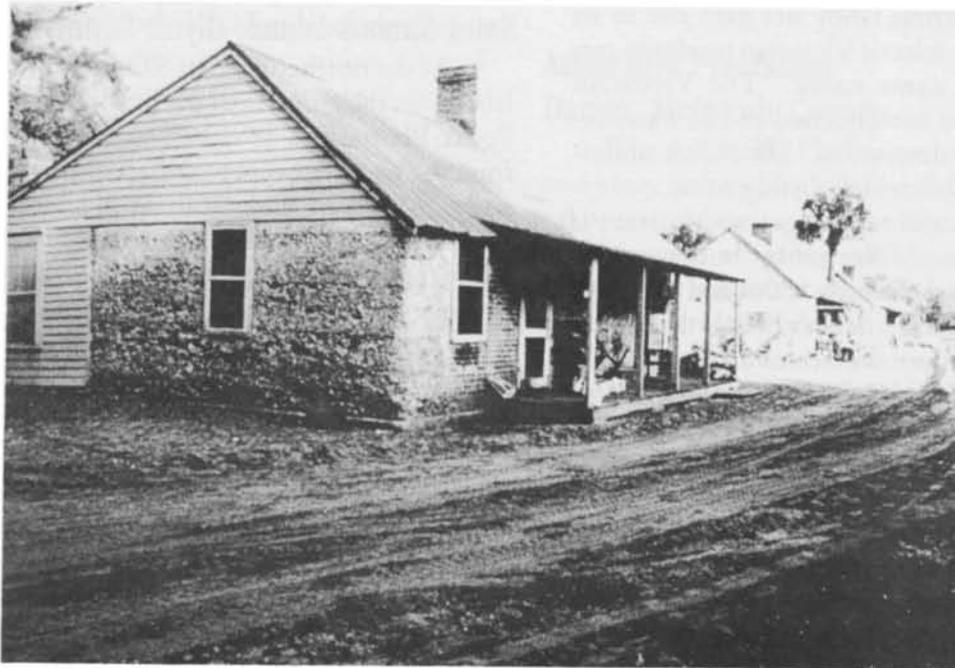
*These two slave cabins are located on Hamilton Plantation, St. Simons Island in Glynn County. One of the cabins has a rear kitchen, but otherwise the overall forms of these two buildings remain intact.*

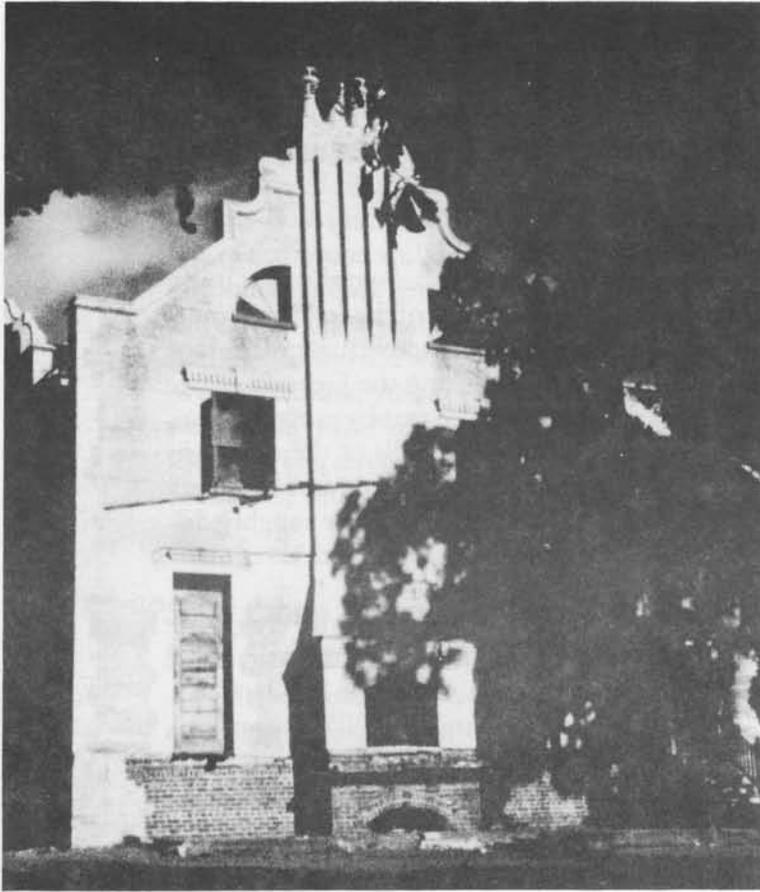
*Hollybourne Cottage on Jekyll Island was built in 1890. The house is presently vacant and has numerous structural problems.*

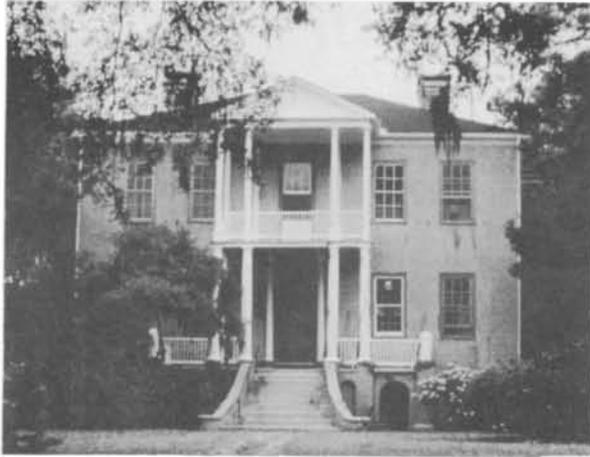
*Dating from 1787, Tabby Manse in Beaufort, South Carolina, has two-story tabby walls on a raised tabby foundation.*

Some of the residences have full exterior walls of tabby. Dating from 1787, Tabby Manse in Beaufort has two-story tabby walls on a raised tabby foundation. The work on the tabby walls and foundation at the Barnwell-Gough House (1789), also in Beaufort, is the subject of one of our case studies.

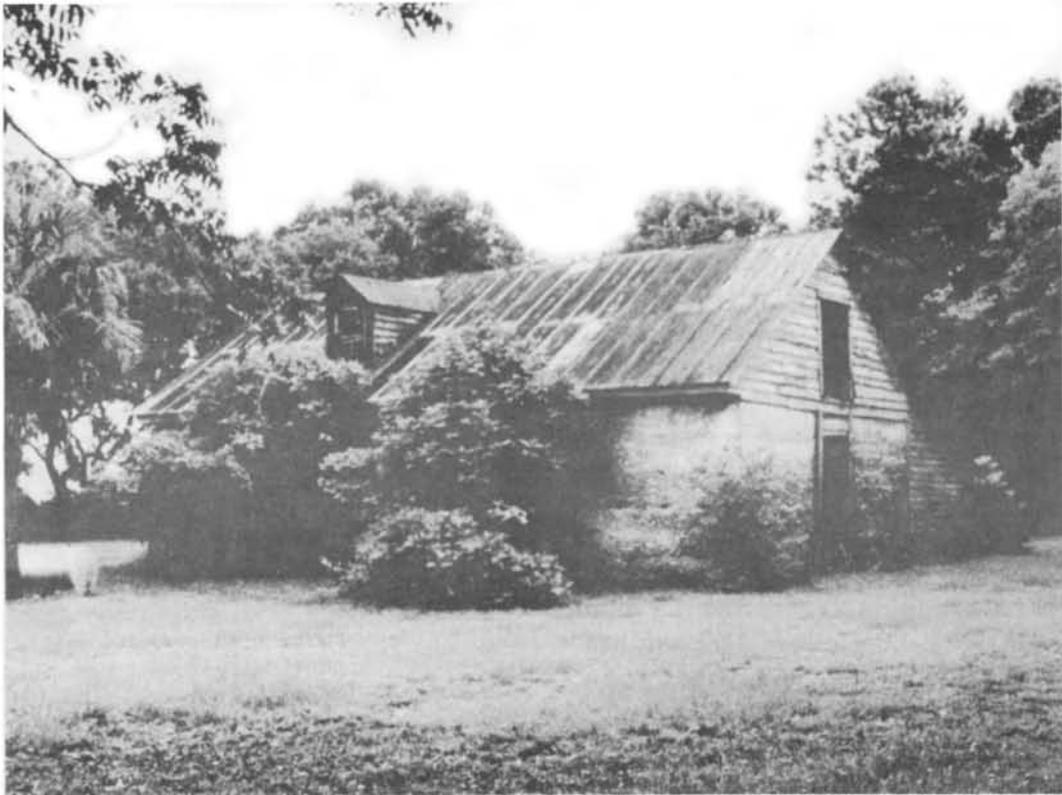
*The tabby barn (circa 1800) at Frogmore Plantation is still in use.*

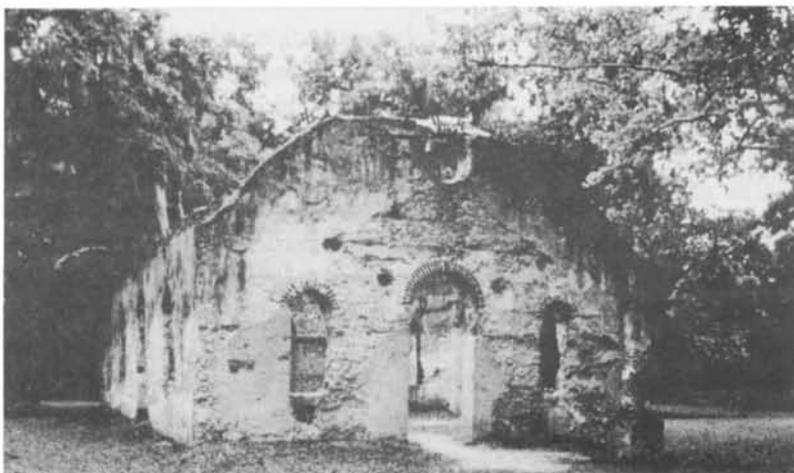
*The Saint Helena Chapel of Ease (circa 1740) features tabby walls with brick columns and brick arches over the window openings.*

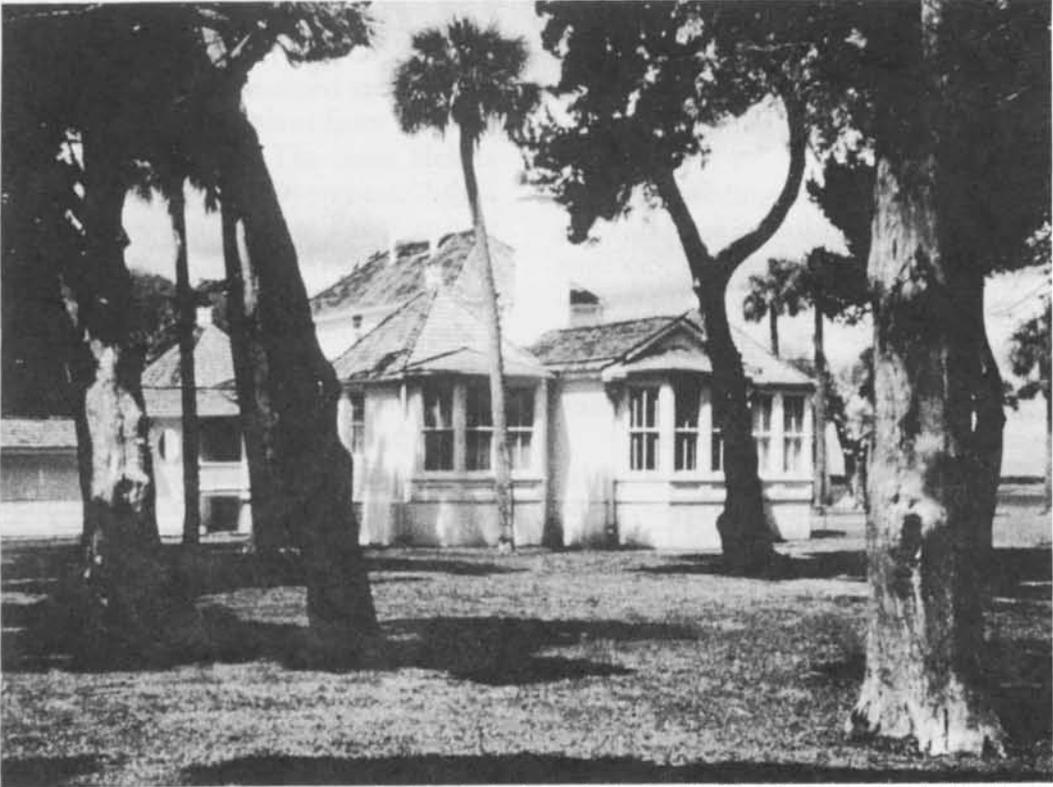
*The Kingsley Plantation on Fort George Island north of Jacksonville features Florida's earliest examples of tabby. Above is the main house.*

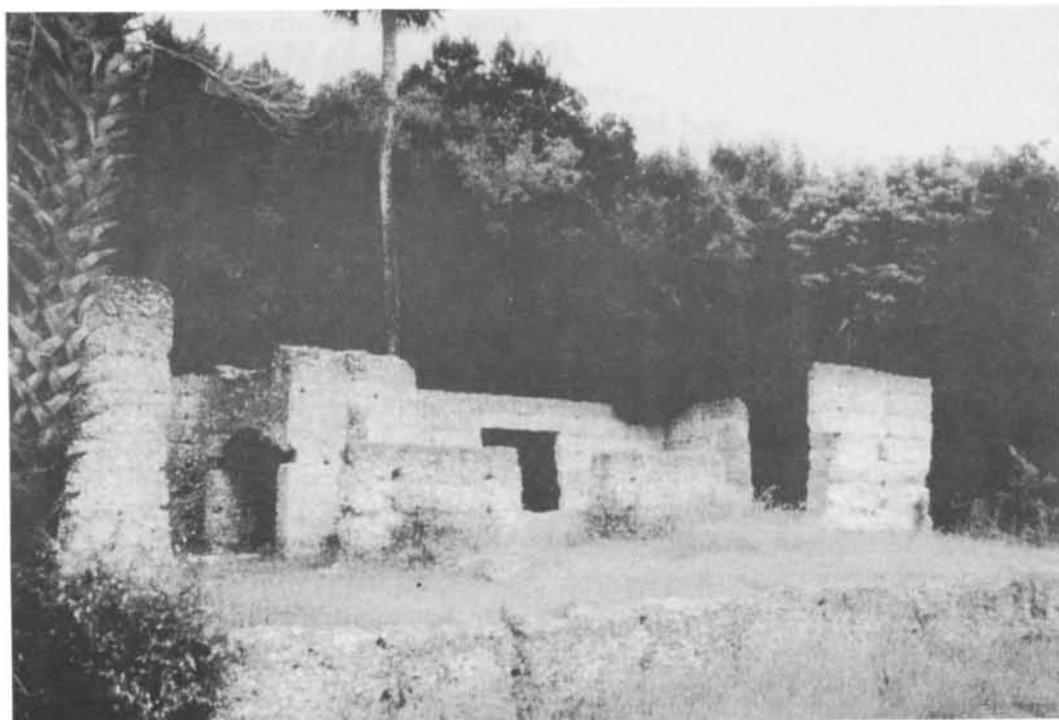
*The ruins of the slave cabins at Kingsley Plantation are in remarkably good condition after almost two hundred years.*

cast-in-place construction method with lifts ranging from nine-and-one-half to eleven inches. They have been most recently worked on in a 1996 training course sponsored by the Williamsport Center under the direction of Tom McGrath. With one reconstructed exception all remain roofless, with only the walls standing, and are in remarkably good condition after almost two hundred years, a lively demonstration of tabby's durability.

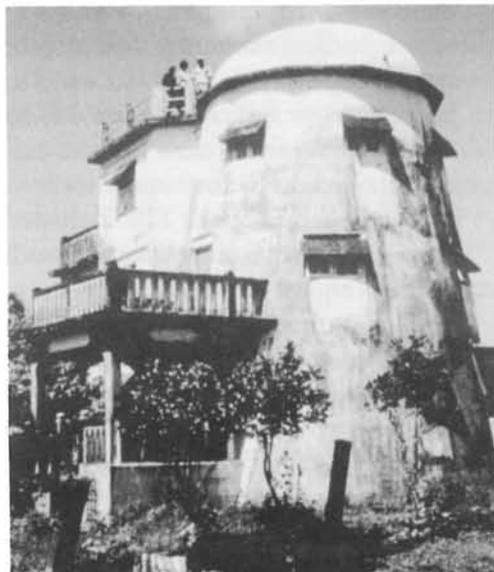
*The Courland Great House/Mill is located near the town of Plymouth on the southwest side of the island of Tobago.*

- **The Existing Great House.** The great house, as it is known today, consists of a modified windmill tower with a two-story addition on the southwest side of the tower. The age of the mill tower is unknown because of extensive twentieth-century modifications. Because of its location between the ruins of the estate house and the sugar factory, it is presumed to have been constructed contemporaneously with the factory.

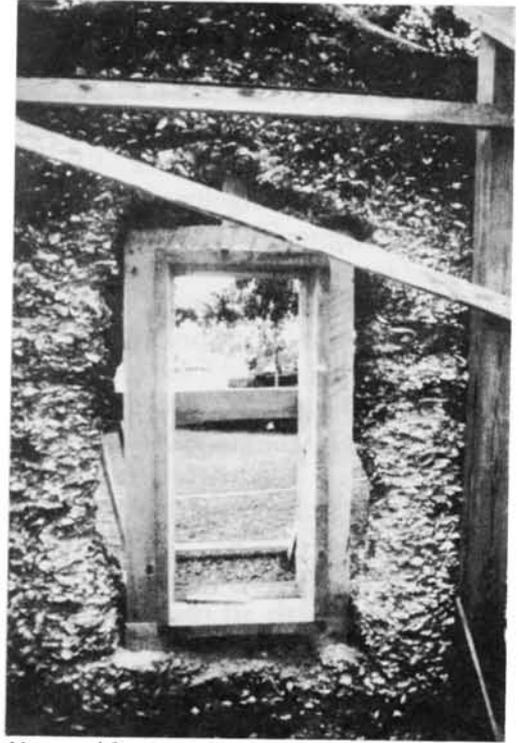
*New wood framing at the slave hospital at Retreat Plantation, Saint Simons Island, Georgia.*

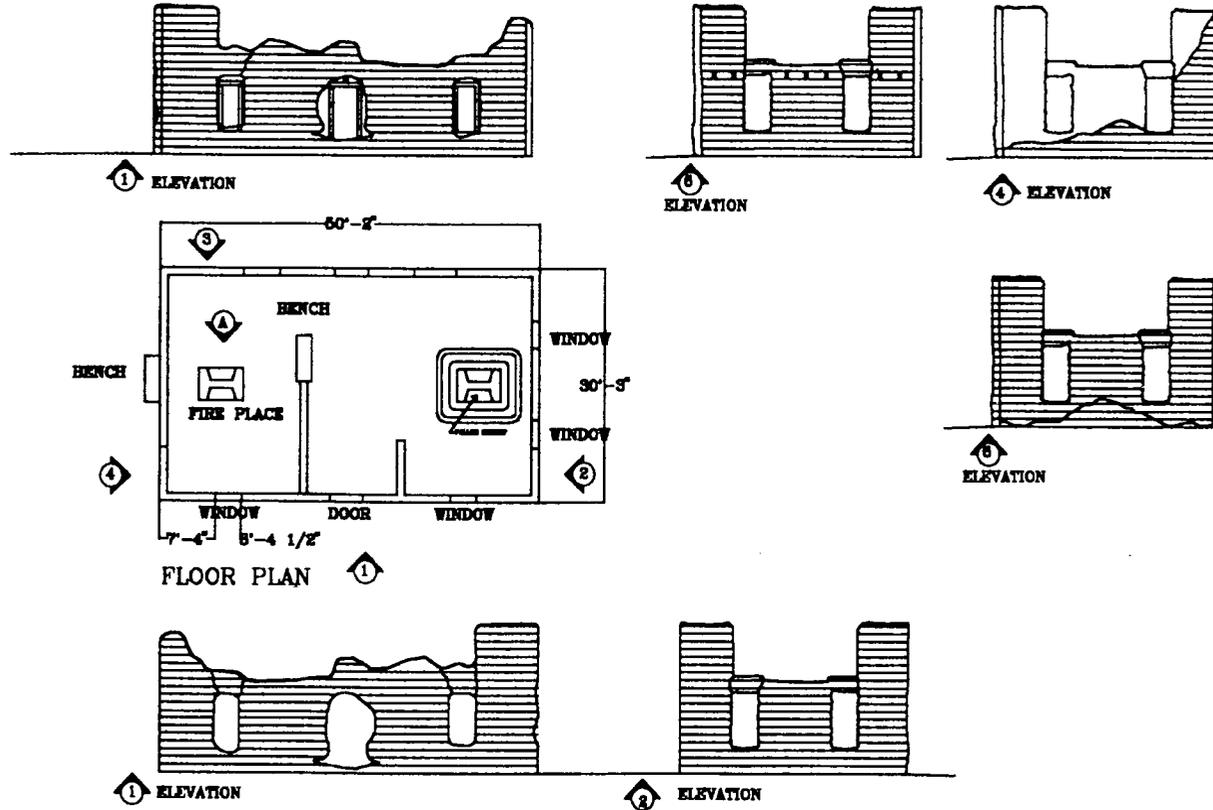
*Tabby construction of the hospital at Retreat Plantation, Saint Simons Island, Georgia*

We used rectified photography to document the wall elevations. We accomplished this purpose by setting targets at an equal distance from the walls to a parallel plane from which photographs were taken. They were then enlarged to a given scale of one-quarter inch. These photos were traced onto mylar plastic sheets and drawn with technical barrel-type pens called Rapidographs. Floor footprints were measured and drawn showing the floor plan of these walls. Archaeologist Tom

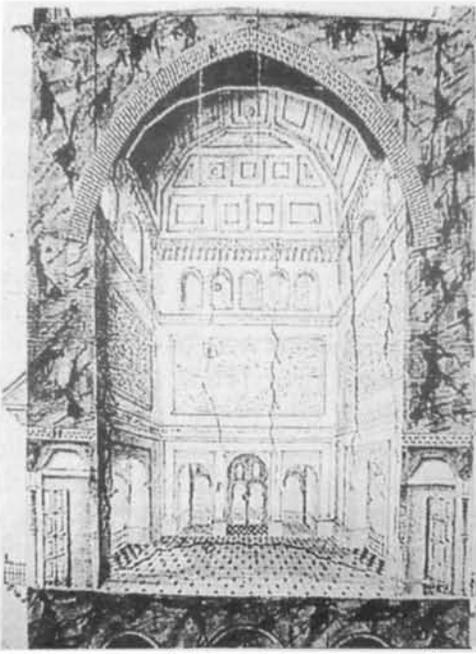
A 1686 drawing of the Torre de Comares at the Alhambra in Granada. Archivo General de Simancas.

The Torre de Comares, at the Alhambra, Granada, provides a memorable monument to such construction.<sup>23</sup> Erected circa 1340, this structure is about forty feet square and approximately seventy feet high and evidences numerous structural repairs. Post-medieval restorations are documented from 1588 down until the present time. A drawing dated 1686<sup>24</sup> is of unique interest, illustrating the structure riven by massive vertical cracks. Later records indicate that decayed, split, or otherwise impaired *tâbiyah* was gradually cut out and replaced with brick (a long-established practice documented at the Alhambra from 1590 onwards but known on other sites much earlier), the tower’s continued structural integrity depending upon intermittent reconstruction episodes. Today, it can be seen that much medieval fabric has been replaced, brick corner rein-

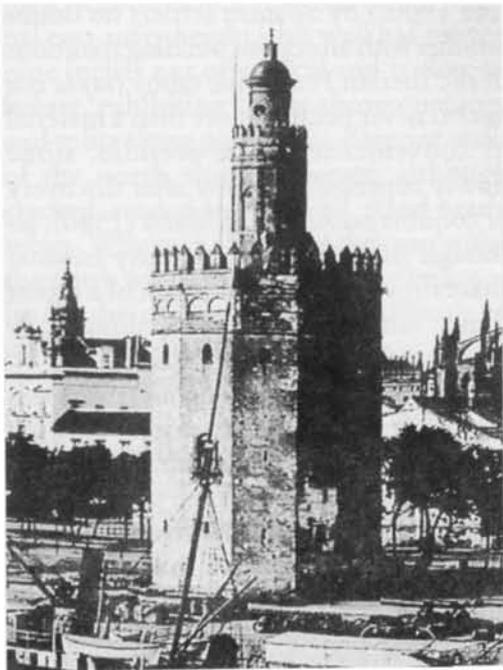
*The Torre del Oro (circa 1220) is one of Seville's most familiar landmarks. (Late nineteenth century photograph).*

The Torre del Oro (circa 1220), one of Seville's most familiar landmarks, displays a similar shift, solid masonry replacing cast materials over time. Now giving the impression of a stone and brick monument, surviving fragments and late nineteenth-century photographs show that lower stages of the tower were originally *tâbiyah*.<sup>26</sup> Elsewhere modern Spanish conservators often follow similar precedent, patching decayed *tâbiyah/tapia* with brick, filling vertical cracks with lime-based mortars, and concealing the result under a stucco finish. Restoration of lost or damaged architectural elements is frequent. Seville's city walls typify the practice, presenting a palimpsest of original eleventh-century work; medieval or post-medieval repairs, and modern finishes. In Cordoba, large breaches in the city walls have recently been filled by casting mortar/gravel mixes into new form-work that replicates medieval form-work design with respect to height and tie arrangements. At the Alcazaba, Almeria, restoration of eleventh-century *tâbiyah* fortifications follows simi-

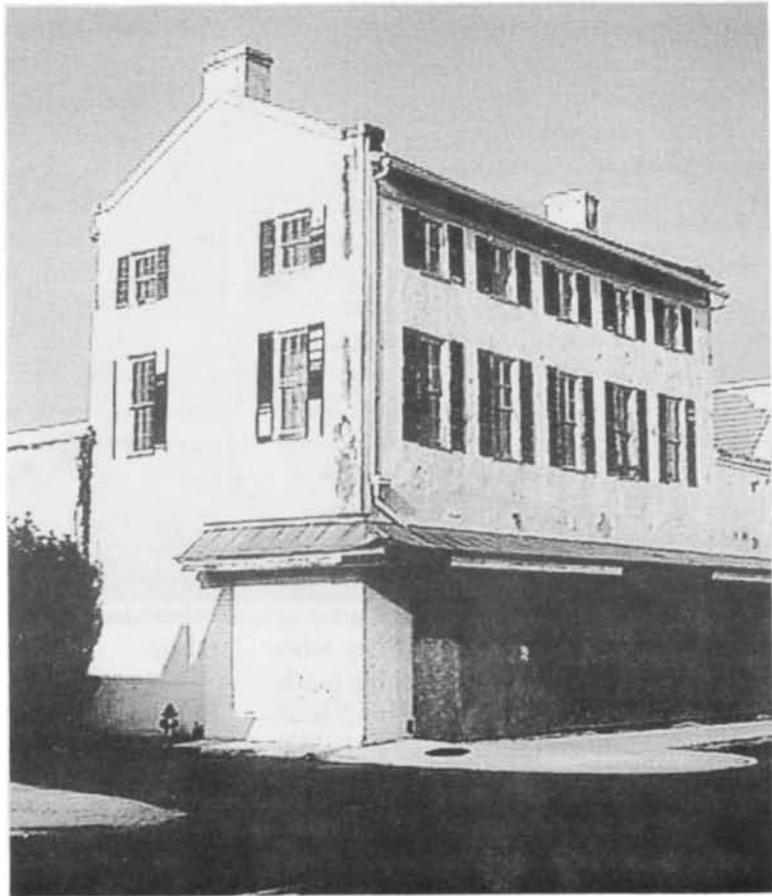
*The Saltus/Habersham House (circa 1797) is located in Beaufort, South Carolina.*

Another egregious example of unsympathetic treatment of an important tabby structure is found at 802 Bay Street, Beaufort, South Carolina, where the Saltus/Habersham House, originally a gable-ended dwelling of three stories raised over an elevated basement, has lost lower portions of its long front (north) and back (south) walls. Built by a local merchant, Capt. Francis Saltus, circa 1797 and remodeled circa 1825, the structure survived the Civil War and its wartime use as a commissary with only minor modification. However its purchase at a direct tax auction by D. C. Wilson in 1869 initiated a period of major alteration. Wilson re-

Upper portions of the old house were supported on steel joists, this highly hazardous exercise made more so by installation of undersized steel supporting members. While the two end facades with their internal brick chimney stacks still stand intact, steel beams carrying upper front and rear tabby walls have deflected as much as seven inches, tabby fabrics above tearing and splitting to a point where the entire building is endangered.

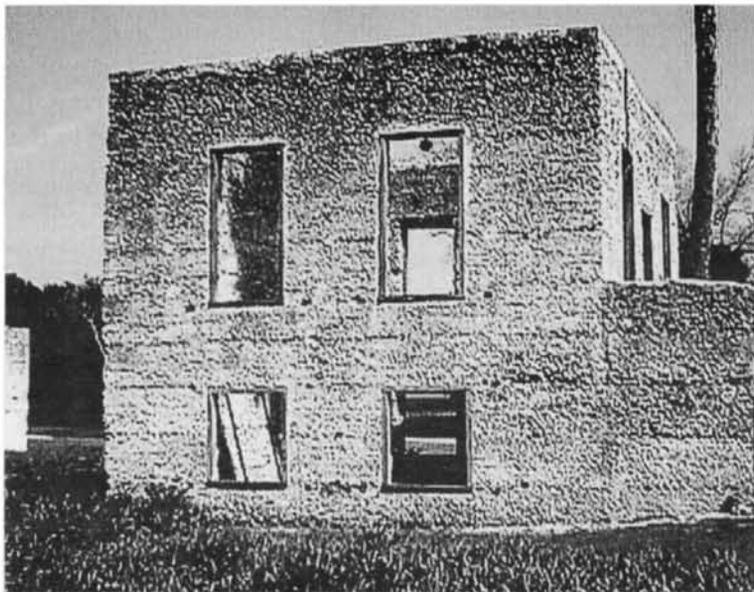
*The Edwards House, located on Spring Island, South Carolina.*

one lintel found *in situ* to allow reproduction of the rest. Likewise, carbonized fragments attested original scantling of first-floor joists spanning across the slave tenement located near the Edwards House, but for both the main residence and its outbuildings nothing survives of roof framing, making even hypothetical restoration uncertain.<sup>36</sup>

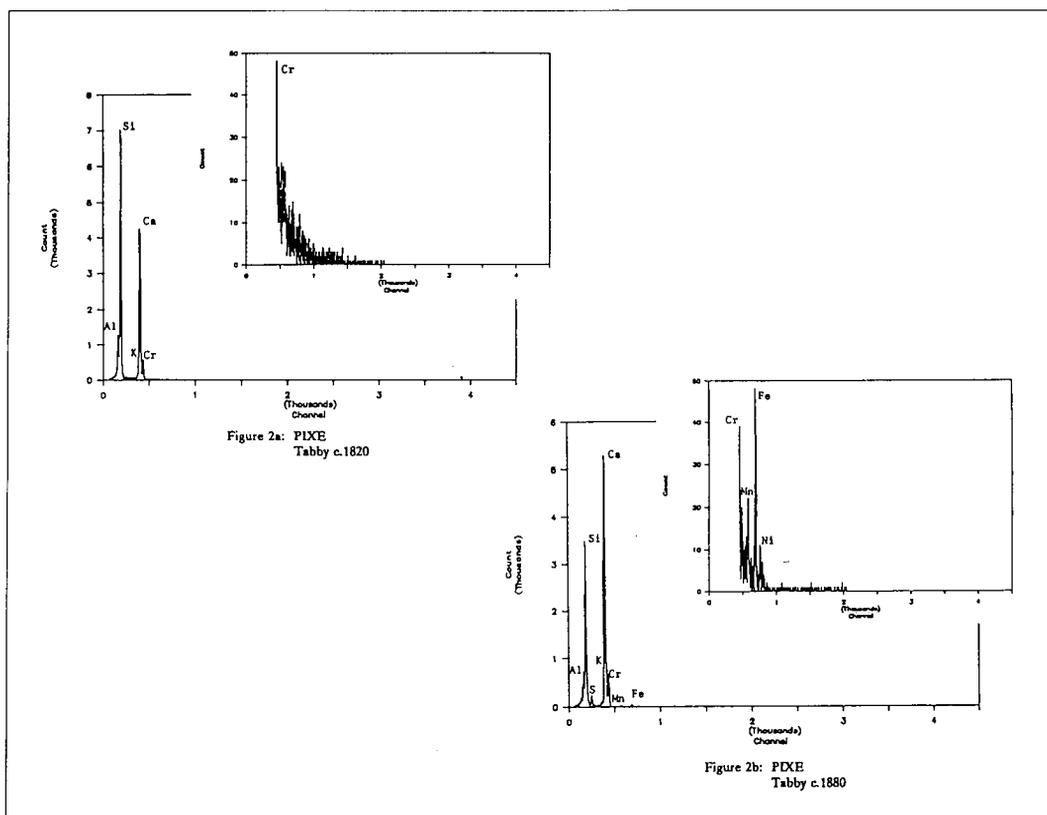
Taken from Lauren B. Sickels-Taves, Michael S. Sheehan, and Gary White, "Applications of Qualitative Trace Element Analyses: An Interdisciplinary Approach to Materials Conservation," *Materials Issues in Art and Archaeology 5*, Materials Research Society Proceedings 462 (1997): 328.

The three most outstanding tests—most useful in preparing the Tabby House for restoration—were particle-induced X-ray emission (PIXE), computer-assisted optical stereology, and ash analysis.

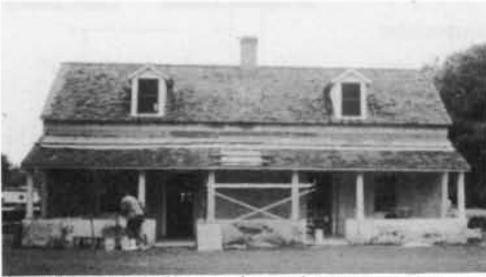
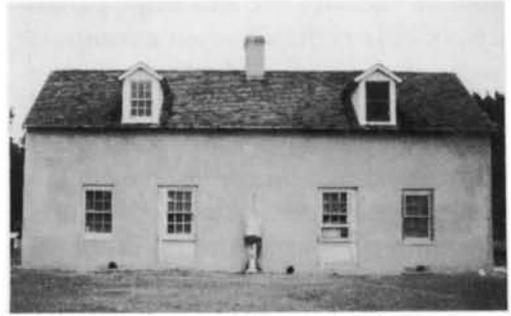
*The Tabby House, front and rear elevations, nearing completion. The completed walls are drying to a uniform, warm, light brown color (Munsell Colour 10YR 8/1), closely matching the original color. Photographs by Melanie Taves.*

The formula for original tabby, based on laboratory analysis, was a 1:3 lime:sand with wood ash, obtained during the lime burning, and oyster shell. This specific formula was one of two recommended by the Roman Vitruvius as early as 46–30

B.C.<sup>14</sup> For the Tabby House, a recipe of 1:2:9 white portland cement:hydrated lime:sand was initially selected. The lack of precise duplication of Vitruvius's formula was based on the necessity of retaining a Type O mix with compressive strength similar to that of tabby. The one part portland cement was the estimated quantity needed to duplicate the effects of wood ash in original tabby.
