**National Register of Historic Places
Registration Form**

historic name Bowlin's Old Crater Trading Post

The Historic and Architectural Resources of Route 66 Through New Mexico

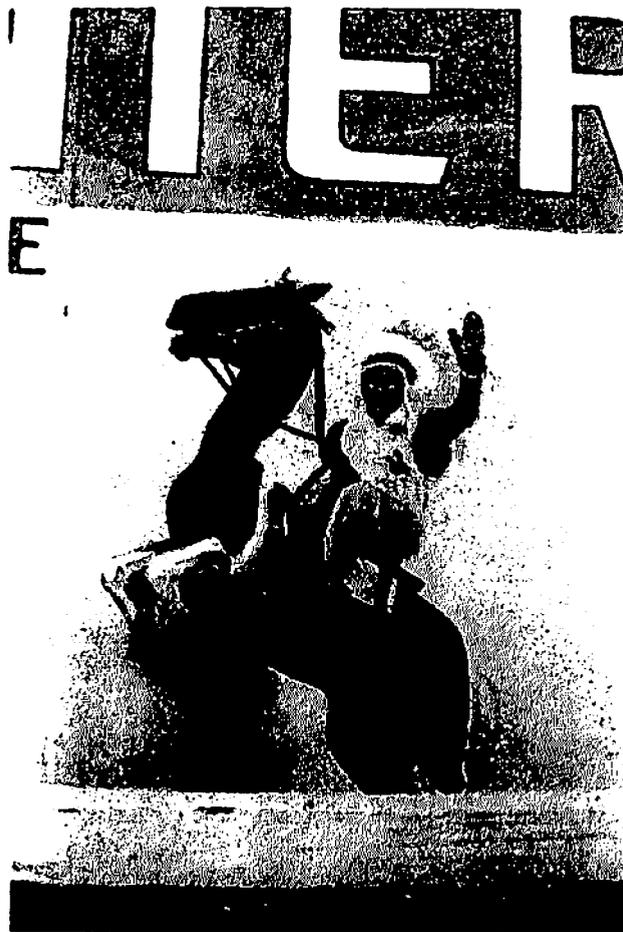
Figure 8-5: Touching up the paintings on the main façade, ca. 1960 (Courtesy Patricia McClure)

Post. The building's eye-catching artwork of Native Americans in traditional settings was originally created by Conrad Barrio from Juarez, Mexico (Figure 8-5). Touch-ups and changes over the years were made by Earl Sherman and Evan Freymiller, a minister to the Navajos and a part-time sign painter. Frank McClure and Earl Sherman created the plaster casts of Native American figurines.¹²
