National Register of Historic Places
Registration Form

historic name Cactus Motor Lodge
other names/site number Cactus RV-Park

street & number 1316 E. Tucumcari Boulevard N/A not for publication
city or town Tucumcari N/A vicinity
state New Mexico code NM county Quay code 037 zip code 88401

Cactus Motor Lodge
Tucumcari, Quay County, New Mexico

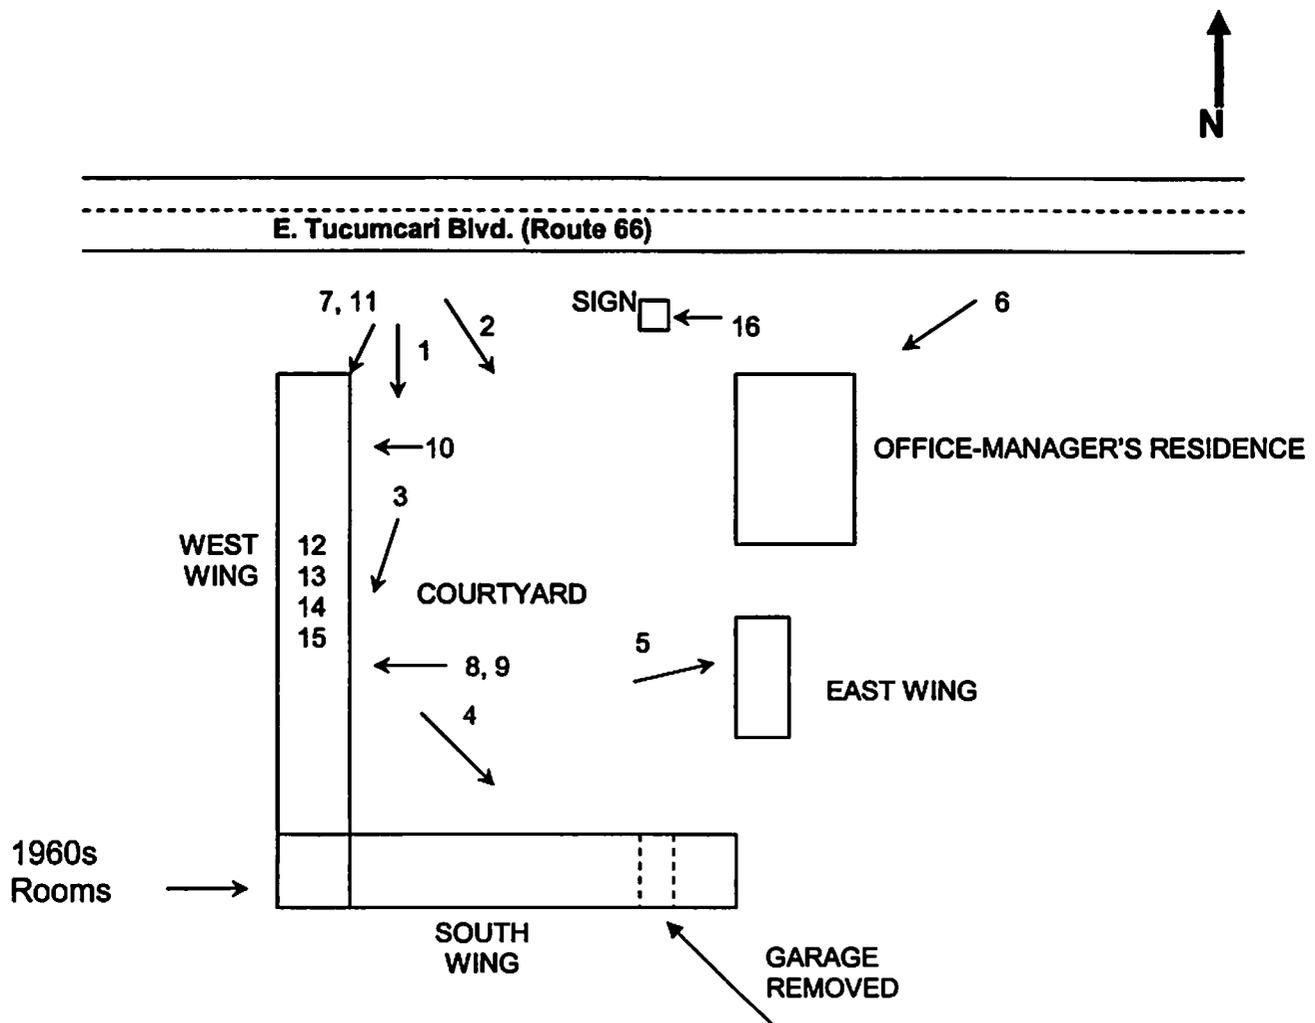
Figure 7-1: Site Plan and Photo Key for the Cactus Motor Lodge

Built in 1941, Cactus Motor Lodge is a U-shaped motel complex of three separate buildings built with poured concrete foundations, stucco exteriors and sloping roofs of wood and rolled asphalt (Figure 7-1). The stucco exteriors of the west and south wings on their main facades were updated with Perma-Stone, an imitation stone concrete material in 1952 (Photos 1, 3, 4, 5, & 6). The original office was located at the north end of the west wing but was converted into a motel unit by the early 1950s (Photo 7).

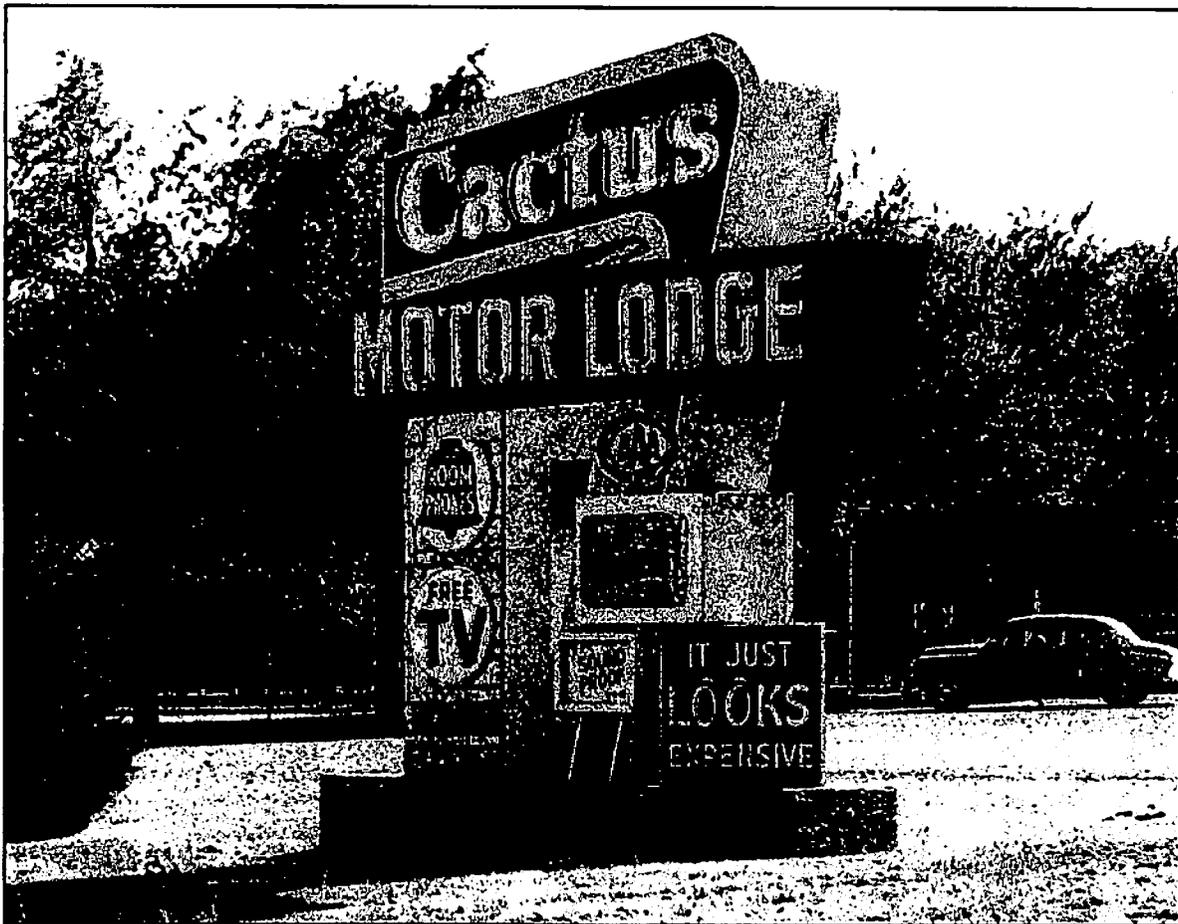
Figure 7-4: Cactus Motor Lodge sign, ca. 1960. (Courtesy of Quay County Museum)

At the north boundary of the property adjacent to Tucumcari Boulevard is a steel sign, which was added ca. 1950 (Photo 16). The sign originally rested on a base of Perma-Stone piers but these were removed and the sign's base rebuilt with steel posts ca. 1970. The sign's neon was placed in storage by the present owner. The sign has been repainted to advertise the present use of the property as an RV park. Due to these changes, the sign is considered noncontributing.

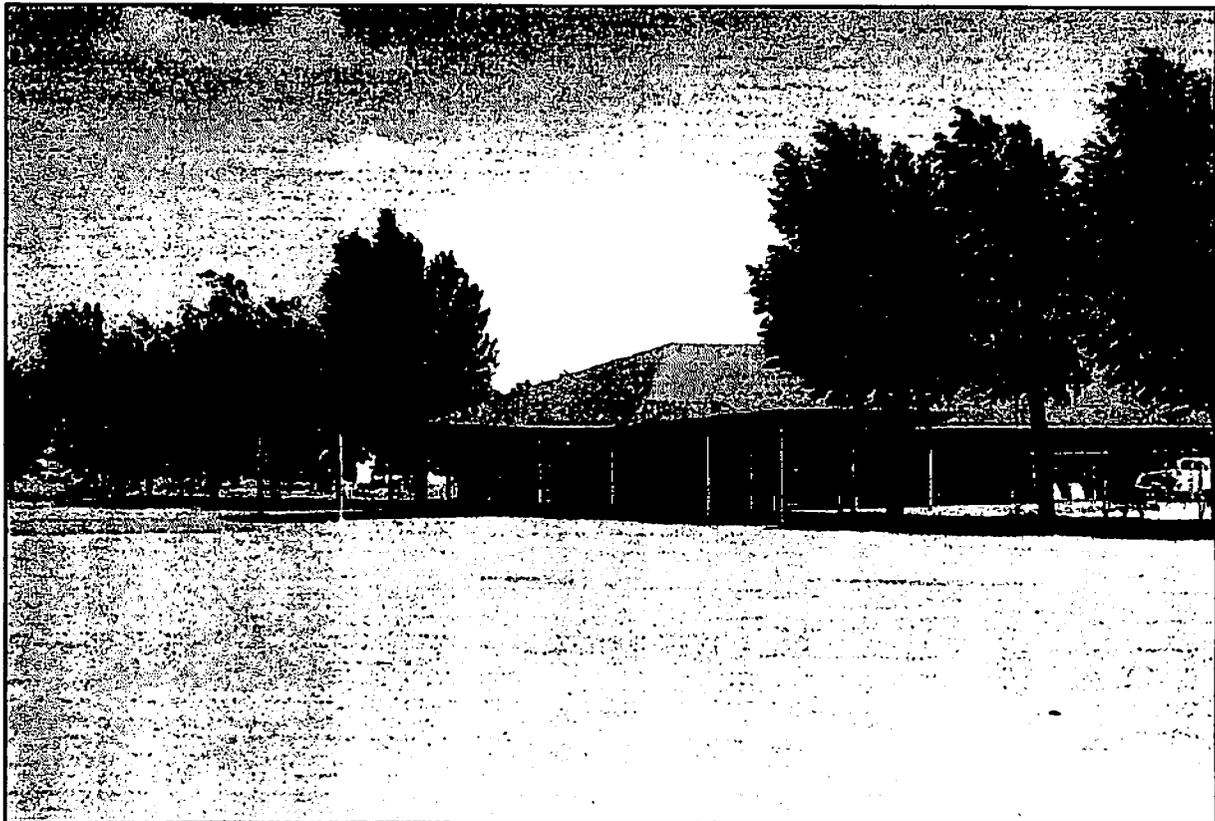
Figure 8-3: Cactus Motor Lodge office, ca. 1960 (Courtesy Quay County Museum)

to adding the Perma-Stone, Wegner also closed the dance hall and converted it into the office and manager's residence (Figure 8-3).¹⁹

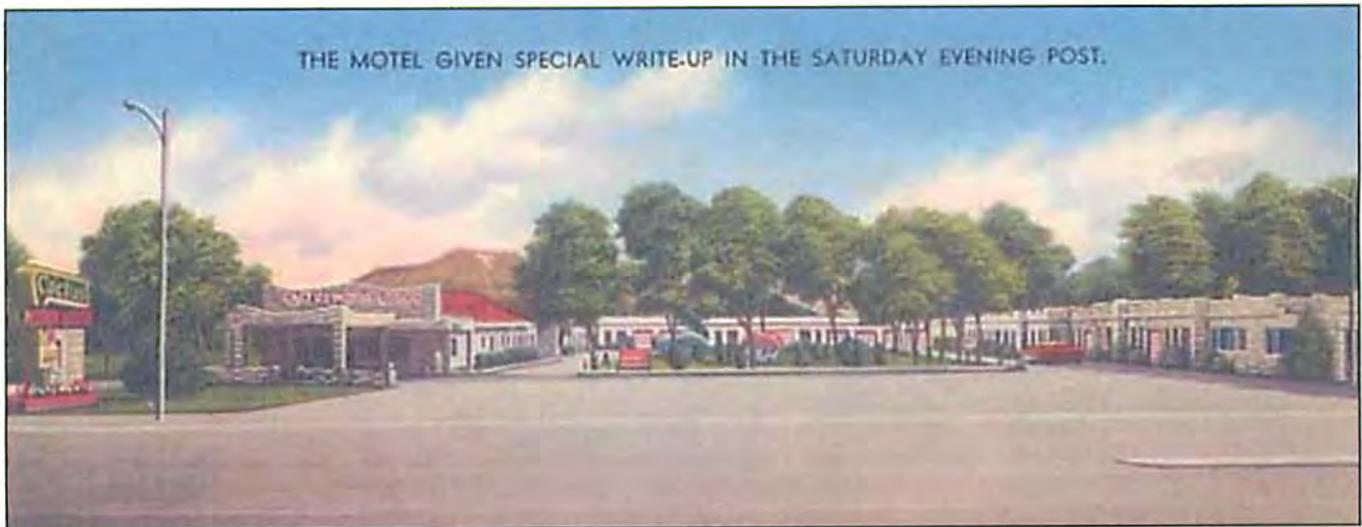
Figure 8-3: This ca. 1955 view of the Cactus Motor Lodge shows the new office location in the Cactus Club building and the exteriors covered with Perma-Stone. (Courtesy of Andy Patel).
